A High Confidence Reserve Determination Study for Surface Water, Groundwater and Wetlands in the Upper Orange

WP11343 Final Wetland Report

REPORT NO.:
RDM/WMA13/00/CON/COMP/0922
November 2022

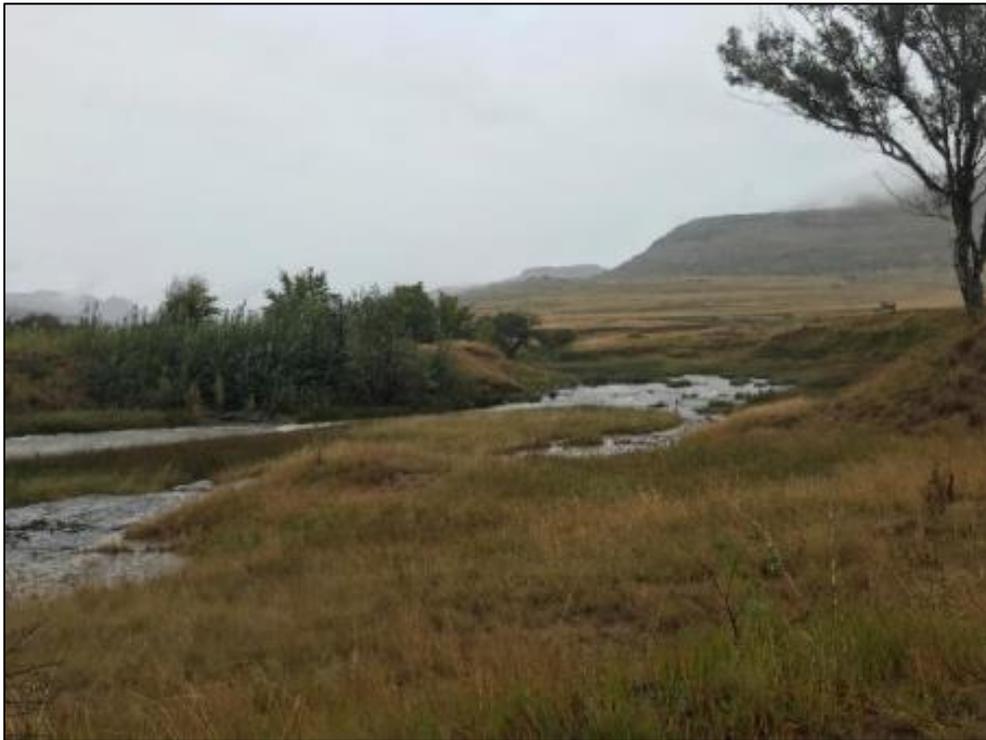
Figure 4-3 Deeply incised and widened channel of the Brandwater River as it flows out of the southern portion of the WRU 02 wetland.

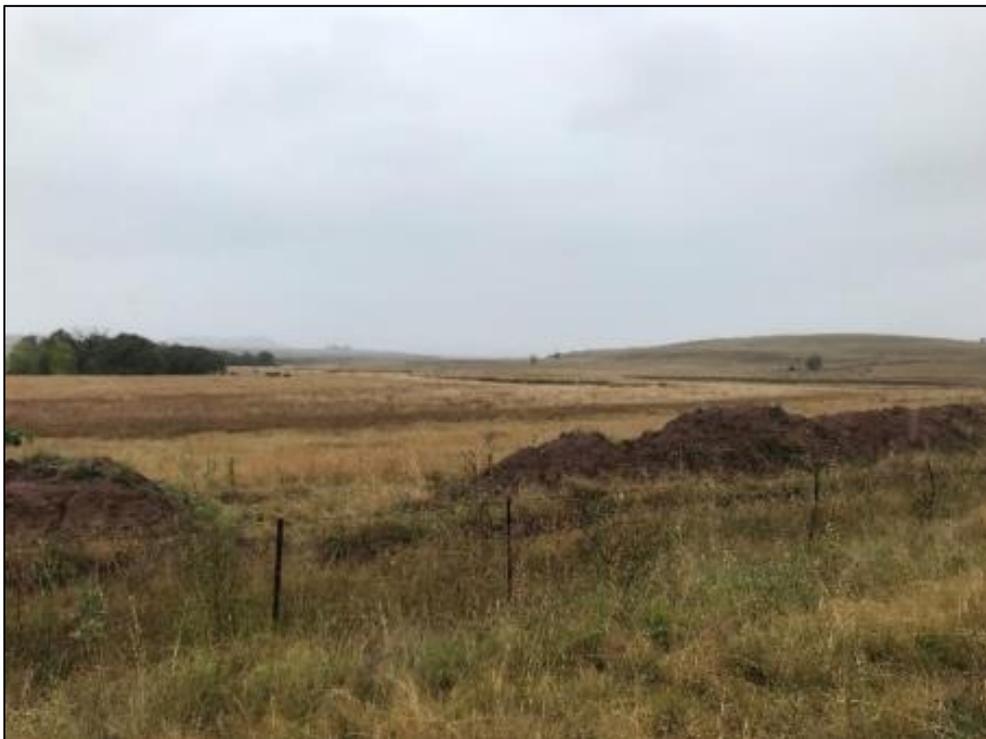
Figure 4-4 Large flood-out features maintained by lateral processes as indicated by darker patches of vegetation in the central and right-hand side of the photograph.

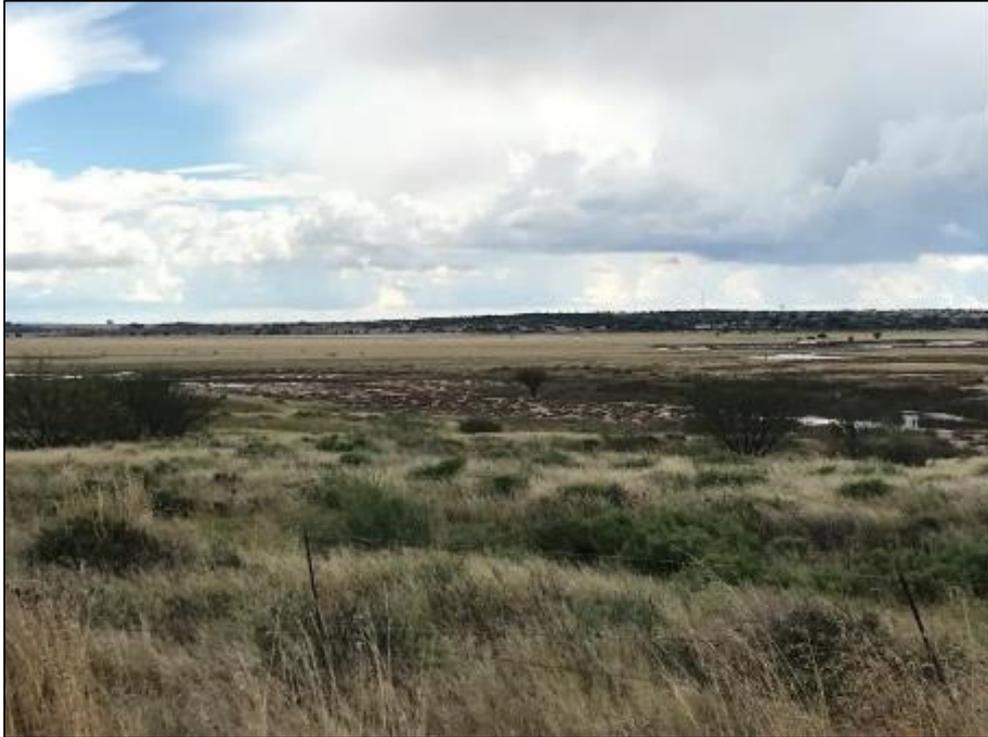
Figure 4-6 Picture of Soutpan with evidence of vegetation clearing in the foreground in preparation to set up a salt mining operation, and an active salt mining operation located to the right of the photograph.

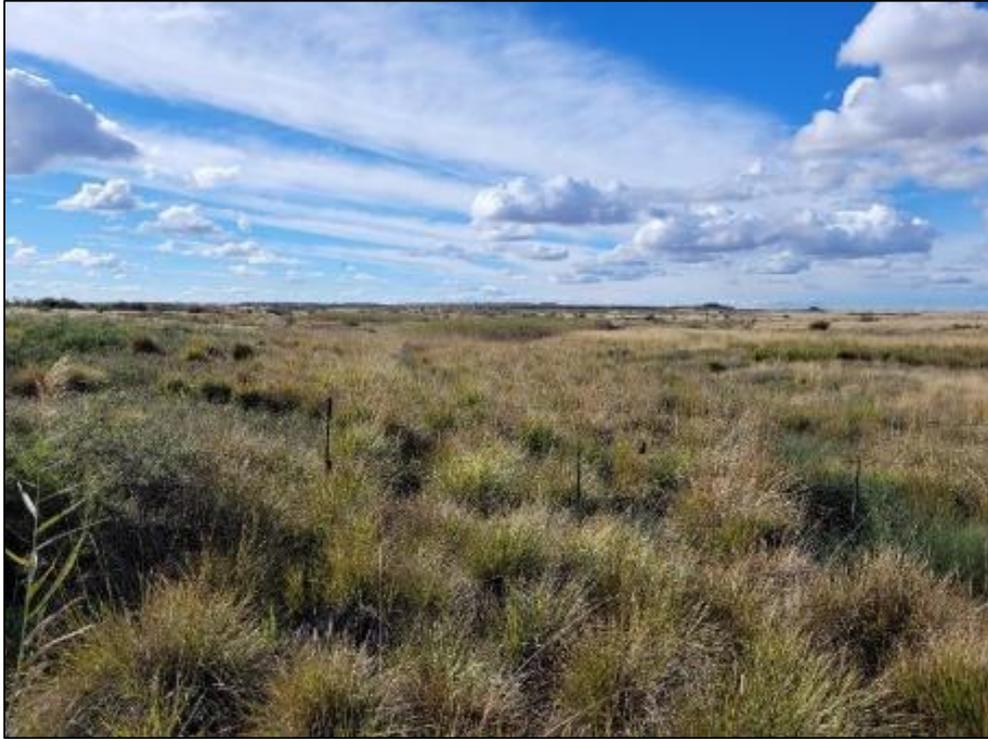
Figure 4-8 Extensive *Phragmites australis* reedbed located downstream of road crossing with extensive stands of *Miscanthus capensis* along the valley-bottom wetland.

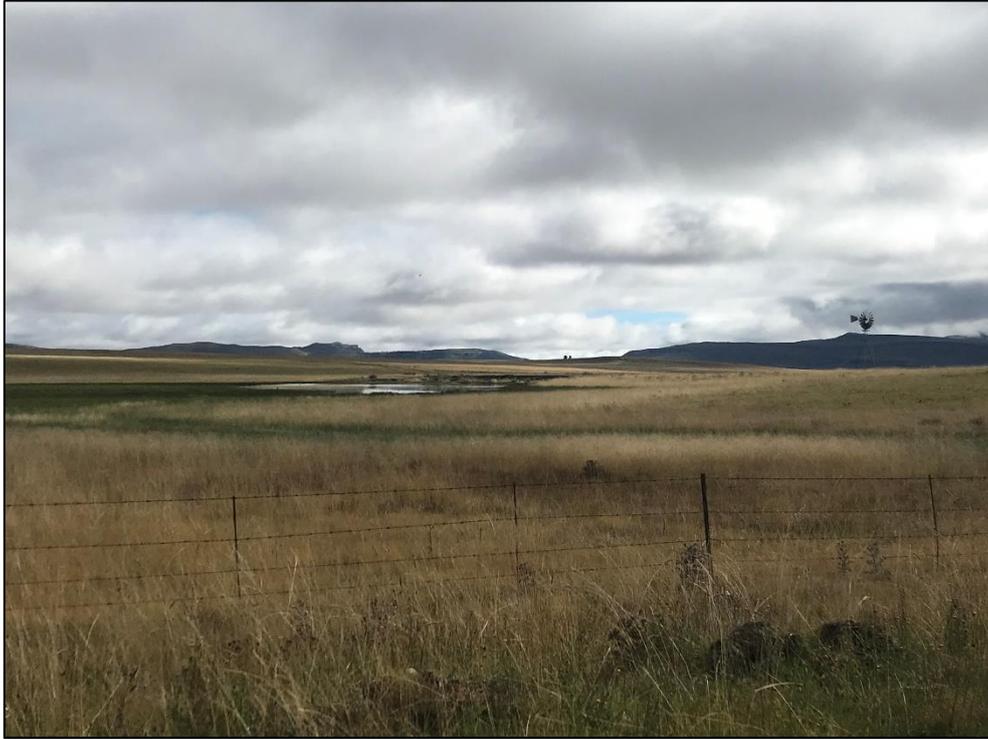
Figure 4-10 Extensive wetland area upstream of a small farm dam visible in the centre of the photograph. A windmill can be seen on the right-hand side of the picture.

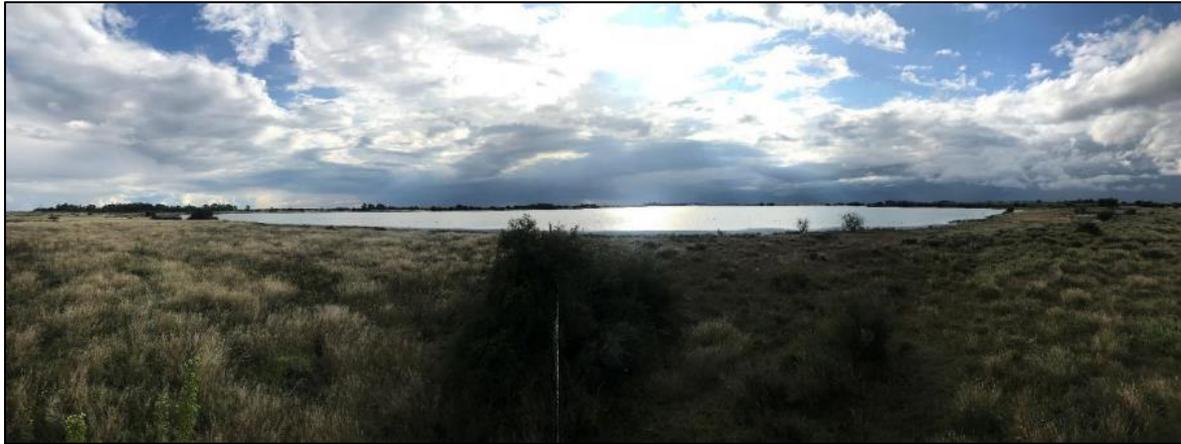
Figure 4-15 Large depression wetland forming a part of WRU11. This depression wetland is unique in that it receives water from the main valley-bottom wetland at its head and feeds water back into the valley-bottom wetland at its toe.

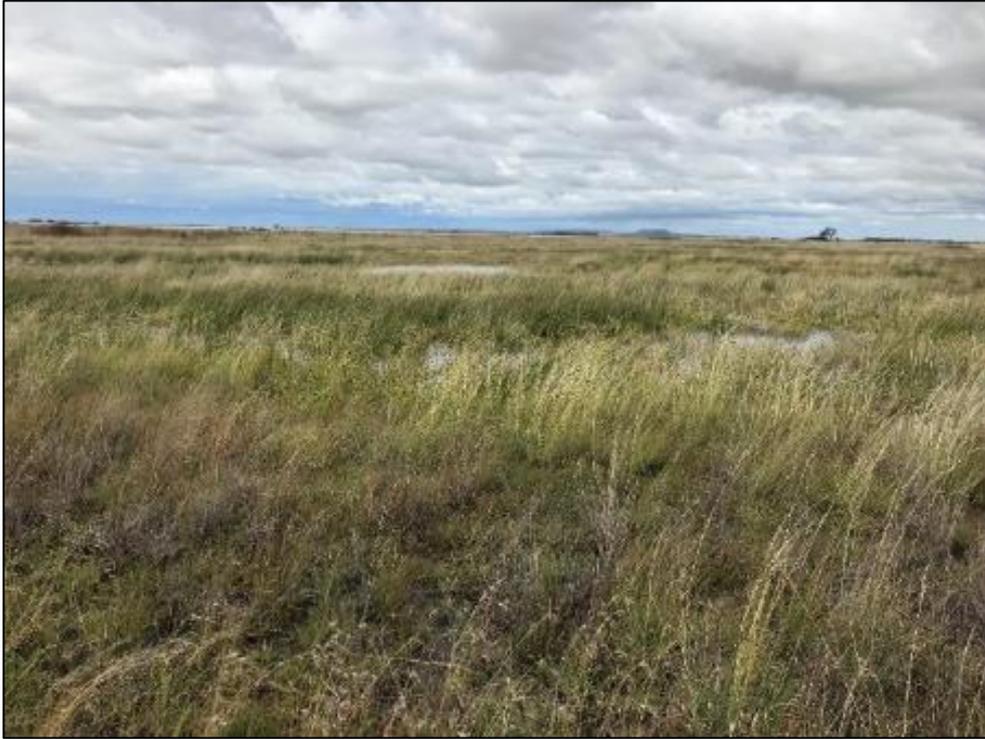
Figure 4-18 Middle section of the large wetland flat looking upstream. Extremely flat topography with extensive areas of standing water due to recent heavy rains in the region

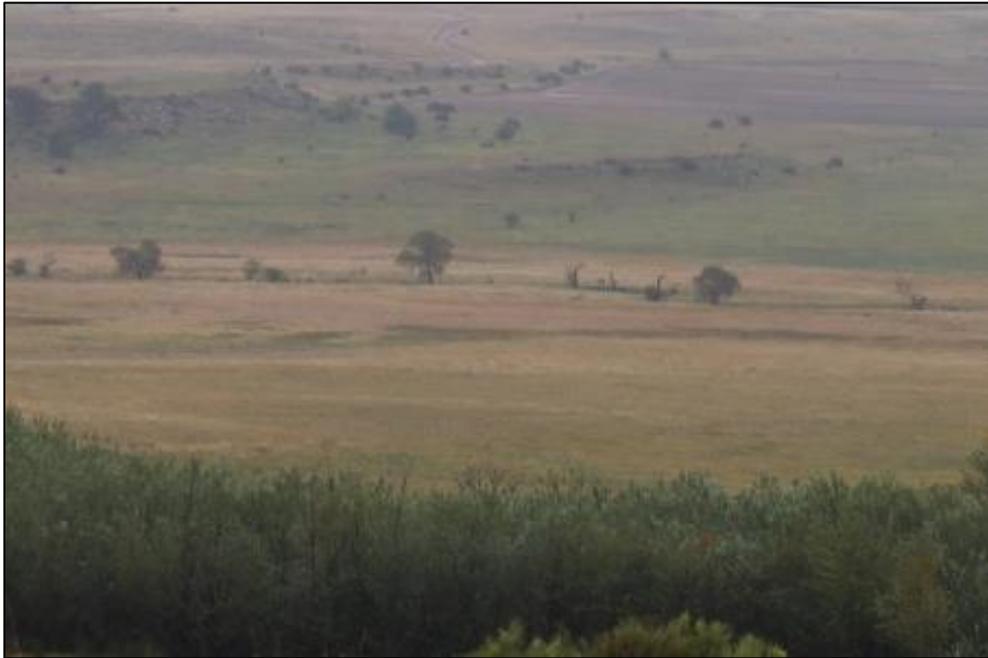
Figure 4-20 Middle section of the floodplain wetland before it loses confinement. Dark patches adjacent to the channel indicate wetland vegetation and lateral seep processes that support wetland habitat. Trees along the channel are *Salix babylonica*.

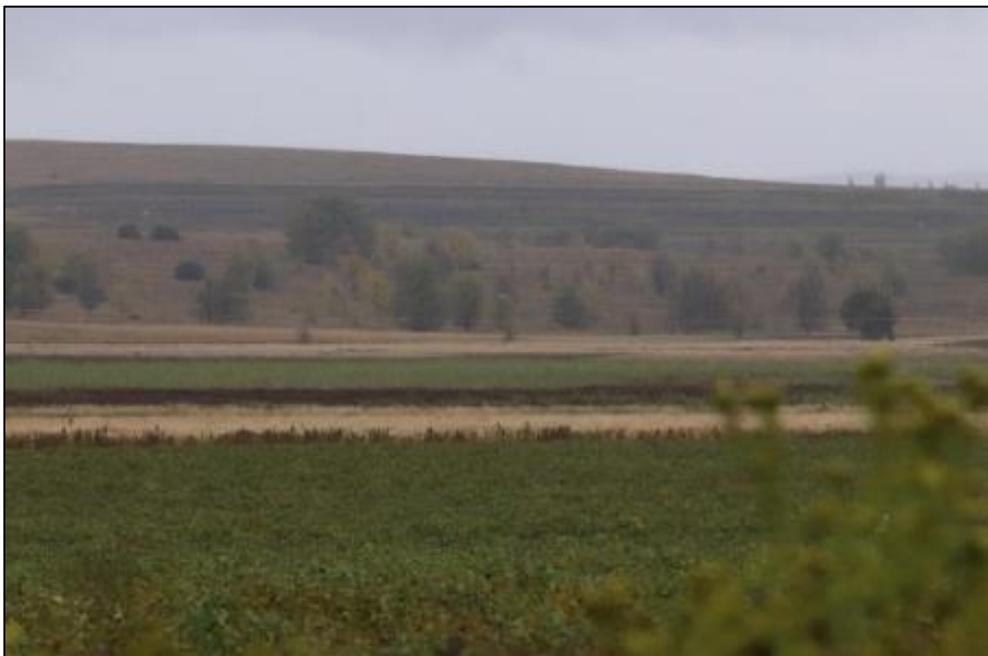
Figure 4-21 Picture taken from the toe of the wetland looking upstream. Green fields in the foreground are cultivated land. The green band in the middle of the picture is the extensive unchannelled valley-bottom and reedbed.

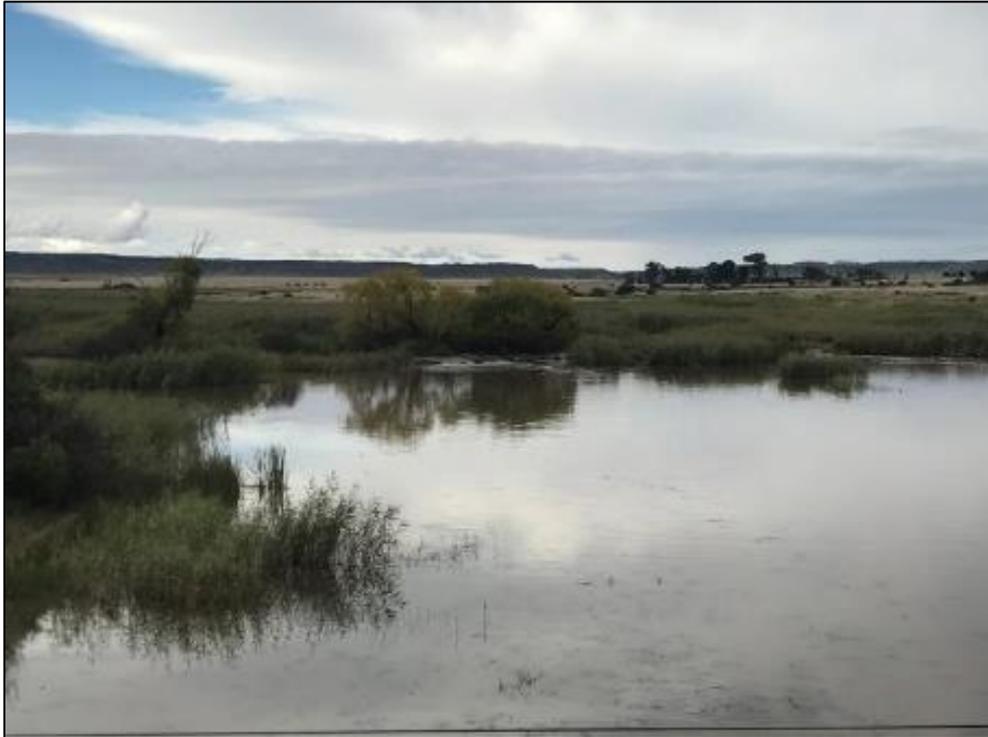
Figure 4-23 Large reedbed at the confluence of the four valley-bottom wetlands.

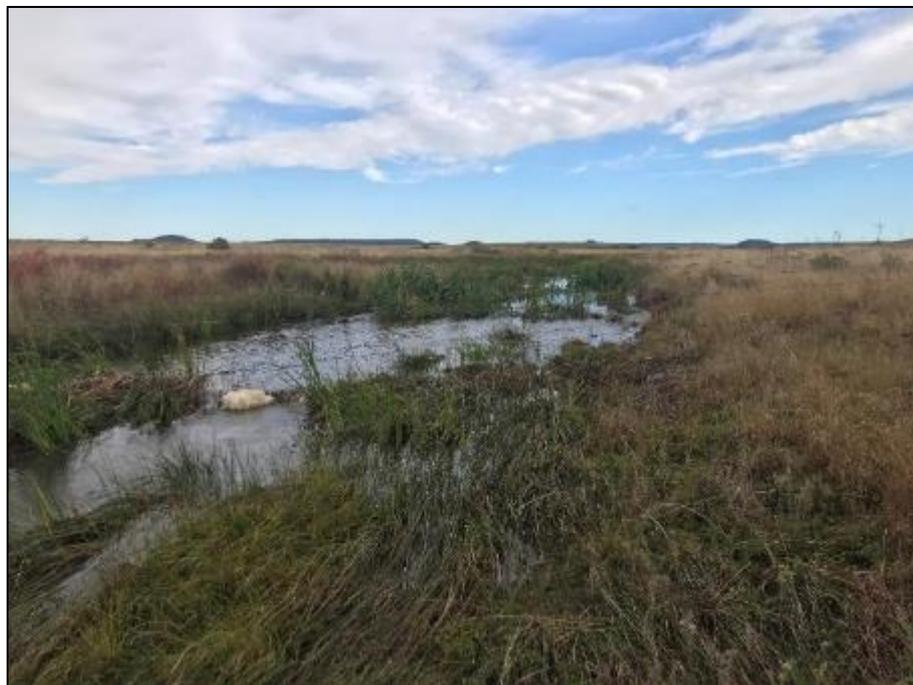
Figure 4-24 Photograph of the northern-most wetland arm with foam and signs of pollution evident within the channel

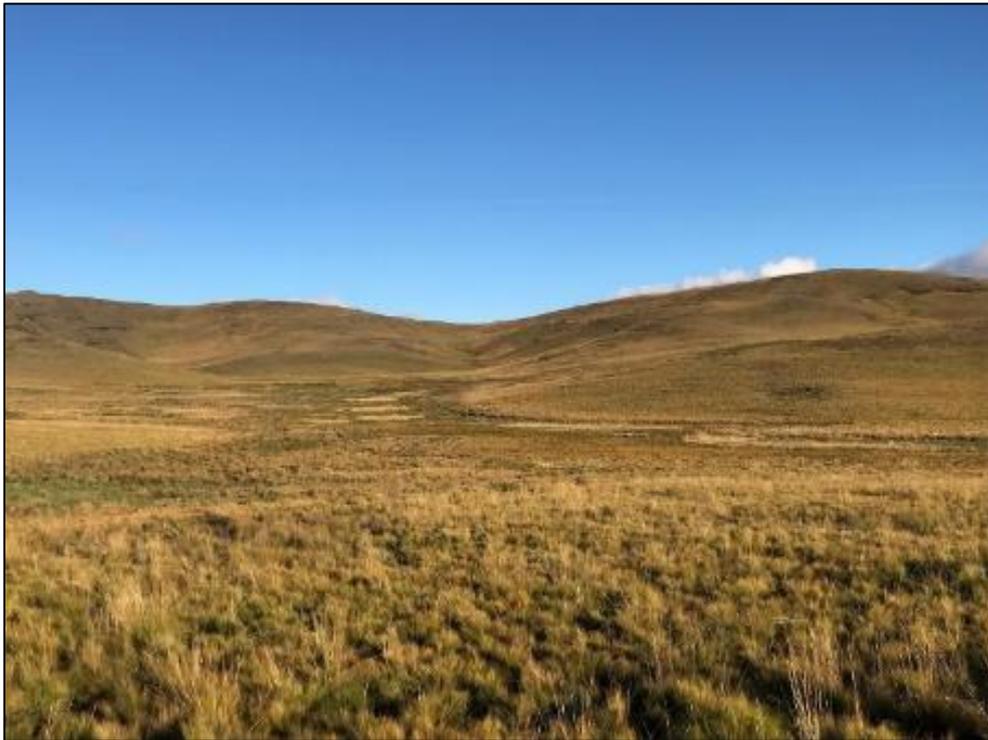
Figure 4-27 Broad valley-bottom wetland with some seeps feeding into it. The darker colour in the landscape indicates the approximate valley-bottom wetland extent.

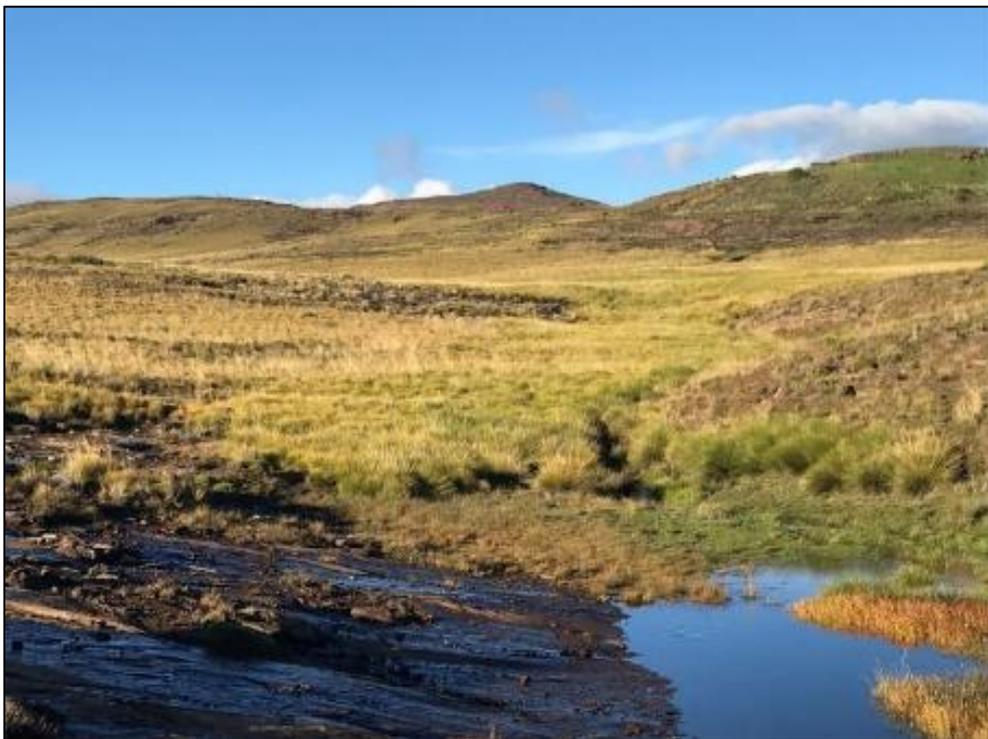
Figure 4-28 An example of an intact hillslope seep wetland dominated by *Merxmuellera disticha*.
