**RESERVE DETERMINATION STUDY FOR SELECTED SURFACE WATER,
GROUNDWATER, ESTUARIES AND WETLANDS IN THE F60 AND G30 CATCHMENTS
WITHIN THE BERG-OLIFANTS WMA**

WP11340

Water Quality Survey Report

3-4 April 2022

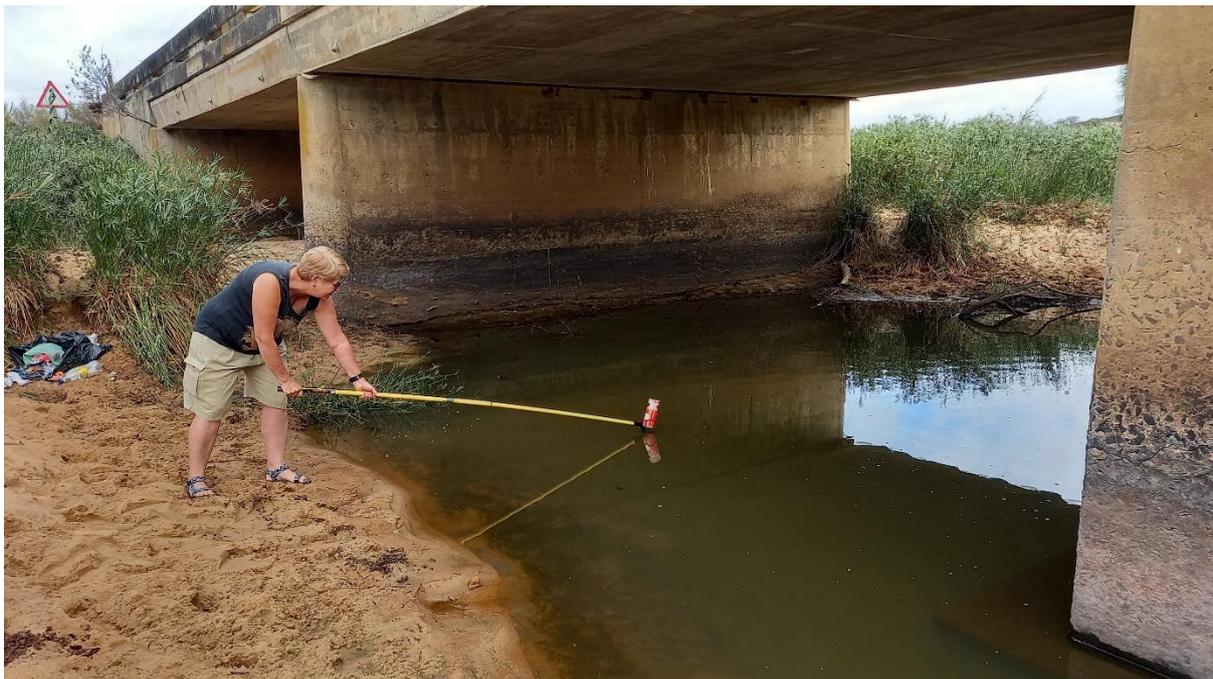
Figure 1: Sampling equipment used

One surface water sample was then collected at each site by lowering the sample bottle into the water to just below the water surface for the chemical analysis of the sample. Care was taken not to disturb the bottom sediment during sampling. The constituents to be analysed for, are pH, Electrical Conductivity, Total Dissolved Salts, Turbidity, Total Suspended Solids, orthophosphate, ammonia, nitrate and nitrite. The photograph below shows the equipment used.

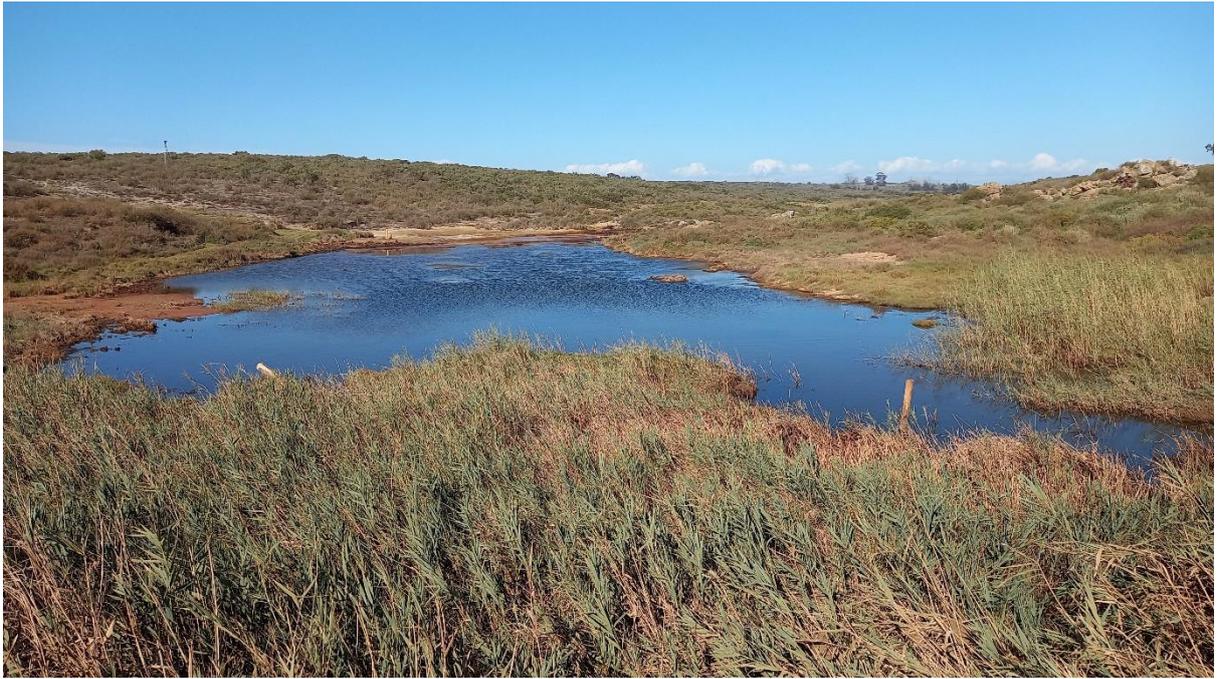
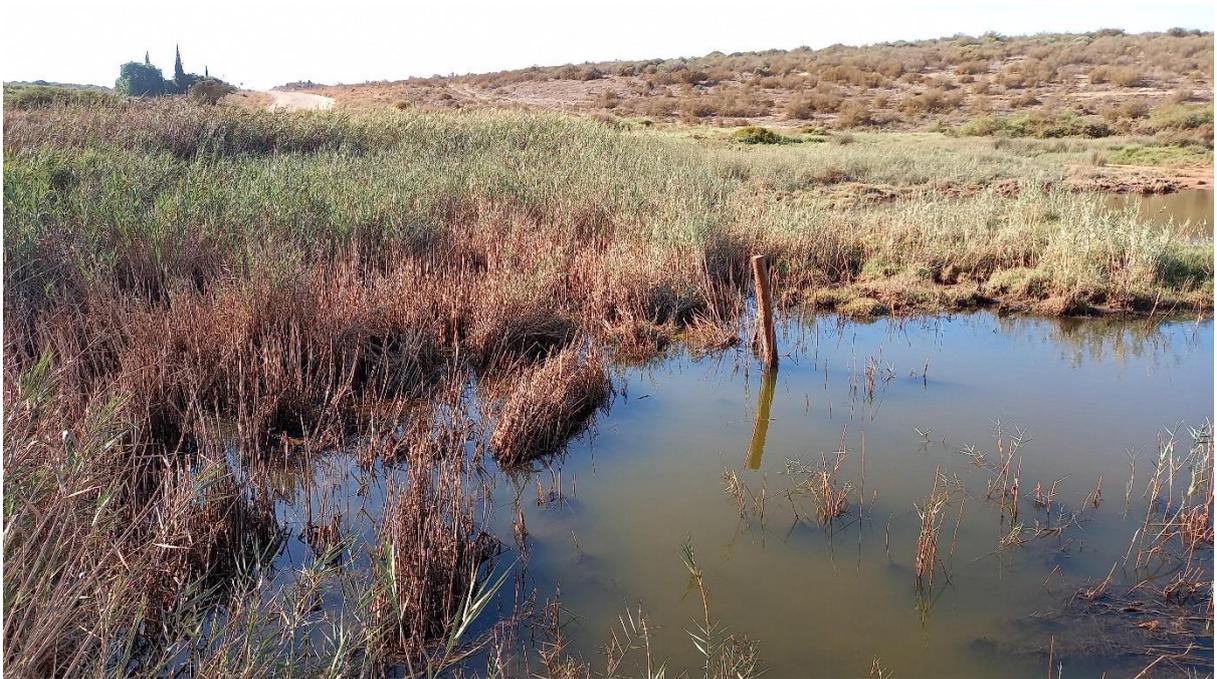
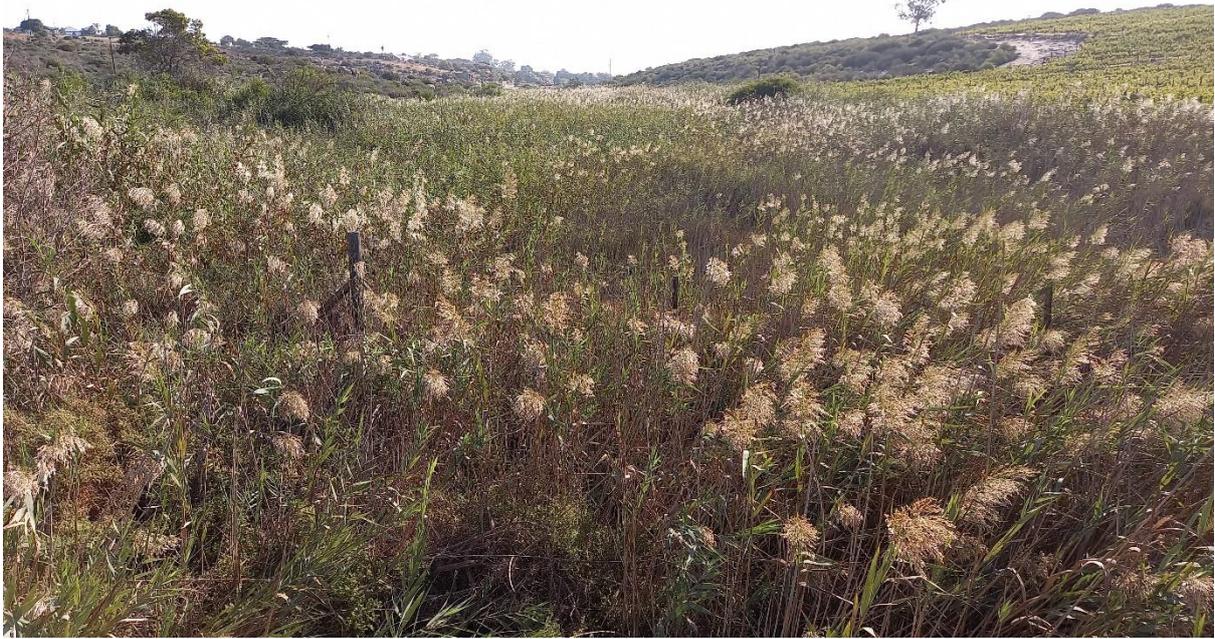
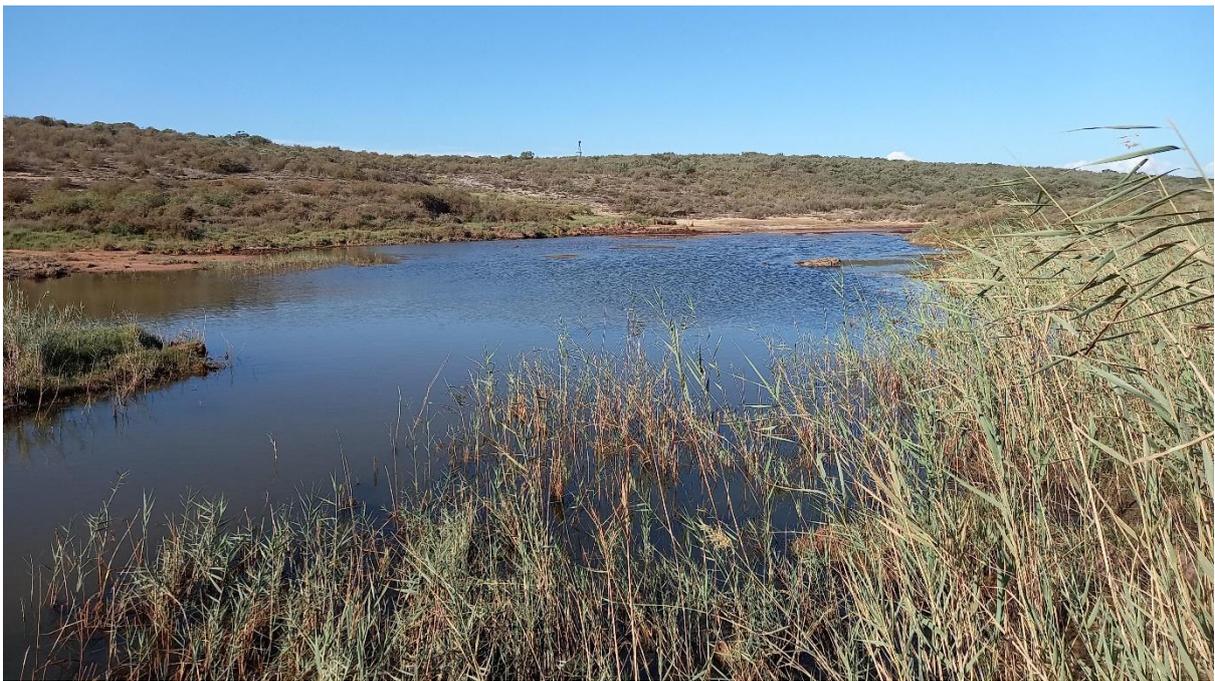
Sampling point: EWR 7 RW – G30G JAKK KOOKF		Date:3 April 2022
Weather conditions @15:25		
Air temperature	Warm (20-30°C)	
% Cloud cover	0-25%	
Days since last rain	Not within last seven days	
Wind	Light	
In-situ measurements		
Water temperature °C	24.3	24.6
Dissolved Oxygen mg/l		17.4 ¹
Electrical conductivity µS/cm	19.99 (upper limit of instrument)	66.3 mS/cm
TDS mg/l	10.0 (upper limit of instrument)	
pH	7.9	
Visual observations		
Water clarity	Slightly muddy	
Colour	Colourless/clear	
Flow	Still/calm	
Algae on rocks	No rocks, no algae visible	
Foam	None visible	
Oily Sheen	None visible	
Odour	No smell	
Other observations	The pool is used as a cattle watering hole

¹ Incorrect measurement. High salinity interferes with the accuracy of the DO sensor.

Figure 2: EWR 7

Figure 3: Closeup of the water at EWR 7

Figure 4: Downstream view of EWR 7

Figure 5: Upstream view of EWR 7

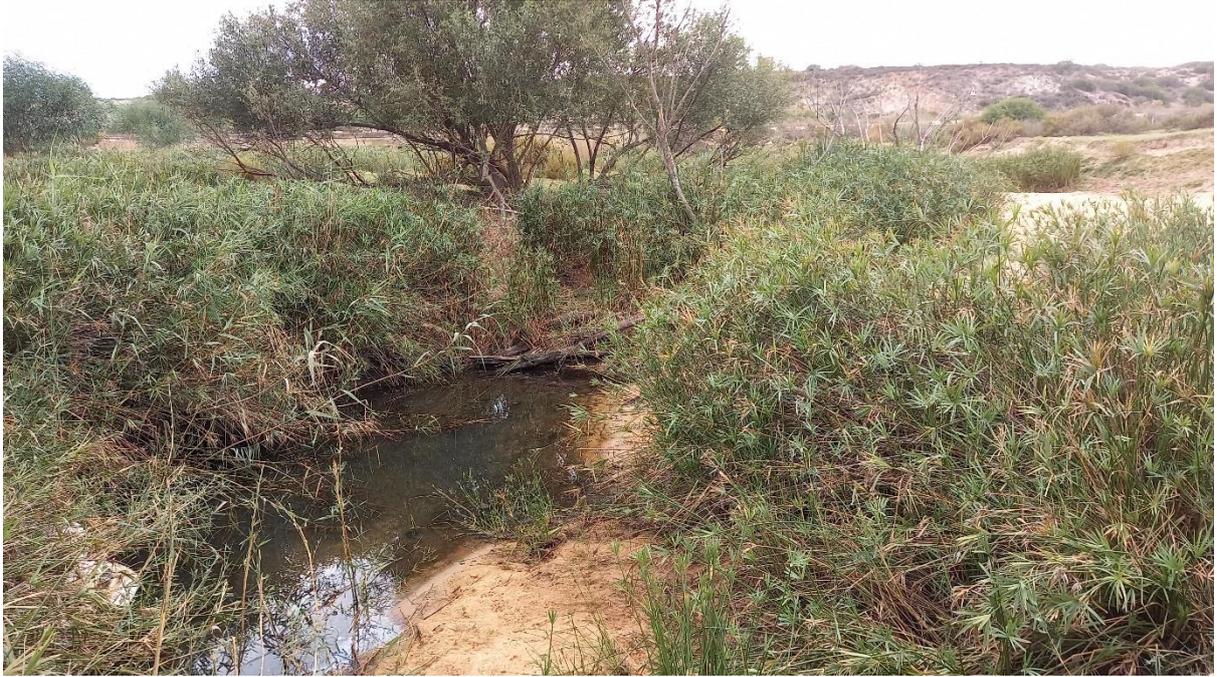
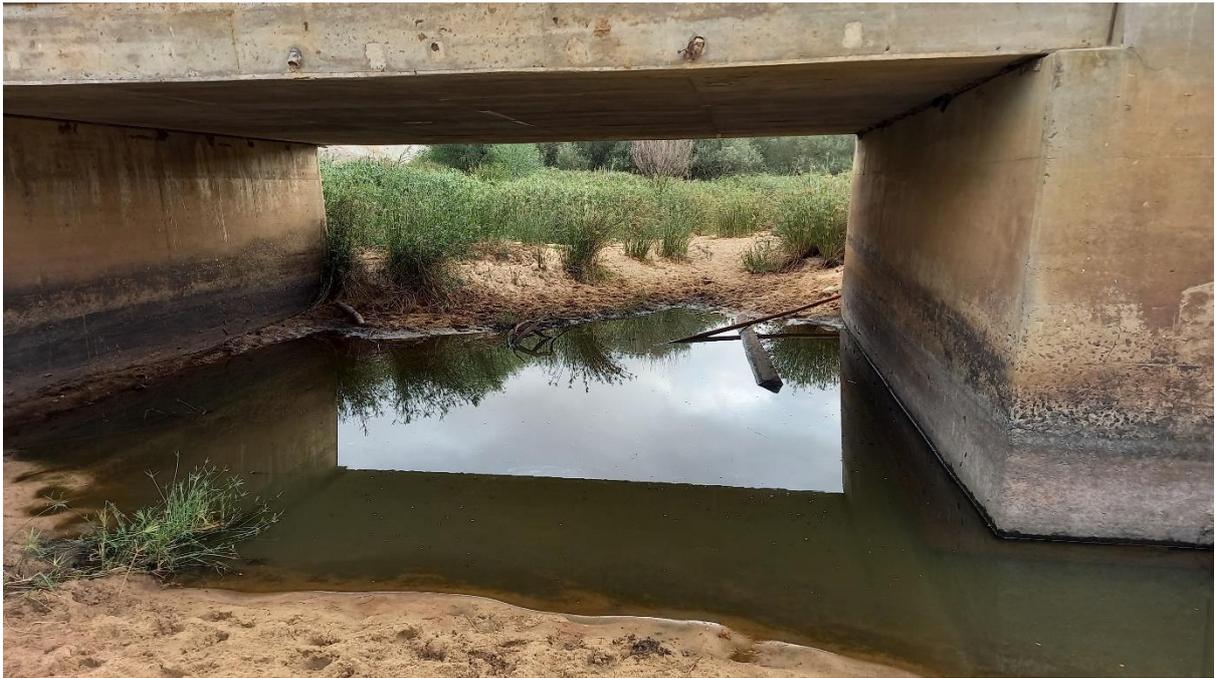
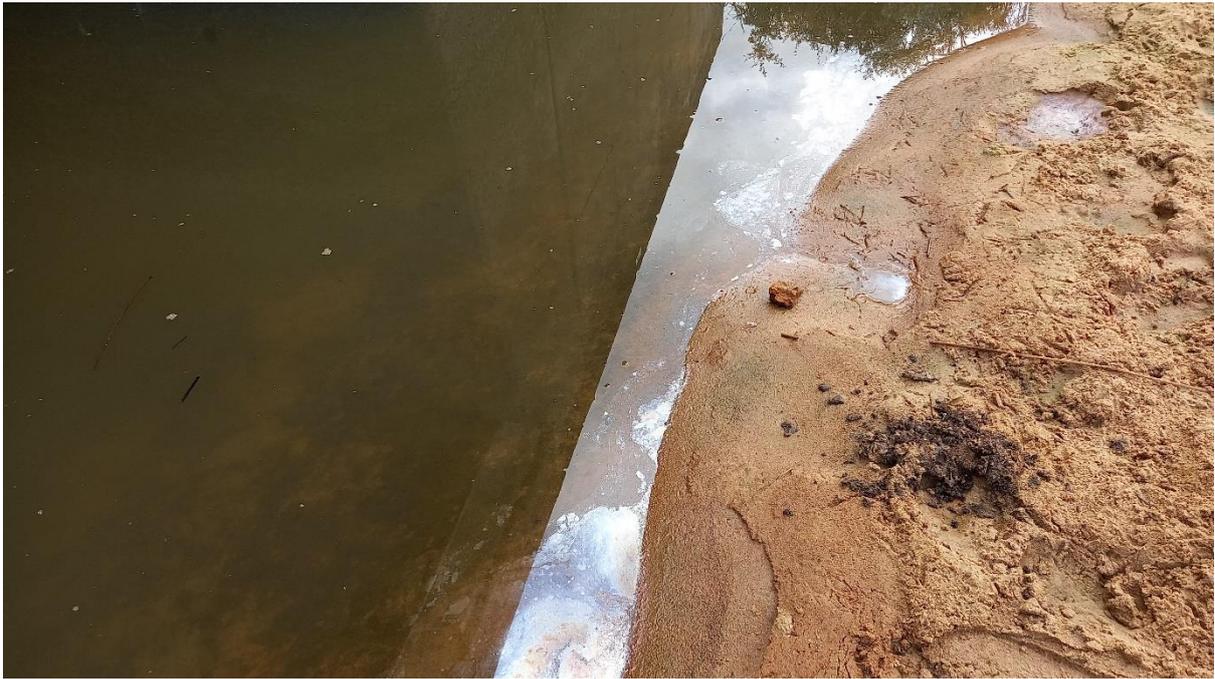
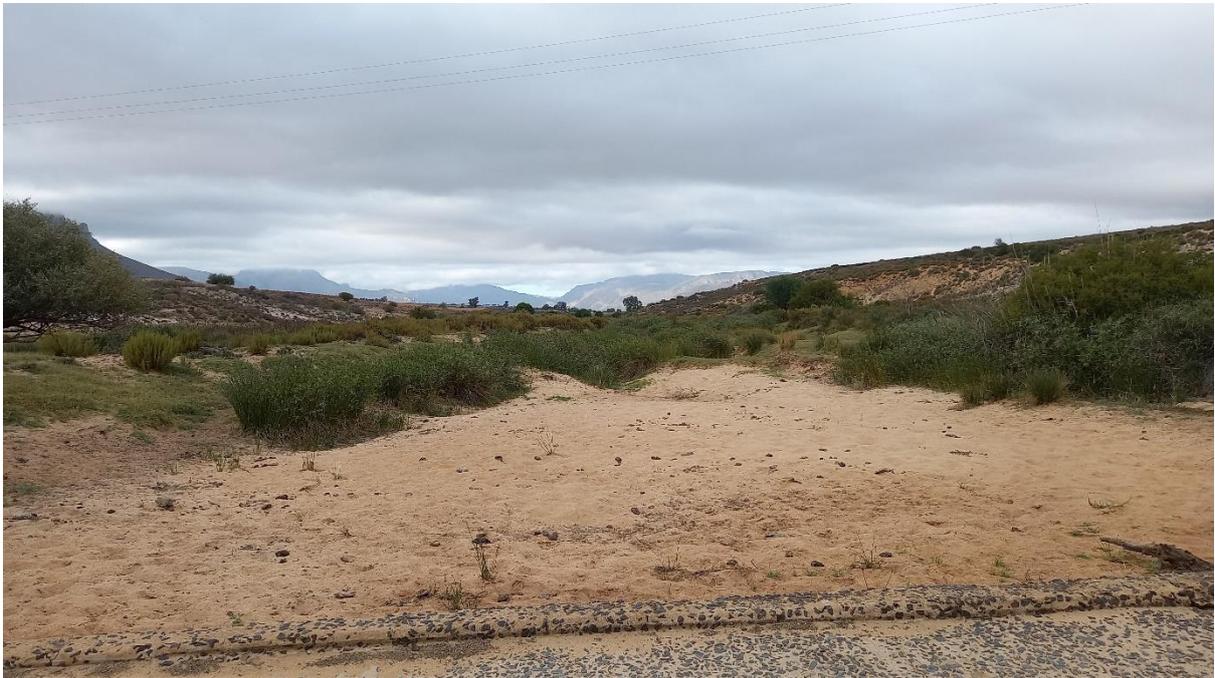
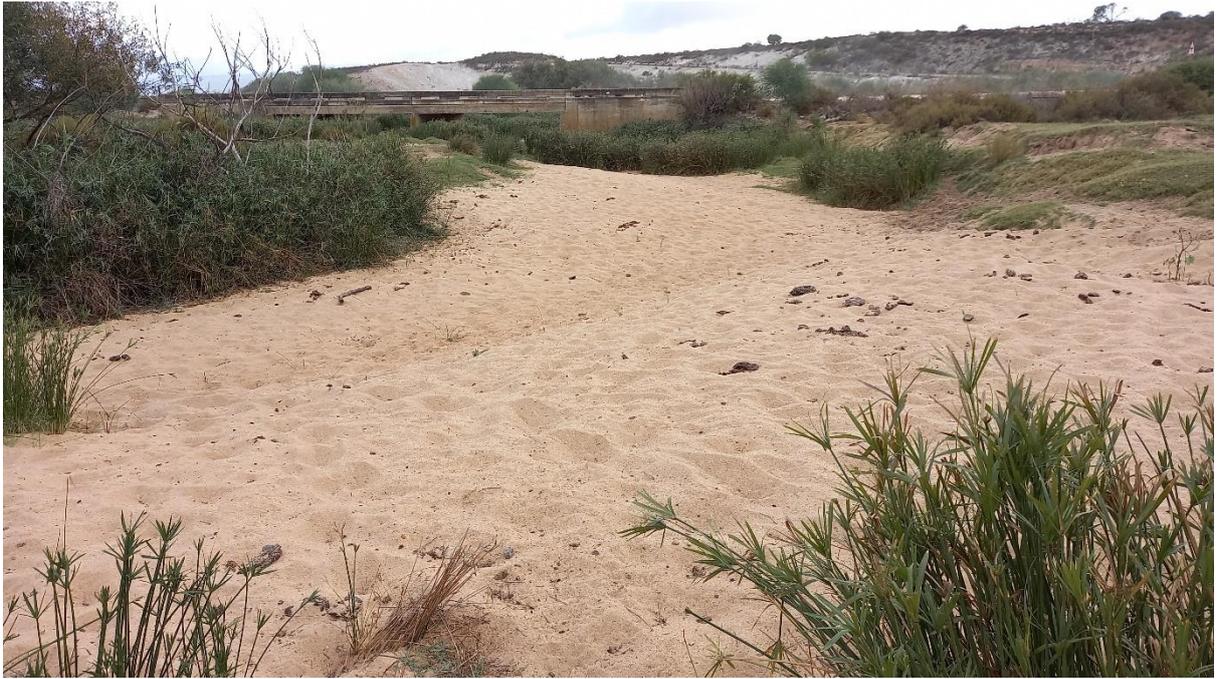
Sampling point: EWR 11 RW-G30D KROM GOERG		Date:4 April 2022
Weather conditions @ 09:20		
Air temperature	Warm (20-30°C)	
% Cloud cover	50-75%	
Days since last rain	Not within last seven days	
Wind	None	
In-situ measurements		
Water temperature °C	17.8	17.8
Dissolved Oxygen mg/l		4.3
Electrical conductivity µS/cm	1622	1.585 mS/cm
TDS mg/l	1.05	
pH	7.4	
Visual observations		
Water clarity	Clear	
Colour	Colourless/clear	
Flow	Still/calm	
Algae on rocks	No rocks, no algae visible	
Foam	None visible	
Oily Sheen	Some visible	
Odour	No smell	
Other observations	<p>There were two pools at this site (one downstream of the low water bridge and one underneath the bigger road bridge) and both are used as cattle watering holes. Field measurements were taken at both pools, but they were almost identical, so a water quality sample was taken only at the pool underneath the bigger road bridge. An oily sheen was observed at this site which is typical of the sheen imparted by iron in groundwater seeping into the pool.</p>

Figure 6: One of the pools at EWR 11 downstream of the low water bridge

Figure 7: The pool at EWR 11 underneath the road bridge

Figure 8: A closeup of the water at EWR 11 showing the oily sheen on the surface of the water where sub-surface flow seeps into the pool

Figure 9: Upstream view from EWR 11

Figure 10: Downstream view of EWR 11

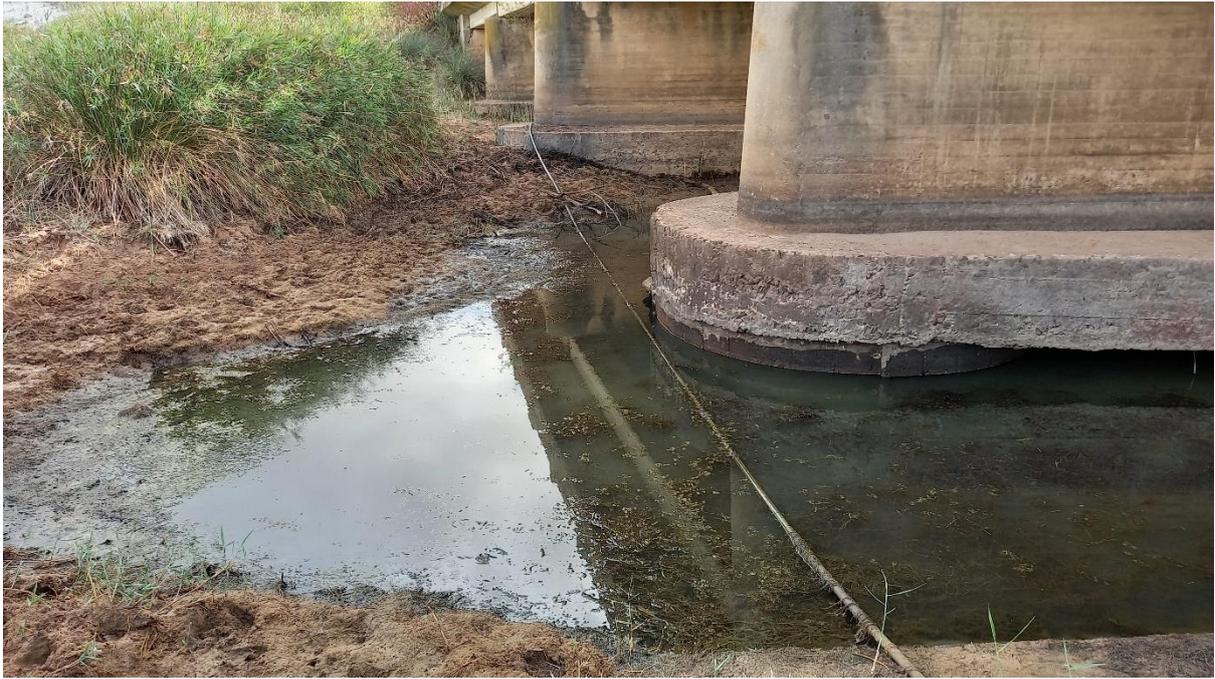
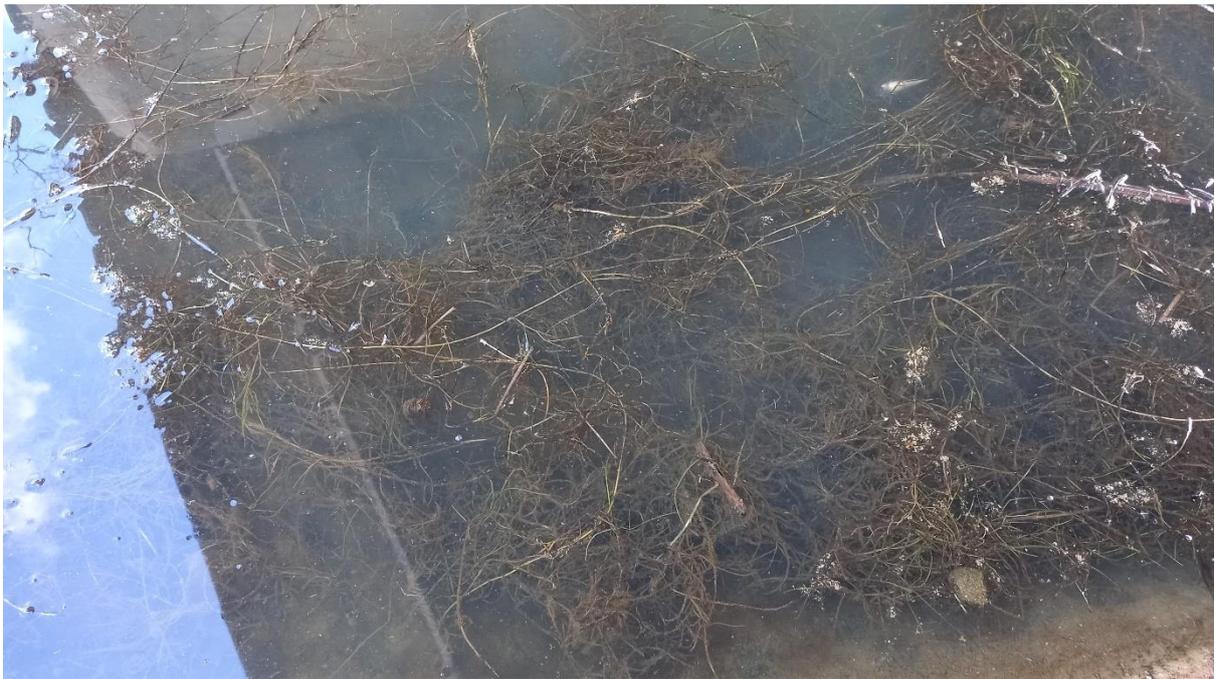
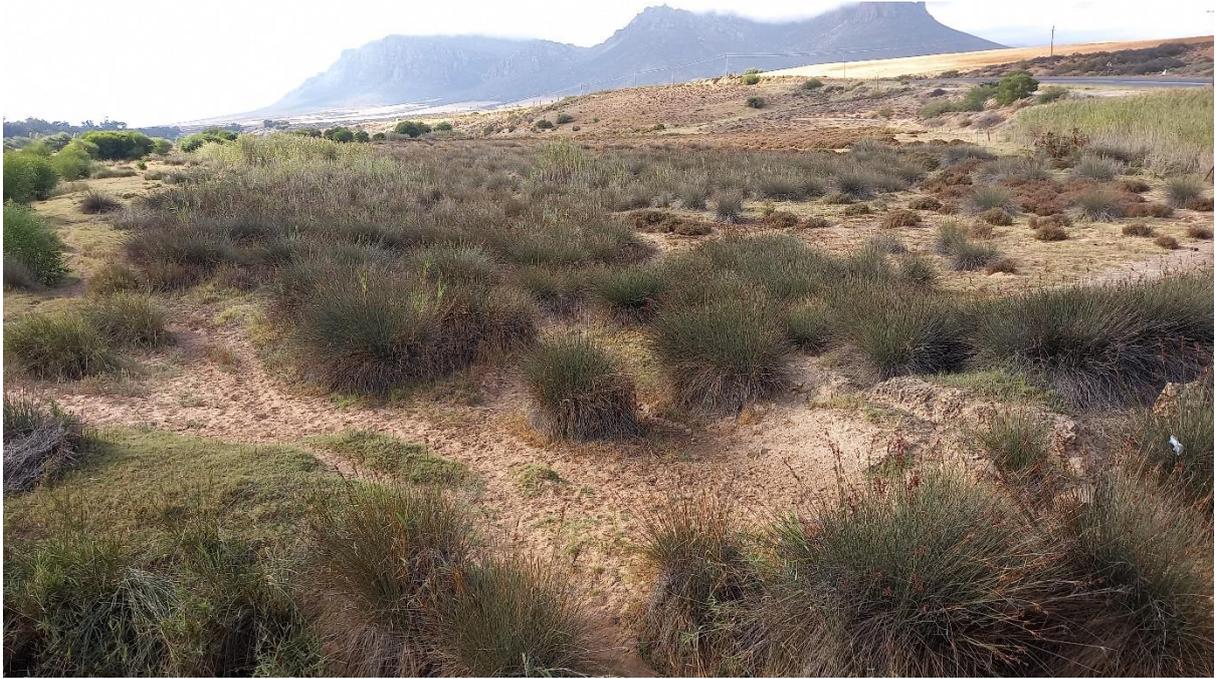
Sampling point: EWR 10 RW-G30D VERL EENHE		Date:4 April 2022
Weather conditions @ 09:55		
Air temperature	Warm (20-30°C)	
% Cloud cover	25-50%	
Days since last rain	Not within last seven days	
Wind	None	
In-situ measurements		
Water temperature °C	18.4	18.4
Dissolved Oxygen mg/l		2.1
Electrical conductivity µS/cm	10.79	10.64
TDS mg/l		
pH	7.65	
Visual observations		
Water clarity	Clear	
Colour	Colourless/clear	
Flow	Still/calm	
Algae on rocks	No rocks, no algae visible	
Foam	None visible	
Oily Sheen	Some visible	
Odour	No smell	
Other observations	The pool is used as a cattle watering hole. The pond was filled with possibly Fennel leaved pondweed (<i>Stockenia pectinatus</i>). There was also one small dead fish.

Figure 11: The pool at EWR 10

Figure 12: A closeup of the water at the pool at EWR 10 showing the dense stand of probably Fennel leaved pondweed

Figure 13: Upstream view of EWR 10

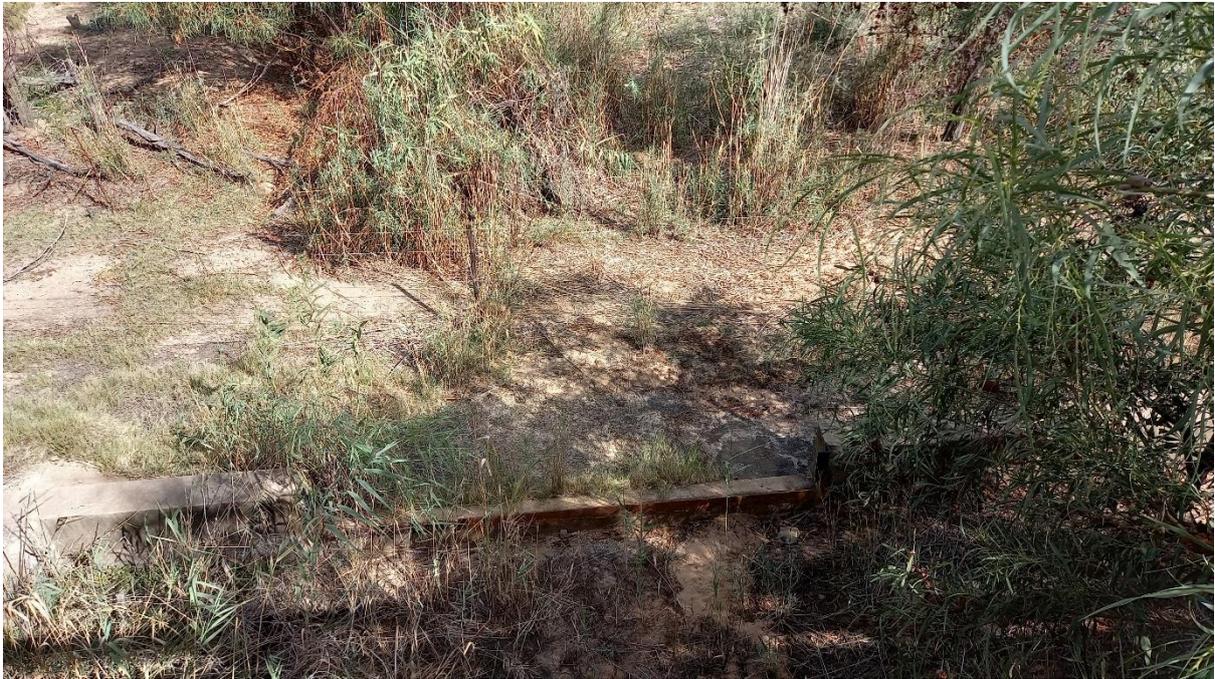
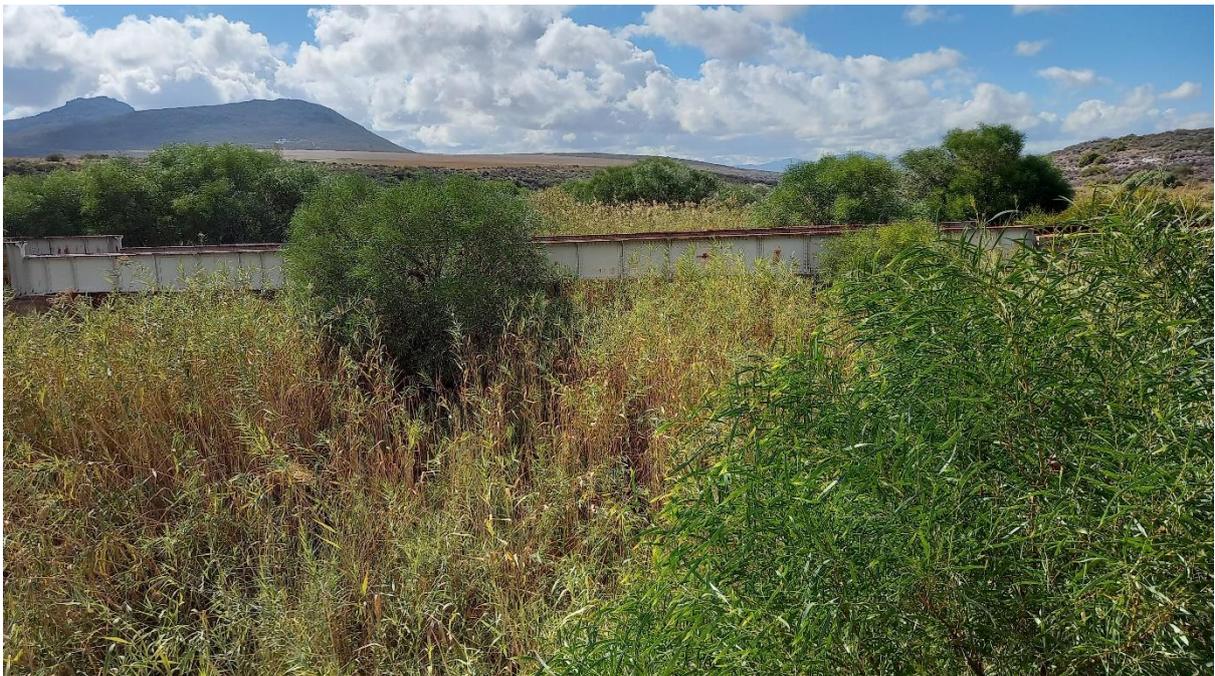
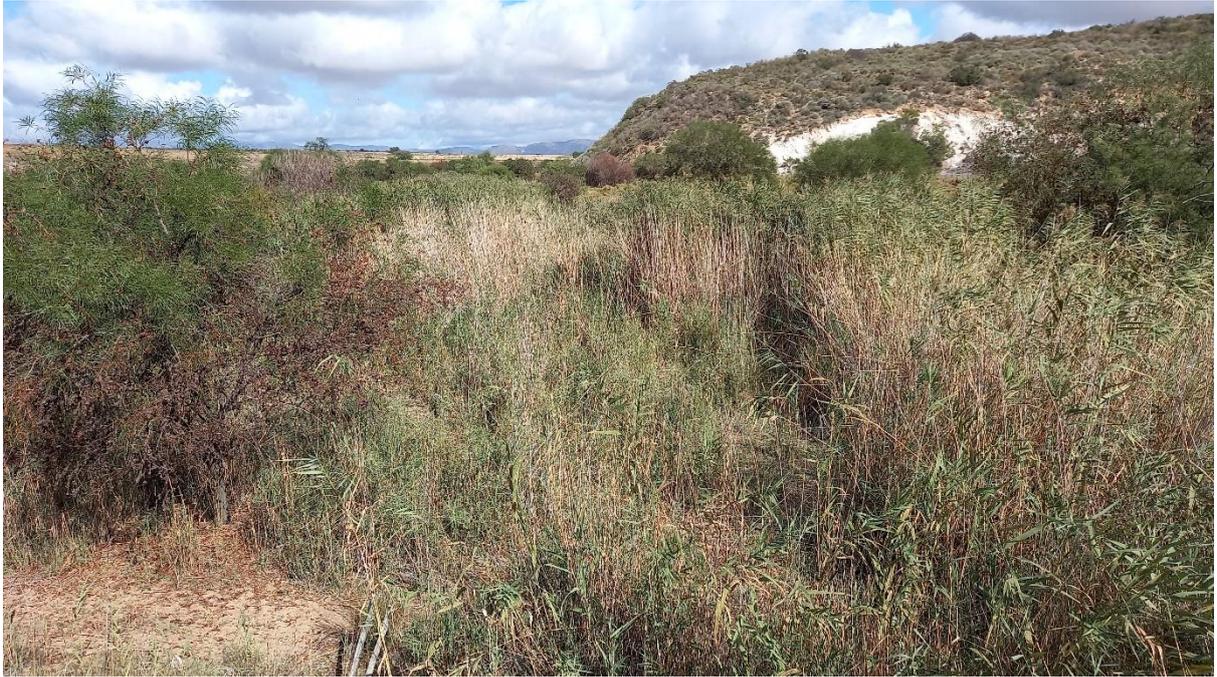
G3H001 Kruis River at Tweekuilen/Eendekuil

The gauging station, G3H001 (Kruis River at Tweekuilen/Eendekuil), was also visited, but as with many of the other sites, it was dry with no visible surface water. See Figures 14 to 16.

Figure 14: The gauging weir at G3H001.; the Kruis River at Tweekuilen/Eendekuil

Figure 15: Upstream view from the gauging weir

Figure 16: Downstream view from the gauging weir

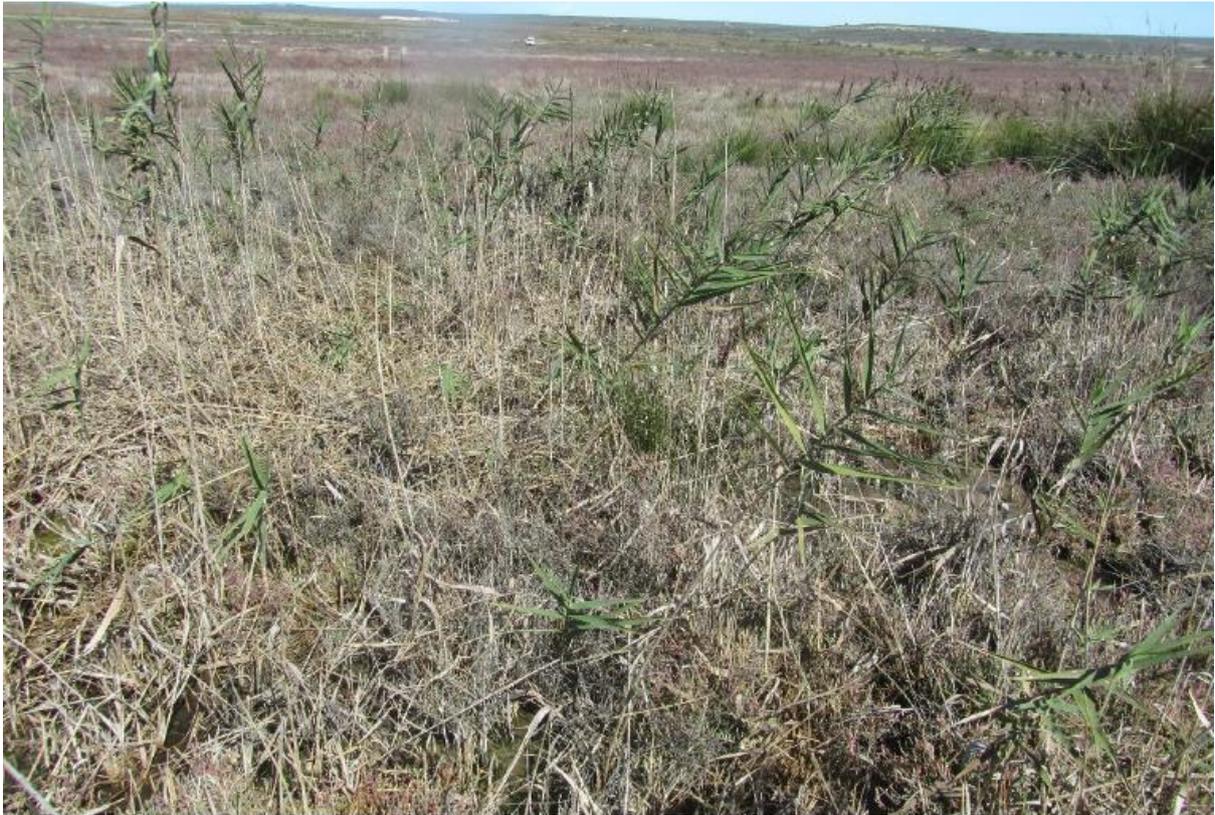
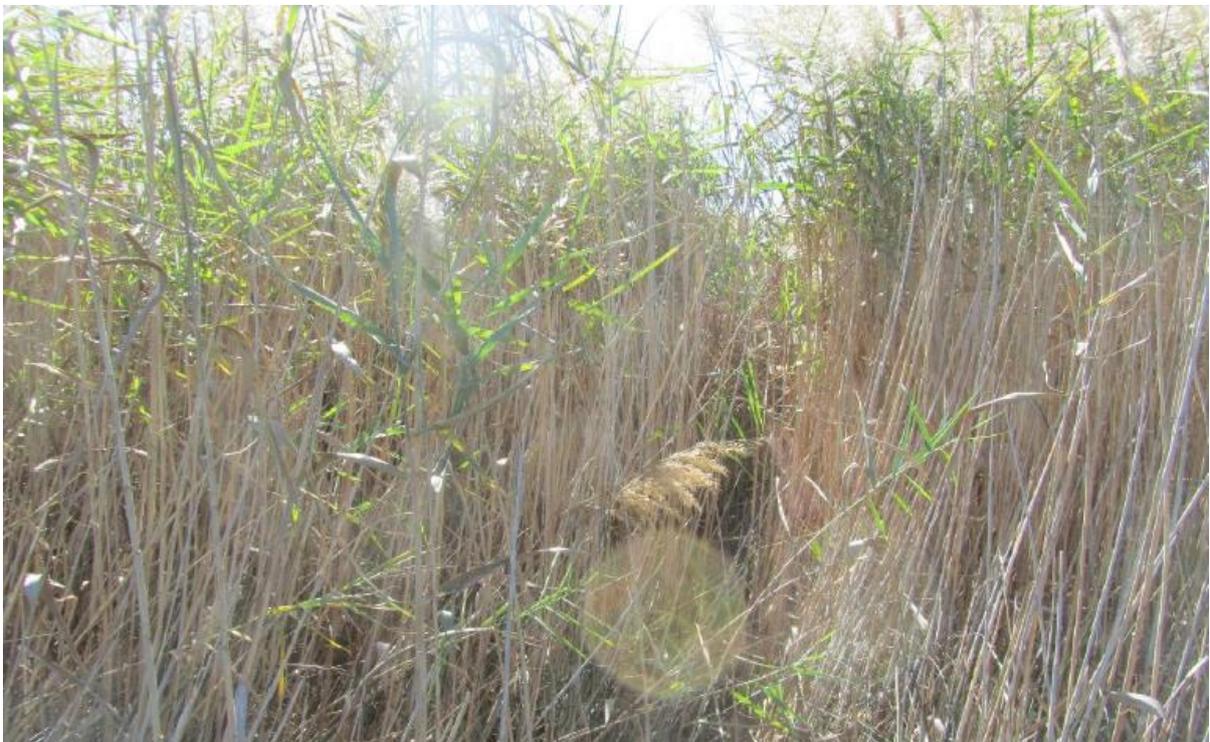
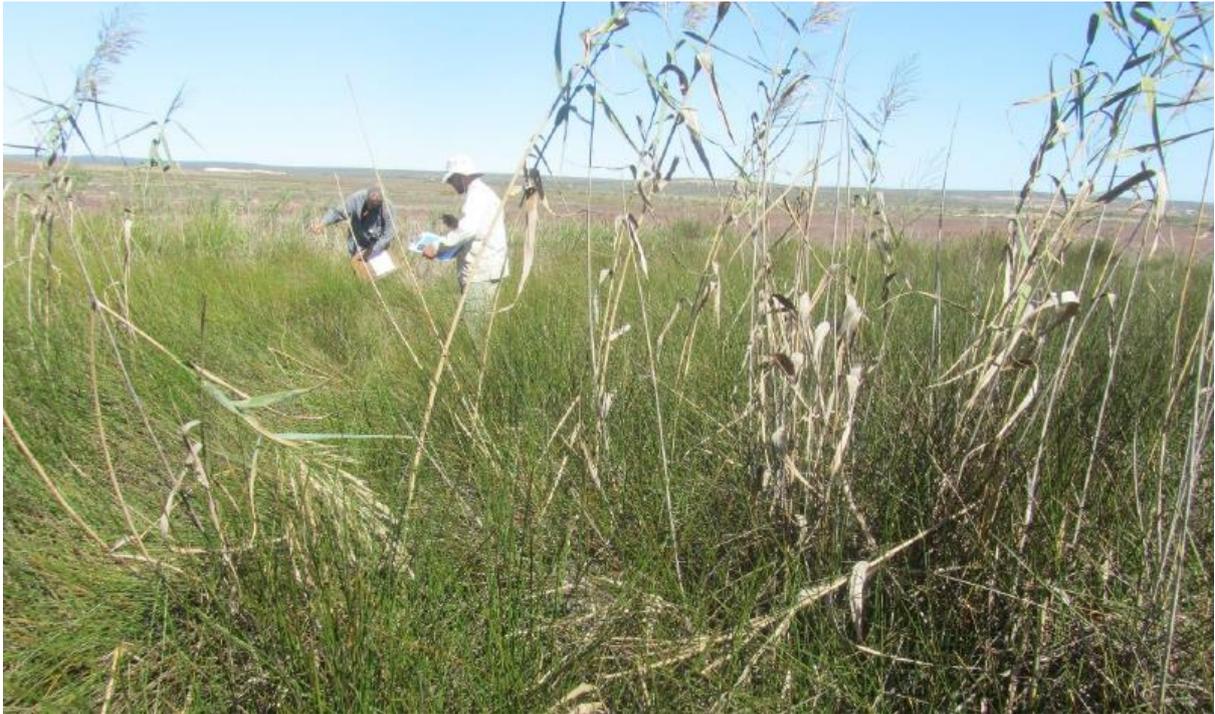
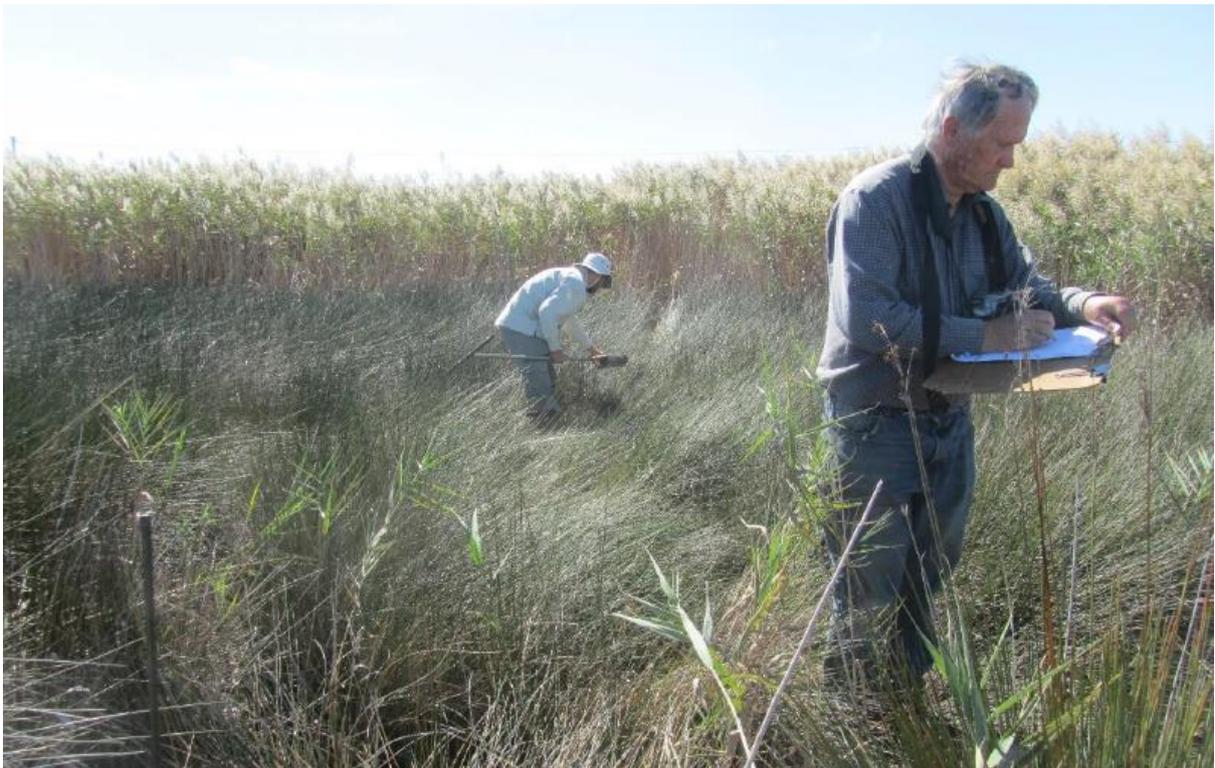
This site was sampled by T Belcher on the 7th April and was part of a combined river and wetland site on the lower Langvlei River.

Sampling point: EWR 8 RW-G30F LANG BRAND		Date:7 April 2022
Weather conditions @ 14:30		
Air temperature	Warm (20-30°C)	
% Cloud cover	25-50%	
Days since last rain	Within last seven days	
Wind	Light	
In-situ measurements		
Water temperature °C	16.4	
Dissolved Oxygen mg/l	4.3	
Electrical conductivity µS/cm	18.382	
TDS mg/l	14 443	
pH	7.18	
Visual observations		
Water clarity	Slightly muddy	
Colour	Colourless/clear	
Flow	Slow moving	
Algae on rocks	Lots visible	
Foam	None visible	
Oily Sheen	Some visible	
Odour	Fishy	
Other observations	Grazing of cattle, ostriches and sheep on the wider site. Site very overgrown with Phragmites, Juncus spp, and <i>Bolboschoenus maritimus</i> and little open water, water also shallow (<30 cm) with deep muddy substrate.

Figure 17: View of the site taken from the sampling point looking southwards

Figure 18: View of the site taken from the sampling point looking northwards

Figure 19: View of the channel where the sample was taken

Figure 20: Another view of the channel where the sample was taken
