REPORT NUMBER: RDM/WMA06/00/CON/COMP/0316

DETERMINATION OF ECOLOGICAL WATER REQUIREMENTS
FOR SURFACE WATER (RIVER, ESTUARIES AND WETLANDS)
AND GROUNDWATER IN THE LOWER ORANGE WMA

The Buffels, Swartlintjies, Spoeg, Groen and Sout Estuaries' Ecological Water Requirements

FEBRUARY 2017

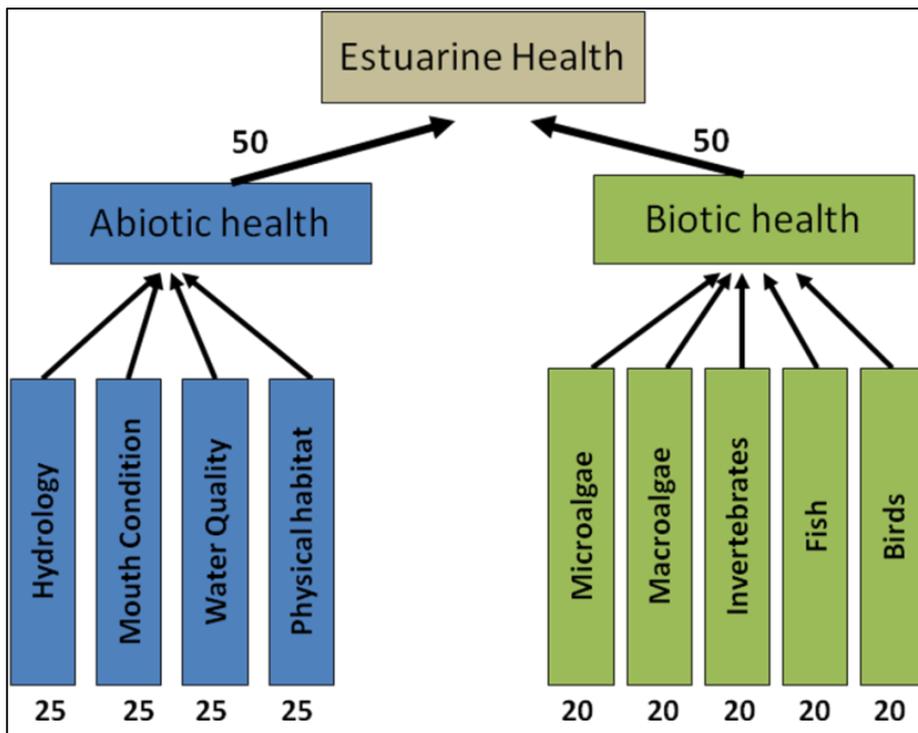
Figure 2.1 Components and weightings of the Estuarine Health Index (DWAf, 2008)

For comparative reasons (with previous assessments) the individual health scores were aggregated as illustrated in Figure 2.2 and Table 2.2. In estuaries, unlike the terrestrial environment, degradation or loss of habitat seldom means a complete loss of system health or function. This can only happen if an estuary becomes completely degraded, e.g. changed into a parking lot or golf course. In most cases, degradation means loss of processes or loss of biological functionality, e.g. the estuarine space is filled with a different salinity condition or different species composition. This loss of functionality happens on a continuum, with estuaries which retain more than 90% of their natural processes and pattern being rated as Excellent and estuaries degraded to less of 40% of natural functionality rated as Poor.

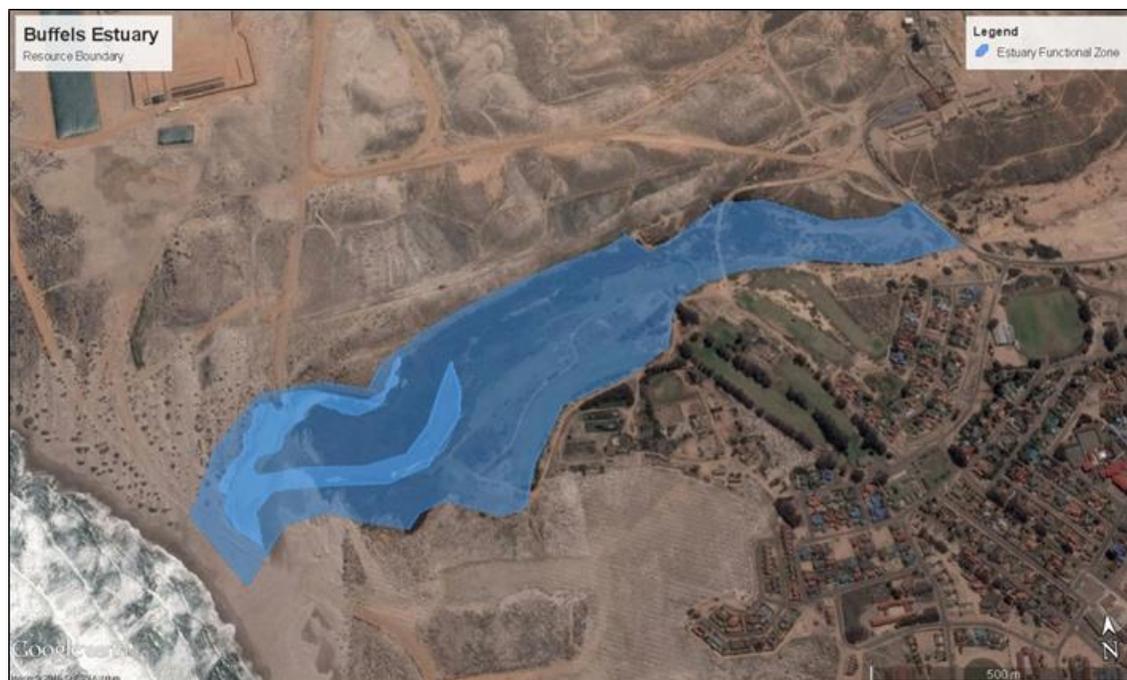
Downstream boundary:	29°40'37.01"S 17° 3'4.41"E (Estuary mouth)
Upstream boundary:	29°40'18.21"S 17° 4'3.30"E
Lateral boundaries:	5 m contour above MSL along each bank

Figure 9.1 Buffels Estuary: Geographical boundaries based on the EFZ

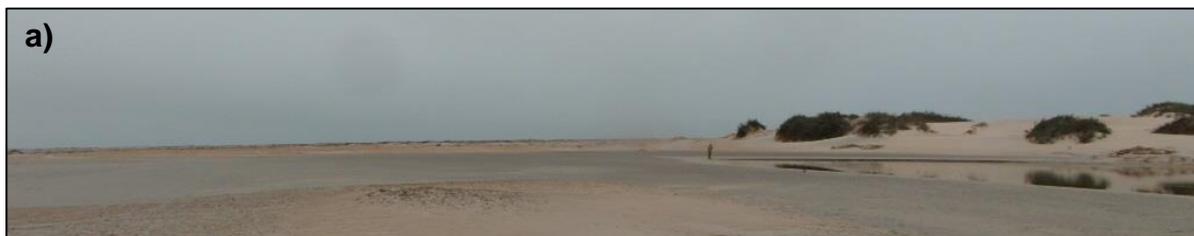
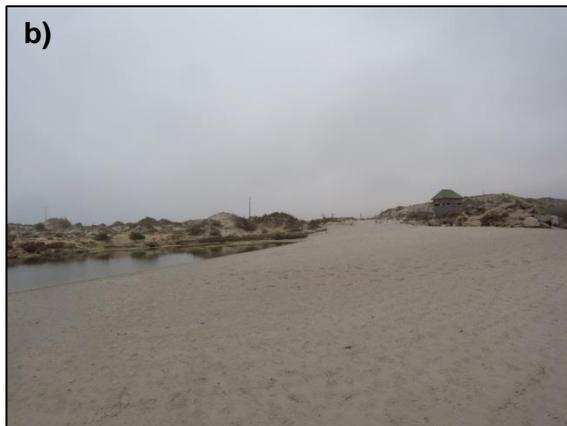
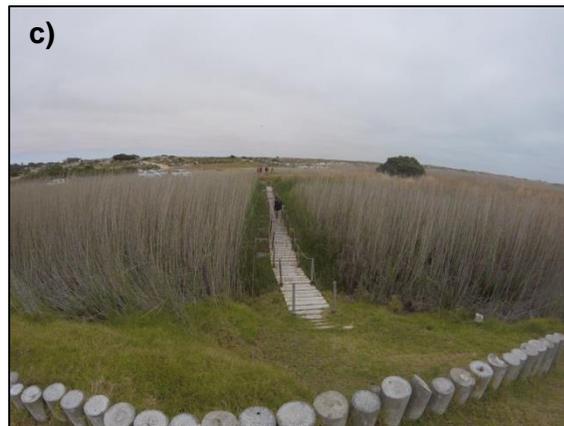
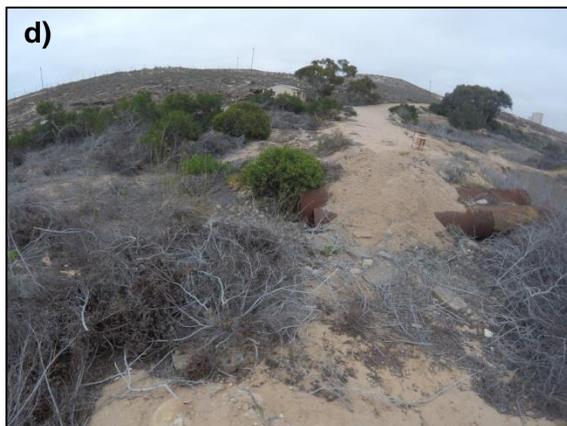
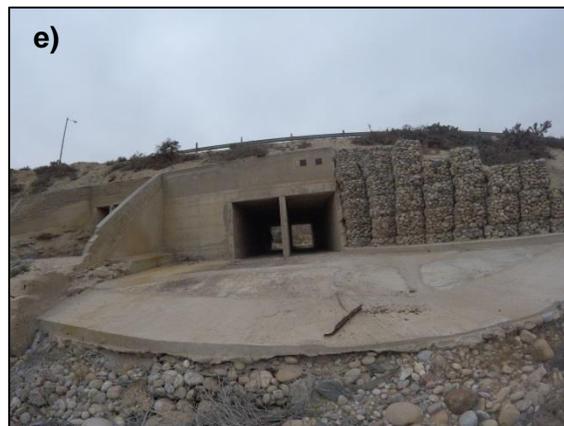
Key obstructions to flow at the Buffels Estuary: (a) The remnants of the road crossing the mouth of the estuary about 3 – 4 m above water level; (b) The road crossing the system at the birdhide bisecting the lower reaches; (c) Reed encroachment at the golf course preventing a free circulation of water; (d) The

The Buffels Estuary is classified as a temporarily open/closed system (Van Niekerk and Turpie, 2012), however the estuary is very seldom connected to the sea. Natural breaching by flood waters is estimated to have occurred every 3 to 7 years during. Open mouth conditions would only prevail for short periods (days to a week or two) as flood peaks in arid catchments generally is a matter of hours with little follow up flow. However, under the reference condition overtopping of the sand bar at the mouth would have occurred regularly at high spring tides even after mouth closure. During these overtopping events, species dependent on both the estuary and sea (e.g. fish and invertebrates) move between the two environments.

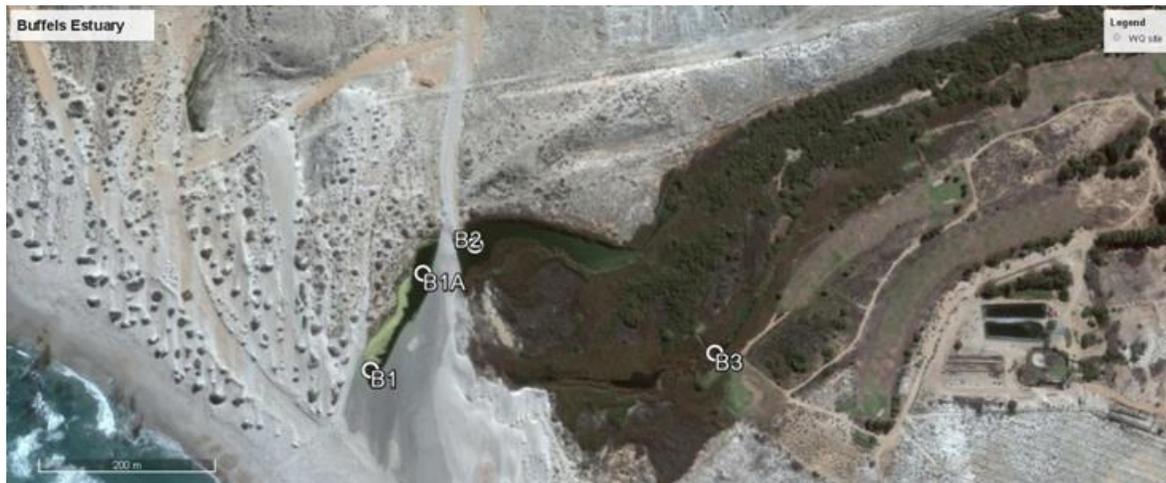
Figure 9.4 Buffels Estuary: Water Quality sampling stations

Figure 9.4 shows locality map of sampling sites in the Buffels Estuary.

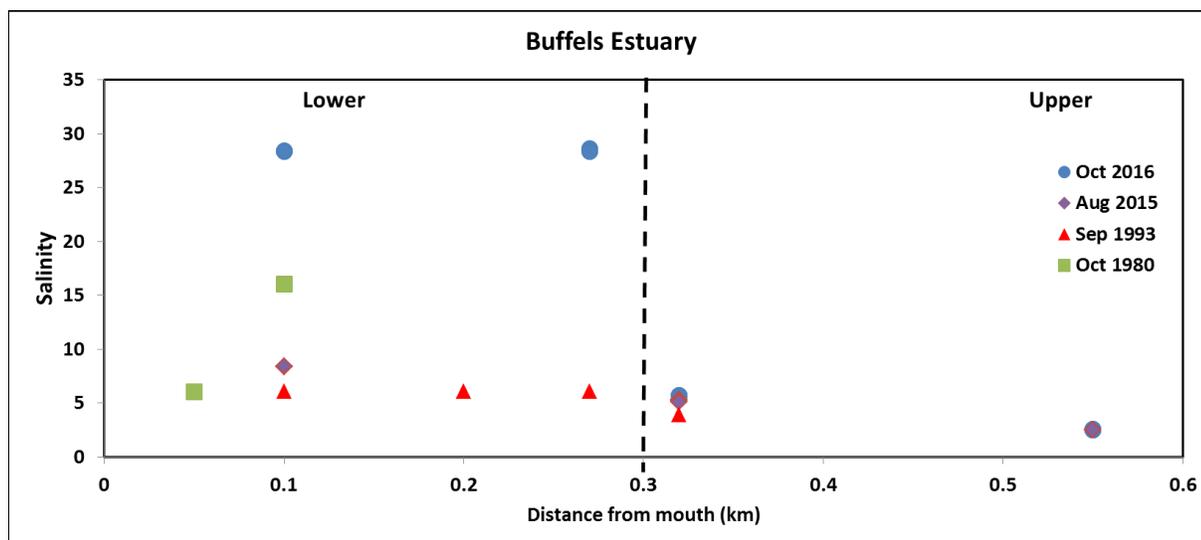
Figure 9.5 Buffels Estuary: Available salinity data

Very little historical information exists on the water quality of Buffels Estuary. What little there is suggests that the Buffels Estuary tends to be brackish in nature. Heinecken (1980) attributes this to the presence of a high water table fed by an aquifer in the lower part of the river resulting in relative stable salinity conditions prevailing. Salinity fluctuating between 6 and 30 (with seawater 35 g per litre) in the lower reaches and between 3 and 5 in the middle and upper reaches. Heinecken (Oct 1980) measured 16 in the lower reaches. Harrison (unpublished data) recorded 6 in the lower reaches and 3 in the middle reaches in September 1993.

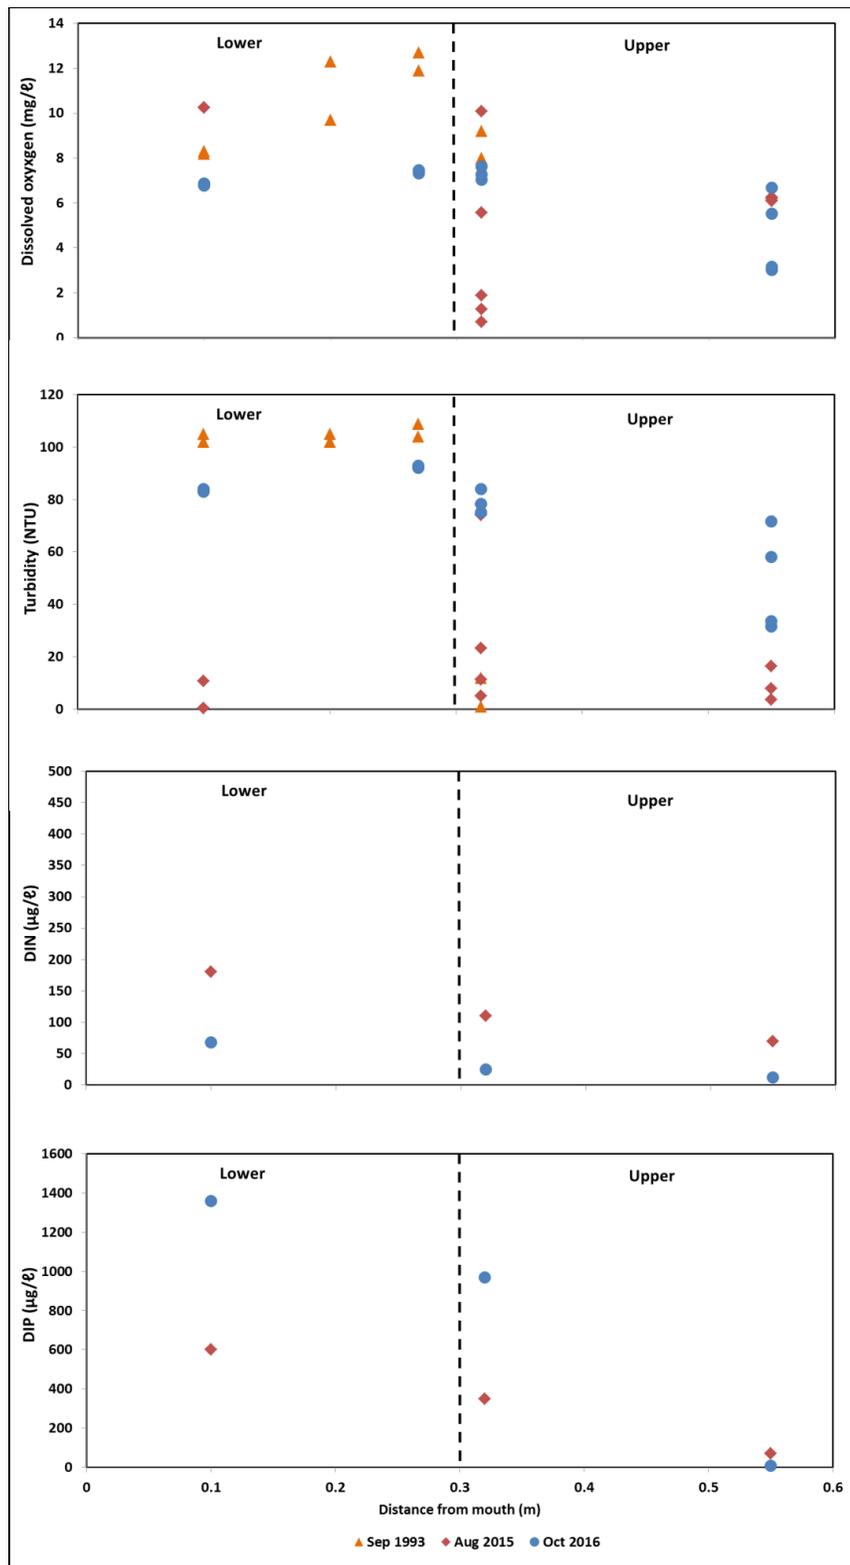
Figure 9.6 Buffels Estuary: Available data for dissolved oxygen, turbidity and inorganic nutrients

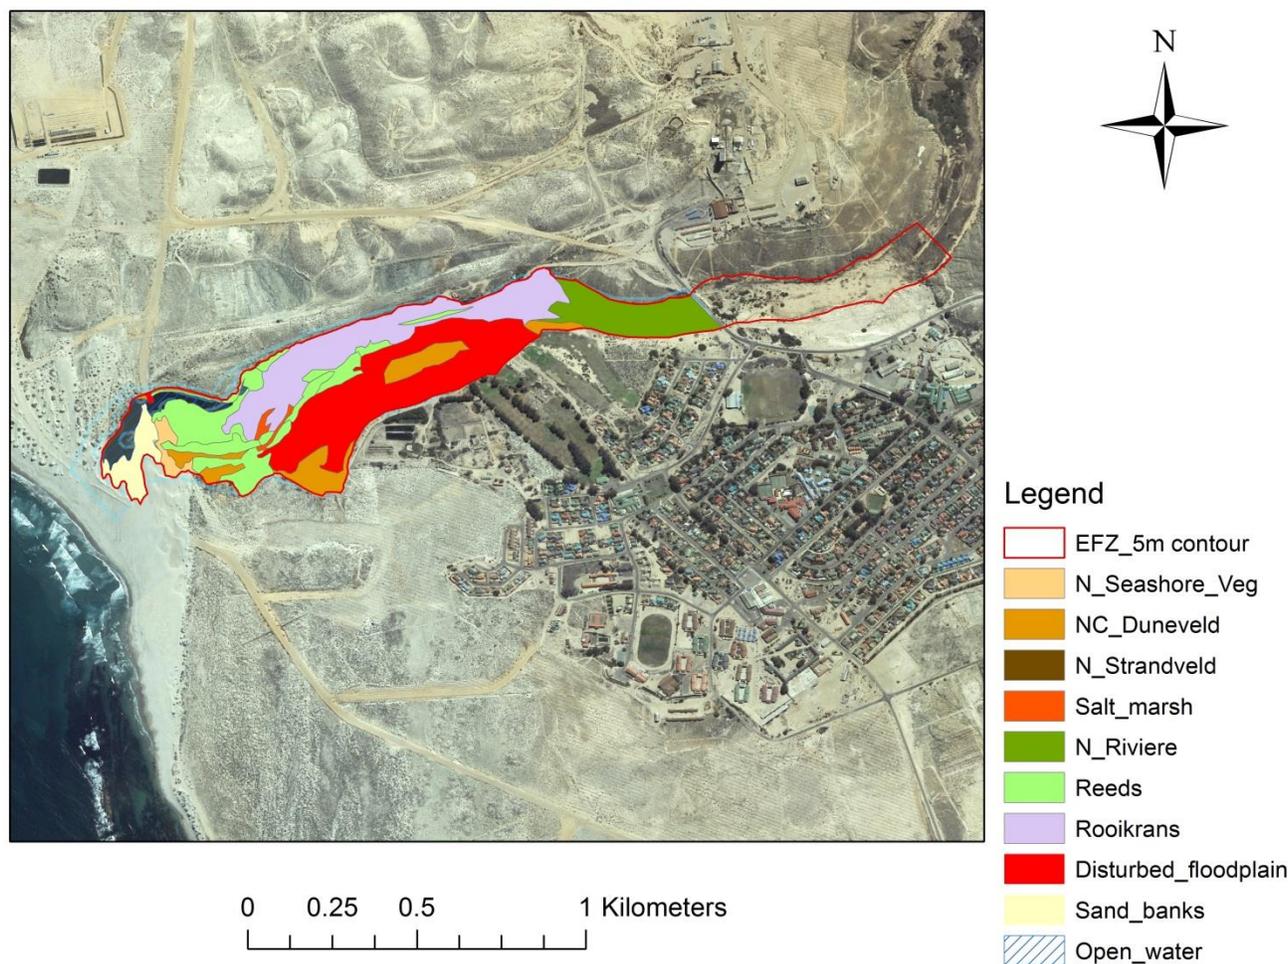
Figure 9.7 Buffels Estuary: Vegetation map for the EFZ based on the 2014 aerial images

The submerged macrophytes *Potamogeton pectinatus* (now *Stuckenia pectinata*) occurs in the open standing water adjacent to the reeds along with *Potamogeton pectinatus*. Macroalgae were not mapped as the area they covered was too small but they were noted as present. A golf course occupies a large part of what would have been Namaqualand Coastal Duneveld.

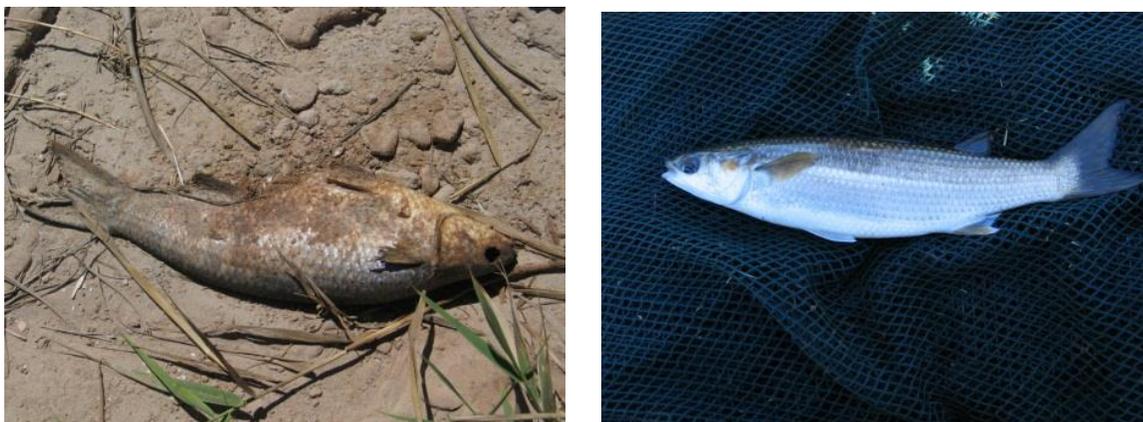
Figure 9.8 Fish smothered by silt during prolonged breaching (2005) and example of mullet in Buffels Estuary

Reference conditions in the Buffels Estuary are also likely to have been dominated by *M. cephalus* and *L. richardsonii* but in much greater abundance than present as the absence of the roads and much lower berm would have seen a much higher incidence (i.e. >1/10 years) of overwash recruitment. The probability of recruitment of more rare species such as white steenbras *Lithognathus lithognathus* would also have been higher. Post recruitment survival would have been higher in the absence of eutrophication and low-oxygen events and in the absence of back-flooding of sediment-laden water against the road berm and resultant gill-clogging and suffocation of fish. Community composition would have been more complex under reference due to the occasional recruitment of the rarer fish species and the occurrence of two or more age cohorts (occupying different “niches”) as compared to the one or none in the present day. Table 9.11 provides the fish similarity EHI scores for the Buffels Estuary.

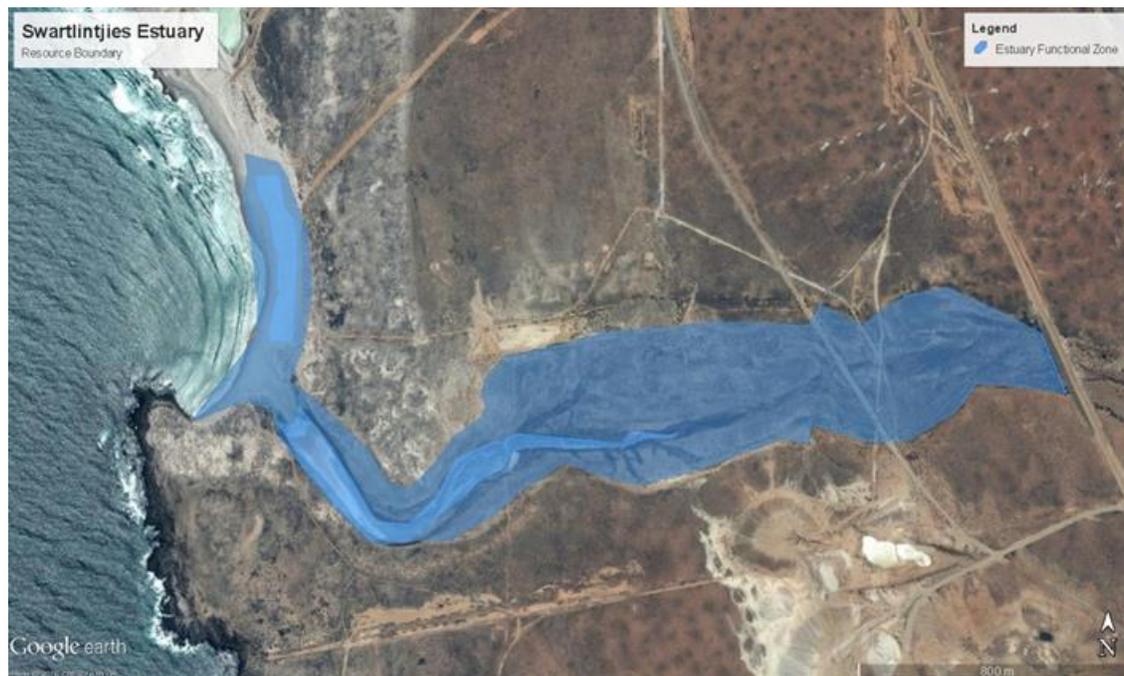
Downstream boundary:	30°15'44.33"S 17°15'36.39"E (Estuary mouth)
Upstream boundary:	30°15'45.73"S 17°17'8.36"E
Lateral boundaries:	5 m contour above MSL along each bank

Figure 10.1 Swartlintjies Estuary: Geographical boundaries based on the EFZ

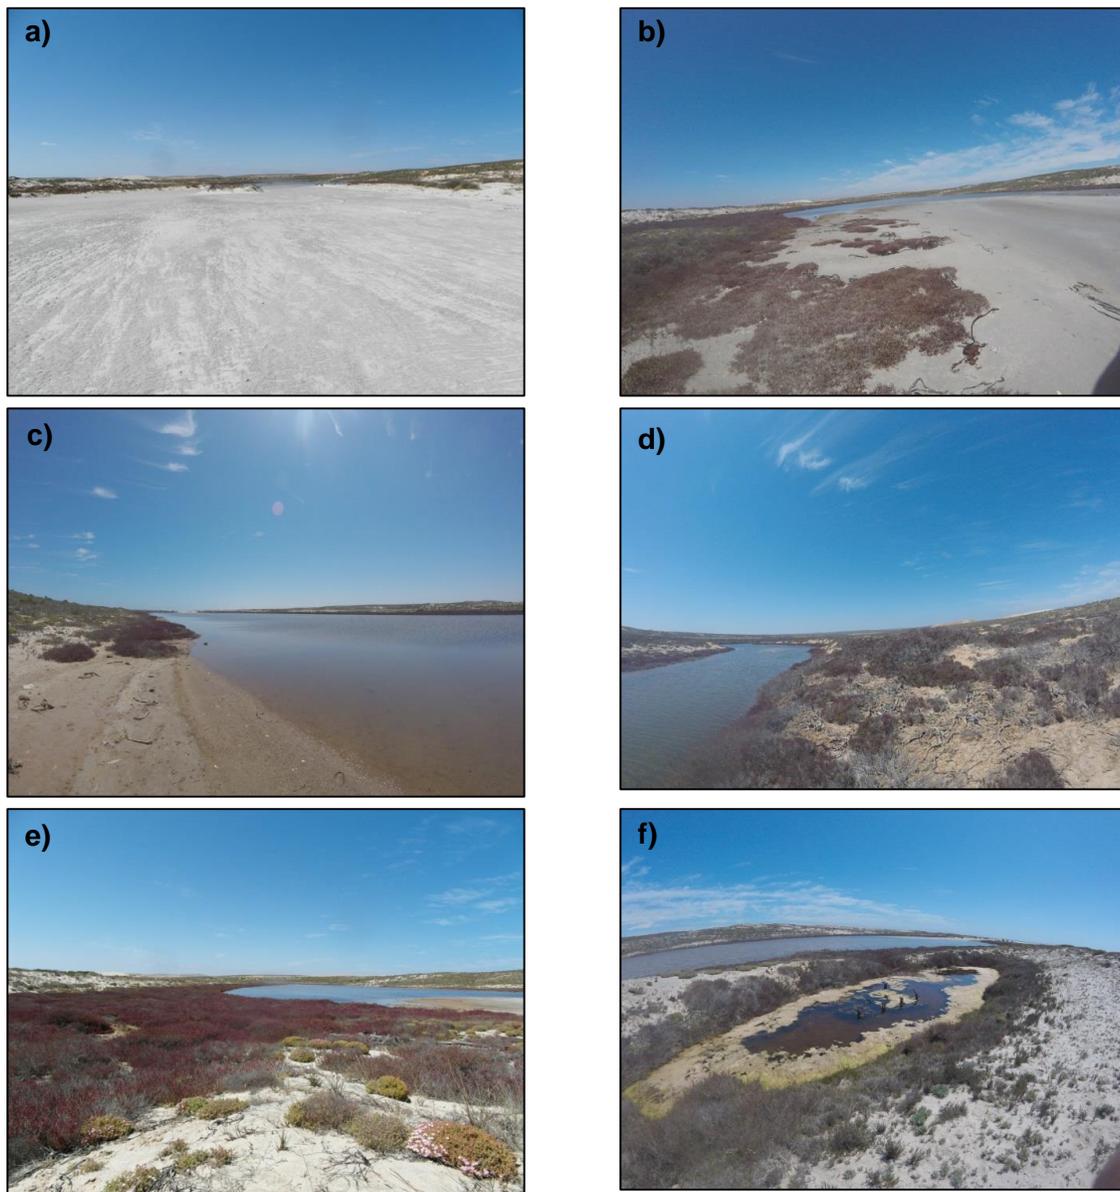
(a) and (b) The exceptionally low berm at the mouth with signs of regular overwash; (c) The middle reaches of the estuary; (c) The upper reaches; (e) An overview of the relatively untransformed EFZ; (f) The remnant sumps along the banks of the Swartlintjies Estuary.

The mouth of the Swartlintjies Estuary was artificially breached by DBCDM in August 1978 and December 1978 to allow seawater into the estuary. It closed naturally shortly thereafter. Artificial breaching was also done in early 1980 and the estuary contained water for approximately 6 months after the breaching (Massie and Clark, 2016).

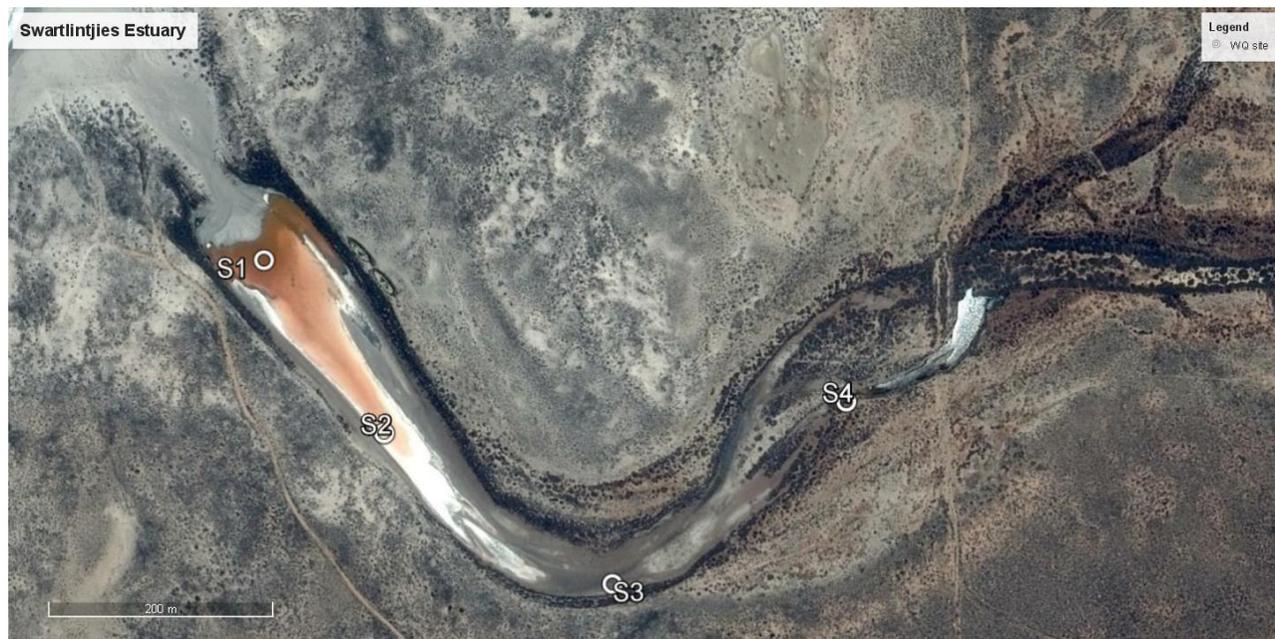
Figure 10.3 Swartlintjies Estuary: Water Quality sampling stations

Figure 10.3 shows locality map of sampling sites in the Swartlintjies Estuary.

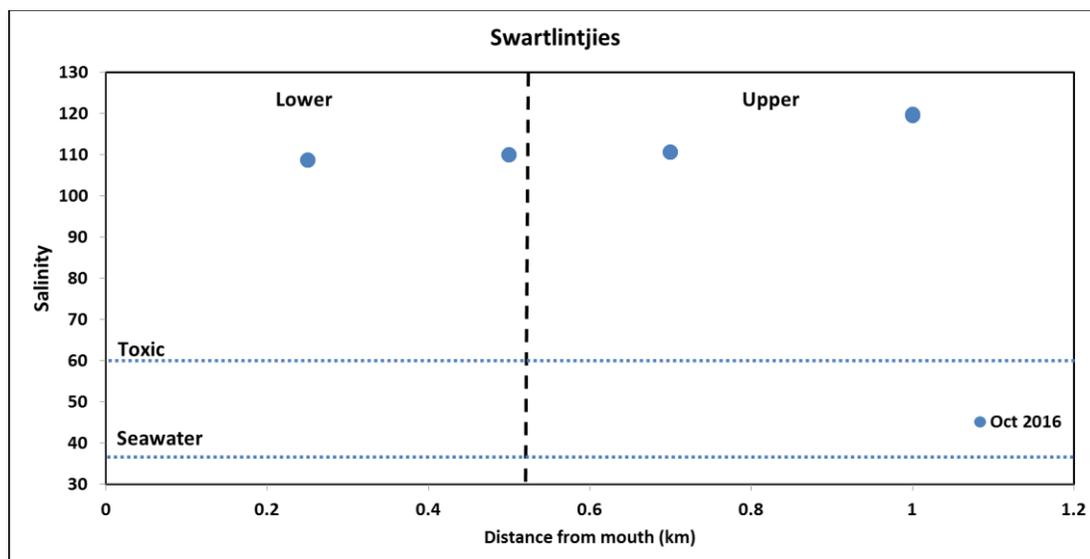
Figure 10.4 Swartlintjies Estuary: Available salinity data

Very little historical information exists on the water quality of Swartlintjies Estuary. What little there is suggests that the estuary tends to be hypersaline in nature. For example, the Swartlintjies estuary was dry during the 1980 ECRU Survey, i.e. no data.

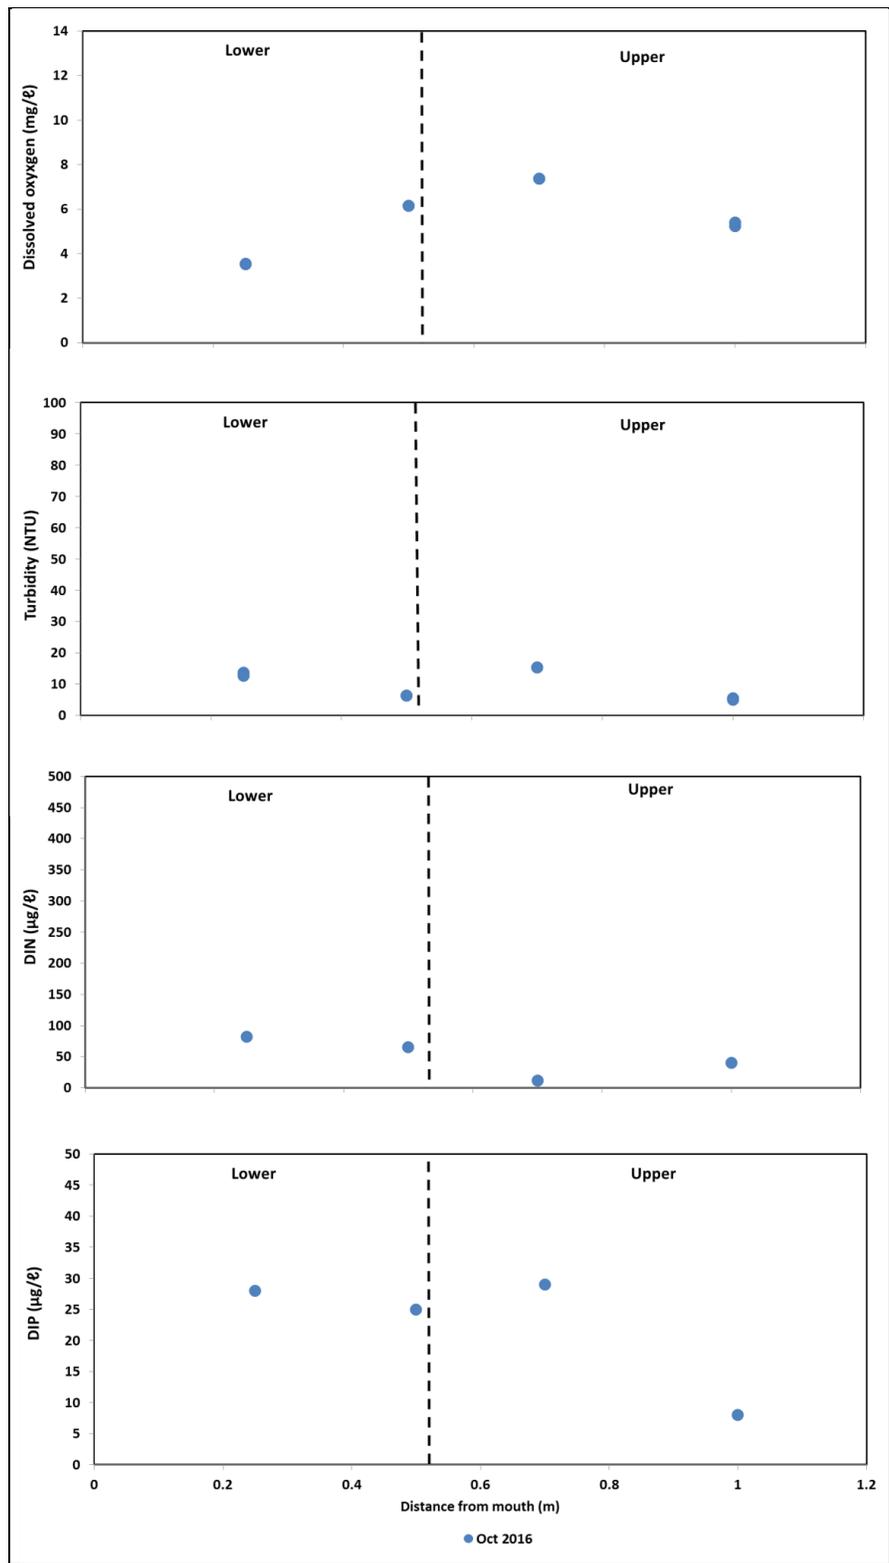
Figure 10.5 Swartlintjies Estuary: Available data for dissolved oxygen, turbidity and inorganic nutrients

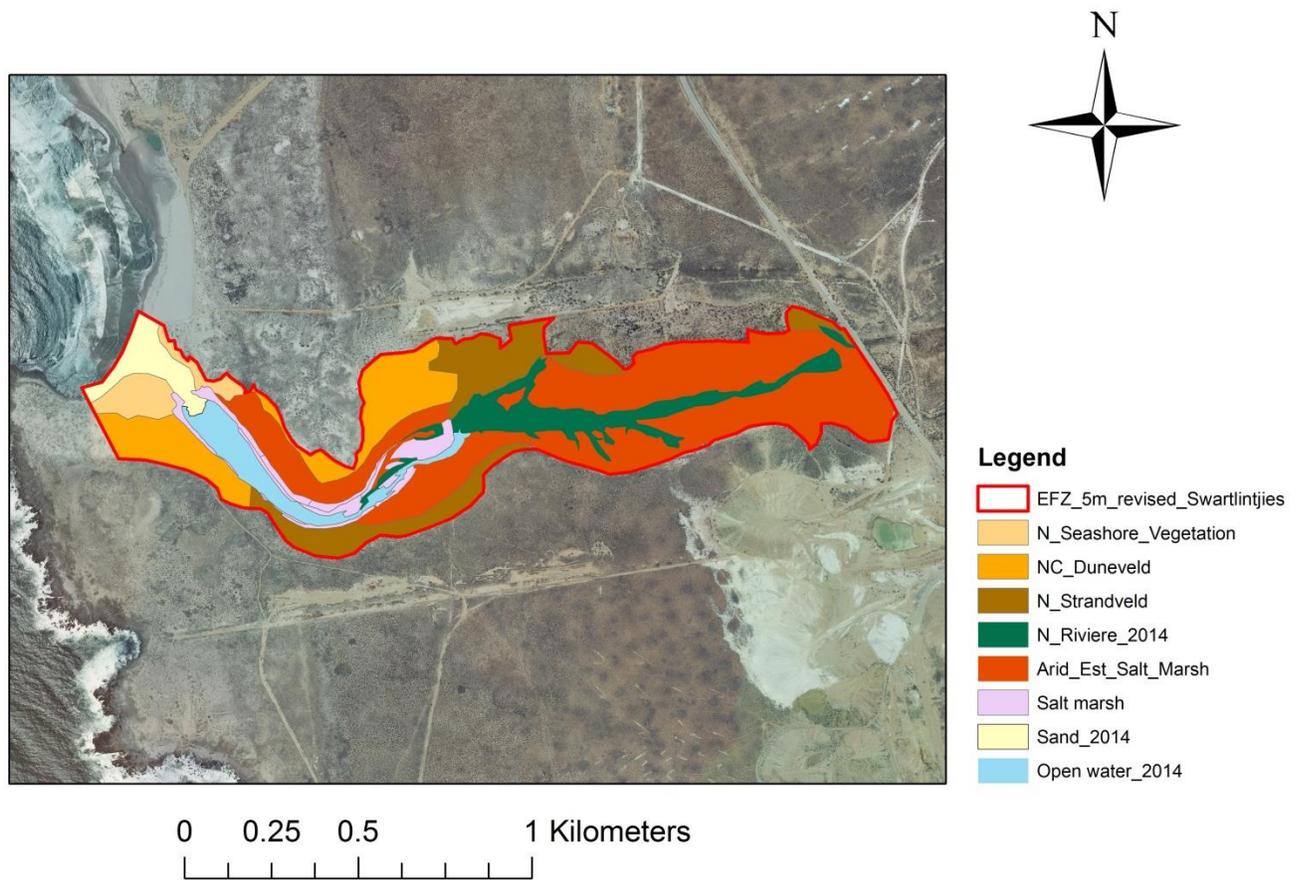
Figure 10.6 Swartlintjies Estuary: Vegetation map for the EFZ based on the 2014 aerial images

From aerial photographs the surrounding vegetation seems to have changed little over time. Massie and Clark (2016) state that 17.8 ha of vegetation have been impacted by mining activities in the functional zone. Open water area has remained relatively stable over time (2003 – 1.79, 2011 – 1.37 ha, 2014 – 1.17 ha) although the image quality in the early years is poor and therefore this assessment has a low confidence. Table 10.10 provides the macrophyte similarity EHI scores for the Swartlintjies Estuary.

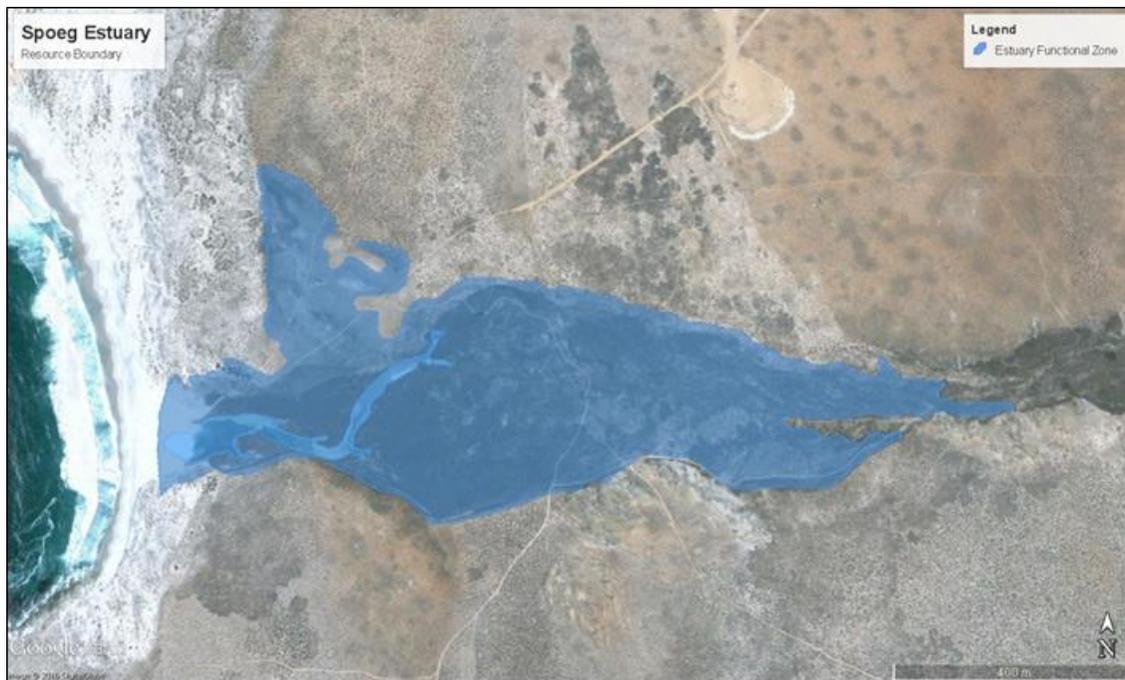
Downstream boundary:	30°28'20.54"S 17°21'34.07"E (Estuary mouth)
Upstream boundary:	30°28'17.92"S 17°22'32.83"E
Lateral boundaries:	5 m contour above MSL along each bank

Figure 11.1 Spoeg Estuary: Geographical boundaries based on the EFZ

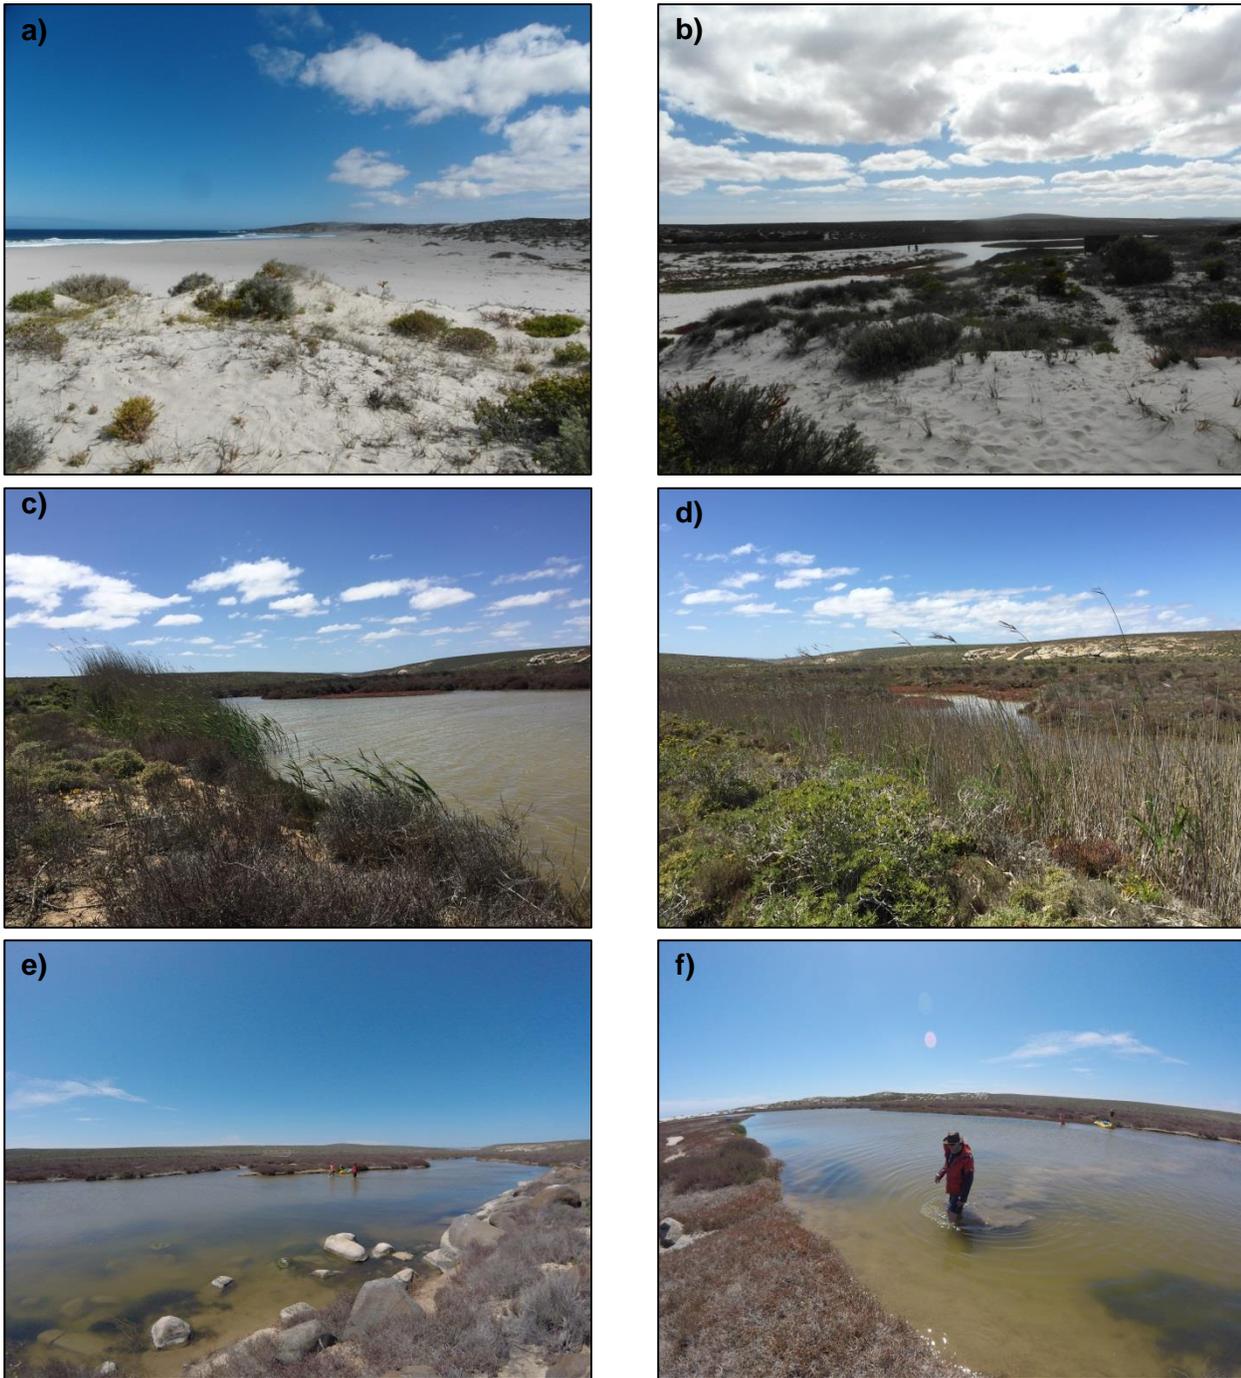
(a) and (b) The wide berm at the Spoeg Estuary mouth showing some signs of overwash; (c) The middle reaches where wind mixing were stirring up the bottom turbidity; (d) the upper reaches of the system; (e) Algal growth in the lower reaches; (f) Fine sediments being stirred up by movement.

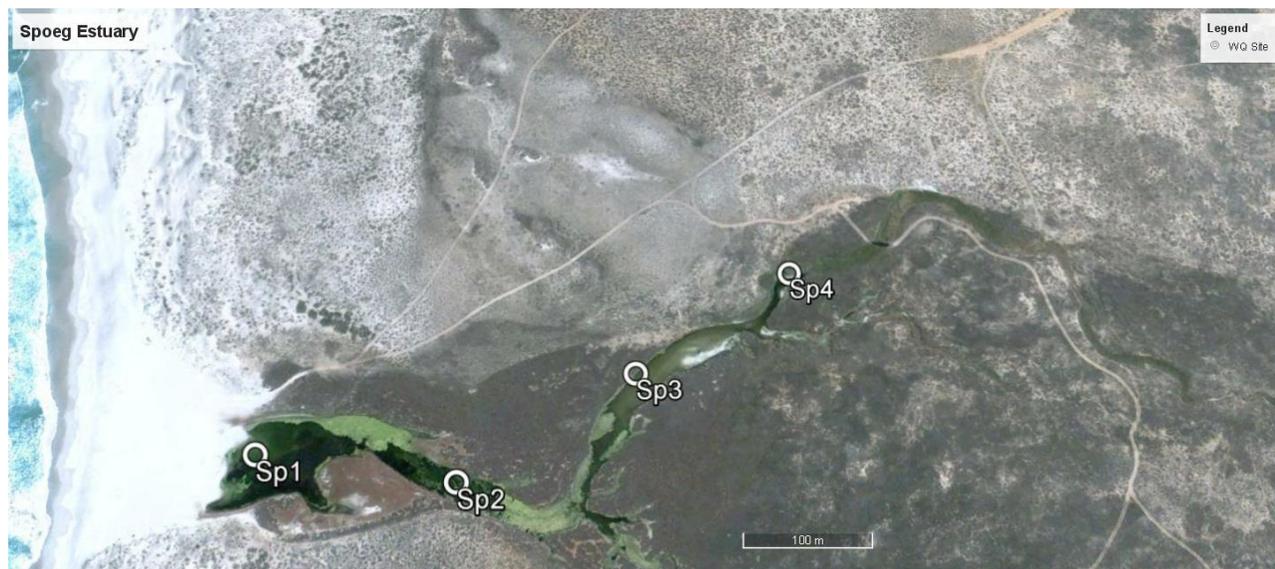
Figure 11.3 Spoeg Estuary: Water Quality sampling stations

Figure 11.3 shows locality map of sampling sites in the Spoeg Estuary.

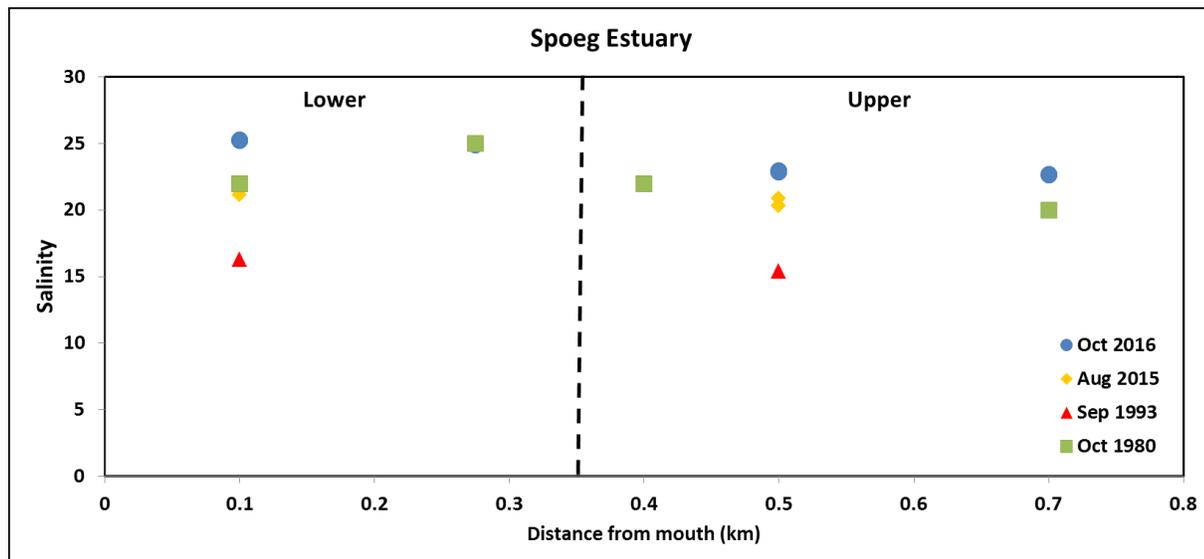
Figure 11.4 Spoeg Estuary: Available salinity data

Very little information is available on the salinity of the Spoeg Estuary. Historical information suggests that the Spoeg Estuary has always been a brackish system. Bickerton reported in October 1980 that the salinity in the system hovered around 25 in the lower reaches to 20 in the top. While Harrison (unpublished data) reported salinity around 15 in the lower and middle reaches. During the August 2015 sampling trip the estuary was again around 21. The October 2016 field trip yielded the highest recorded salinity for the system at 25 in the lower reaches and 22 in the middle and upper reaches.

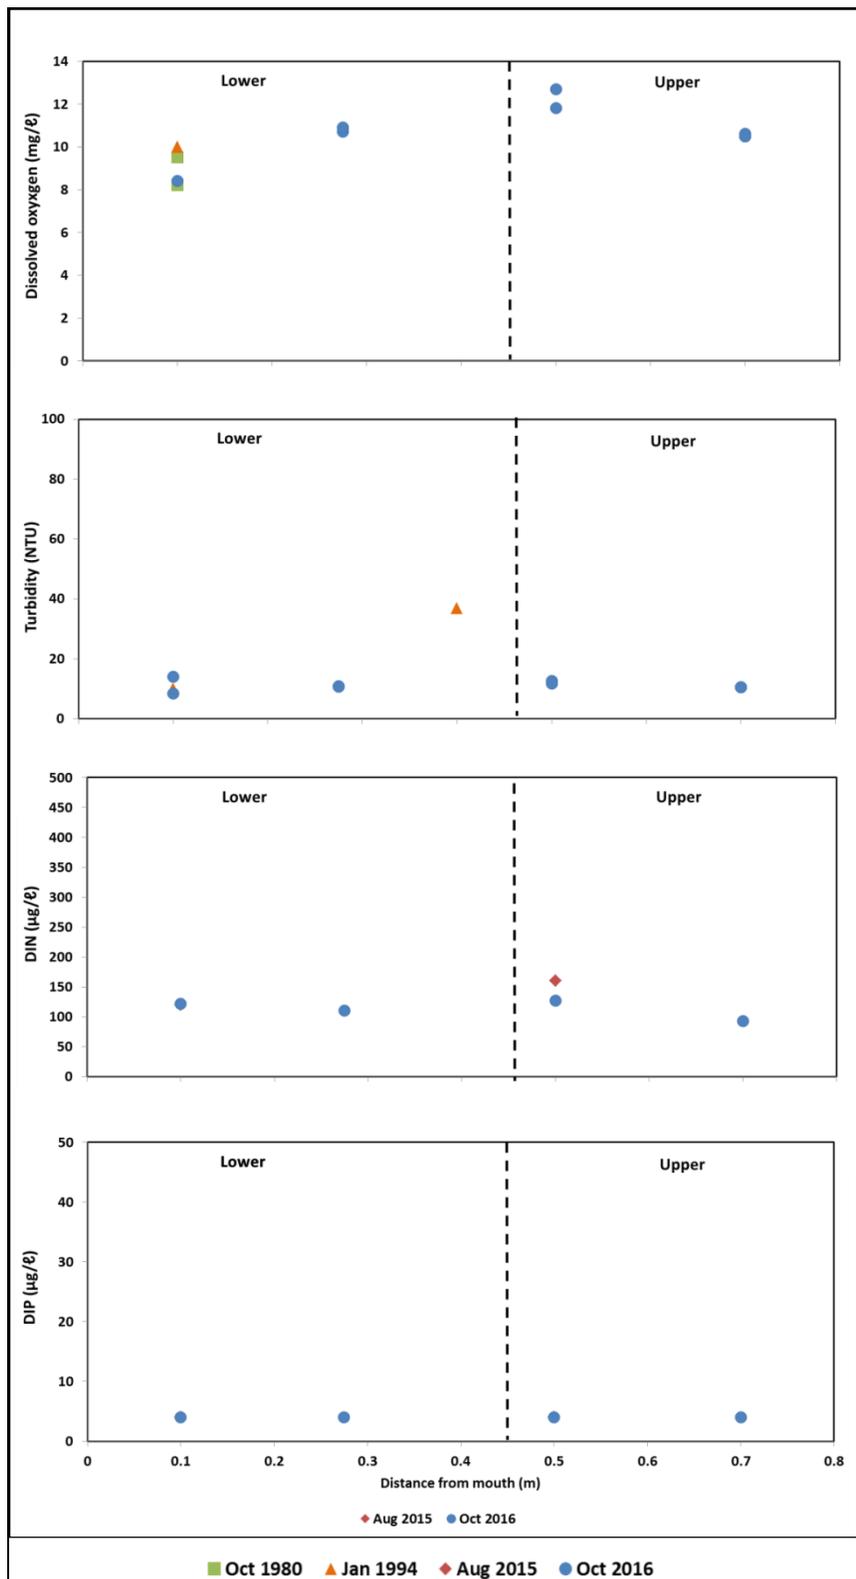
Figure 11.5 Spoeg Estuary: Available data for dissolved oxygen, turbidity and inorganic nutrients

Available data on other water quality parameters is also limited (Heinecken, 1981c, Harrison, 1998; DAFF, unpublished data, this study) (Figure 11.4). Data on DO suggest super-saturation, especially in the upper reaches. Super-saturation is most likely attribute to high algal productivity during the day. However, it can be indicative of hypoxia developing at night associated with high respiration rates). Turbidity levels average ~ 15 NTU, with occasional higher levels were probably associate algal production/bacterial blooms (Heinecken, 1981c). Grazing in the catchment could also contribute to slight increase in turbidity under the present. Measured DIN concentrations ranged between 50 - 160 µg/l, mostly present as Total Ammonia-N (typical non-enriched concentrations in estuaries ~50 µg/l). DIP concentrations were below detection in both August 2015 and October 2016 (<10 µg/l) (typical non-enriched concentrations in estuaries <10 µg/l). Heinecken (1981c) attributed algal growth to high nutrients associated with large flocks of ducks on the systems. Considering the small size of this system, it is likely that birds contribute to nutrient loading (e.g. Hahn *et al.*, 2007 and 2008), but that it is taken up by algal and do not accumulate in the water column (therefore the relatively low measured data). However, this would have been the case in the reference condition as well. The slight increase in nutrients in the lower reaches (under present) is associated with reduced freshwater inflow (i.e. less overall volume receiving same nutrient loading) which then ripples through DO (associated with slight increase in suspended algal growth/organic debris). Some toxic accumulation is expected to have occurred due to extensive mining (or historical mining) activities in the catchment.

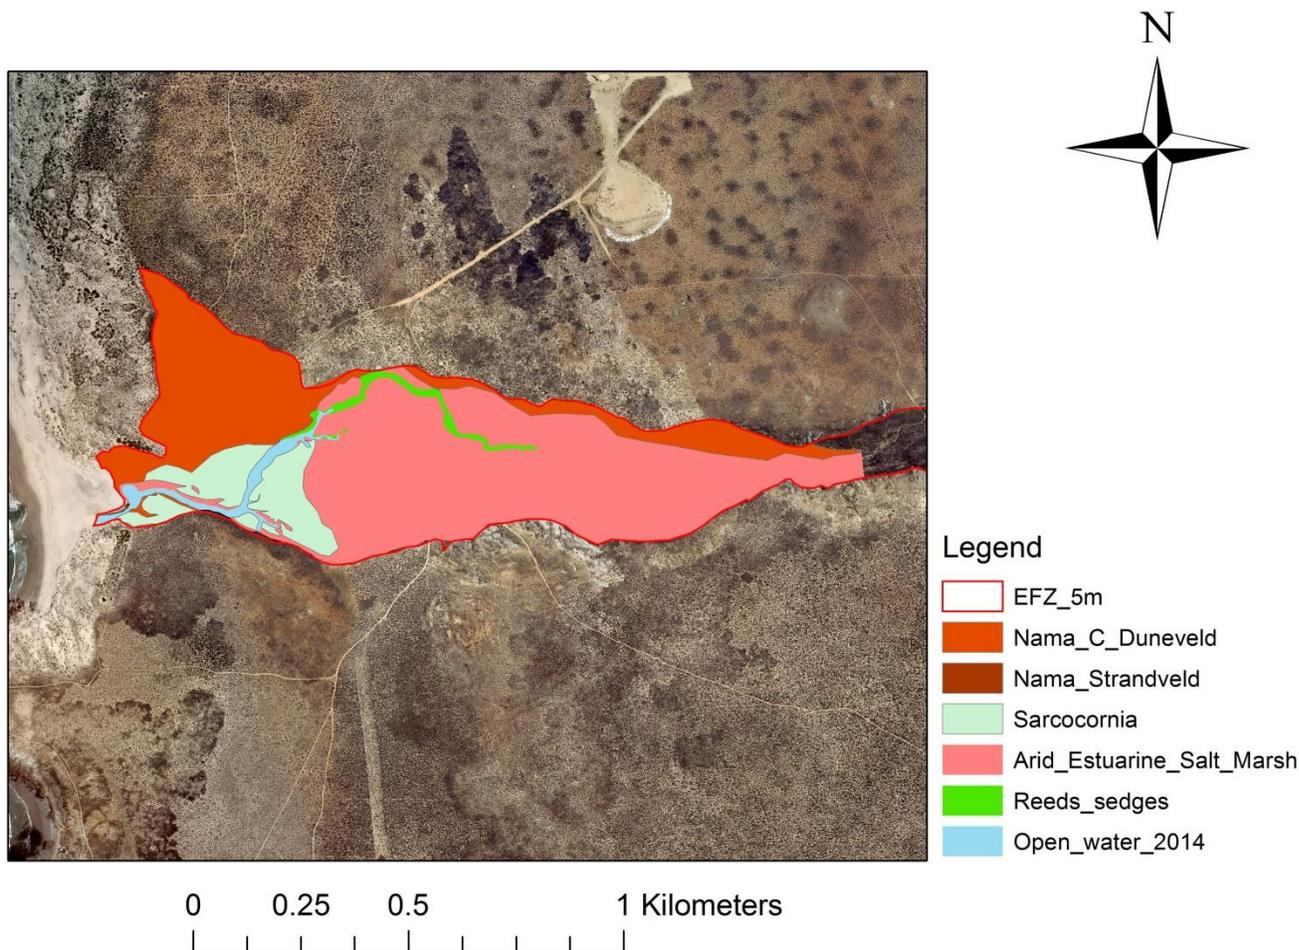
Figure 11.6 Spoeg Estuary: Vegetation map for the EFZ based on the 2014 aerial images

The Spoeg Estuary consists of a long straight floodplain bounded by rocks and cliffs on the southern side. Within this floodplain Arid Estuarine Salt Marsh mixes with Namaqualand Riviere, particularly in the upper areas, making a separation of the two vegetation types difficult. It has been mapped as Arid Estuarine Salt Marsh. Around the mouth Namaqualand Seashore Vegetation and Namaqualand Coastal Duneveld occurs, with large monospecific stands of two *Sarcocornia* in the lower reaches; *Sarcocornia natalensis* in the lower elevation and *Sarcocornia pillansii* in the higher elevations. Namaqualand Strandveld occurs on the higher elevations. Reed beds (*Phragmites australis*) occur circa 400 m upstream and are often associated with patches of *Juncus kraussii* at freshwater seepage sites or areas where the water table is high. These patches of *Juncus* and *Phragmites* continue up the river course. Reeds and sedges were difficult to map and might represent an overestimation due to their patchy nature. The vegetation of the Spoeg Estuary remains relatively unchanged and in a good condition. Small disturbances are from farm roads and diamond mining fences. Table 11.9 provides the macrophyte similarity EHI scores for the Spoeg Estuary.
