REPORT NUMBER: RDM/WMA06/00/CON/COMP/0316

DETERMINATION OF ECOLOGICAL WATER REQUIREMENTS
FOR SURFACE WATER (RIVER, ESTUARIES AND WETLANDS)
AND GROUNDWATER IN THE LOWER ORANGE WMA

The Buffels, Swartlintjies, Spoeg, Groen and Sout Estuaries' Ecological Water Requirements

FEBRUARY 2017

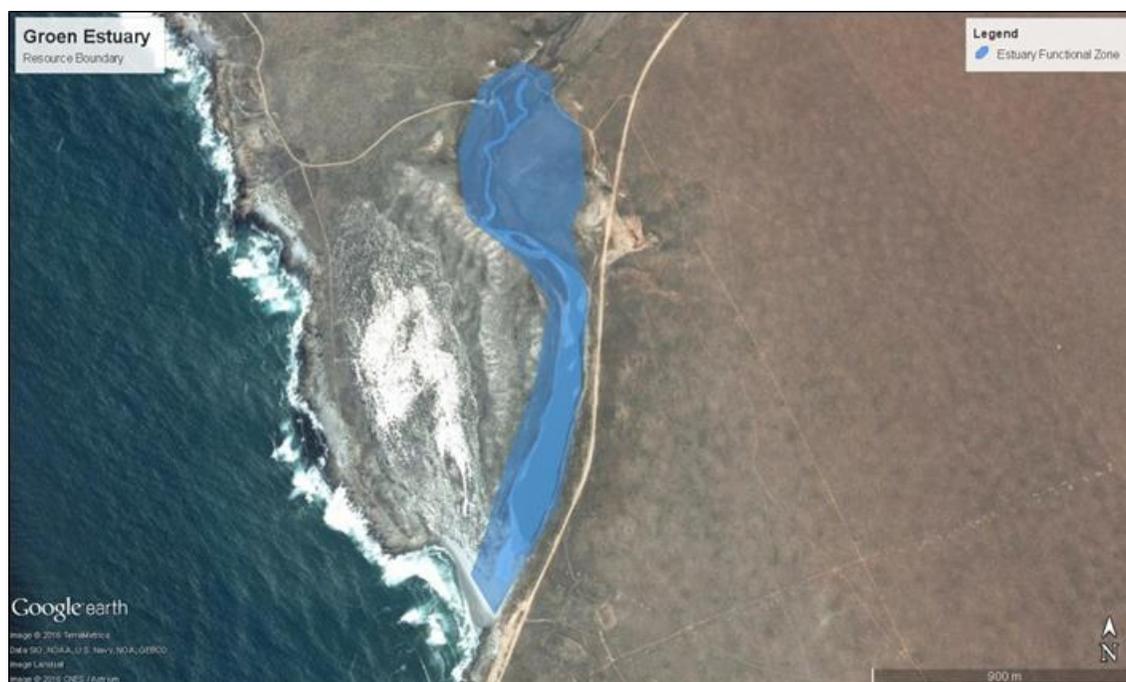
Downstream boundary:	30°50'49.05"S 17°34'35.72"E (Estuary mouth)
Upstream boundary:	30°49'38.26"S 17°34'40.18"E
Lateral boundaries:	5 m contour above MSL along each bank

Figure 12.1 Groen Estuary: Geographical boundaries based on the EFZ

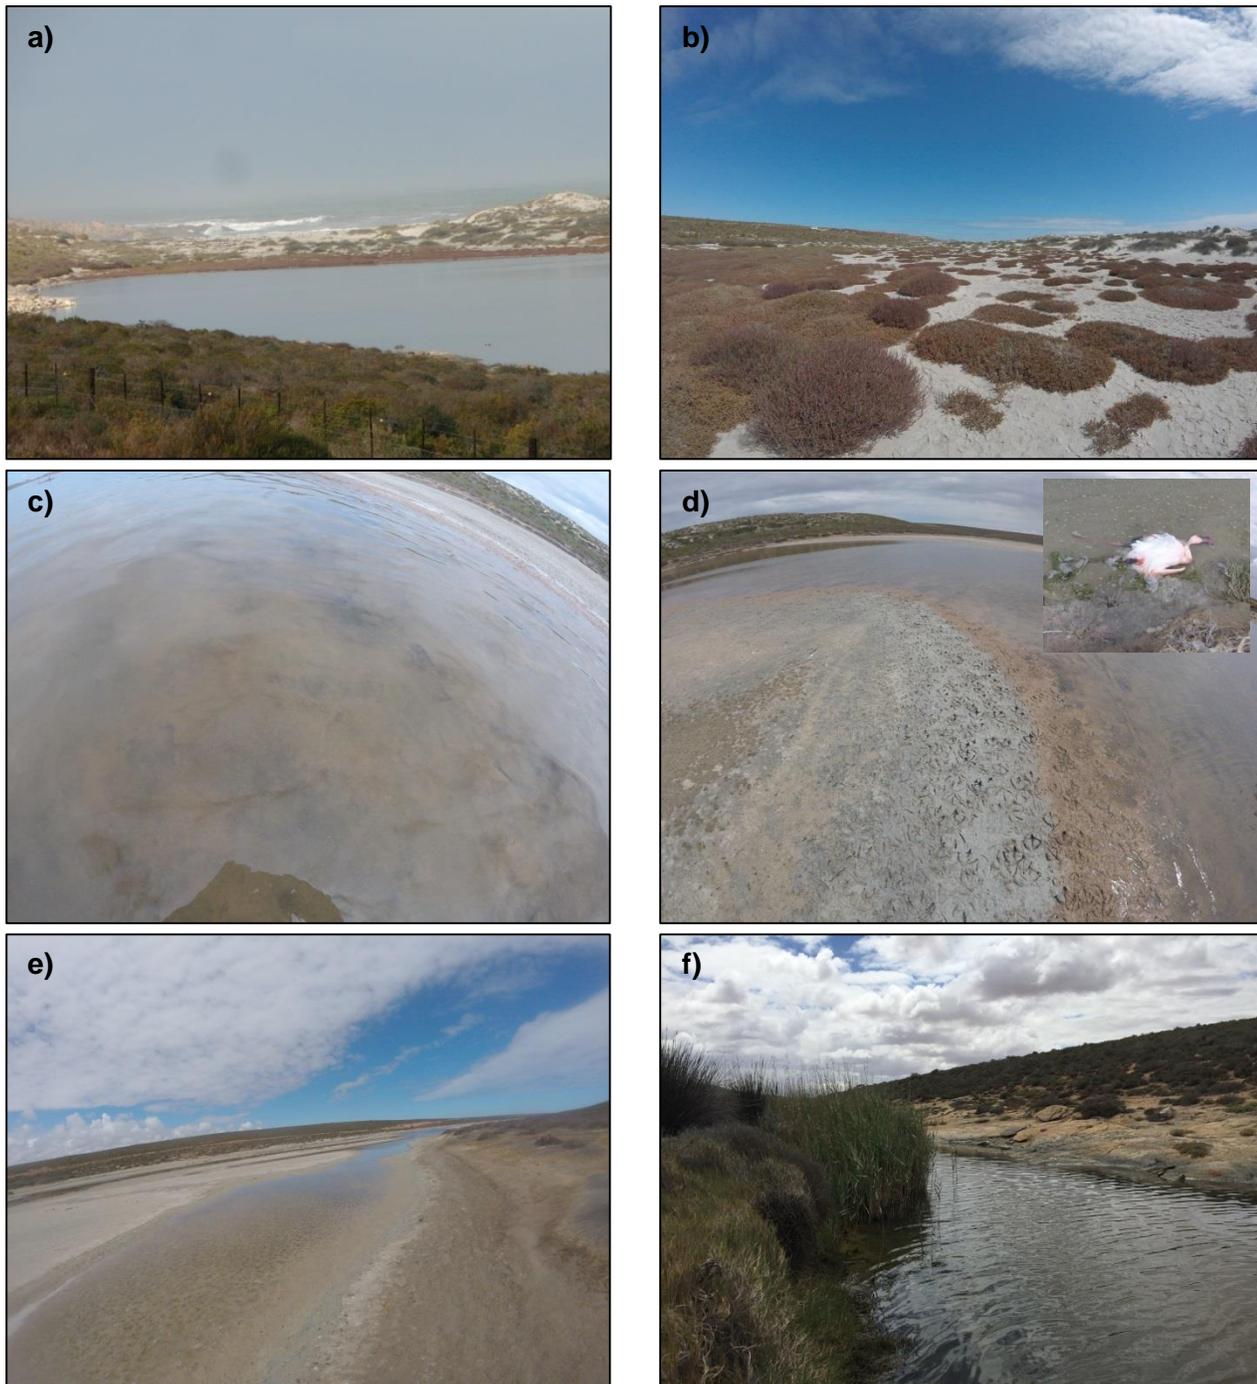
(a) The very high berm and (b) well establish plant cover at the mouth of the Groen Estuary indicating very little connectivity with the sea; (c) and (d) The middle reaches of the system showing high degree of sediment disturbance by birds; (e) Salt rings indicating that at times the water level in the system is much higher than the October 2016 survey; (f) The upper reaches of the Groen Estuary with reeds indicating brackish conditions.

The Estuary Functional Zone of the Groen Estuary is largely untransformed. With the most significant impact, a causeway running through the upper reaches to the local Namaqualand National Parks office. As the road is at a low level, the impact of it on floods is judged to be limited.

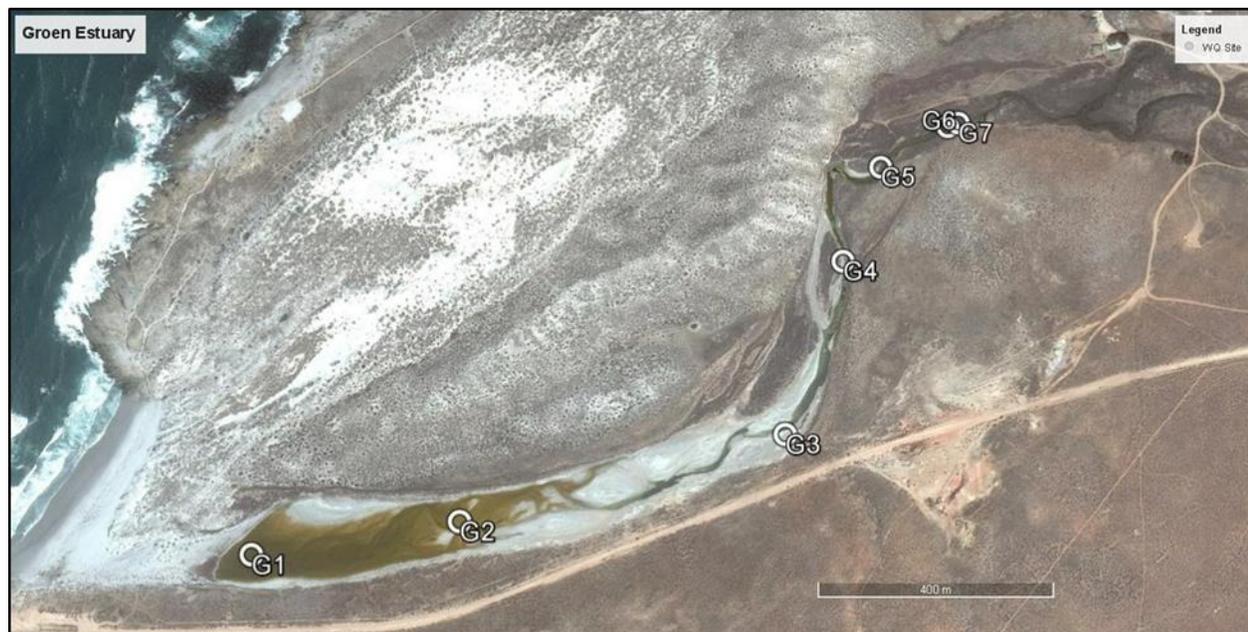
Figure 12.3 Groen Estuary: Water Quality sampling stations

Figure 12.3 shows locality map of sampling sites in the Groen Estuary.

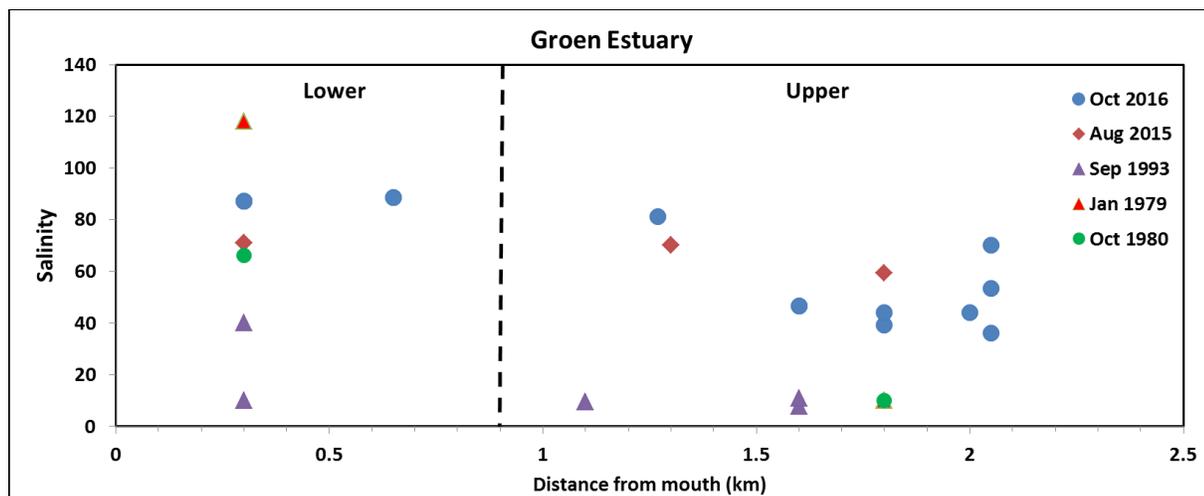
Figure 12.4 Groen Estuary: Available salinity data

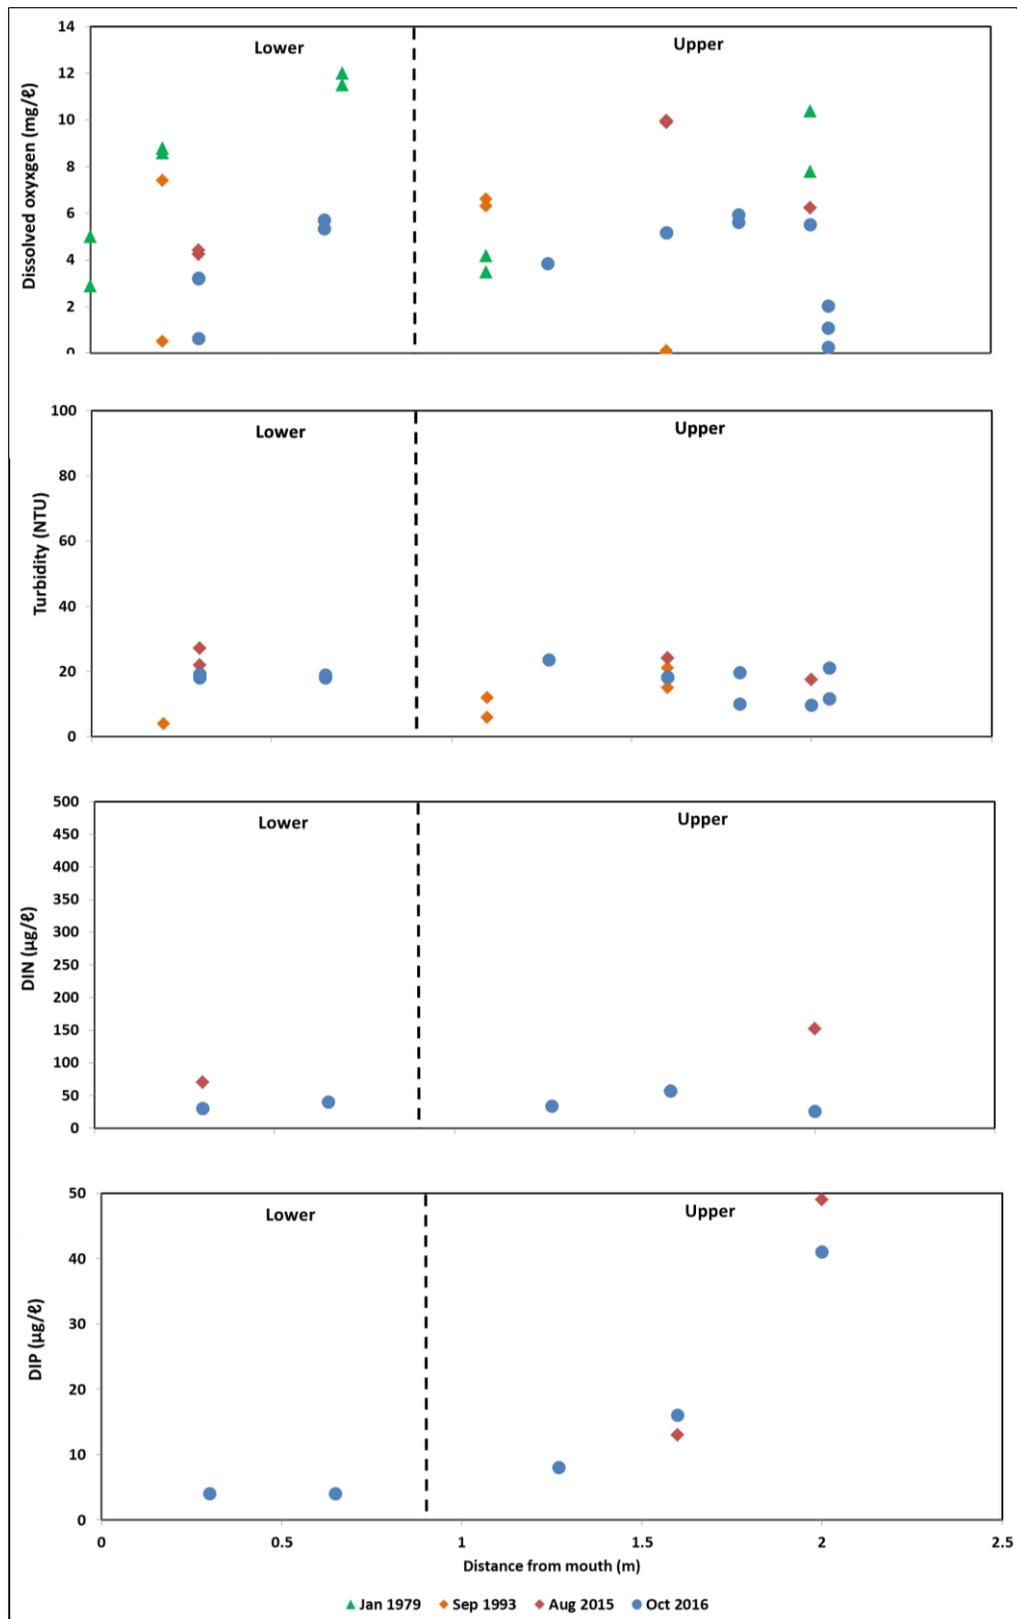
Figure 12.5 Groen Estuary: Available data for dissolved oxygen, turbidity and inorganic nutrients

Available data on other water quality parameters is also limited (Bickerton, 1981; Harrison, 1998; DAFF, unpublished data; Adams et al. 2015; this study) (Figure 12.4). Data on DO show large variation in concentrations with average values in the lower and upper estuary at 4 mg/l and 5 mg/l, respectively. Average turbidity also varied by averaged around 20 NTU across estuary. Grazing in the catchment could also contribute to slight increase in turbidity under the present. Measured DIN concentrations averaged ~60 µg/l in lower reaches increasing to ~70 µg/l in upper reaches, mostly present as Total Ammonia-N (typical non-enriched concentrations in estuaries ~50 µg/l). DIP concentrations in the lower reaches remained low (<10 µg/l), but levels in the upper reaches averaged ~30 µg/l, showing a distinct increasing trend moving upstream. The small size and bird population are indicative of nutrient loading from birds (also under reference) (e.g. Hahn *et al.*, 2007 and 2008). Thus although reduction in flow could have contributed to relatively higher loading from birds, the increasing trend towards the upper reaches (especially in DIP) suggests that diffuse runoff from ablation of the houses/offices adjacent to the upper estuary is a more likely driver of this increase. Some mining in catchment could have contributed to toxic accumulation in this system.

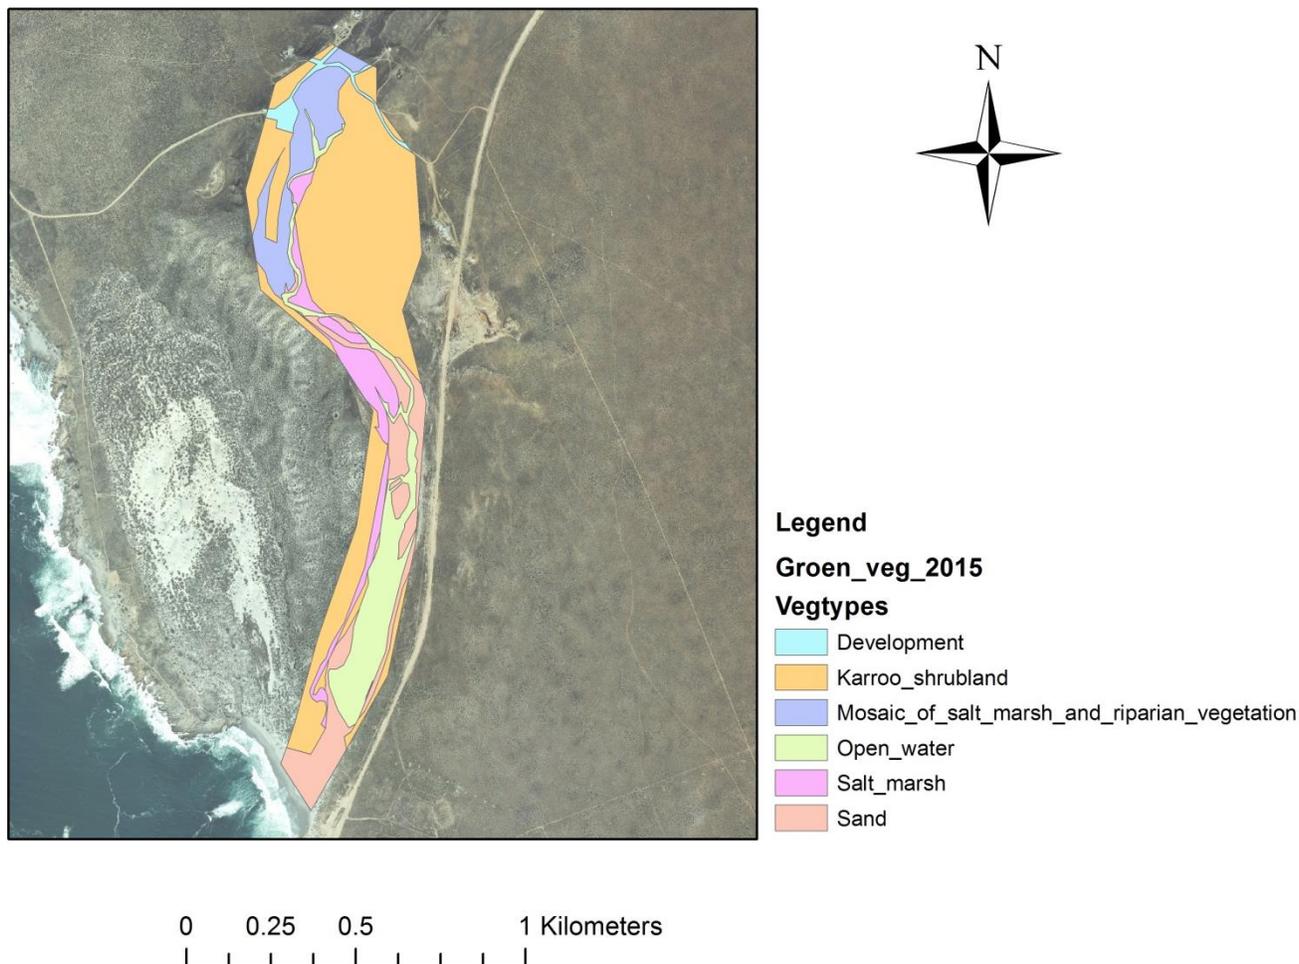
Figure 12.6 Groen Estuary: Vegetation map of the Groen Estuary for the EFZ based on the 2014 aerial images

The low-level road crossing, fences, agriculture and development in the floodplain has decreased the health of the Groen Estuary. Groundwater abstraction and increases in salinity have had the greatest effect on the macrophytes potentially decreasing the abundance of reeds and sedges. Table 12.10 provides the macrophyte similarity EHI scores for the Groen Estuary.

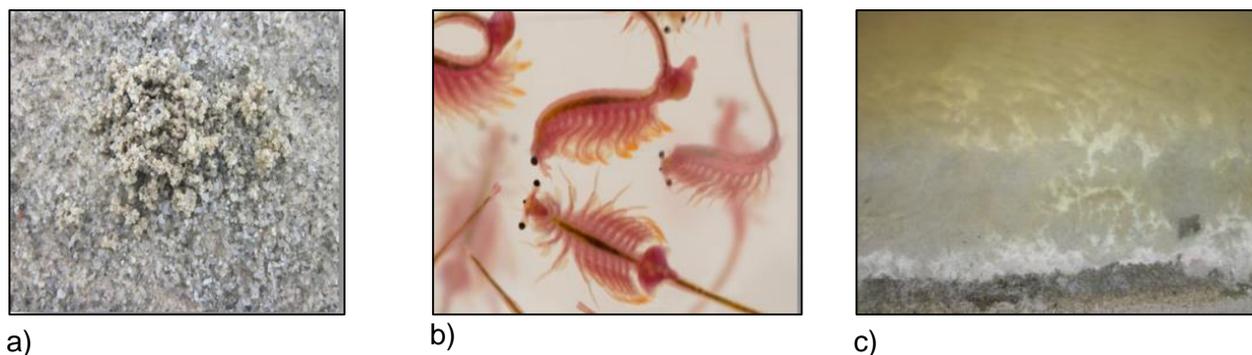
Figure 12.7 Groen Estuary: Blue green flies perhaps kelp-flies *Thinophilus sp.* associated with burrows and tiny sand-heaps above the waterline (a); brine shrimp *Artemia salina* (b); and carpet of algae floating at the water surface (c)

More recently, no macro-invertebrates were present in benthic samples collected at seven sites in February 2015 (Adams *et al.*, 2015). Salinity ranged from 70 to 223 psu in the main water body to 9 to 31 psu in the spring-fed headwaters. An anoxic black layer was present immediately below the surface of the sediment and extended down to a depth of at least 0.5 m. Any disturbance of the sediment (even superficial) resulted in a strong smell of Hydrogen sulphide (H₂S). Zooplankton samples showed the same pattern – reflecting an absence of zooplankton in the water column. However, 26 insect larvae (ca 20 ind/m³) were collected in the upper reaches in February 2015 where a salinity of 26 psu was recorded. These insects were associated with the underside of the carpet of algae floating at the water surface. No brine shrimp *Artemia salina* were reported from anywhere in the estuary. Similarly, a sampling visit six months later in August 2015 had seen salinity drop to 70 psu but *Artemia* had yet to hatch out of encystment (Lamberth unpublished data). On both occasions, the unavailability of *Artemia* was evident in the virtual absence of flamingos and other avian predators. The only invertebrates seen in August 2015 were blue green flies perhaps kelp-flies *Thinophilus* sp. associated with burrows and tiny sand-heaps above the waterline. These animals were been foraged by Kittlitz's sandplover *Charadrius pecuarius* one of the few bird species present at the time.

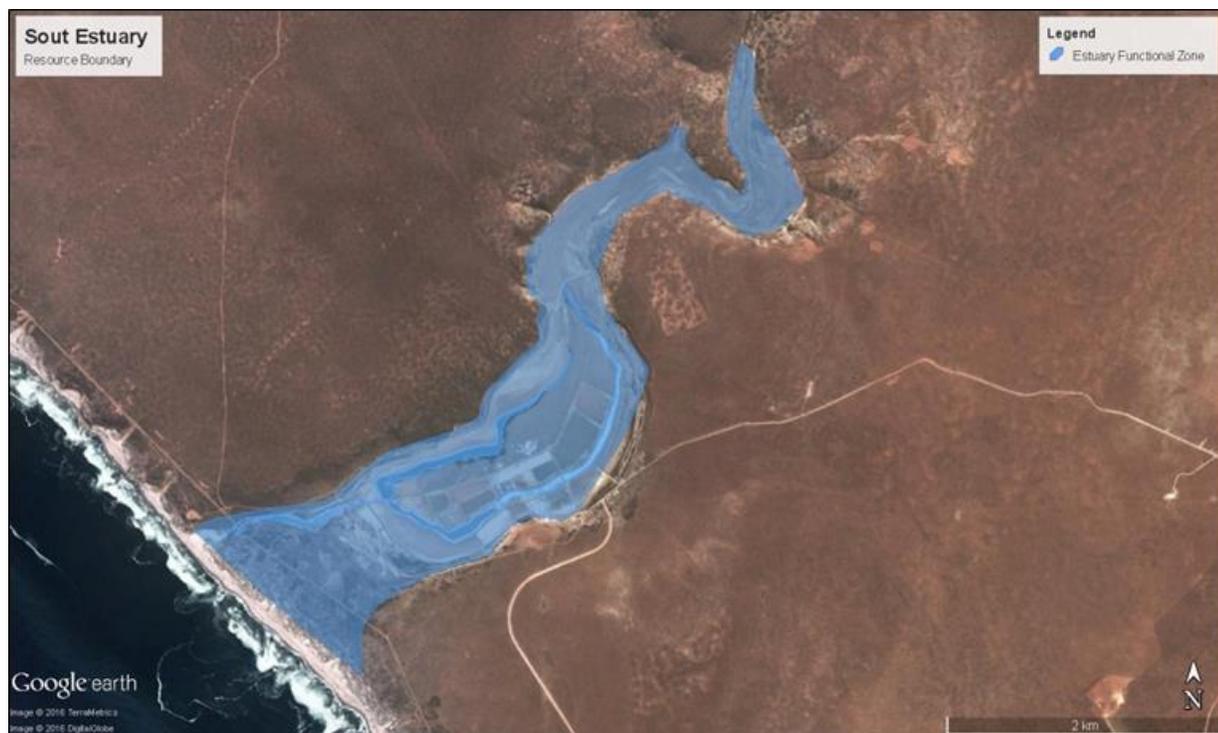
Figure 13.1 Sout Estuary: Geographical boundaries based on the EFZ

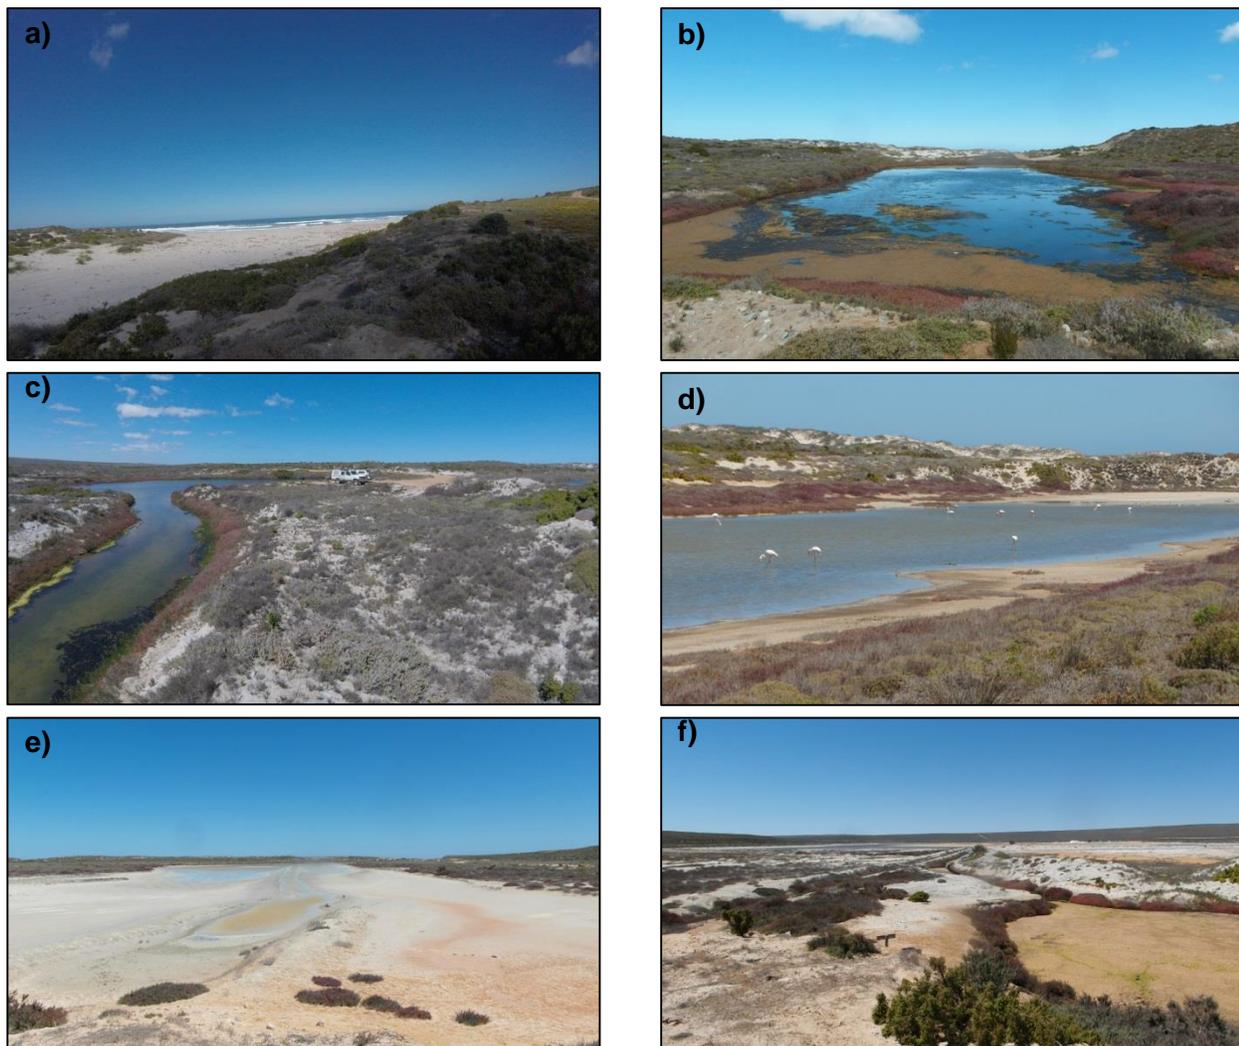
(a) A very high and wide berm showing little signs of overwash or vegetation growth; (b) The lower reaches cut off by road from main water body; (c) Channels connecting the lower reaches with middle reaches and road bisecting the lower reaches; (d) The middle reaches teeming with bird life; (e) and (f) Saltworks in the upper reaches of the Sout Estuary.

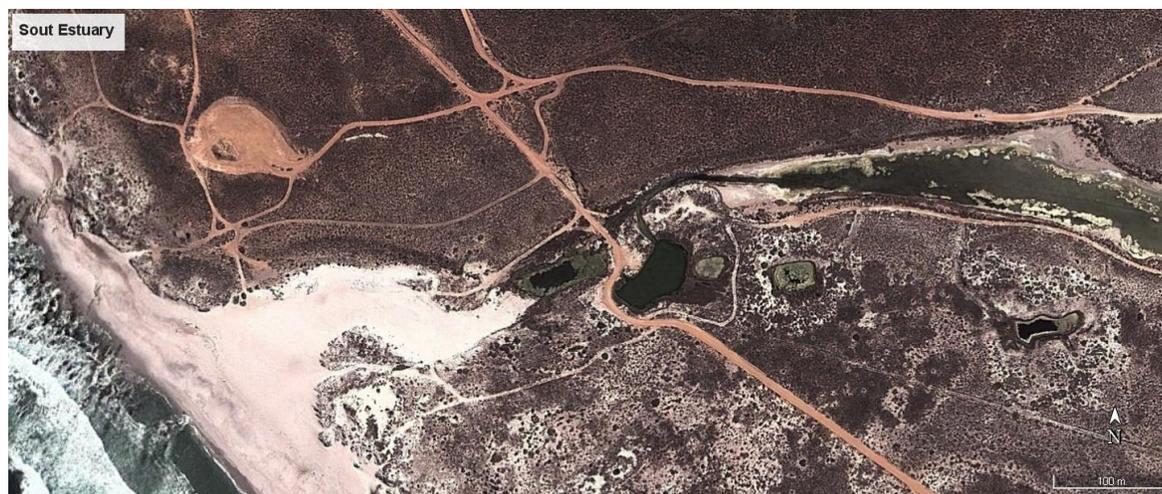
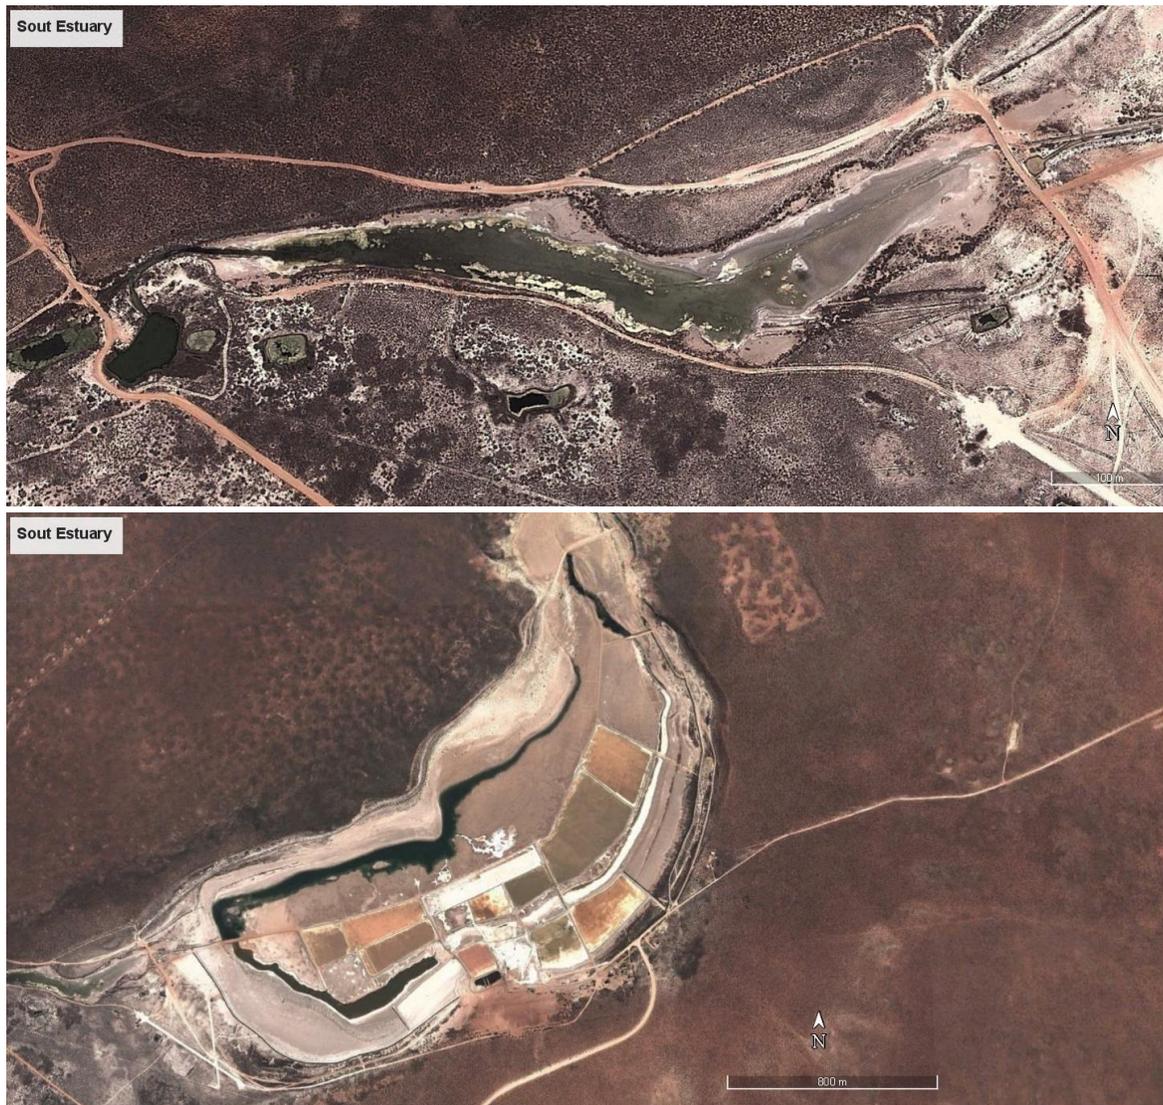
Figure 13.3 Sout Estuary: Roads, diverted channels, salt works and weir

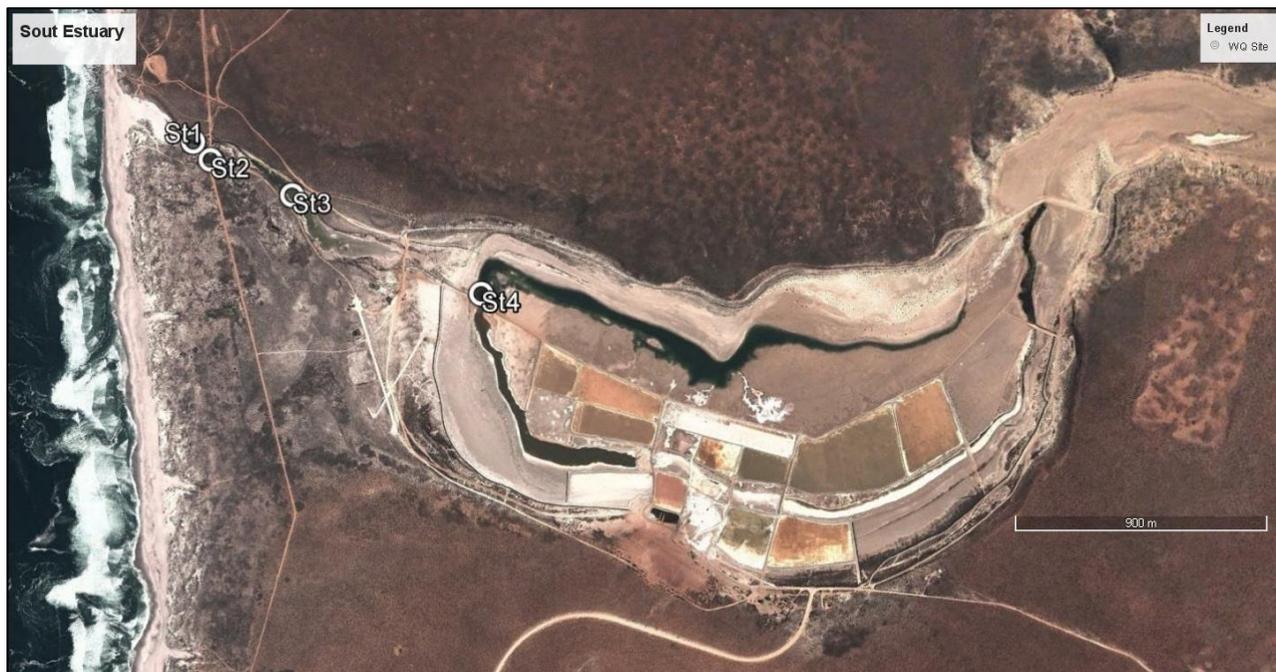
Figure 13.4 Sout Estuary: Water Quality sampling stations

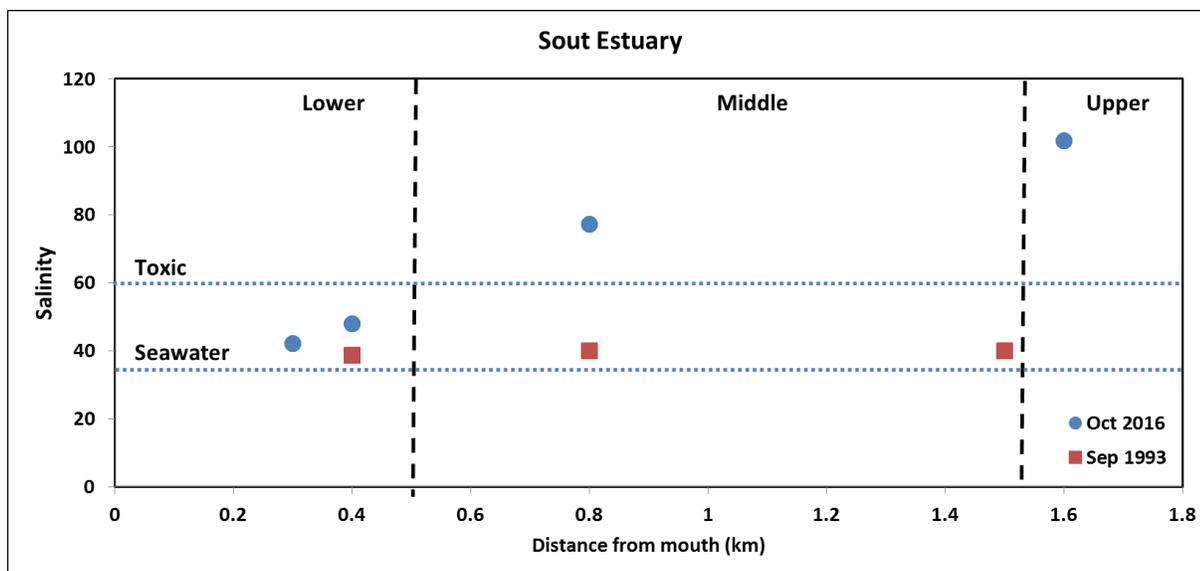
Figure 13.5 Sout Estuary: Available salinity data

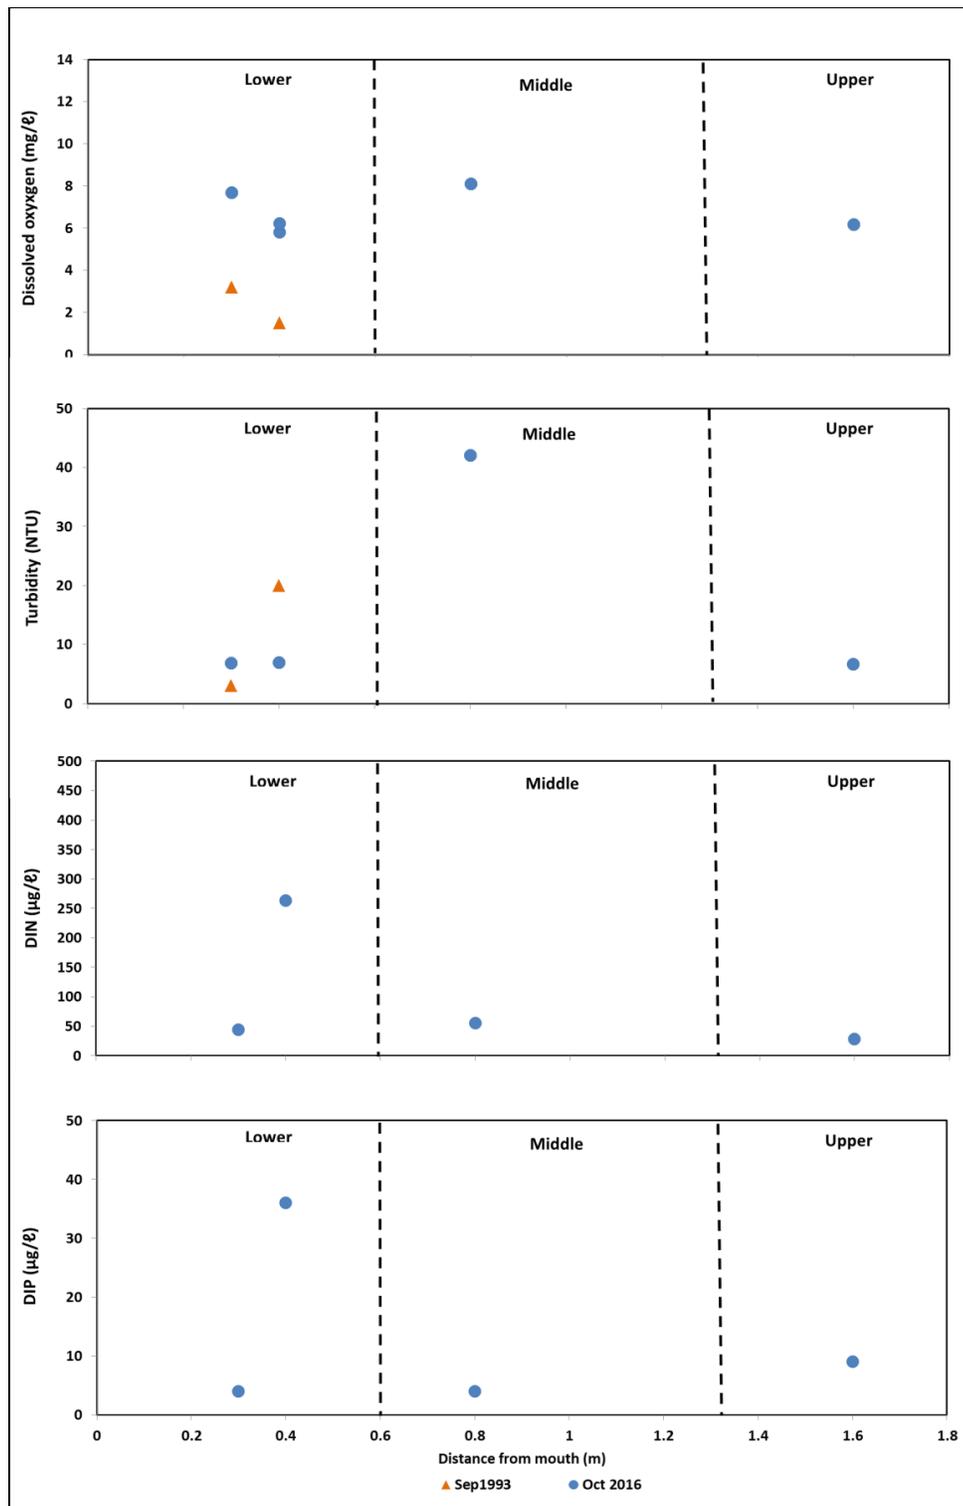
Figure 13.6 Sout Estuary: Available data for dissolved oxygen, turbidity and inorganic nutrients

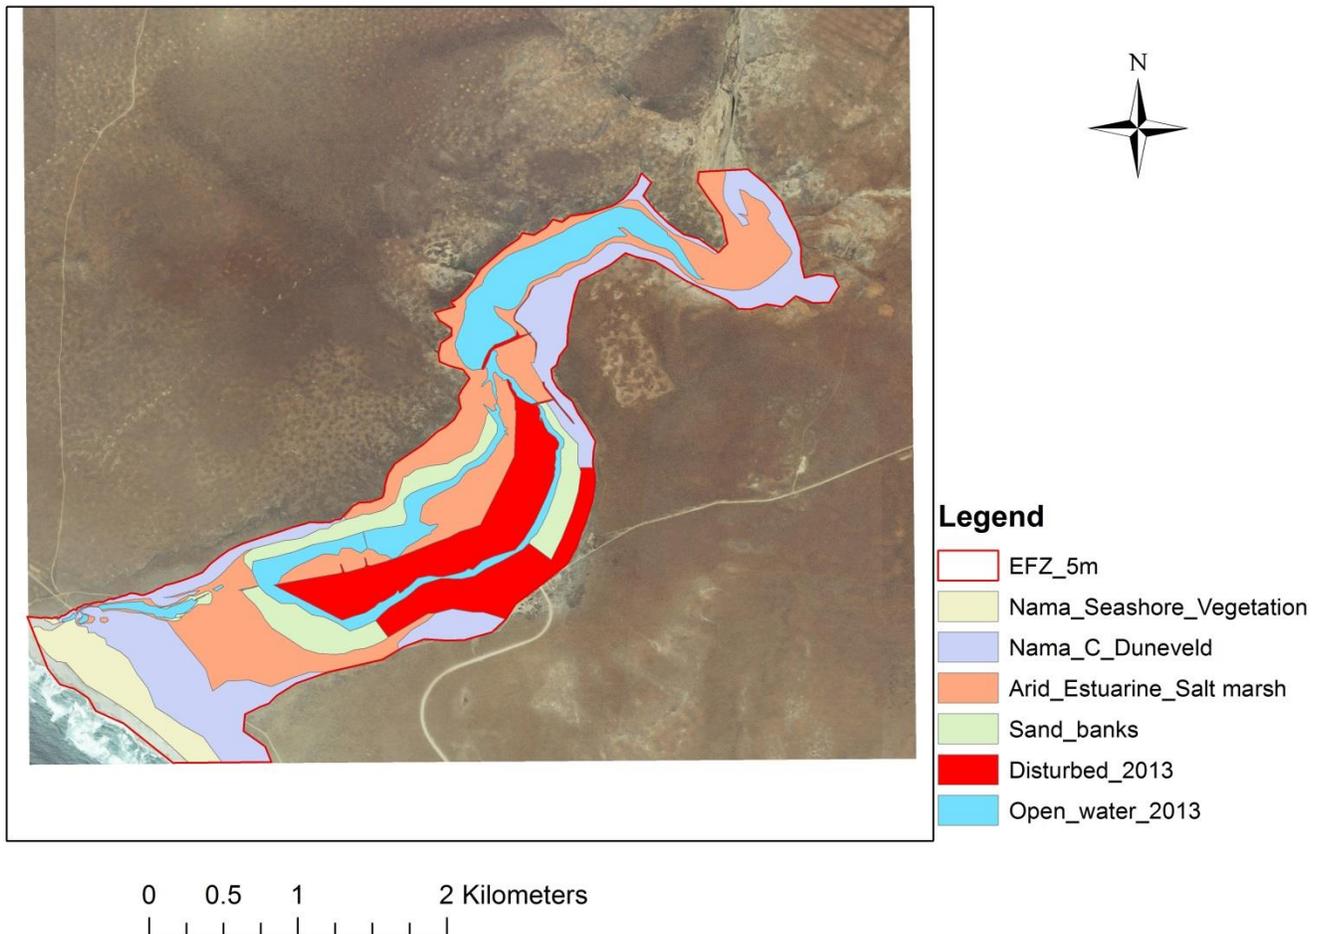
Figure 13.7 Sout Estuary: Vegetation map for the EFZ based on the 2014 aerial images

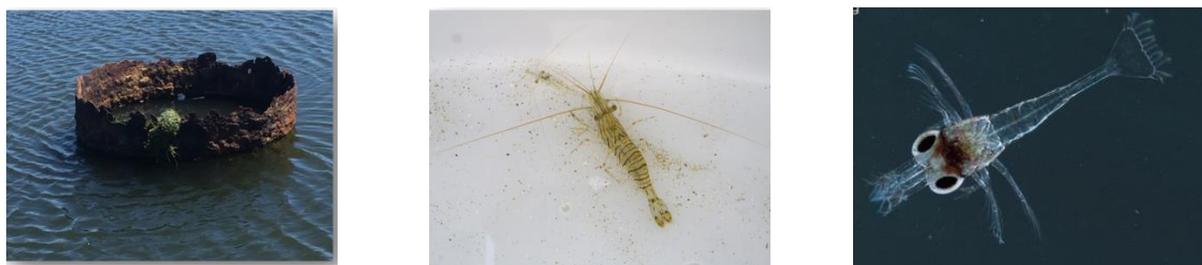
Figure 13.8 Harpacticoid copepods, Palaemon sp and Hydrophilid beetles in the Sout Estuary

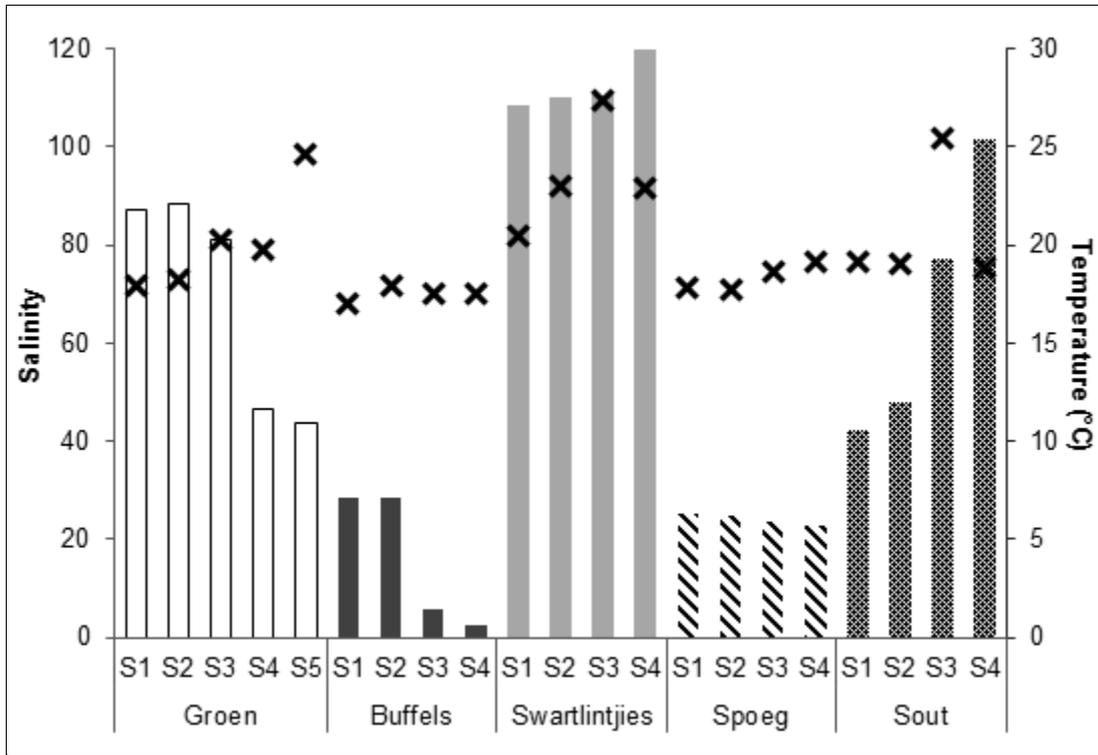
Figure 14.1 Salinity (*bars; primary y-axis) and temperature (*crosses; secondary y-axis) distribution profiles along five South African west coast estuaries

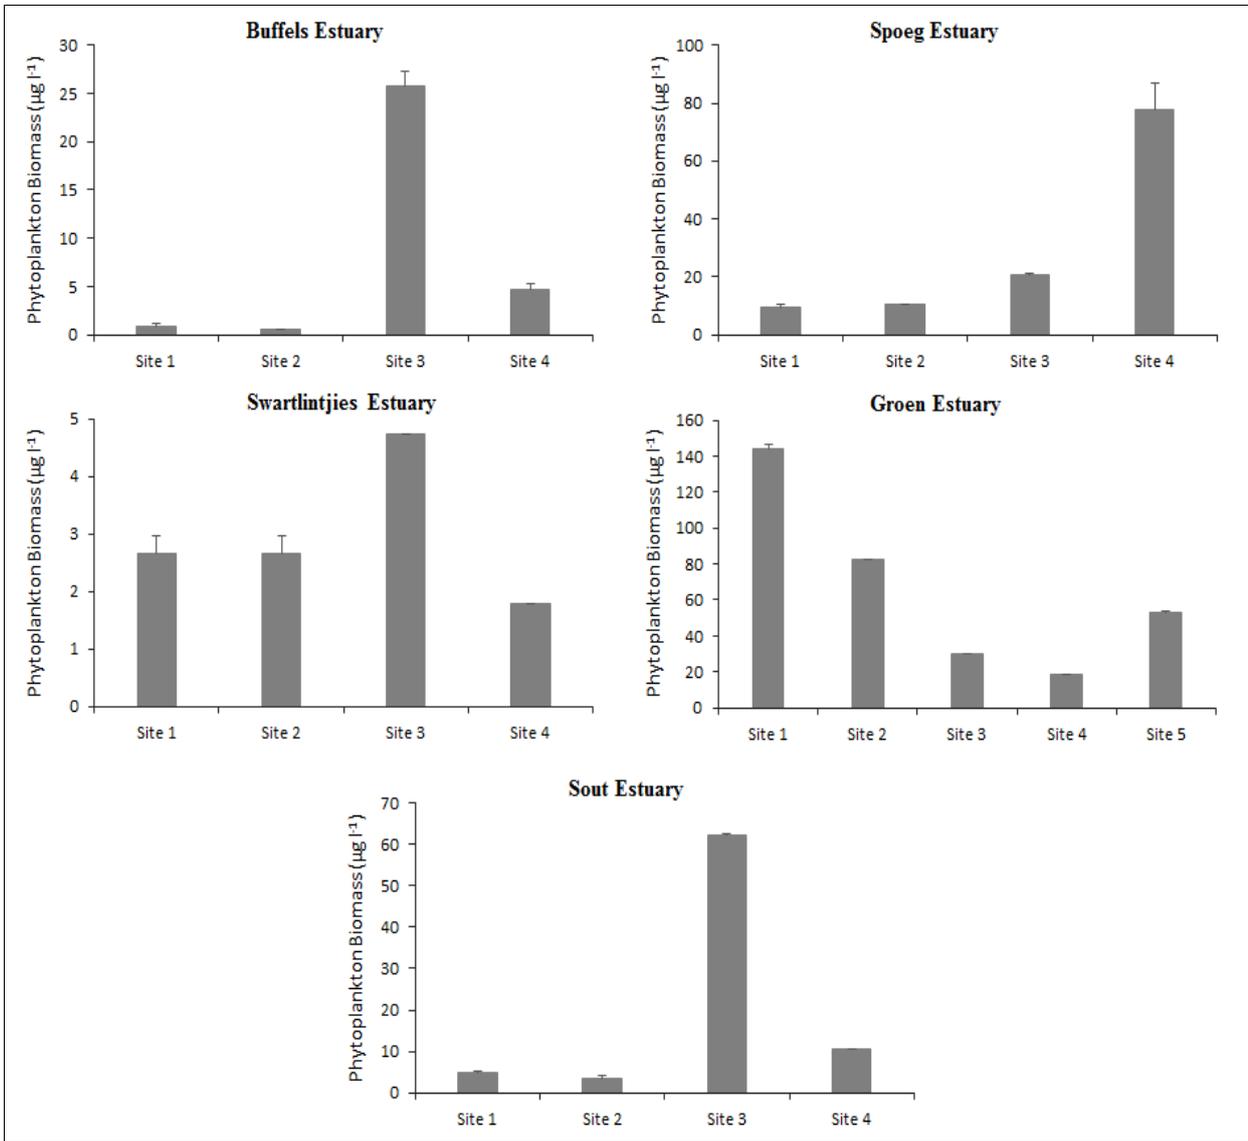
Figure 14.2 Spatial distribution of phytoplankton biomass along the length of five South African west coast estuaries

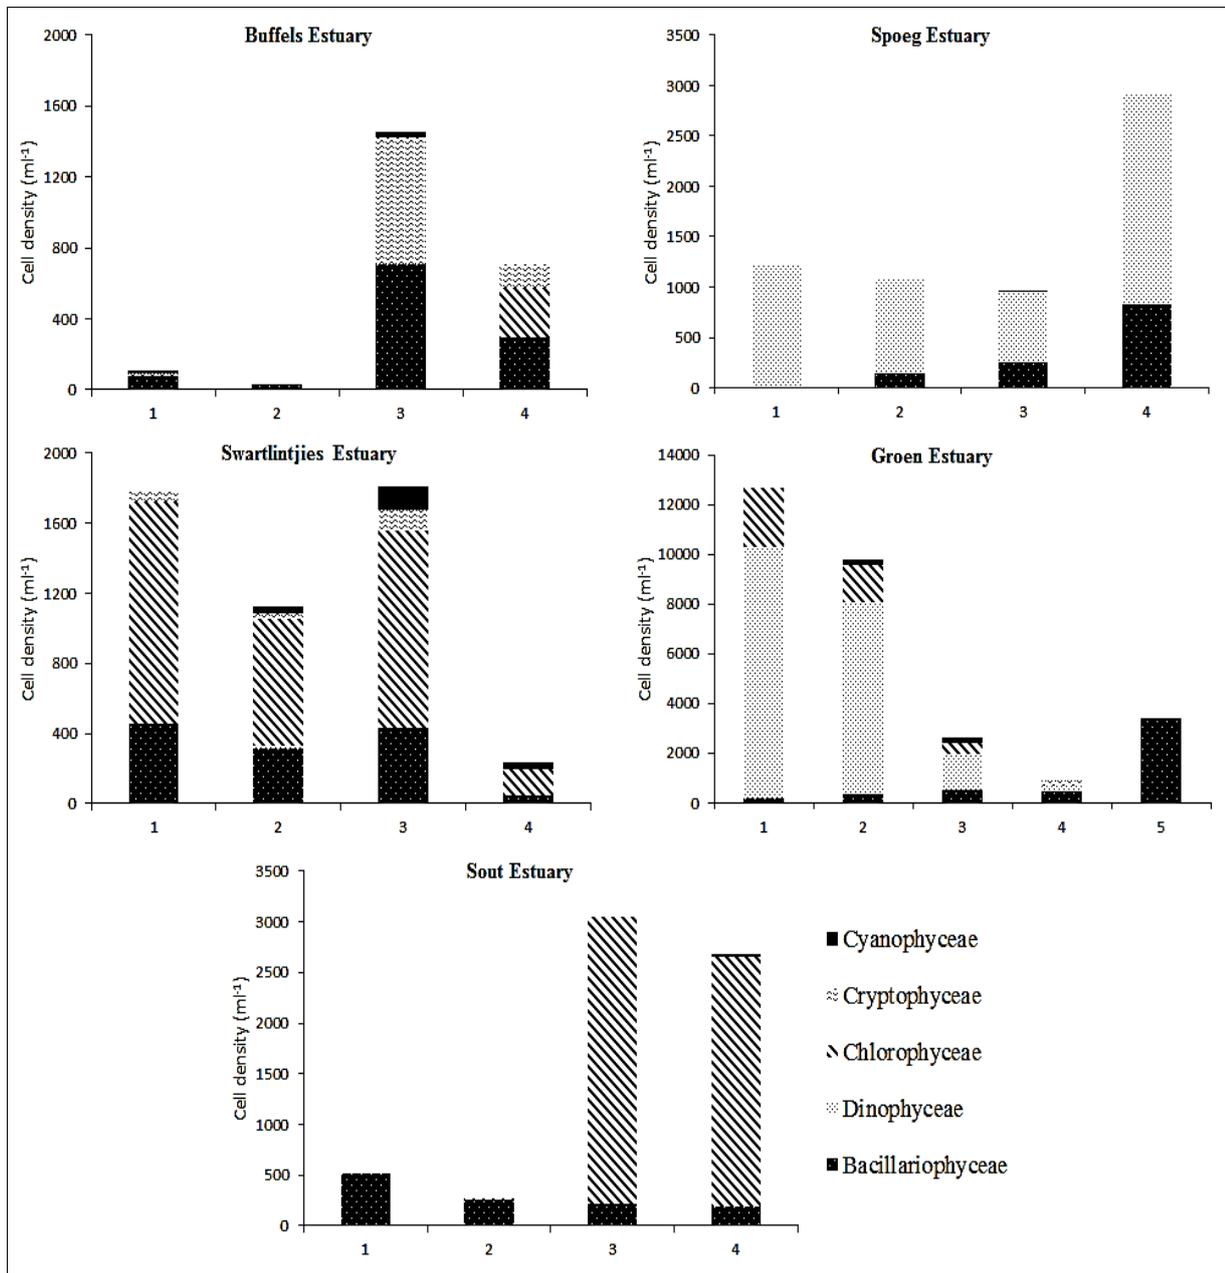
Figure 14.3 Phytoplankton community composition along the length of five South African west coast estuaries

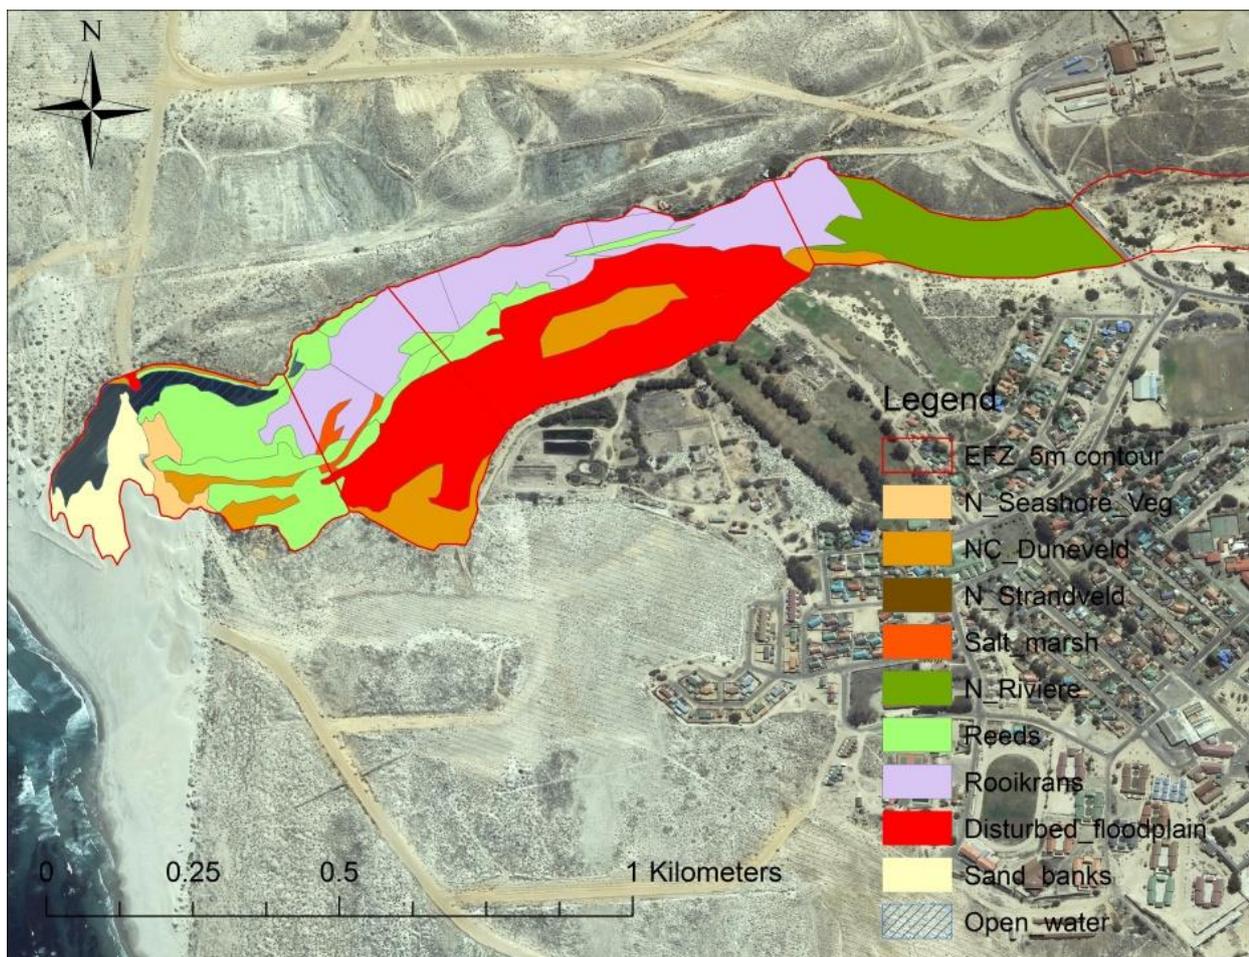
Figure 14.4 Vegetation map of the Buffels Estuary for the Estuarine Functional Zone based on the 2014 aerial images
