REPORT NUMBER: RDM/WMA06/00/CON/COMP/0316

DETERMINATION OF ECOLOGICAL WATER REQUIREMENTS
FOR SURFACE WATER (RIVER, ESTUARIES AND WETLANDS)
AND GROUNDWATER IN THE LOWER ORANGE WMA

The Buffels, Swartlintjies, Spoeg, Groen and Sout Estuaries' Ecological Water Requirements

FEBRUARY 2017

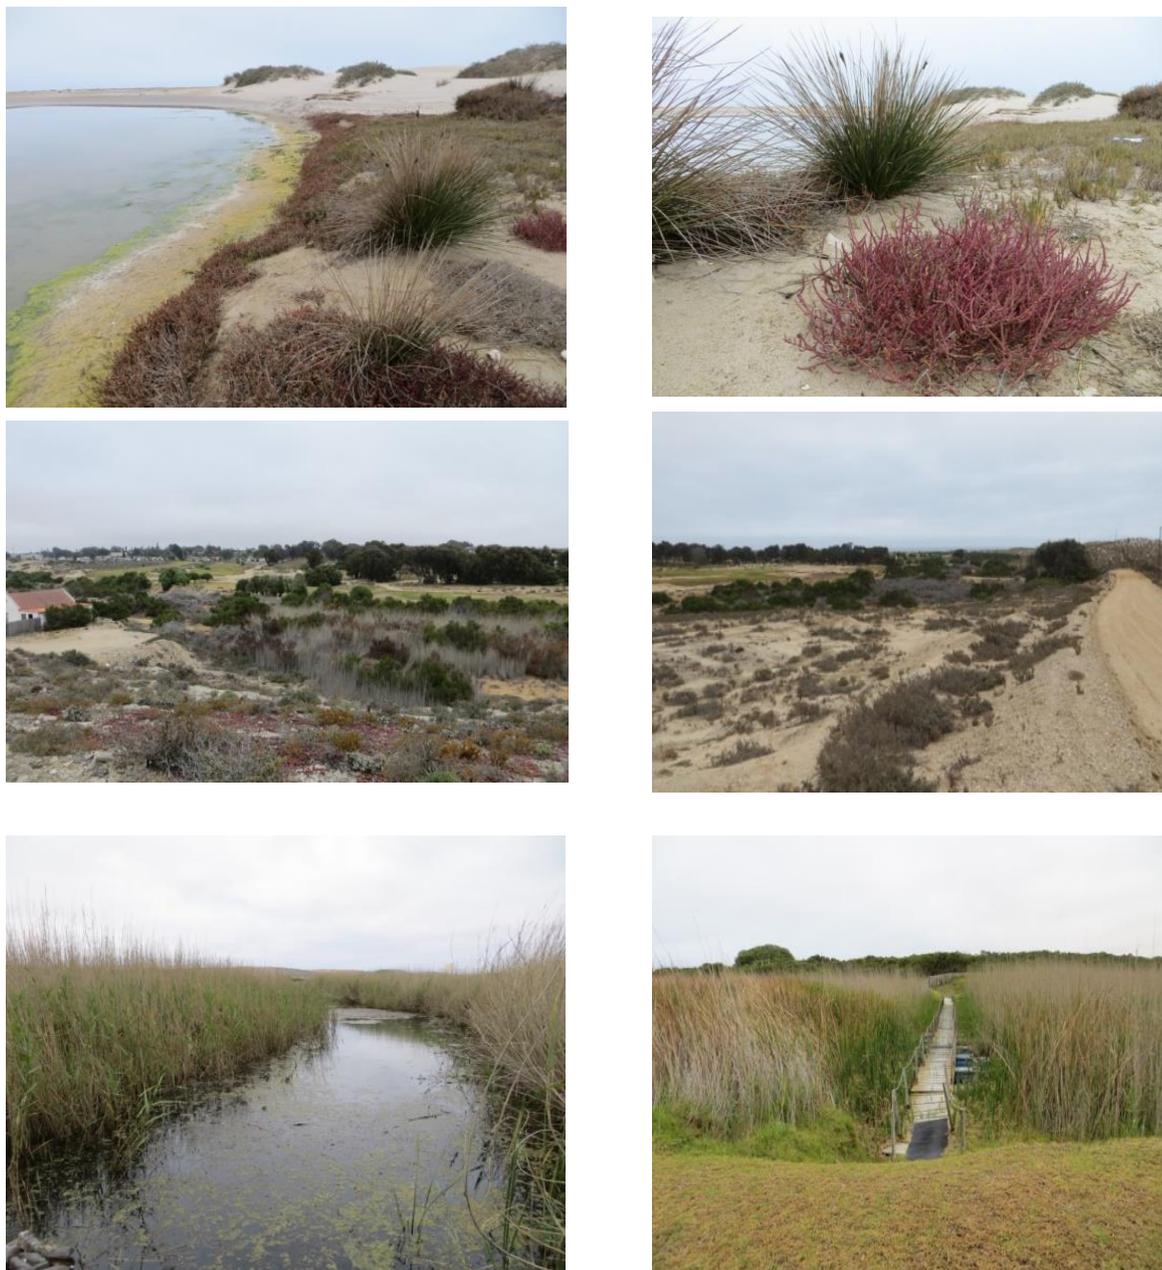
Figure 14.5 Top) Salt marsh at the mouth of the Buffels Estuary, northern side, Middle) Namaqualand Riviere vegetation type, and Bottom) reed beds

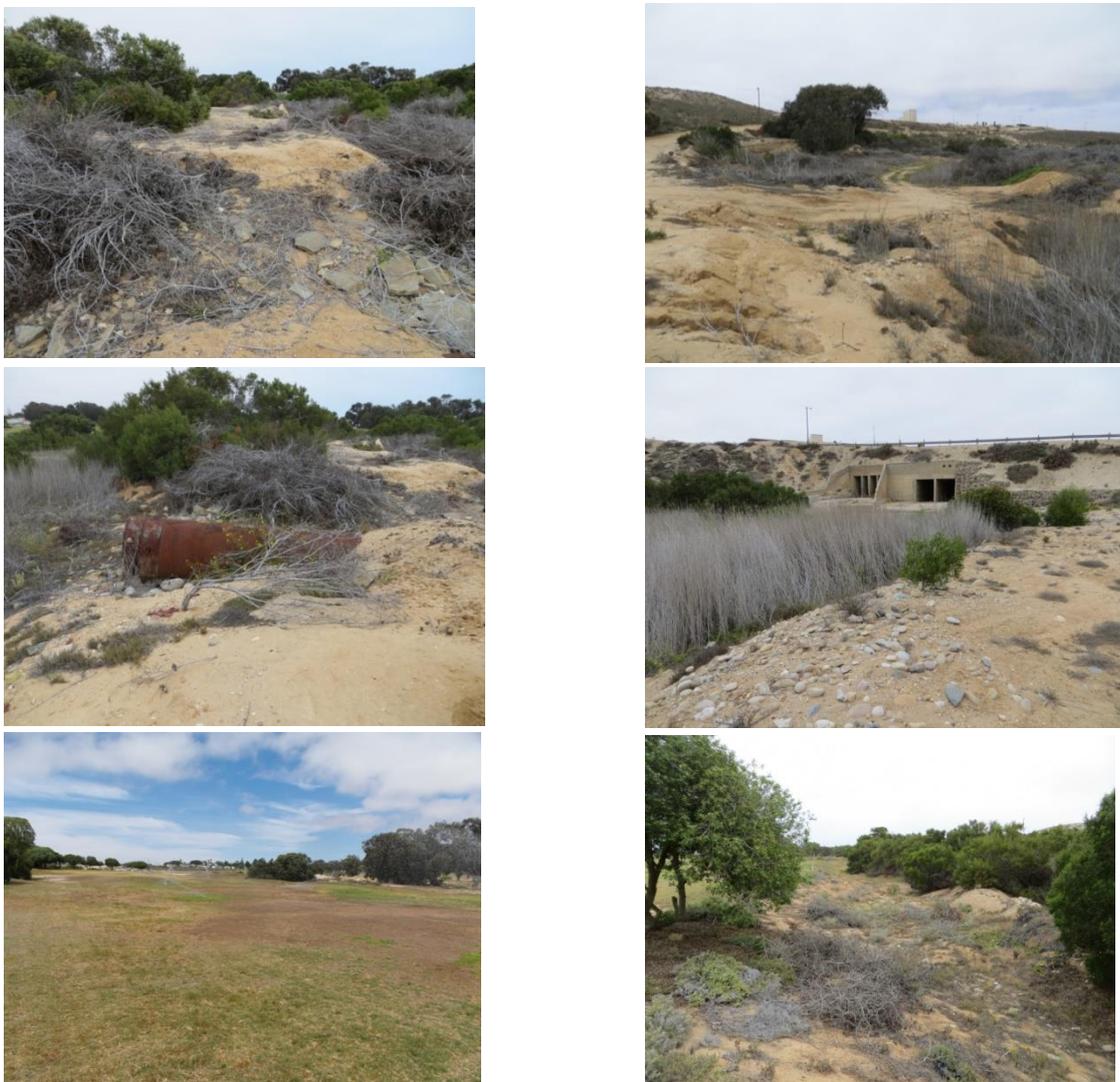
Figure 14.6 Obstructions and modifications to the Buffels Estuary Top) minor access roads in the river course, Middle) remaining pipes after the bridge washed away and two large culverts at the tarred road, and Bottom) golf course within the EFZ and 700 m long levee to protect the golf course from flooding

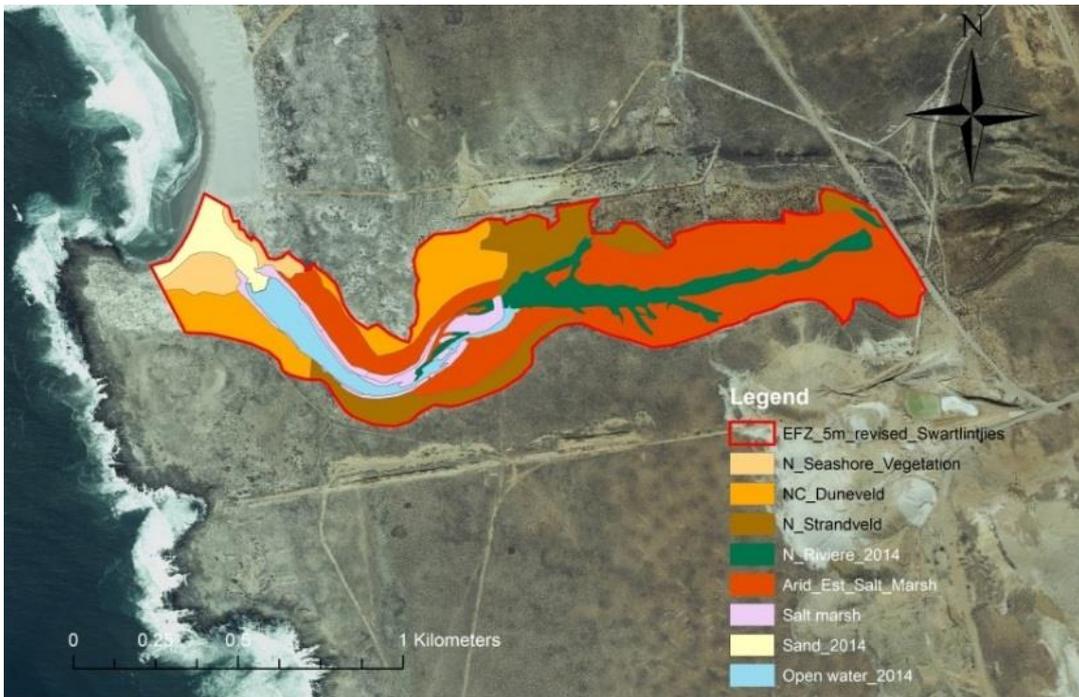
Figure 14.7 Vegetation map of the Swartlintjies using 2014 NGI aerial imagery

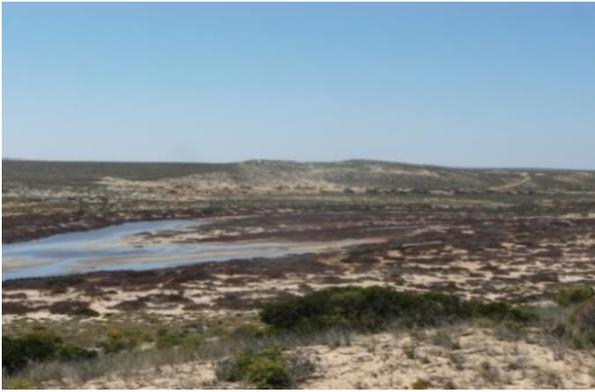
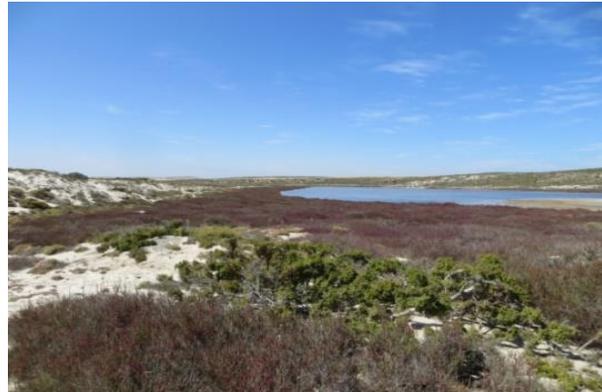
Arid estuarine salt marsh with the dominant *Sarcocornia pillansii* (red colour) extending into upper reaches.

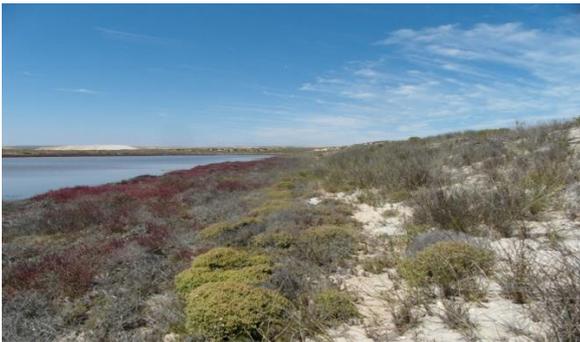
Clear zonation along elevation gradient.

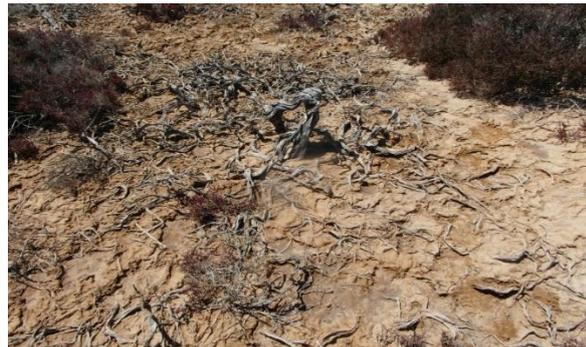
Dead *S. pillansii* plants in saline areas.

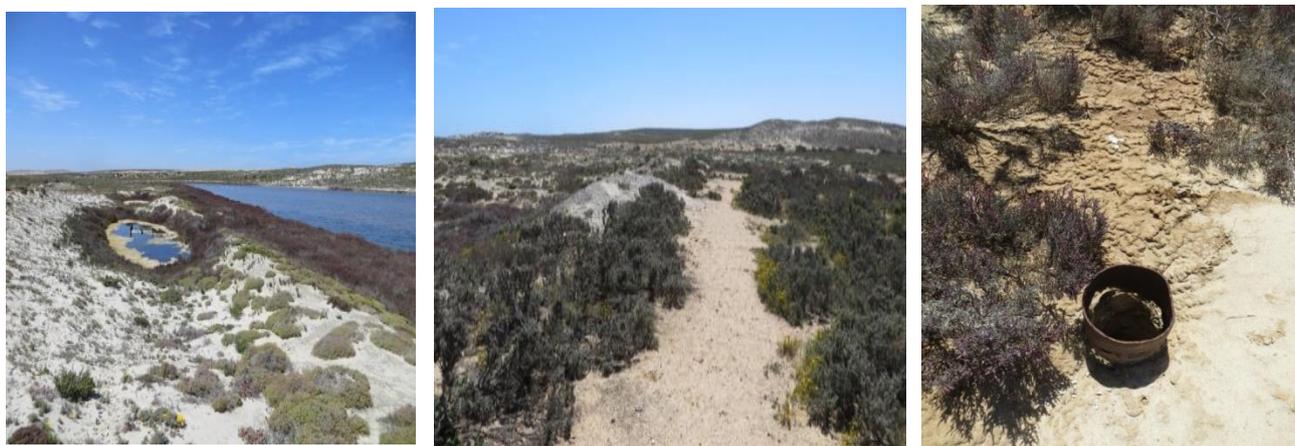
Figure 14.9 Photographs of disturbance in the Swartlintjies Estuary (Left: an old trench in the lower reaches of the Swartlintjies Estuary probably used for the extraction of water, Middle: unused access road and Right: old borehole)

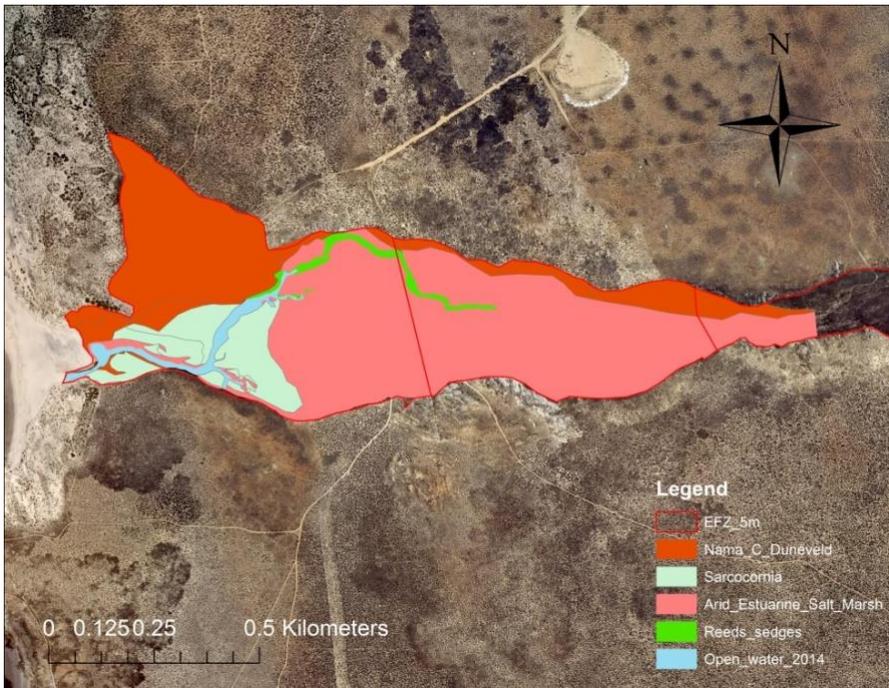
Figure 14.10 Vegetation map of the Spoeg Estuary for the estuarine functional zone based on the 2014 aerial images.

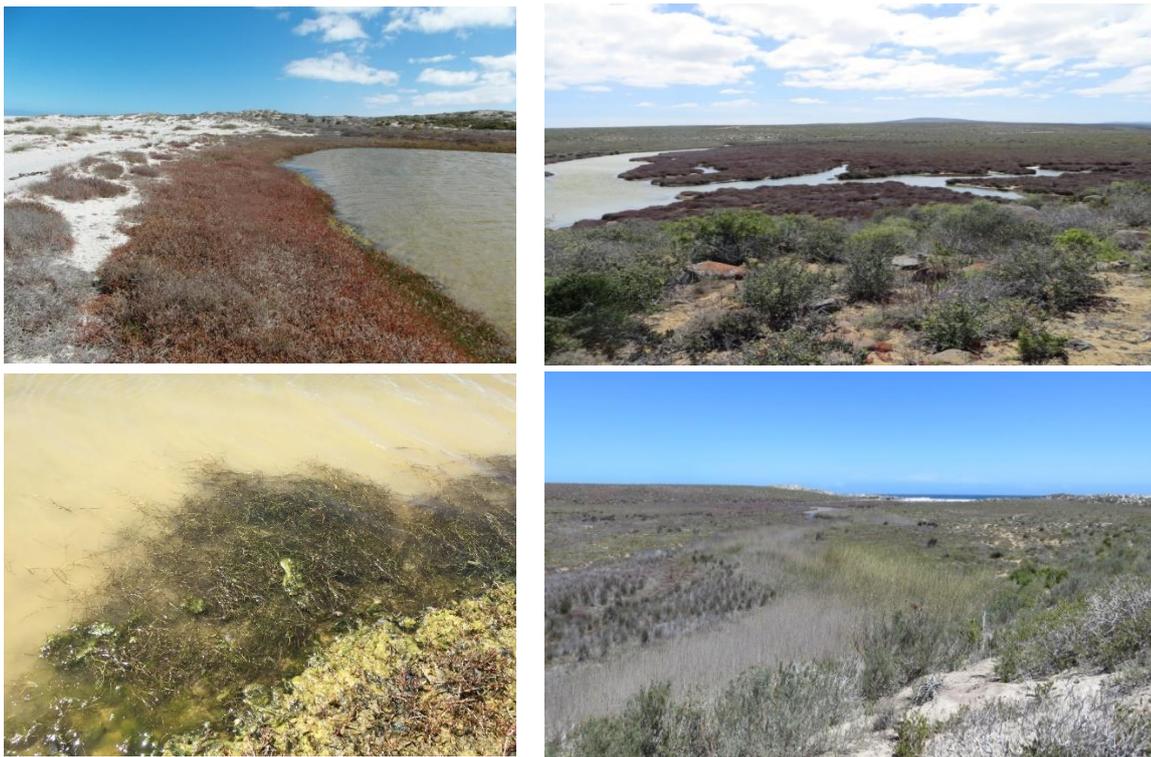
Figure 14.11 Macrophyte habitats of the Spoeg Estuary. Top) *Sarcocornia* stands in the lower reaches and mix of Arid Estuarine Vegetation and Namaqualand Riviere in the water course, Bottom) *Ruppia cirrhosa* and macroalgae in standing water and *Phragmites australis* and *Juncus kraussii* stands in seepage/standing water areas

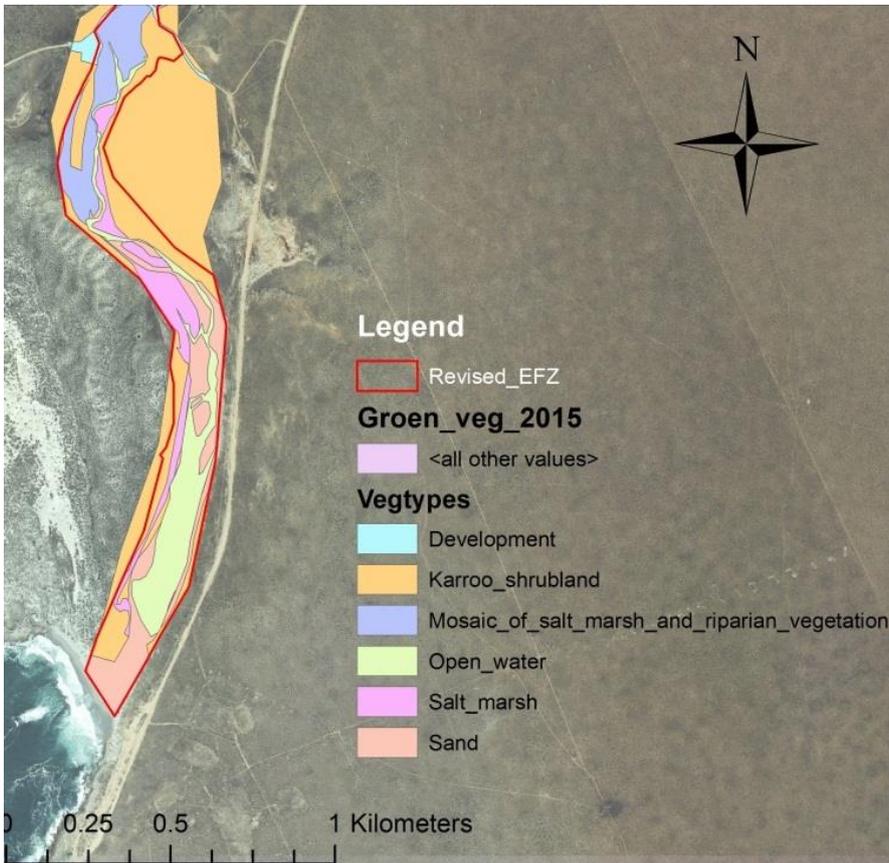
Figure 14.12 Present vegetation map of the Groen Estuary

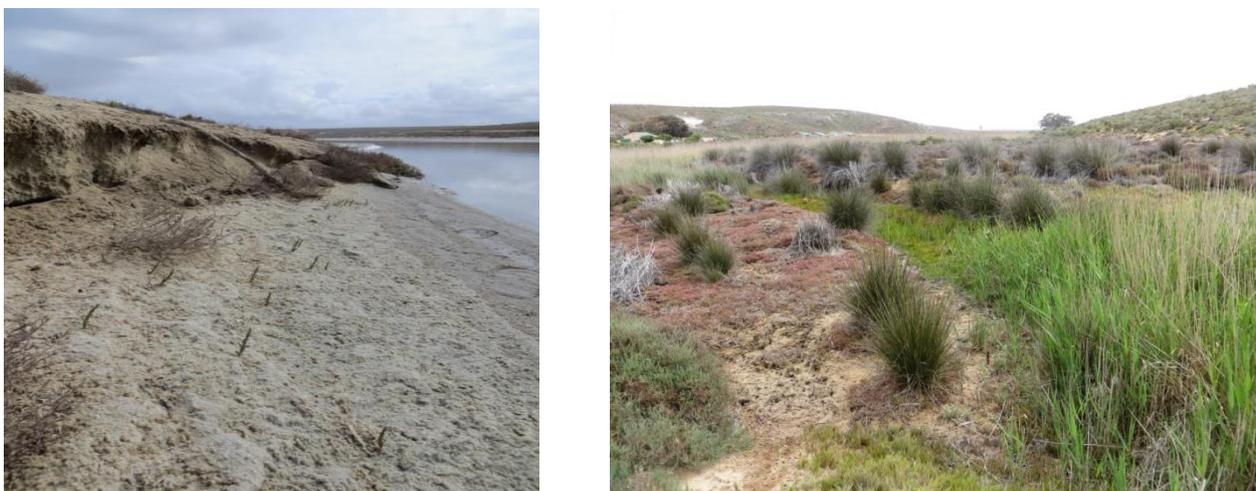
Figure 14.13 Left) New seedling growth of *Sarcocornia* spp. in the middle reaches of the Groen Estuary and Right) freshwater seepage area with *Phragmites australis*, *Juncus kraussii* and *Isolepis* sp.

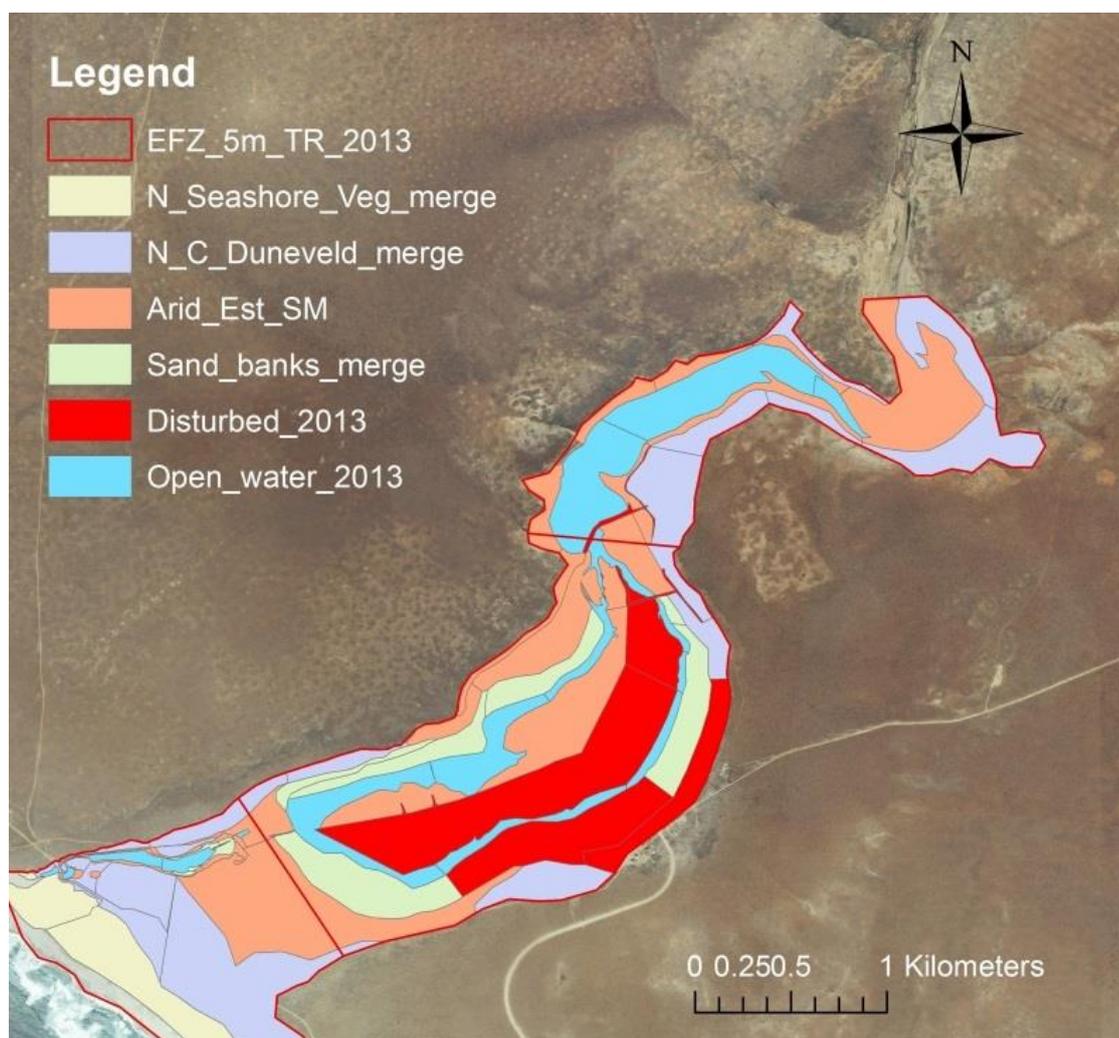
Figure 14.14 Vegetation map of the Sout Estuary for the estuarine functional zone based on the 2013 aerial images

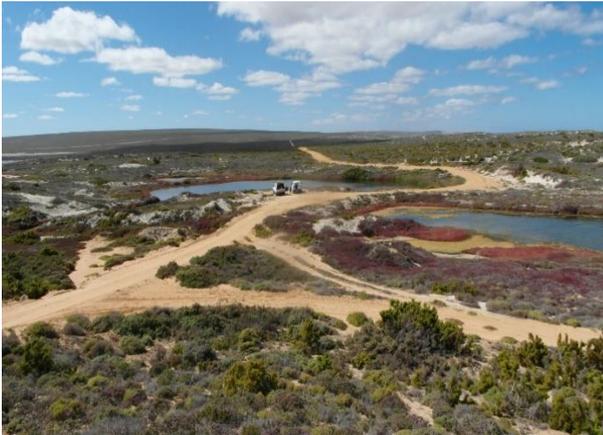
View of the lower reaches showing the two ponds

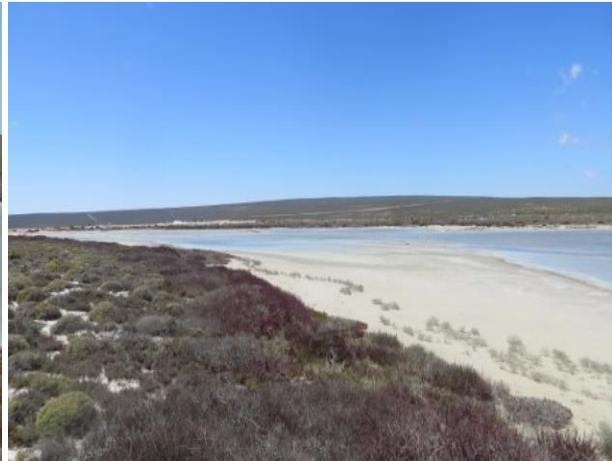
Arid estuarine with large bare areas in the middle reaches.

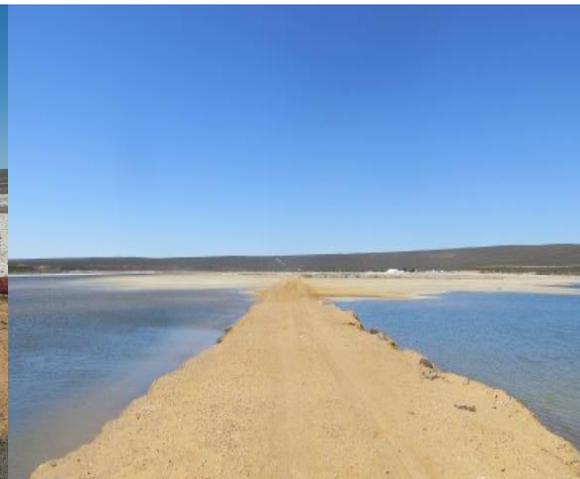
Access roads through the estuary.
