NATIONAL ASSEMBLY: QUESTION 2751 FOR WRITTEN REPLY

OUR REFERENCE: DWA/MWS/LOC-PWO/Maj/170221

RE: INTERIM PROGRESS REPORT – PROCESS WATER OVERFLOW AT KAREERAND TAILINGS STORAGE FACILITY RETURN WATER DAM ON 21 FEBRUARY 2017.

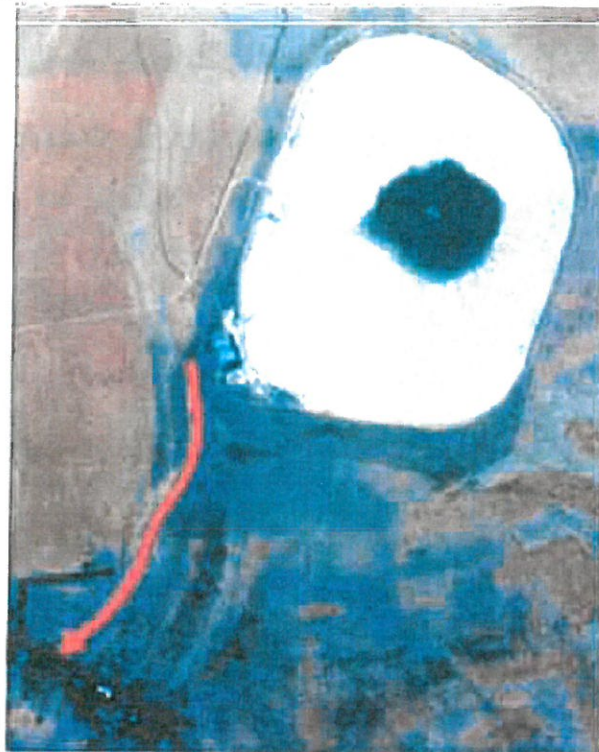
Figure 1: Drainage line towards the Vaal River

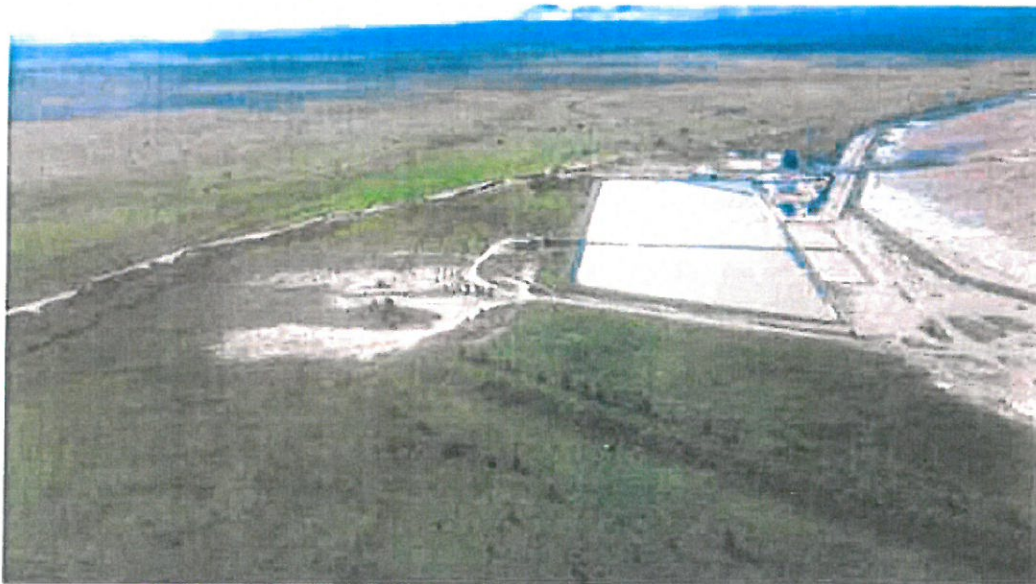
On the 21st of February 2017, following a heavy rainstorm event of more than 50mm in less than 3 hours, the return water dam at Kareerand overflowed into the drainage line and subsequently discharged downstream into the Vaal River.

In addition to the return water overflow, storm water and some tailings material from the area surrounding the Kareerand tailings dam also spilled towards and into the Vaal River.

Figure 2: Spillage towards the Vaal River (21 Feb 2017)

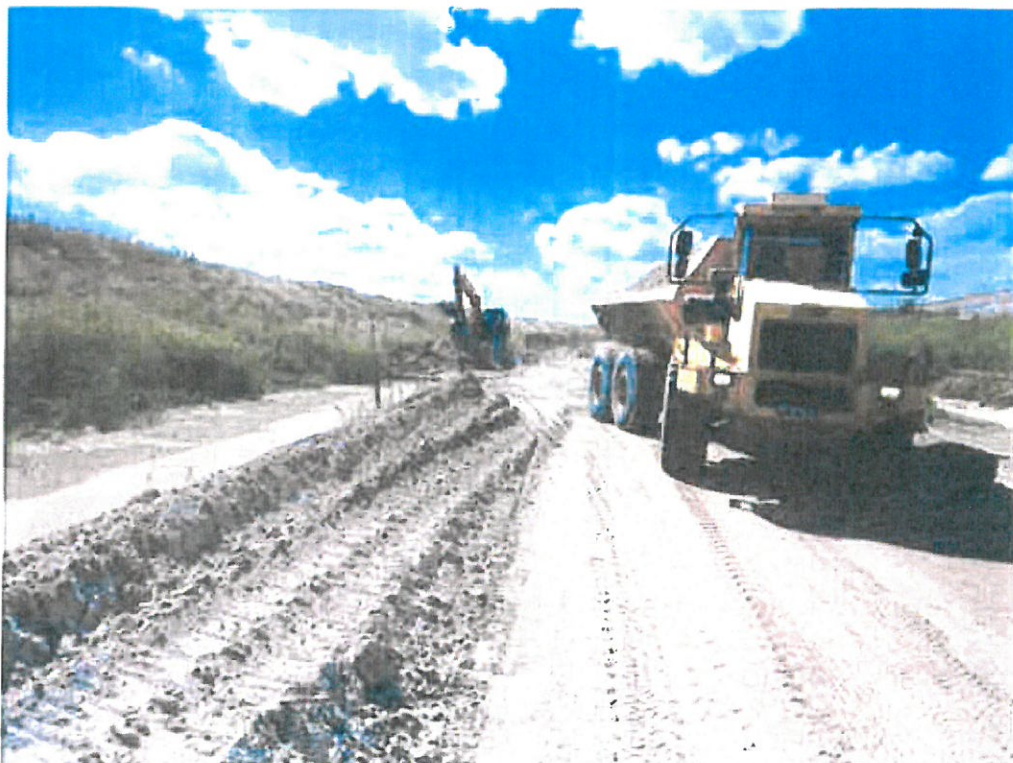
Figure 4: Clean-up in progress around Kareerand TSF (inside containment area)

- The clean-up of residue around the offices and workshops (see Figures 4 to 12);
- Construction and maintenance of the toewall on the TSF side slope to contain slurry and storm water (Construction complete & maintenance ongoing) (see Figure 13);

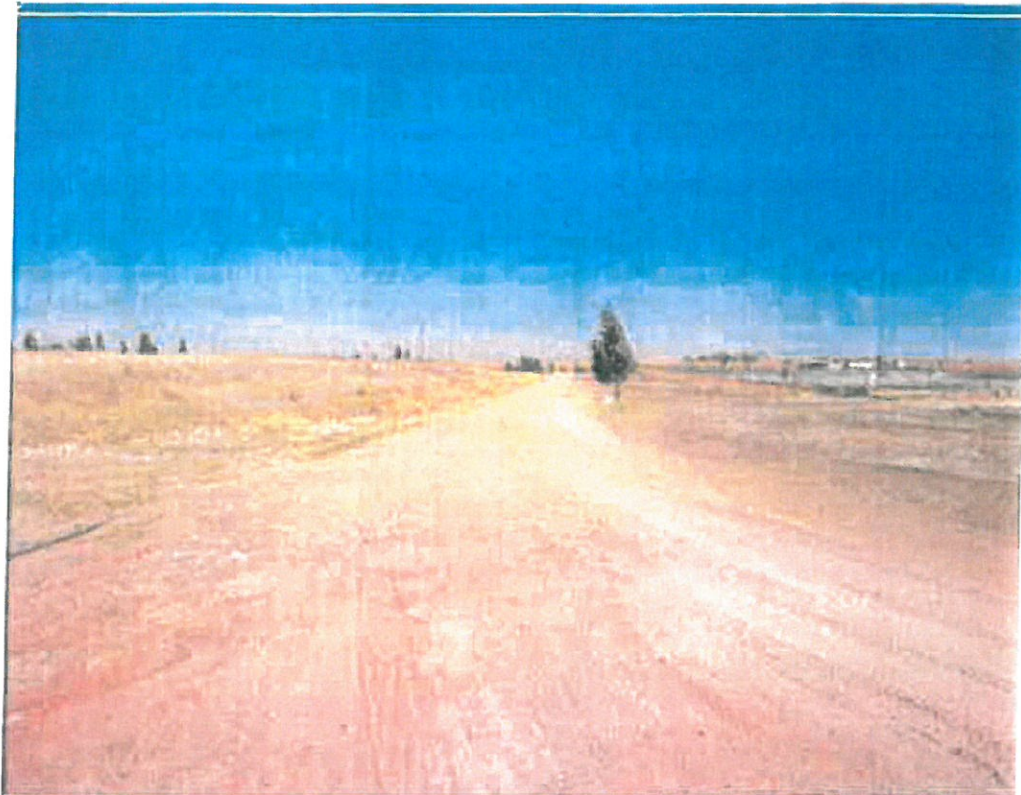
Figure 5: Cleanup completed around Kareerand TSF (inside containment area) - September 2018

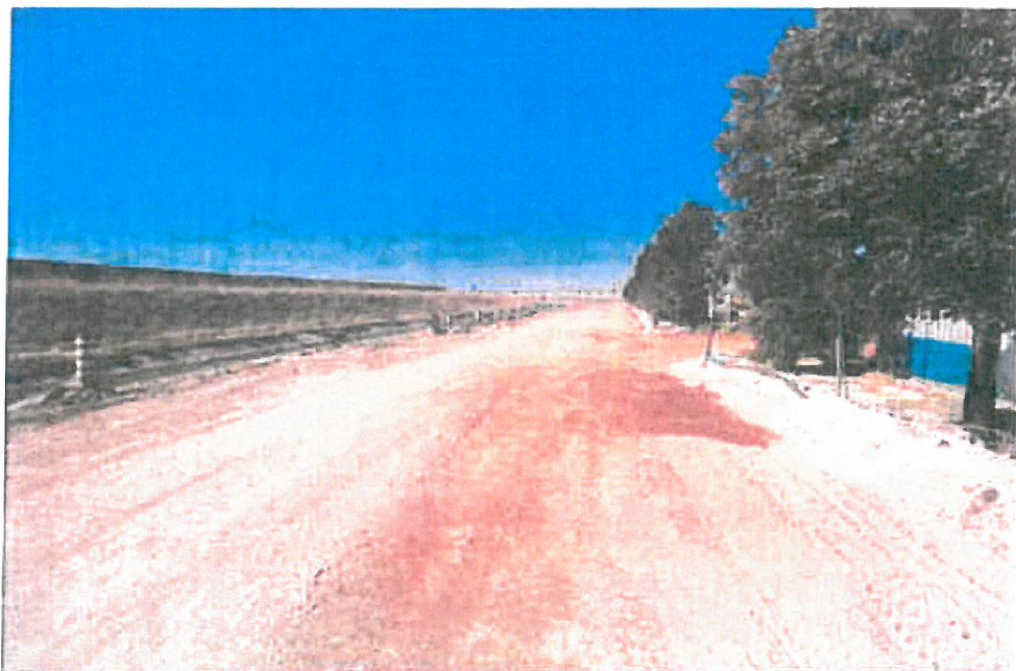
Figure 6: Cleanup completed around Kareerand TSF (inside containment area) - September 2017

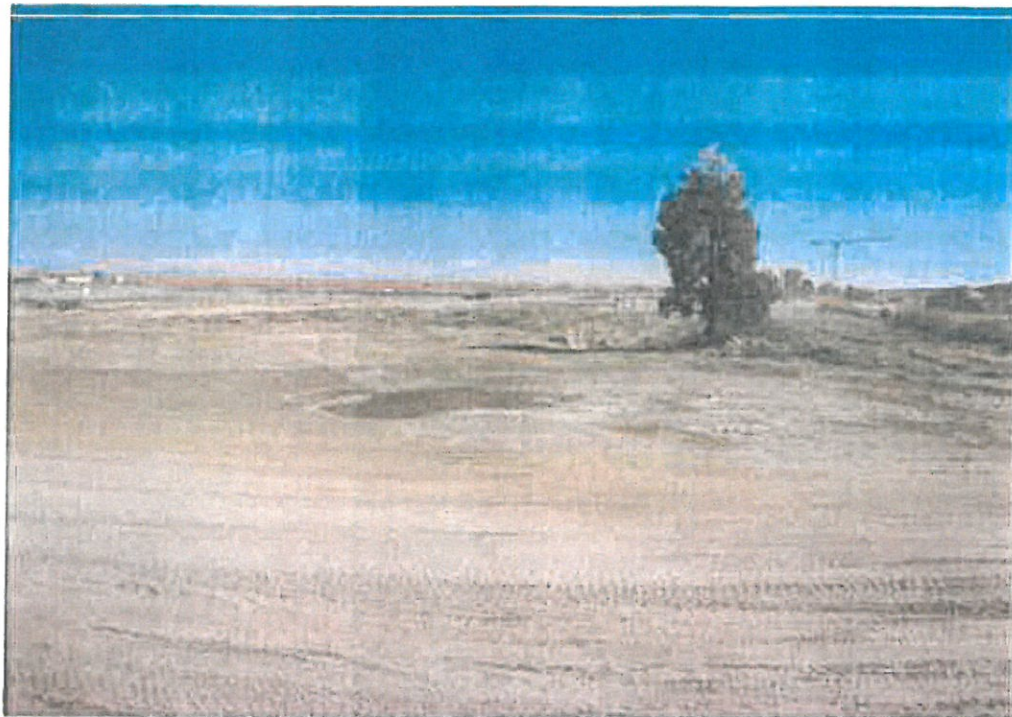
Figure 7: Cleanup completed around Kareerand TSF (outside containment area) - March 2018

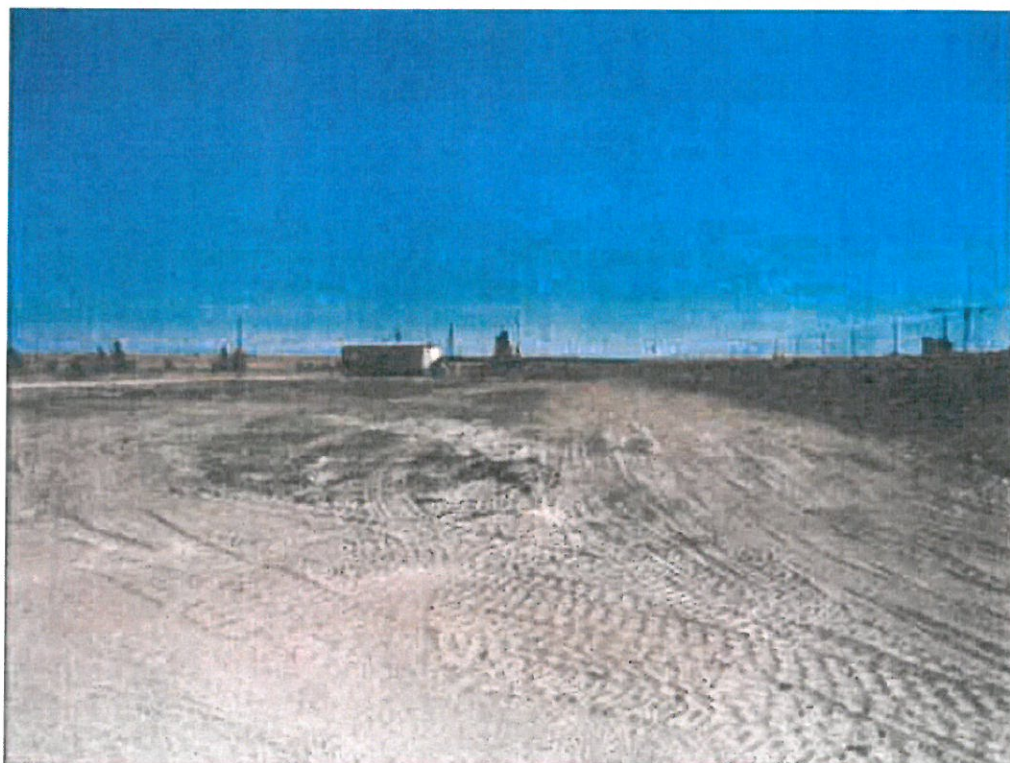
Figure 8: Cleanup completed around Kareerand TSF (outside containment area) - March 2018

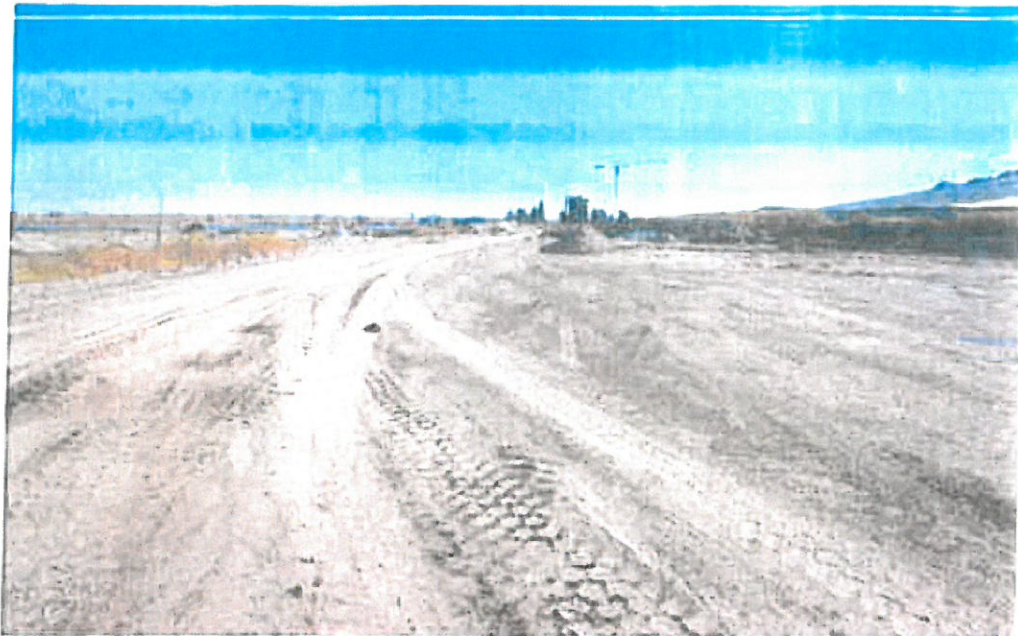
Figure 9: Cleanup completed **around Kareerand TSF** (outside containment area) - August 2018

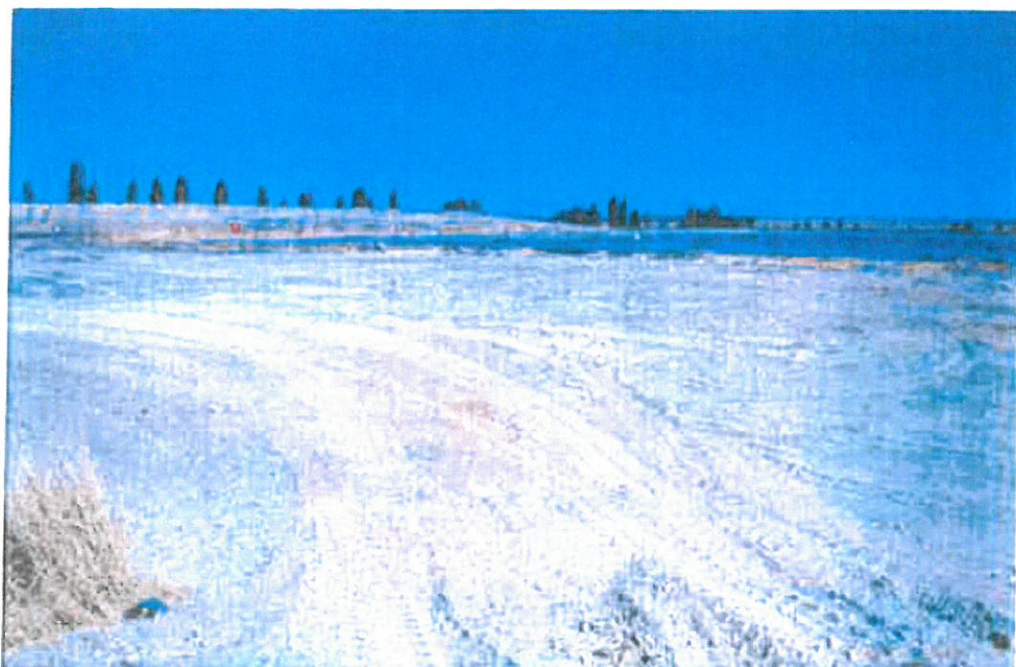
Figure 10: Cleanup completed around Kareerand TSF (outside containment area) - August 2018

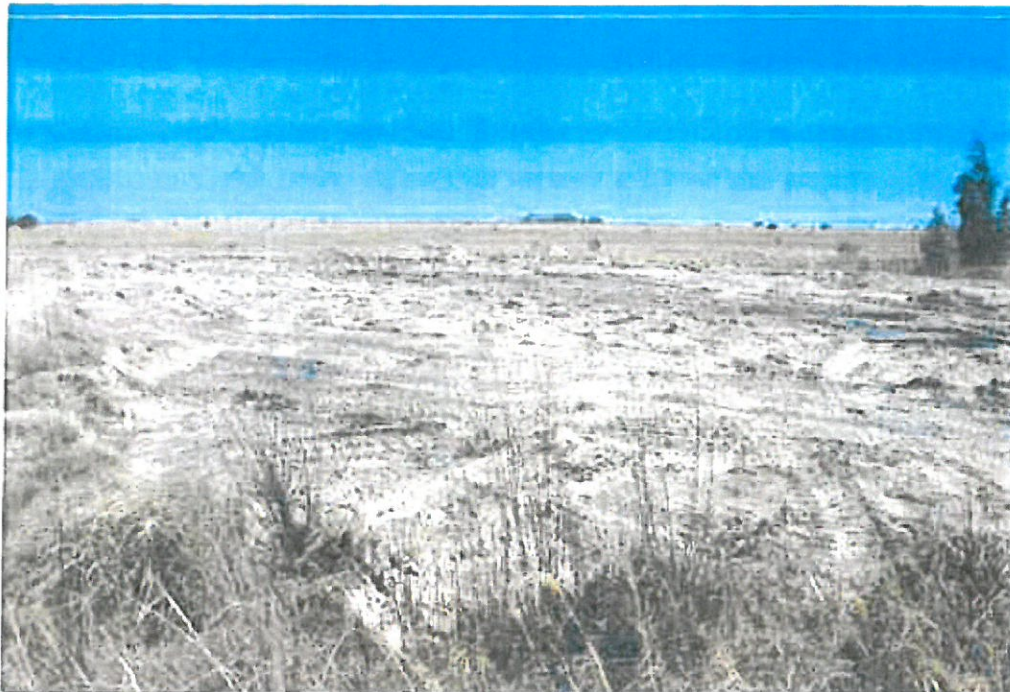
Figure 11: Cleanup completed around Kareerand TSF (outside containment area) - August 2018

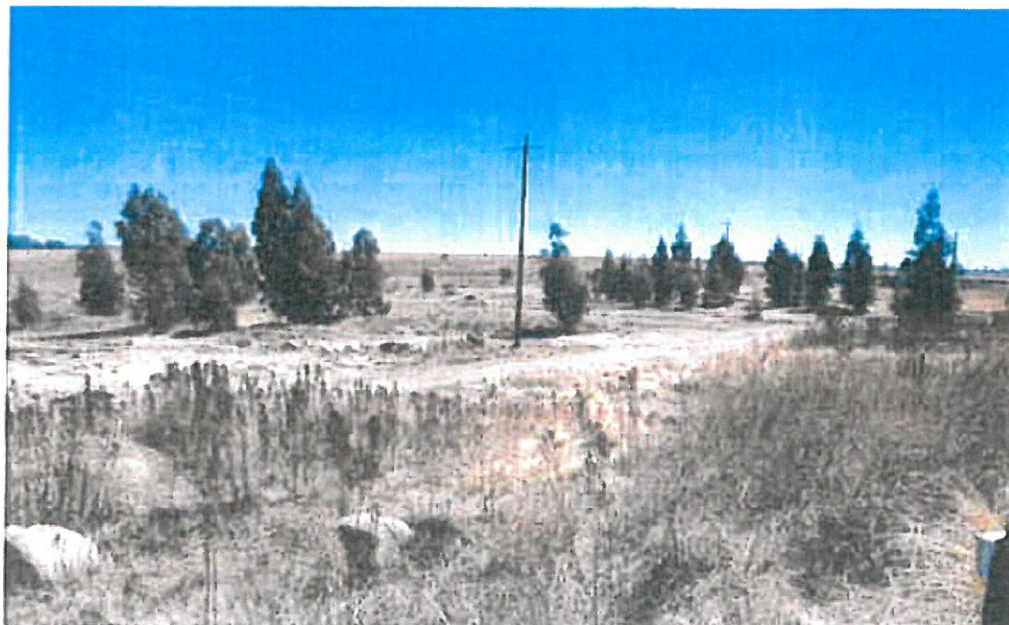
Figure 12: Cleanup completed around Kareerand TSF (outside containment area) - August 2018

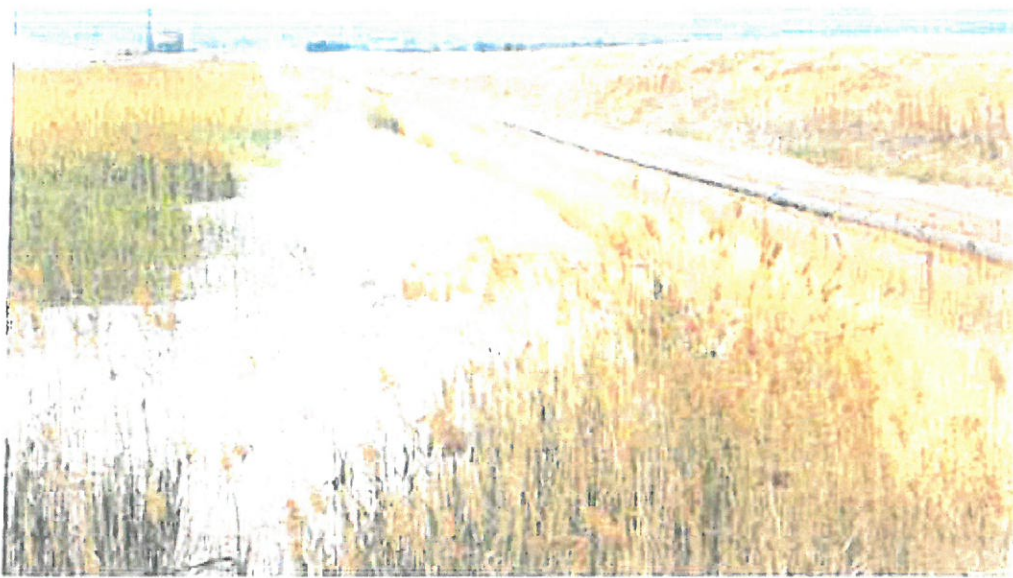
Figure 13: Toewall at bottom TSF sideslopes

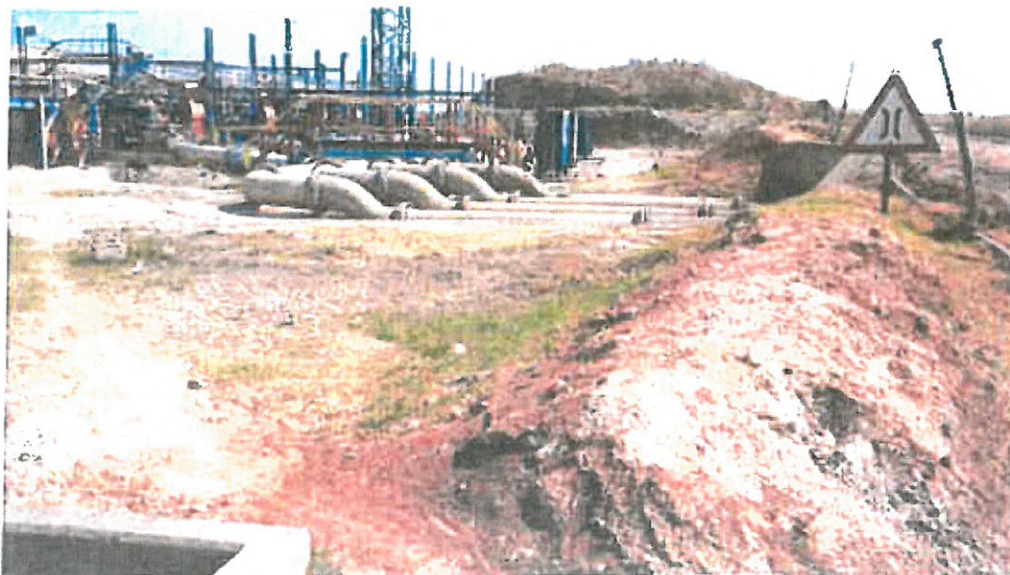
Figure 14: Rolled edge constructed to protect pump station and office

- Construction of a rolled edge at the Kareerand offices and workshops to prevent surface water from flooding the offices and leaving the site, clean / dirty water separation. (see Figure 14);

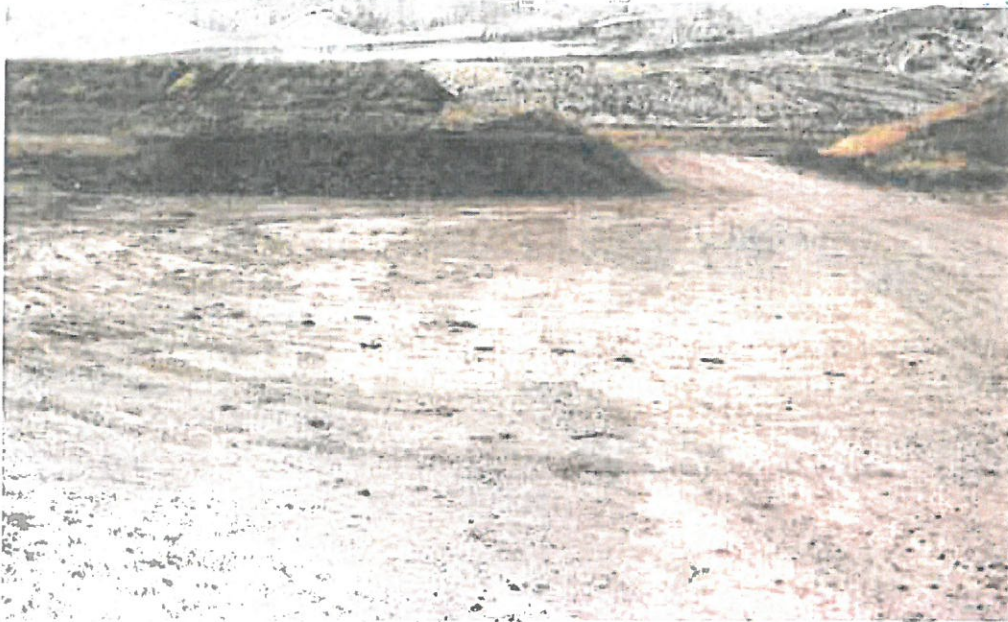
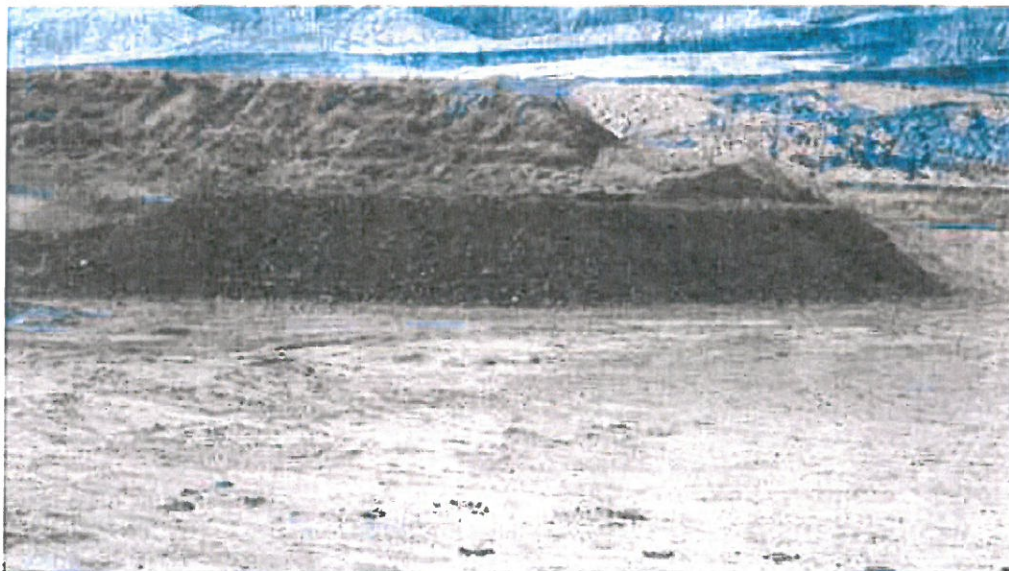
Figure 15: Clean storm water diversion culvert at entrance to Kareerand T&F

Figure 16: Clean storm water diversion culvert at entrance to Kareerand TSF

- Installation of clean storm water diversion culverts at the entrance to Kareerand, to prevent clean water from entering the TSF footprint (see Figures 15 to 16);

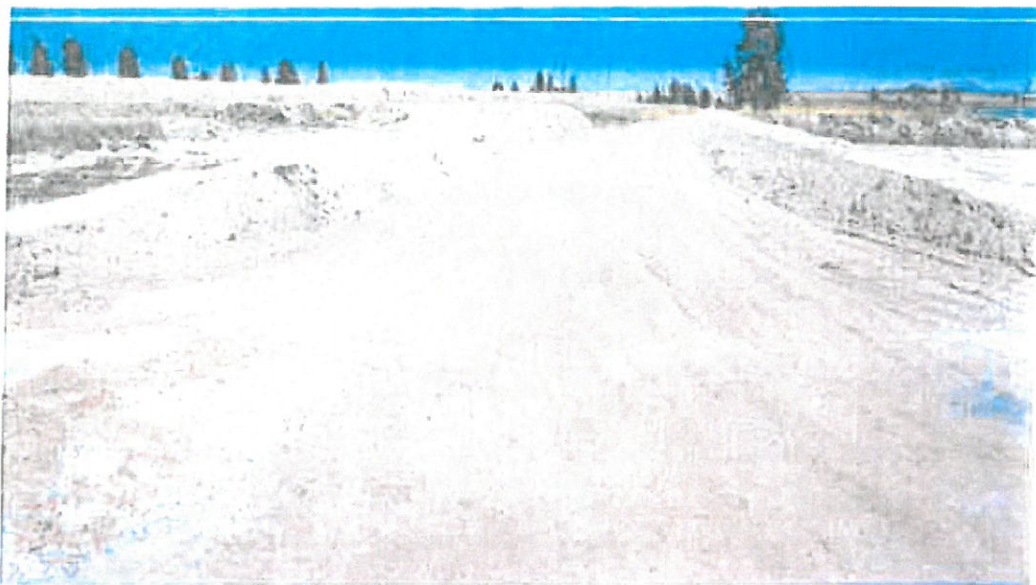
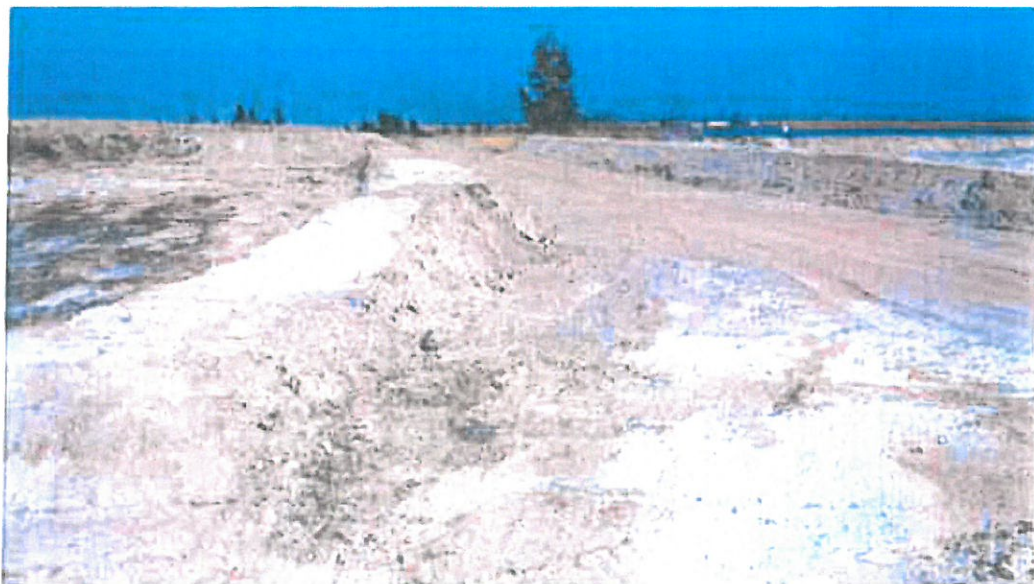
Figure 17: Temporary storm water containment next to return water dams (till East Storm Water Dam constructed)

Figure 18: Temporary storm water containment next to return water dams (till East Storm Water Dam constructed)

- Construction of temporary storm water containment inside Kareerand TSF footprint to attenuate storm water. (see Figures 17 to 18);
- Review current pollution control dam's containment capacity to contain a 1 in 50 year rain storm event;
