**ESTABLISHMENT OF A MONITORING SYSTEM FOR  
SURFACE WATER AND GROUNDWATER  
IN THE CRADLE OF HUMANKIND  
WORLD HERITAGE SITE**

**THE KOELENHOF FARM FISH MORTALITY EVENT  
OF MID-JANUARY 2011**

**JANUARY 2011**

**BIQ005/2008**

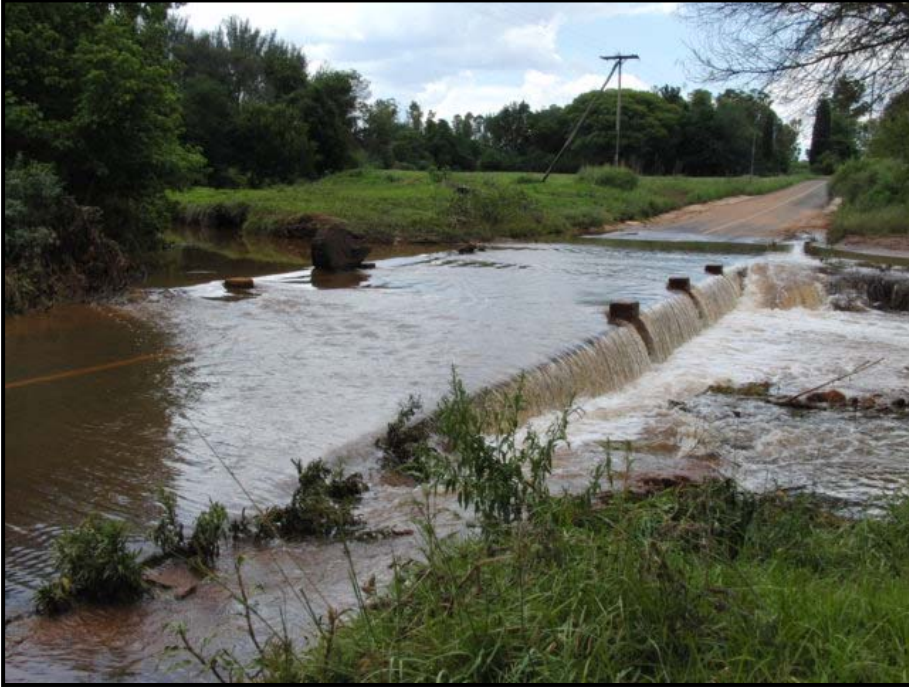
**Plate 1. View of station BB@M on 18/12/2010 showing inundation of the causeway following the flood conditions precipitated by high rainfall experienced in the region *ca.* 16/12/2010. Similar flow conditions again prevailed on 14/01/2011. (Photo: Phil Hobbs).**

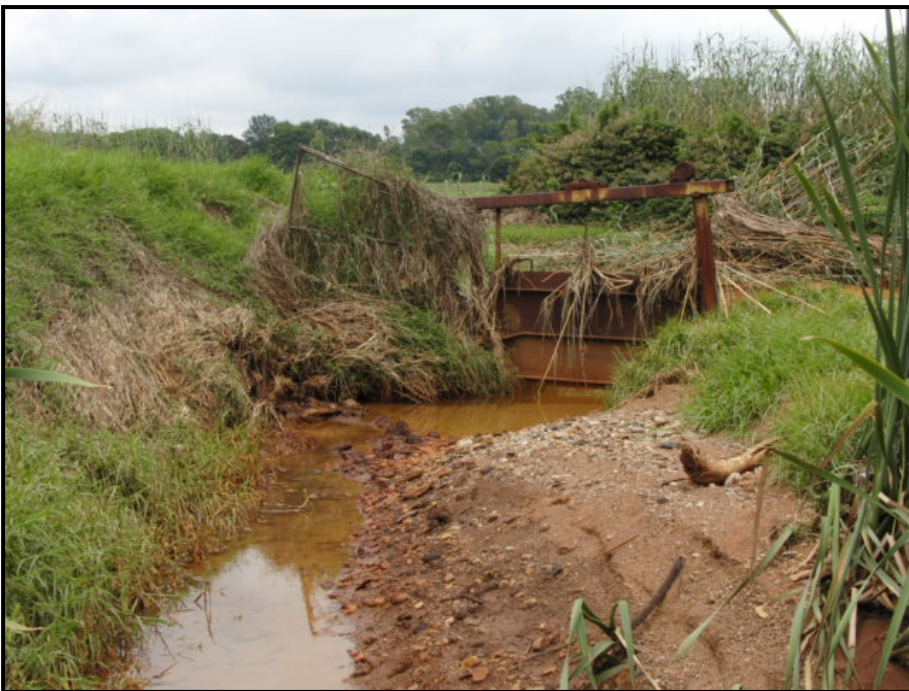
**Plate 2. View from downstream of the sluice gate at the entrance to the A-furrow downstream of the Zwartkrans Spring following the high discharge conditions experienced in the Bloubank Spruit in mid-December 2010; note the disruption of flow into the furrow and the sediment deposition on the left bank (right foreground). (Photo: Phil Hobbs).**

Perhaps the most significant impact was the disruption of flow into the A-furrow (Plate 2) that serves properties on the right bank of the Bloubank Spruit downstream of the Zwartkrans Spring (Figure 2).

The A-furrow feeds numerous off-channel dams that store primarily irrigation water, but are also stocked with fish. Flow into this furrow from out of the Bloubank Spruit was only restored, albeit partially, on 10/01/2011 (M. Gomes, personal communication), i.e. a day before the fish mortality event. Concern was expressed for the yellow appearance of the furrow water and its suitability for various uses including stock watering and irrigation. Unaware of the fish mortality event, this communication precipitated another round of field water quality monitoring on 12/01/2011, the results of which are also reported in Table 1. Further, a surface water sample was collected at station BB@M for more complete laboratory chemical analysis. The result of this analysis is presented in Annexure A.

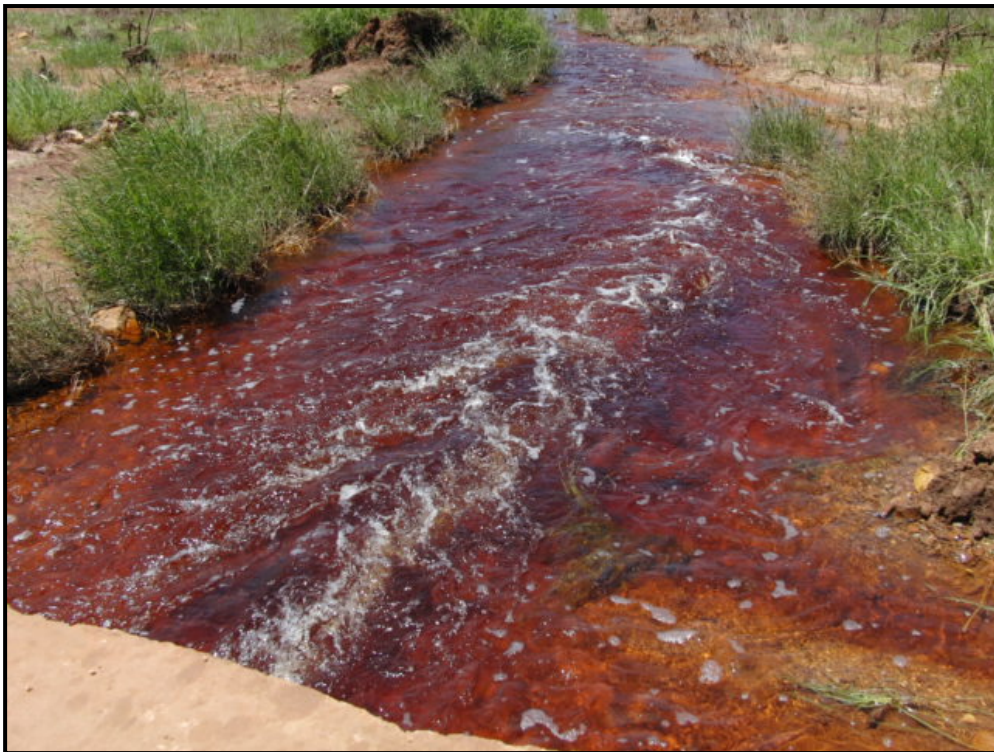
**Plate 3. Discharge in the Riet Spruit at its intersection with the Malmani Road (station MRd1) on 12/01/2011; note the red colouration of the water indicative of a strong acid mine water character (refer Table 1 for supportive field chemistry variable values). Downstream of this position, this water merges with sewage wastewater delivered by the Blougat Spruit. (Photo: Phil Hobbs).**

- The very low pH values and elevated salinity values of ~400 mS/m at the uppermost two stations F11S12 and MRd1 indicating a strong mine water signature at these localities (Plate 3).

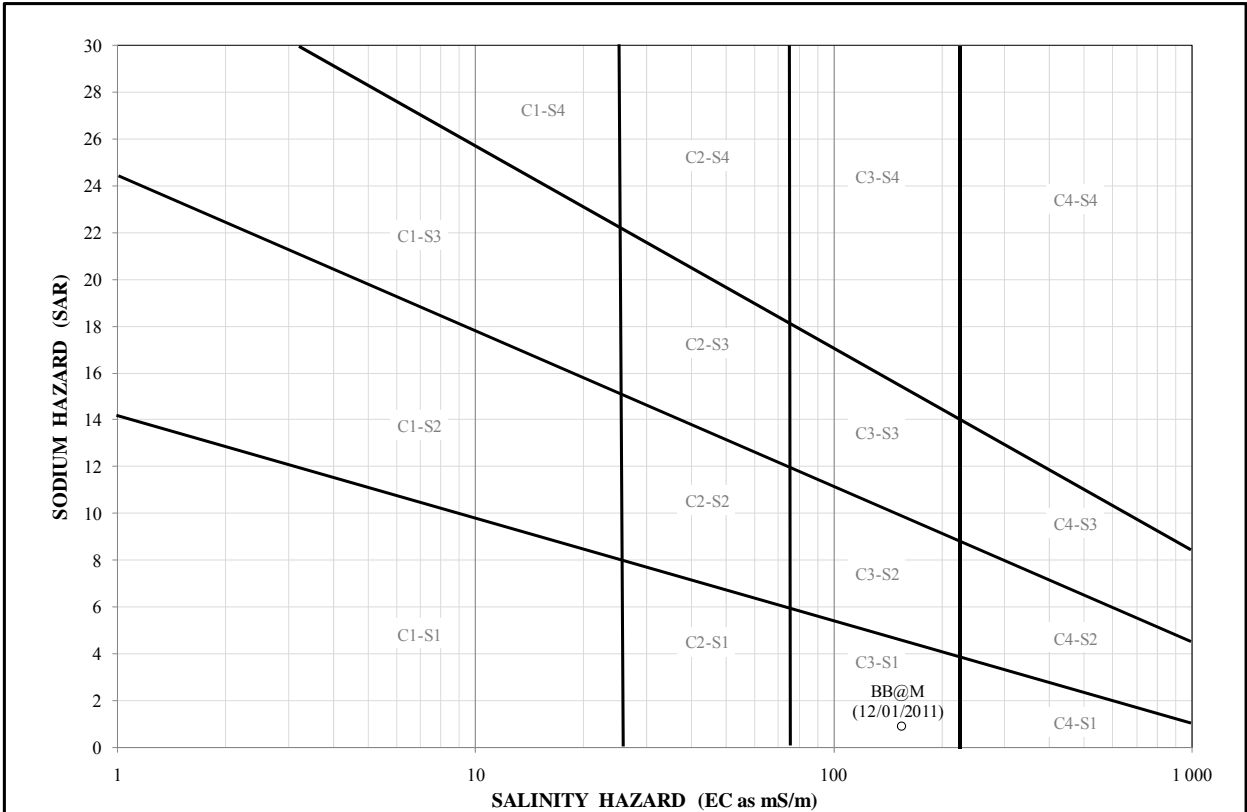
to derive the sodium hazard (designated S) associated with the water. This value is graphed against the electrical conductivity value, which represents the salinity hazard (designated C), to derive an alpha-numeric classification (e.g. C#-S#) defined by the Wilcox diagram (Figure 3), and where the numeric component ranks from 1 = **low** through 2 = **medium** and 3 = **high** to 4 = **very high**. The C3-S1 classification (Figure 3 and Annexure B) is in keeping with that typically observed in the Blougat Spruit and the Riet Spruit (Hobbs, 2011), and clearly identifies salinity (EC) as the limiting variable.

**Figure 3. Wilcox diagram illustrating the classification of the Bloubank Spruit surface water chemistry on 12/01/2011 for irrigation purposes**
