# **GEOHYDROLOGICAL REPORT**

**Groundwater source development at De Villiersdale 313LR  
and Buffelshoek 261LR for stock watering.**

**For  
The Department of Agriculture**

**REPORT-VSALEB/PR05/075  
August 2006**

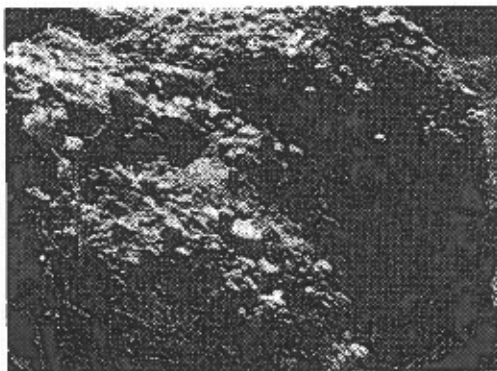
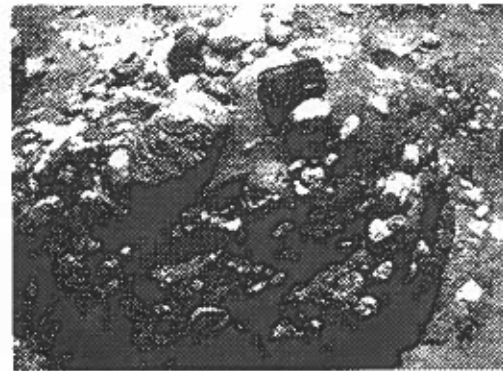
Figure 1: Conglomerate of the Mogalakwena formation.

Usually it rests conformable on the Makgabeng formation but in the Blouberg area it unconformably overlies the Blouberg formation and rocks of Swazian and Randian age. It is characterized by purplish brown, coarse-grained sandstone with interbedded conglomerate and boulder conglomerate. The well-rounded clasts may attain a diameter of 80cm but in general they measure between 3 and 10 cm (Brandl 1996).

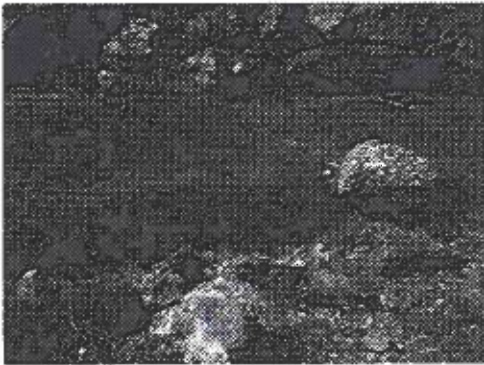
Figure 2: Diabase sill, Brodie Hill.

Diabase intrusions and other inferred lineaments indicated on the 1:250 000 geological map mainly transects the area from southwest to northeast with minor intrusions transecting the area from southeast to northwest. These intrusions were mainly targeted in the search for groundwater as secondary fracturing in the sandstone can occur near or at the contact with the diabase

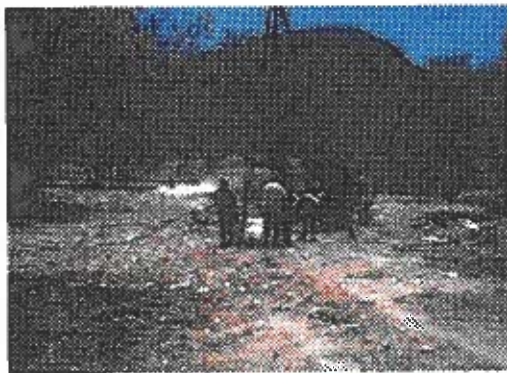
Figure 3: Colluvial deposits-scree -Madibeng.

Extensive scree is found along the slopes of the Blouberg.

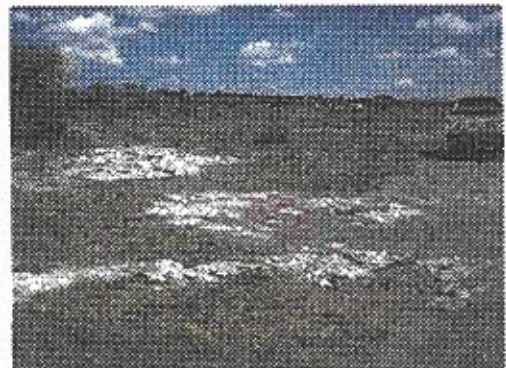
Figure 4: Calcrete-Brodie Hill

Scree deposits foreground, testing rig background.

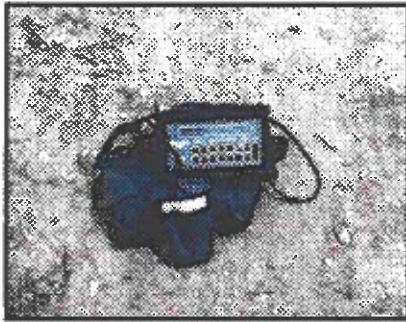
Figure 5: The Chemtron model G5 proton-precision magnetometer.

The different magnetic susceptibilities of different rock types result in contrasting magnetic signatures. Analysis of the amplitude or intensity of the magnetic anomalies as well as its graphical shape taking in

account the traverse direction bears some relationship to magnetic mineral content, size, depth, shape and orientation of the buried body or structure. Hence, the magnetic data may be interpreted to represent dykes, geological contacts and faults that may have a bearing on the occurrence, storage and movement of the groundwater. A Chemtron model G5 proton-precision magnetometer (Fig.5) was used, measuring directly the strength of the total magnetic field at a given locality.

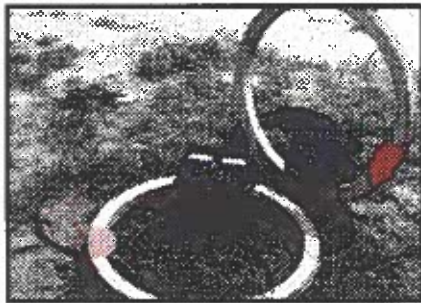
Figure 6:: The EM-34 System.

The operating principles of the EM-34 system are briefly discussed below. The technique provides rapid and easy measurement of terrain conductivities and facilitates the detection of steeply dipping

conductor type targets such as dykes, fracture zones, faults etc. through electromagnetic coupling. The EM-34 (Fig.6) is a moving source-moving receiver system, which measures the ratio of the quadrature component of the secondary magnetic field to the free space primary magnetic field. A cable connects the transmitter and receiver units, acting as a reference to the primary magnetic field.

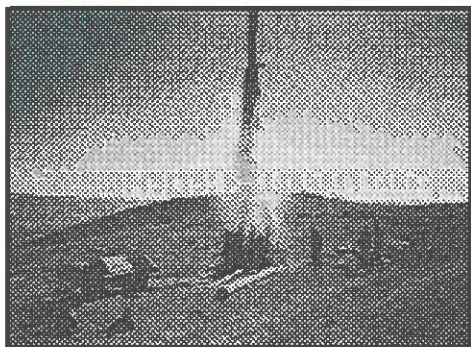
Figure 7 : The rotary air percussion drill rig

The method employed for the sinking of water supply boreholes was that of rotary air percussion drilling employing a down-the-hole (TDH) hammer. This drilling technique is ideally suited for hard rock formations.

The cuttings brought to the surface by air return from the bore were collected and described for each metre drilled. The lithologies described are presented in borehole logs in the Appendix, together with all other relevant information pertaining to and obtained from the boreholes.

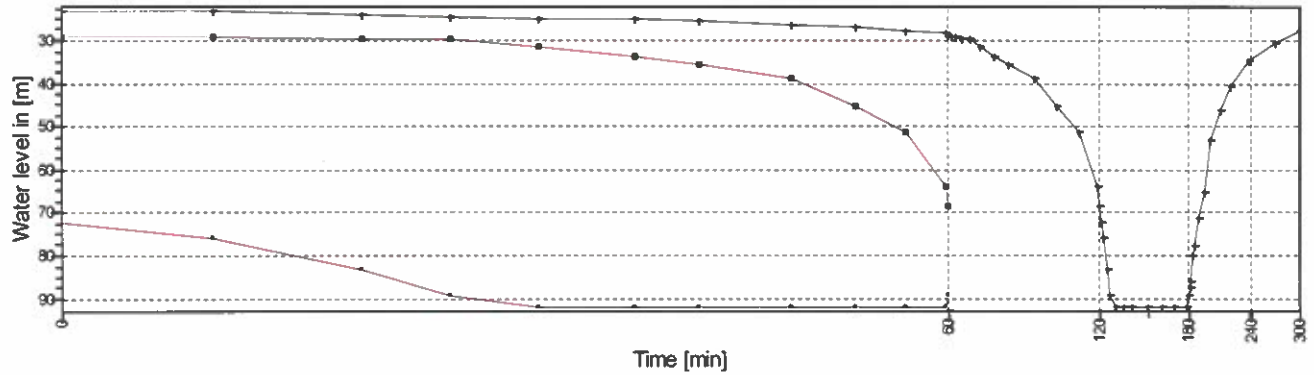
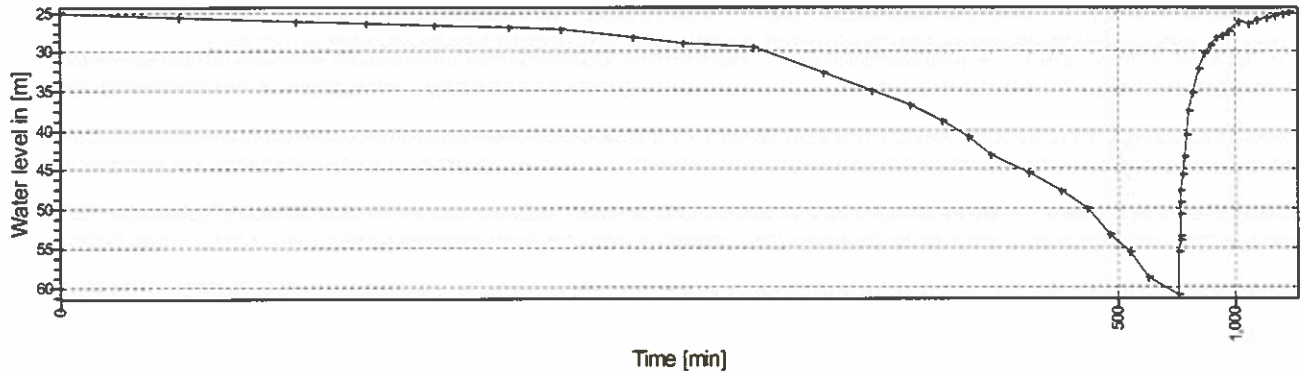
Rep. Inst.	Meth. tested	Depth to intake [m]	Starting Date	Time	Ending Date	Time	Transmis. [m <sup>2</sup> /d]	Storativ.	Rec. abs. [l/s]
VSA	Multirate test	93.00	20060204	1101	20060204	1600			
VSA	Constant rate test	93.00	20060204	1831	20060205	1730

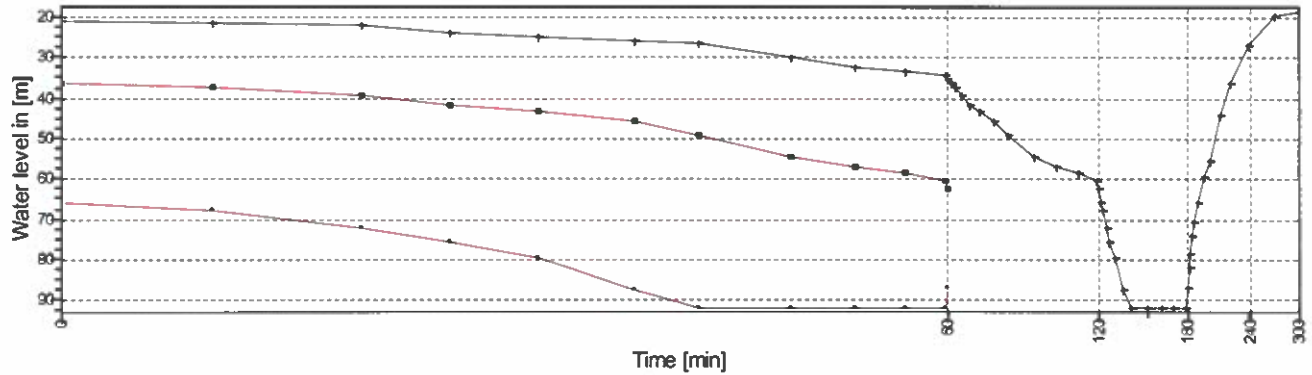
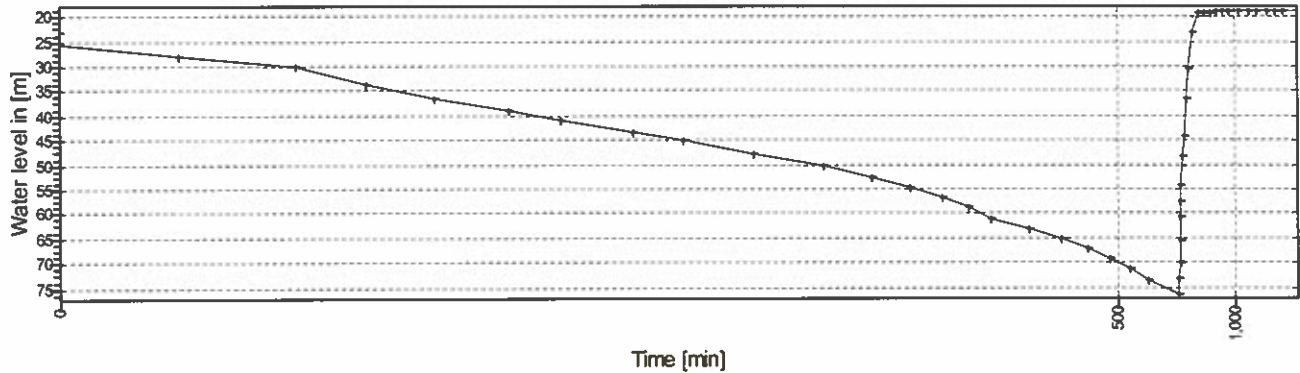
PUMPING TEST:		Depth to intake [m]	Starting Date	Ending Date	Transmis. [m <sup>2</sup> /d]	Storativ.	Rec. abs. [l/s]
Rep. Inst.	Meth. tested		Time	Time			
VSA	Multirate test	93.00	20060206 1311	20060206 1810			
VSA	Constant rate test	93.00	20060206 1821	20060207 1820

TESTING DETAILS:		Durat. [min]	Depth to intk. [m]	Disch. rate[l/s]	Drawd. [m]	Recov. [m]	Rec. Dur. [min]	Trans. [m <sup>2</sup> /d]	Perm. [m/d]	Storat.	Q/st
Description	Time start.					%					
MULTI STEP 1	1311	60	93.00	0.31	34.36						0.01
MULTI STEP 2	1411	60	93.00	0.62	60.13						0.01
MULTI STEP 3	1511	60	93.00	0.61	91.80	18.60	100	120			0.01
CONSTANT RATE	1821	720	93.00	0.51	76.39	18.68	99	720			0.01
