INKOMATI-USUTHU WATER MANAGMENT AREA GEOHYDROLOCAL DESKTOP STUDY

Client: Inkomati-Usuthu Water Catchment Management Agency

Date: February 2016

Prepared by: Thoka Geosciences cc

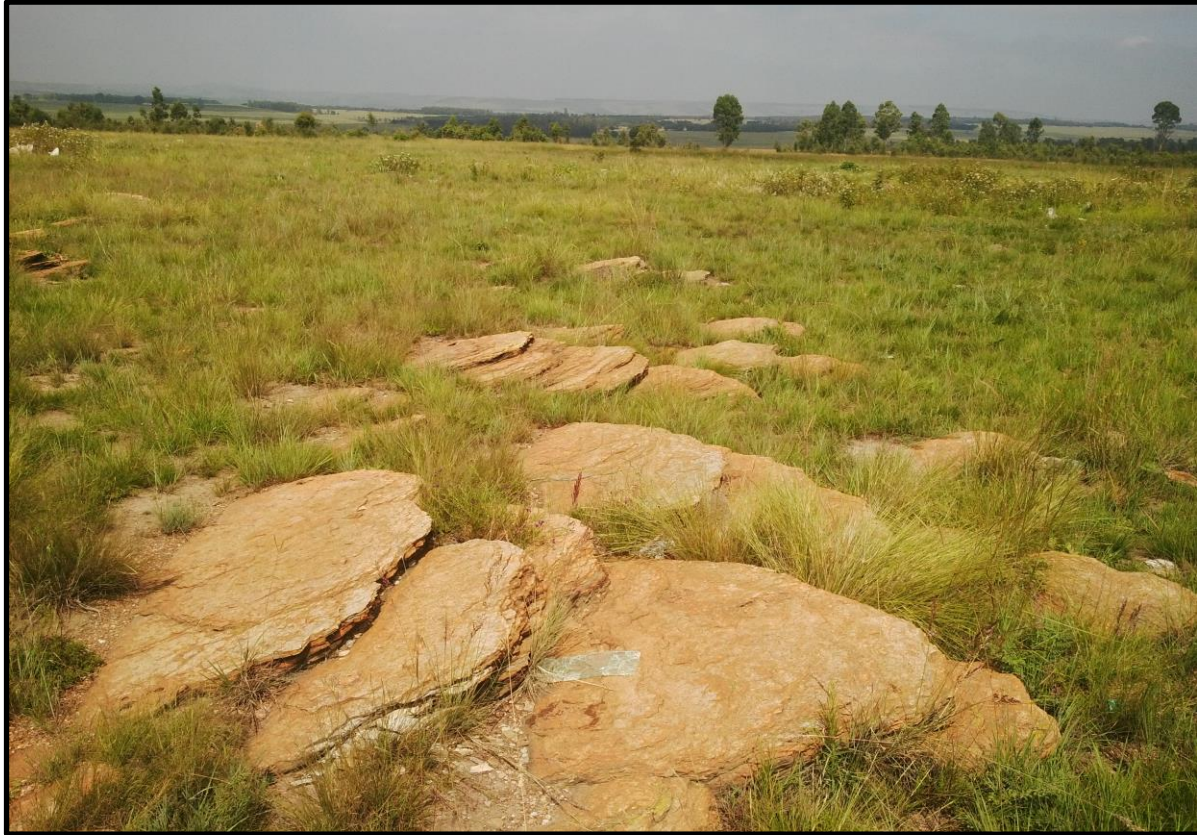
Figure 4: Shows outcropping shale rocks at the Amsterdam Borehole Site.

Local topography in the area is depicted by an average slope of about 1.6% slopping towards the western direction. The far eastern side of the site has outcropping shale rocks dipping towards the eastern direction.

Groundwater in the area is expected to be primarily hosted by fractured and contact rock features. Site observation and the analysis of the regional geological map covering the site indicates possible geological contact zones within proximity of the boreholes site. Site conditions indicated shale rocks dipping towards the eastern direction outcropping on the eastern parts of the site. The far western portion of the site indicated no outcrops.

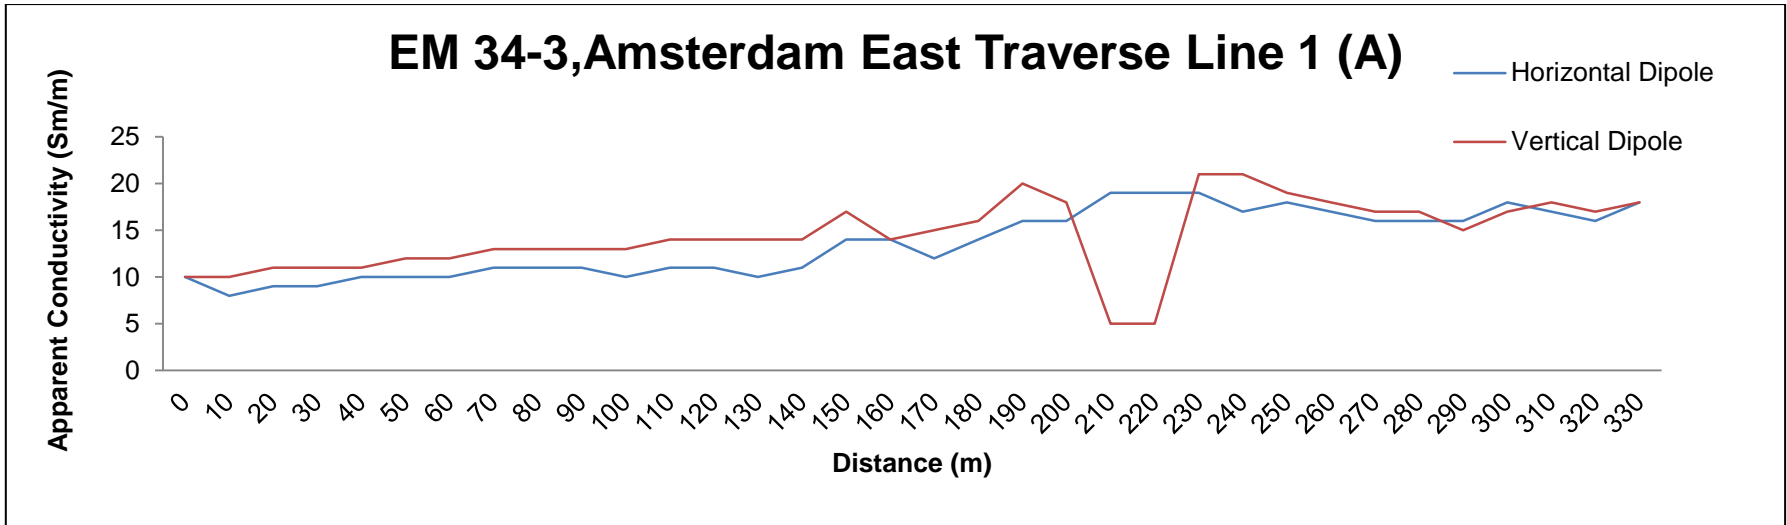
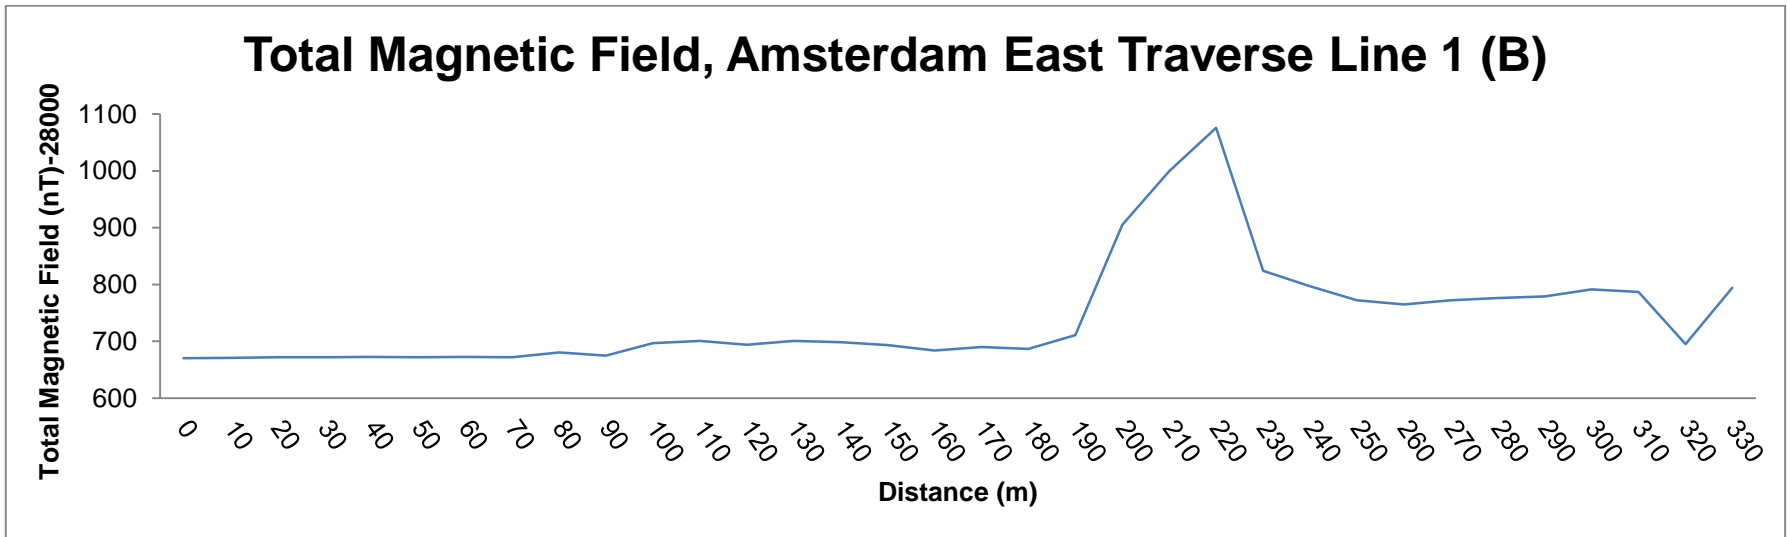
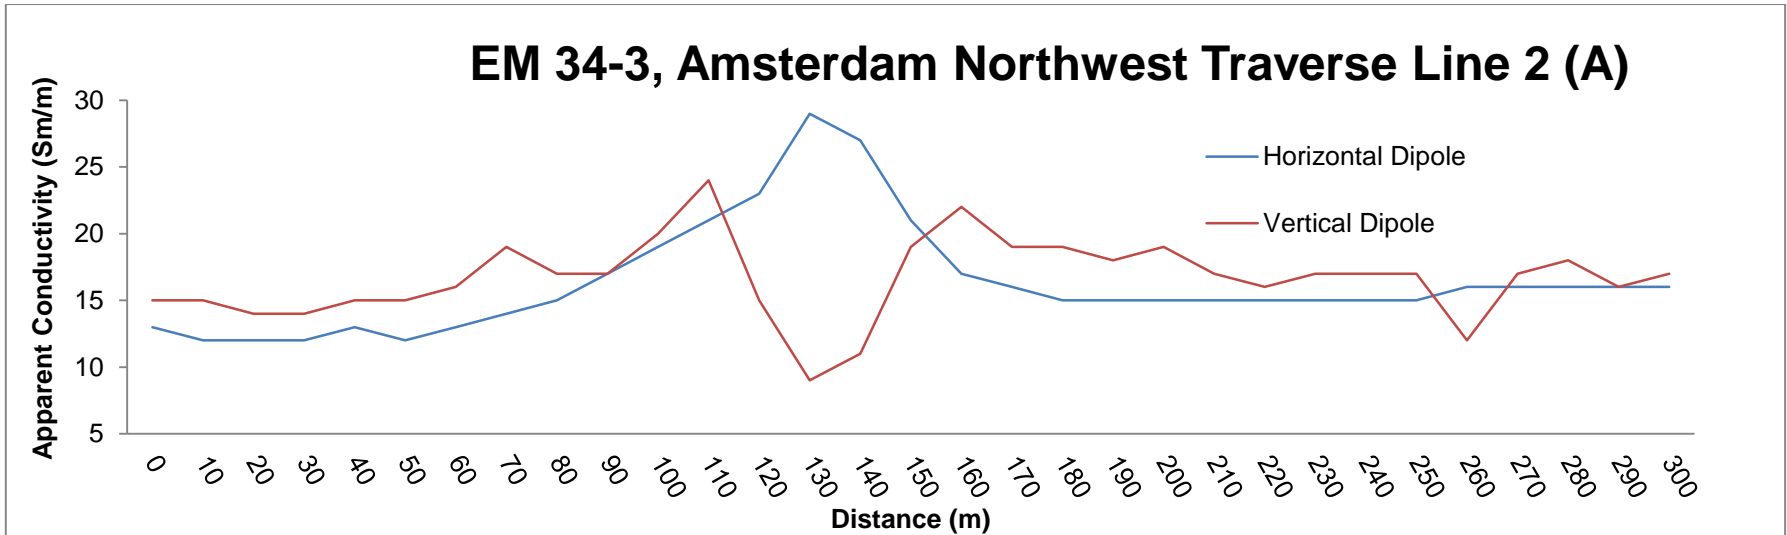
Figure 9: shows the plotted graphs of the EM 34-3 and Magnetic Survey for Travers Line 1 (A&B) & Line 2 (A) in Amsterdam

Two traverse lines were setup for both the Magnetic Survey and Electromagnetic Survey. The survey stations were setup at every 10 m interval along the traverse lines unless there was obstruction (e.g. pits/ground holes). Both Horizontal and Vertical Readings were recorded for the electromagnetic survey on every survey station. Figure 9 portrays the traverse lines taken. The primary aim of the traverse lines was to detect/cross zones of weathered, fractured rock within the area and on the interim detect contacts between older granites with earlier dolerite intrusions. The fractured and weathered zones were targeted as potential groundwater host features. It should be noted that some traverse lines are longer than others due to site conditions interfering with the geophysical instruments i.e. shale quarries were avoided at certain instances resulting in shorter traverse lines and non parallel traverses. Thus traverse line directions were also chosen with consideration of available traversing space and the consideration of obstruction.

The analysis of the traverse lines at Amsterdam monitoring borehole site shows a clearly defined anomaly (Figure 9). The anomaly is caused by a geological contact of a dike nature (Figure 3) causing a drop in apparent conductivity and rise in total magnetic field along the feature. Thus the drilling points were selected to take advantage of the geological characteristics discussed.

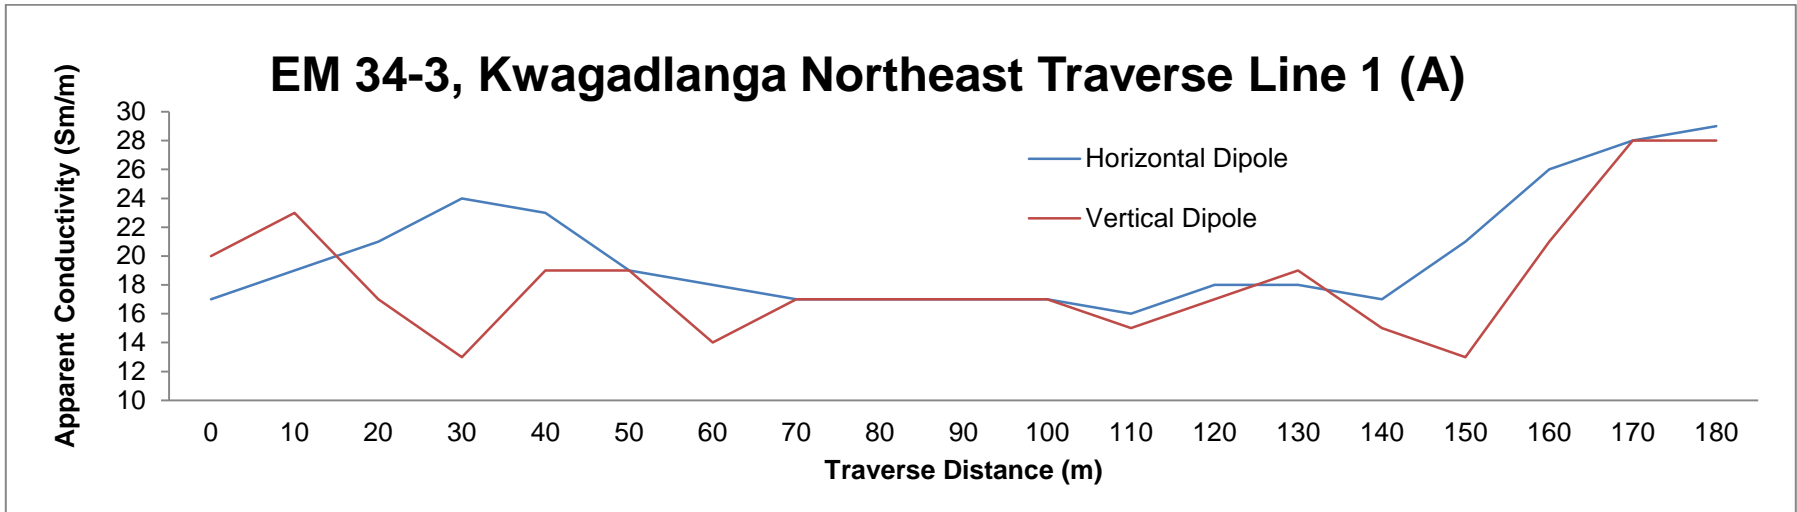
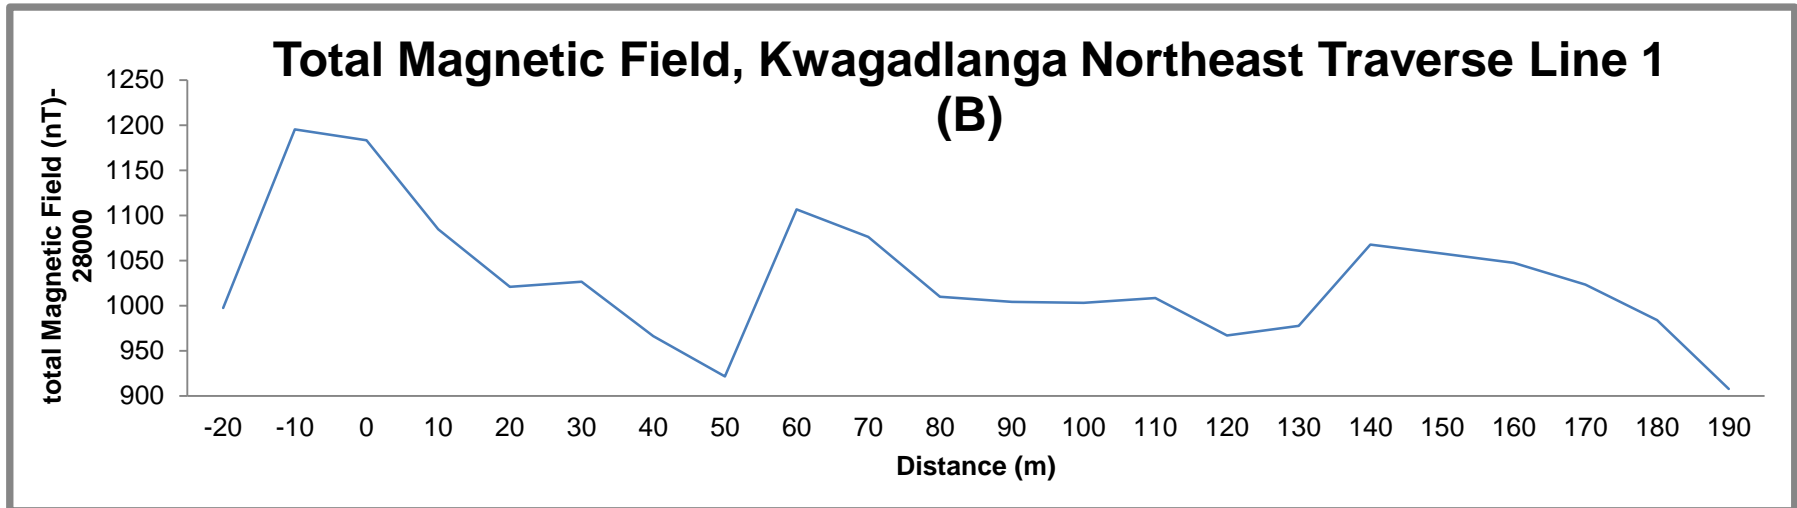
Figure 10: shows the plotted graphs of the EM 34-3 and Magnetic Survey for Travers Line 1 (A & B) in KwaGadlanga

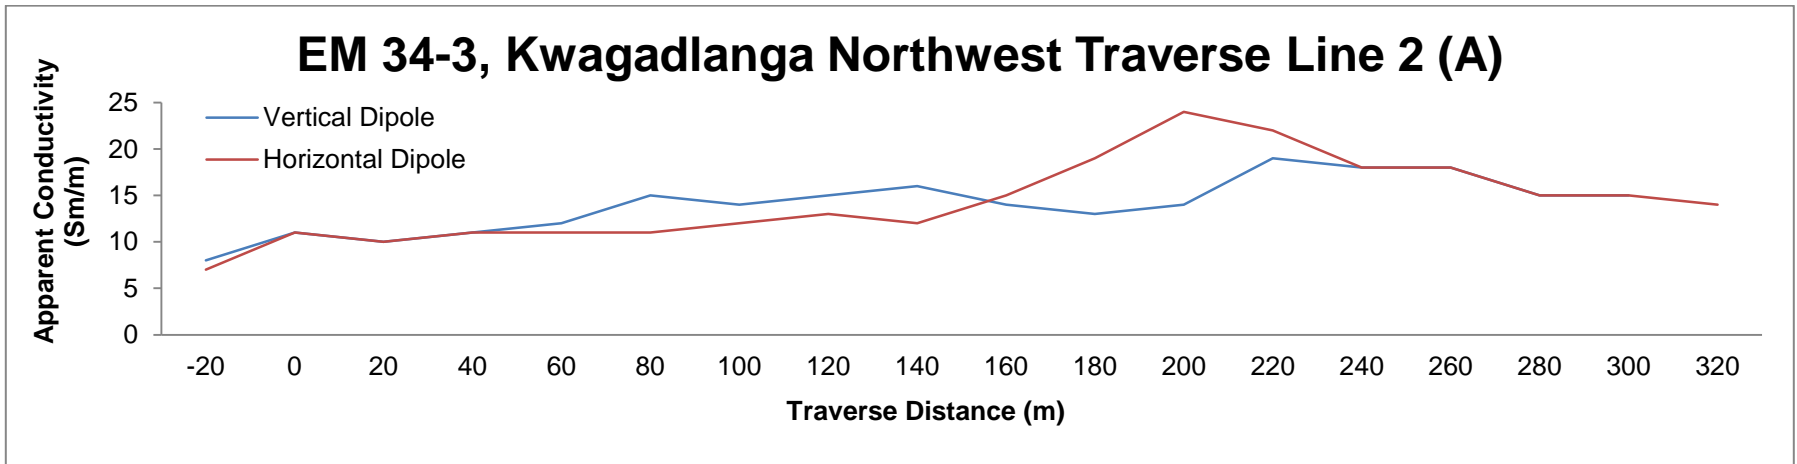
Figure 11: shows the plotted graphs of the EM 34-3 and Magnetic Survey for Travers Line 2 (A & B) in KwaGadlanga

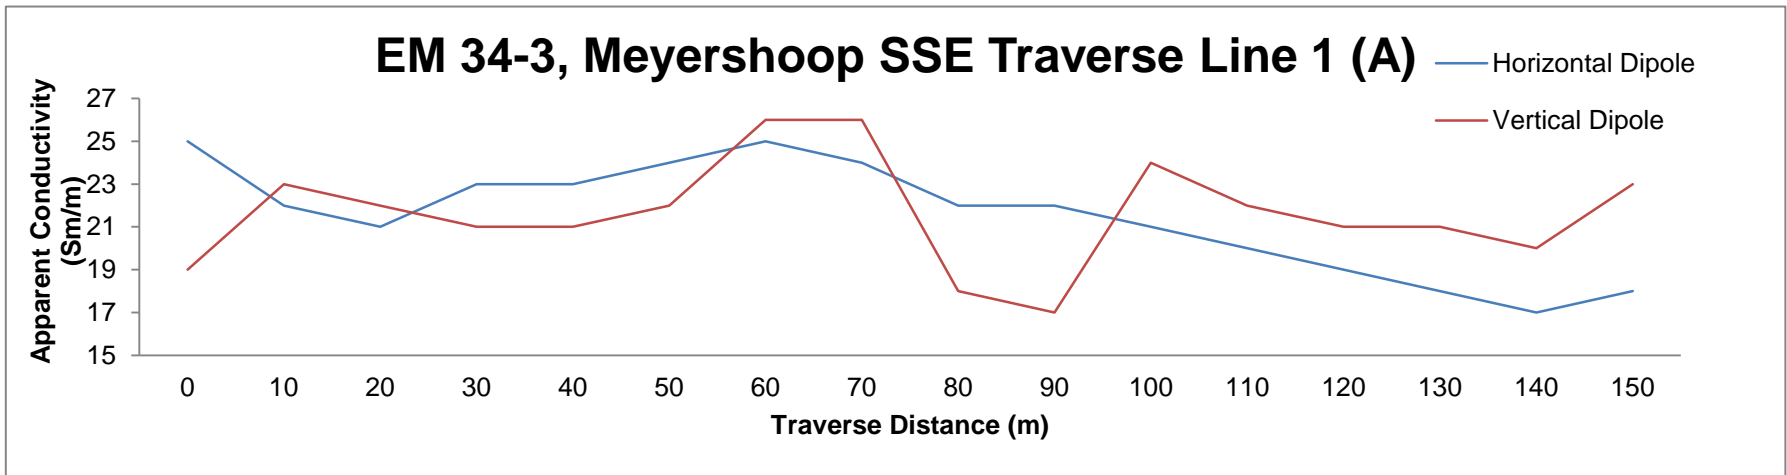
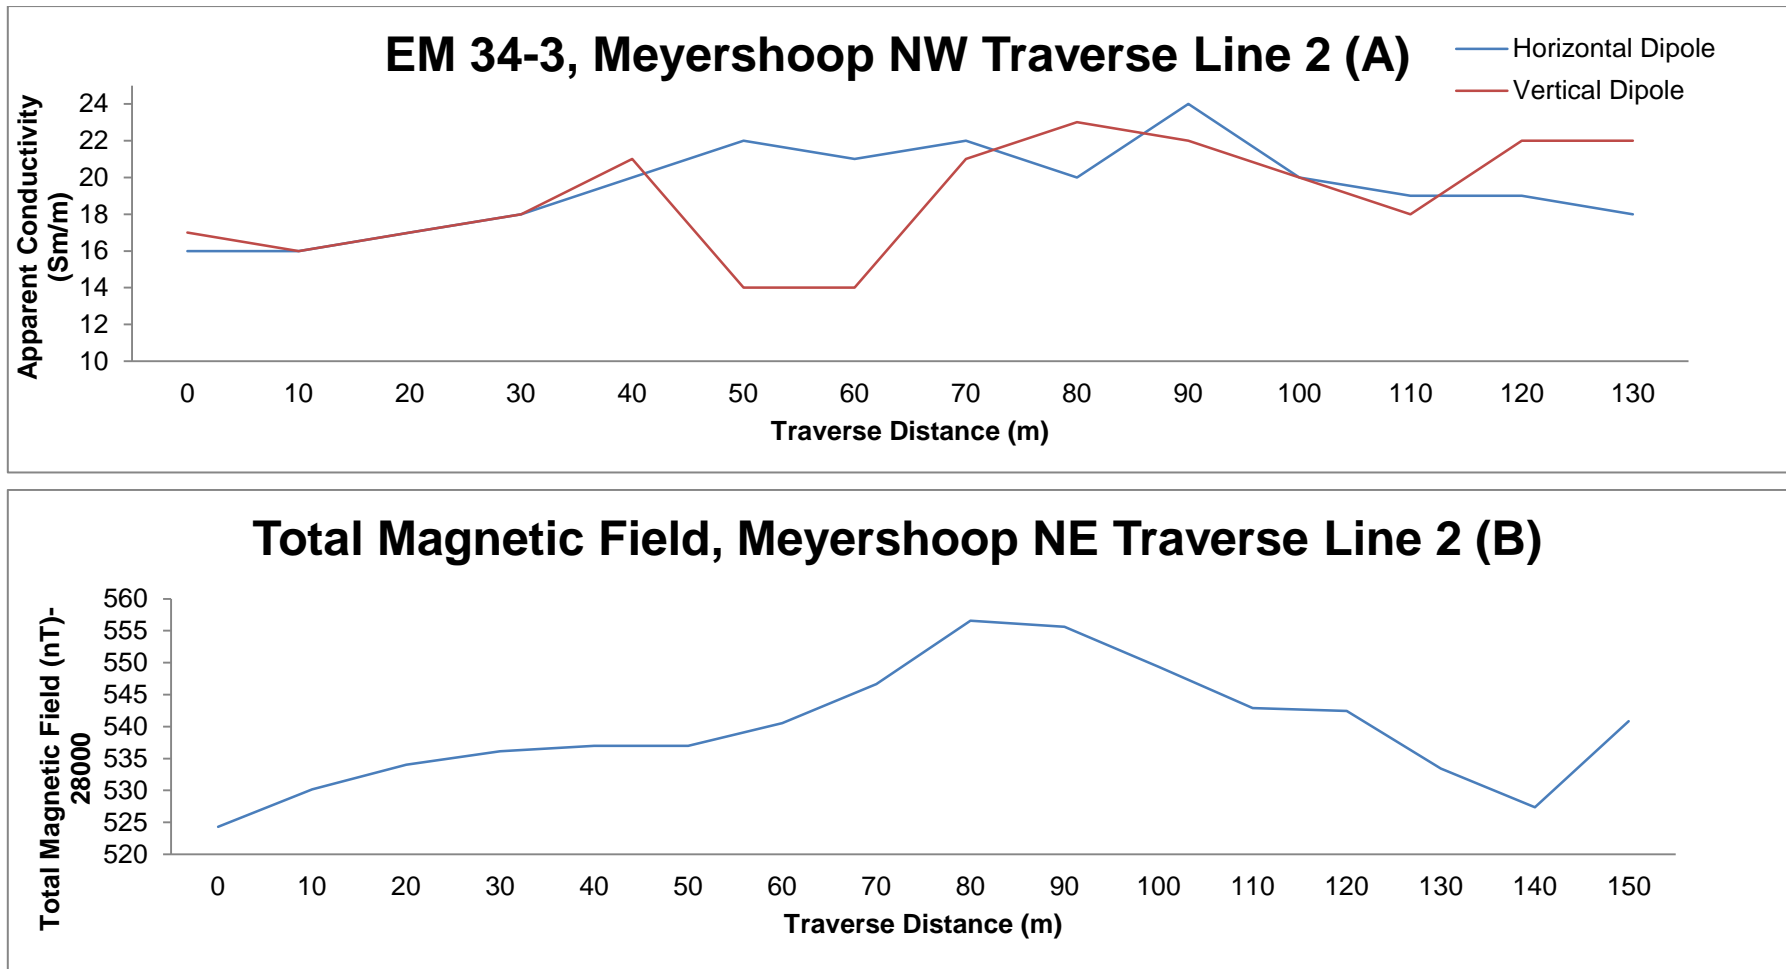
Figure 12: Shows the plotted graphs of EM 34-3 and Magnetic Survey for Traverse Lines 1 (A) & 2 (A & B) in Meyershoop

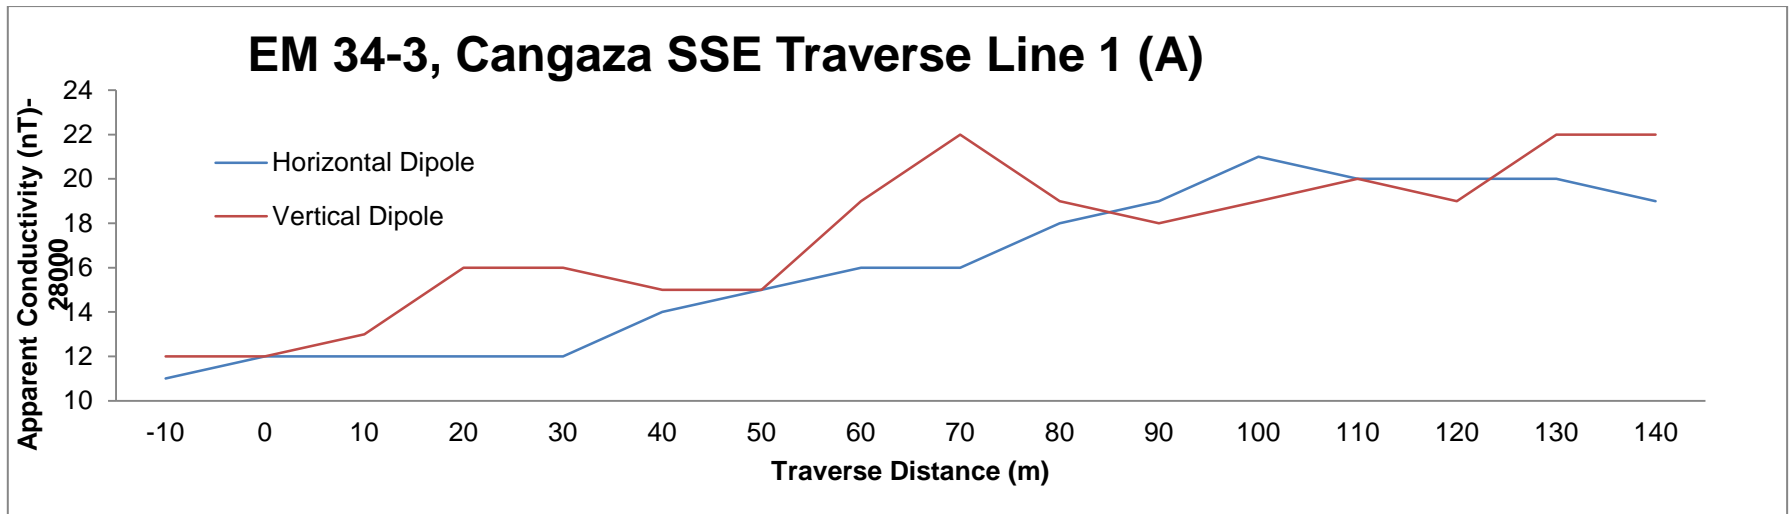
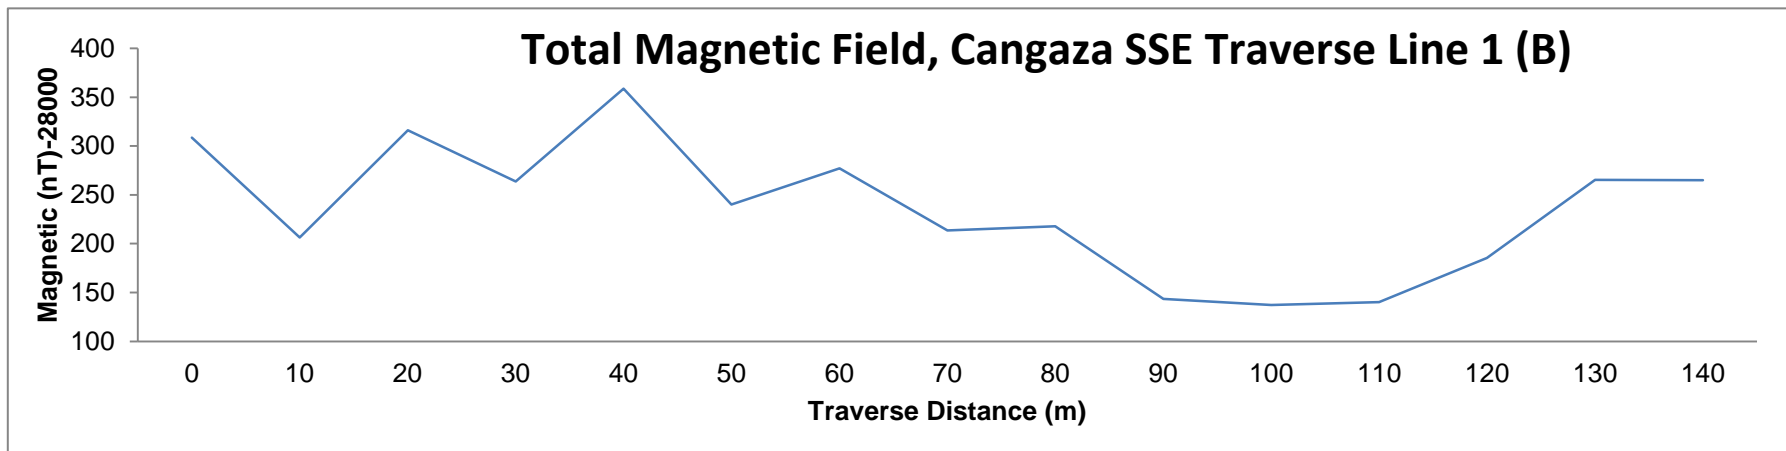
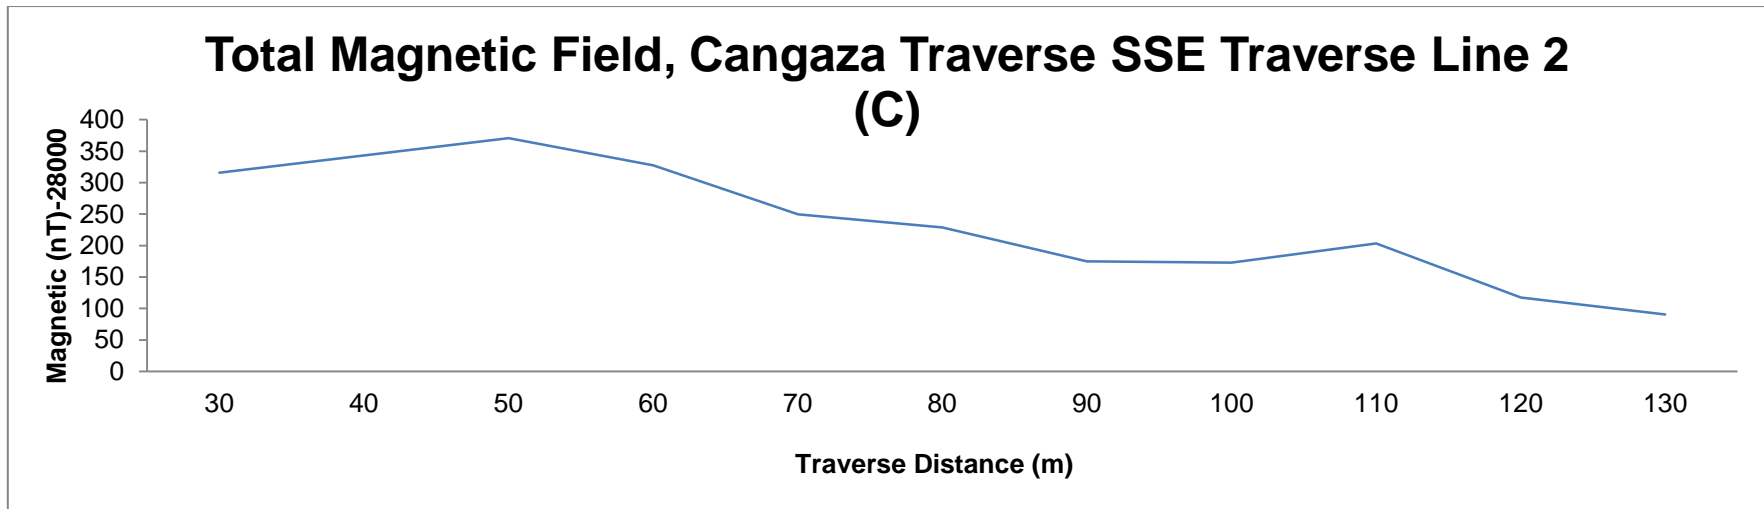
Figure 13: shows the plotted graphs of the EM 34-3 and Magnetic Survey for Traverse Lines 1 (A&B) and Line 2 (C)

Traverse Line 1 transgressing towards the SSE direction results indicated a sharp rise in apparent conductivity for the vertical dipole readings between 50 - 70 m traverse distances. The sharp rise was also mirrored by the continuous gradual drop in total magnetic field. The horizontal dipole reading on the other hand indicated a steady rise in apparent conductivity from 30 m traverse distance until 100 m traverse distance whereby the apparent conductivity levelled up. In relation to the horizontal dipole, the total magnetic field experienced a drop of about 200 nT until 110 m traverse distance whereby total magnetic field started rising again. A potential drilling point is inferred from the relationship between the horizontal dipole and total magnetic field readings. Thus a potential drilling point is selected to be at 100 m traverse distance for Traverse Line 1 and a secondary drilling point at 70 m traverse distance (Figure 13).

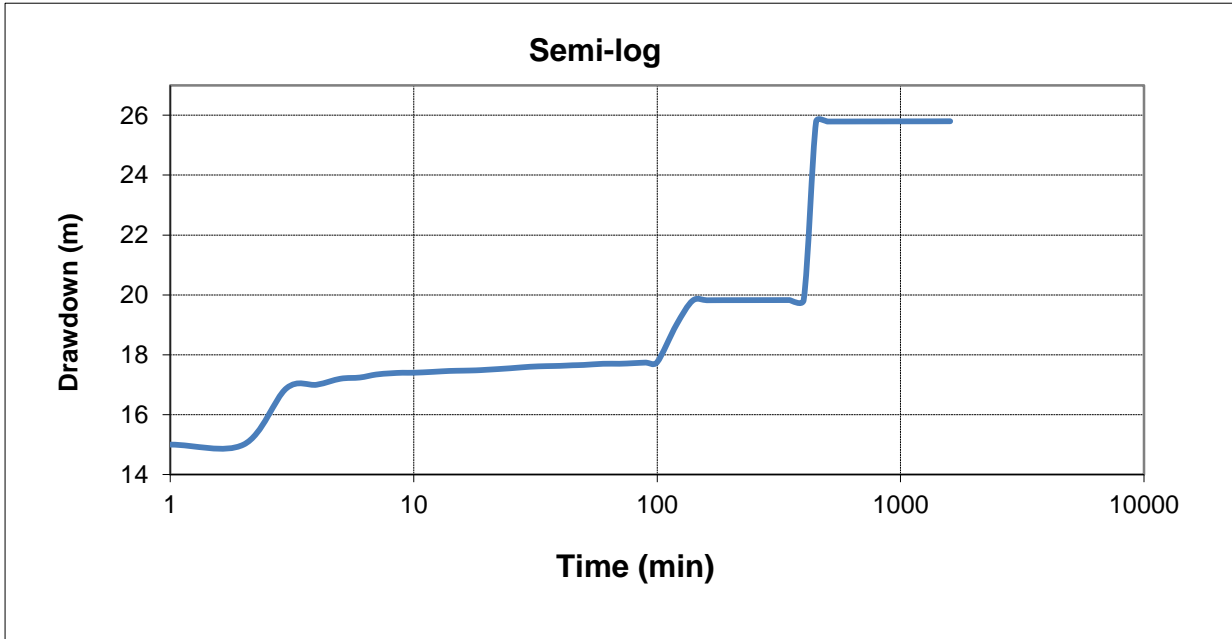
Figure 14: Semi-log plot of drawdown against time for Meyershoop Community Borehole

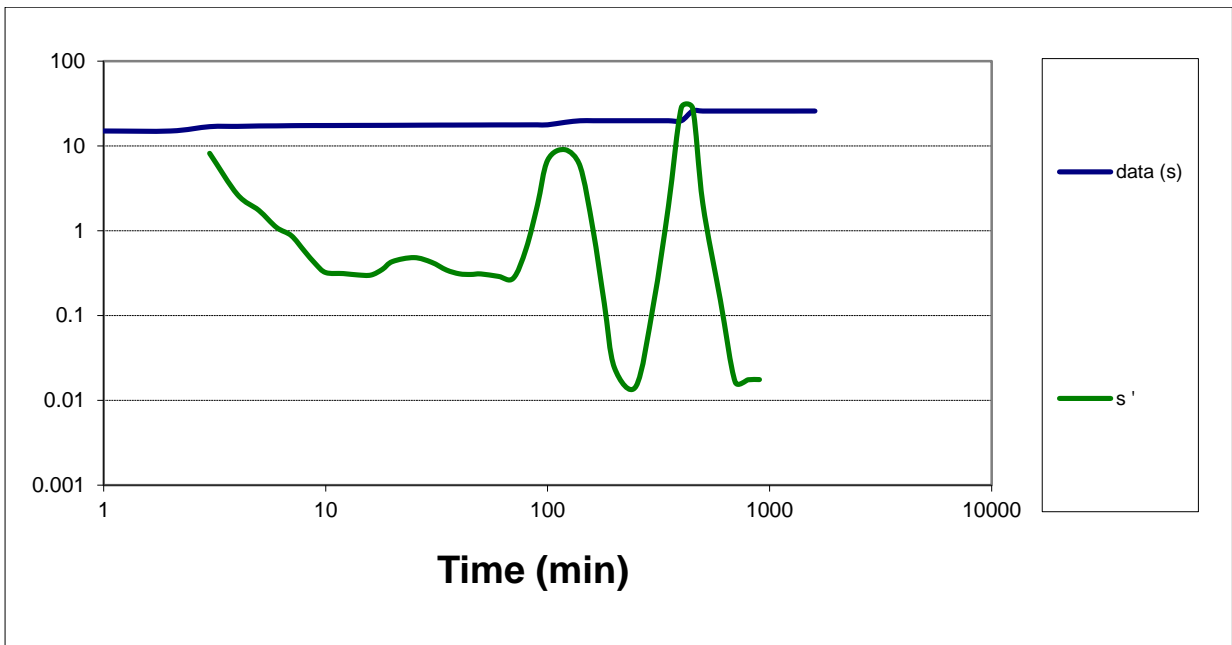
Figure 15: Log-log plot of drawdown derivative against time for Meyershoop Community Borehole

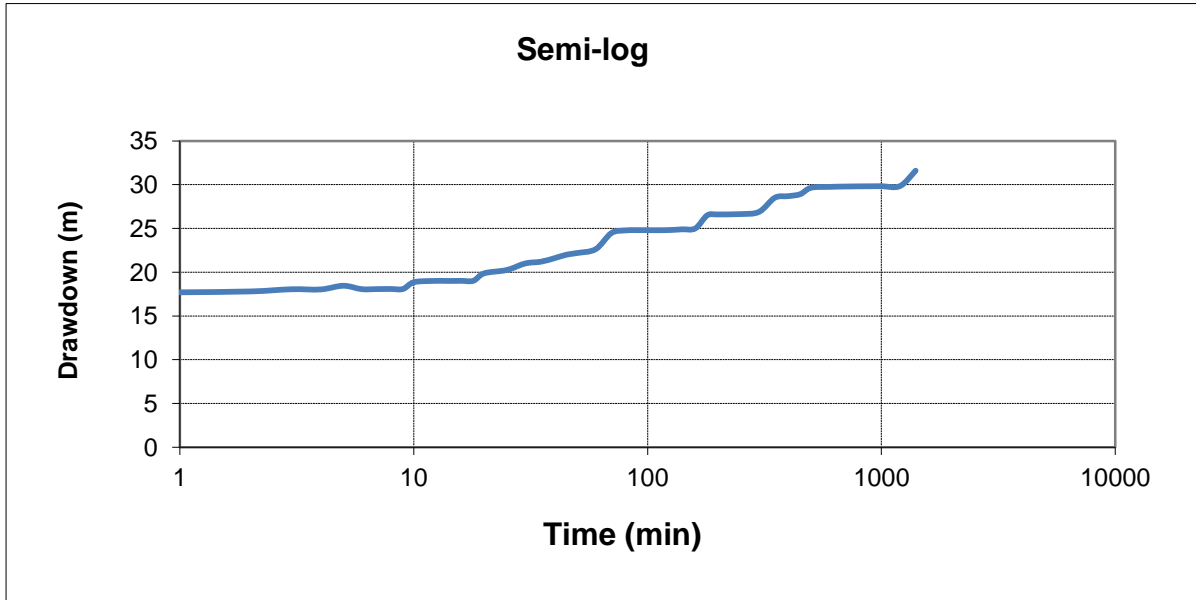
Figure 16: Semi-log plot of drawdown against time for Meyershoop Monitoring Borehole

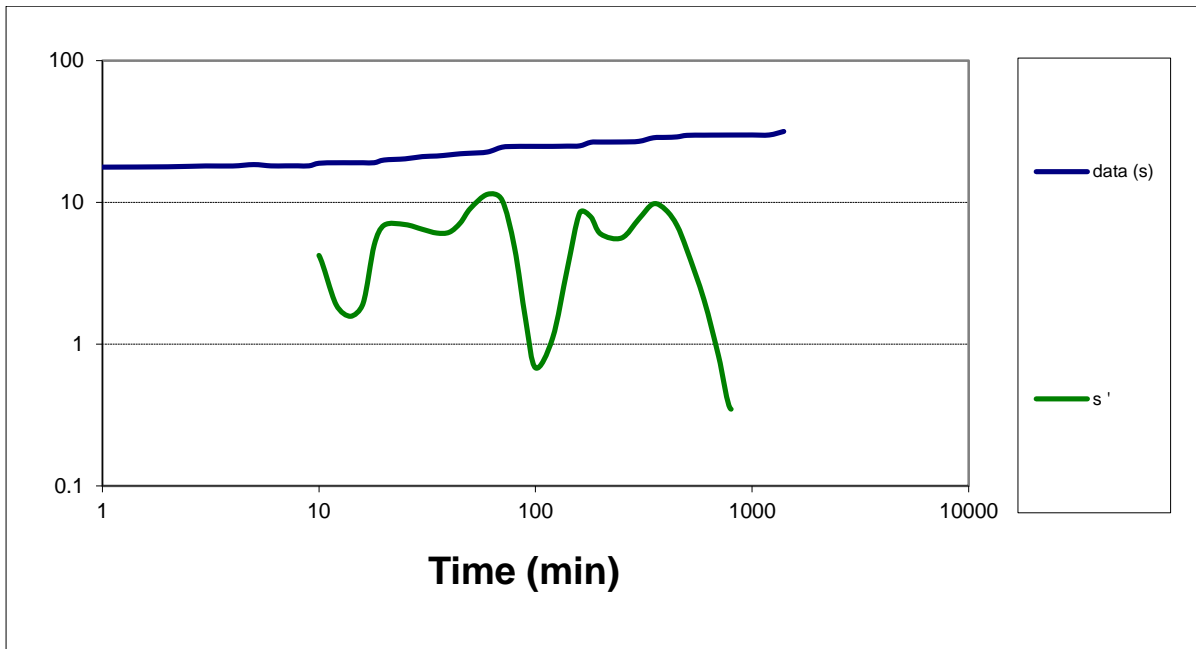
Figure 17: Log-log plot of drawdown derivative against time for Meyershoop Monitoring Borehole

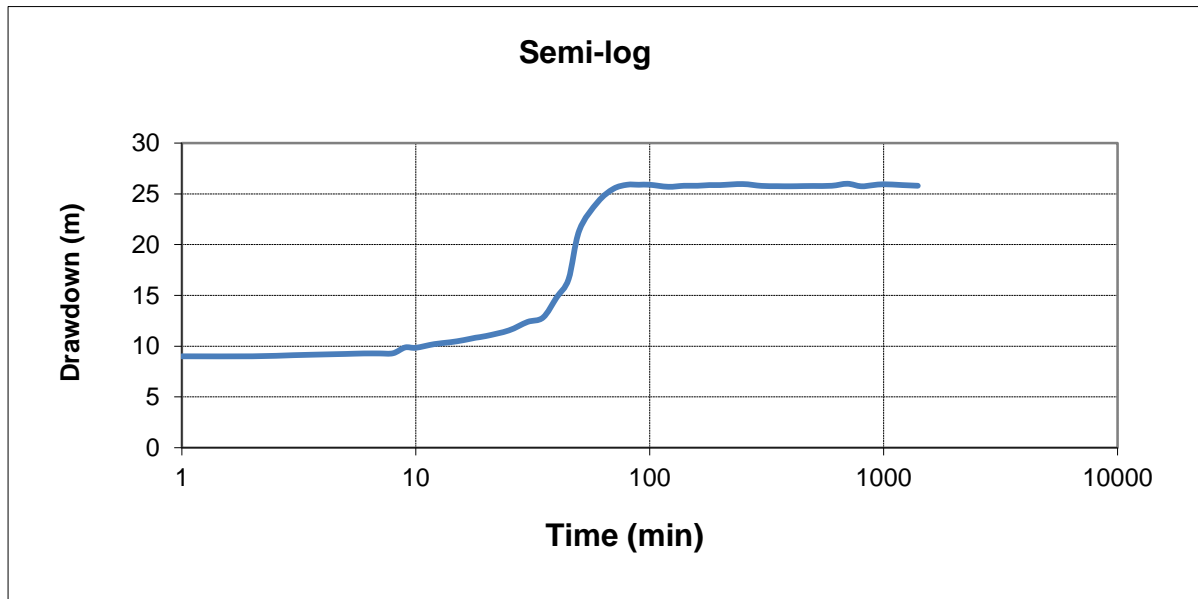
Figure 18: Semi-log plot of drawdown against time for Kwagadlanga Monitoring Borehole

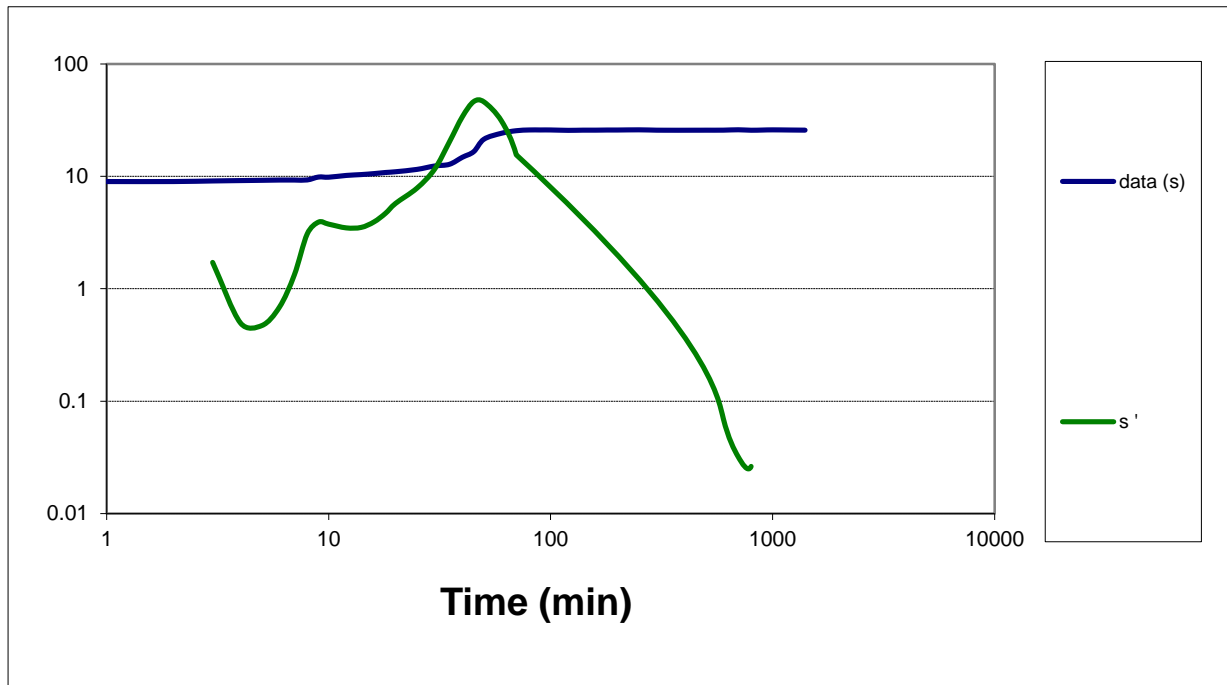
Figure 19: Log-log plot of drawdown derivative against time for Kwagadlanga Monitoring Borehole

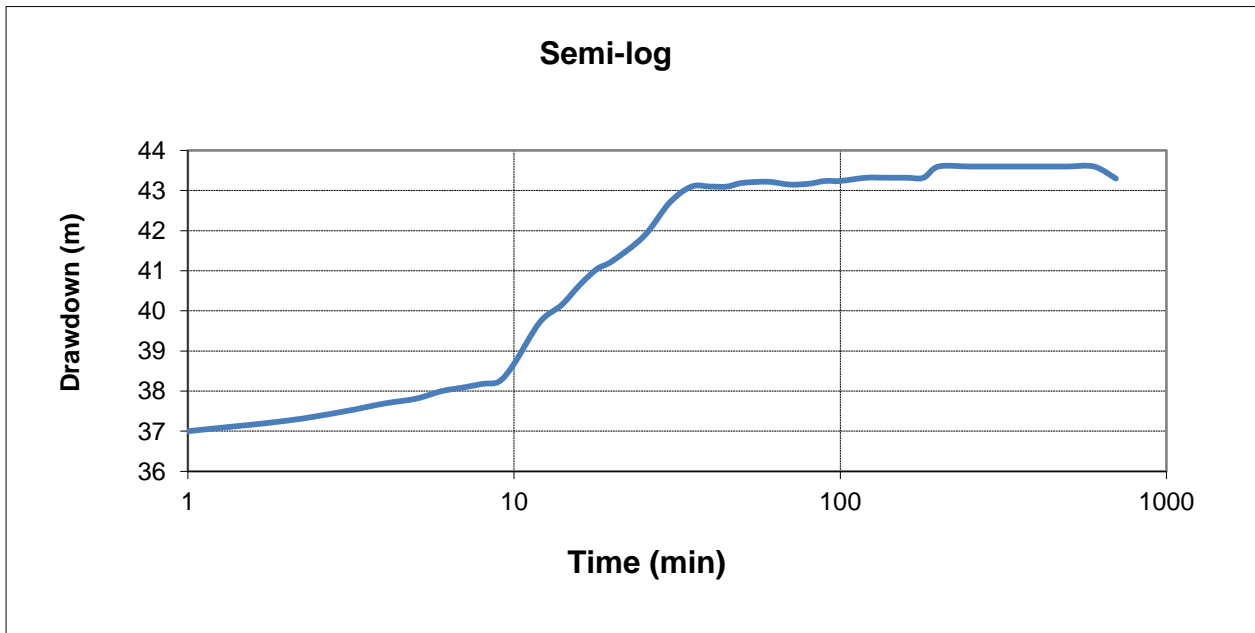
Figure 20: Semi-log plot of drawdown against time for Athalia Monitoring Borehole

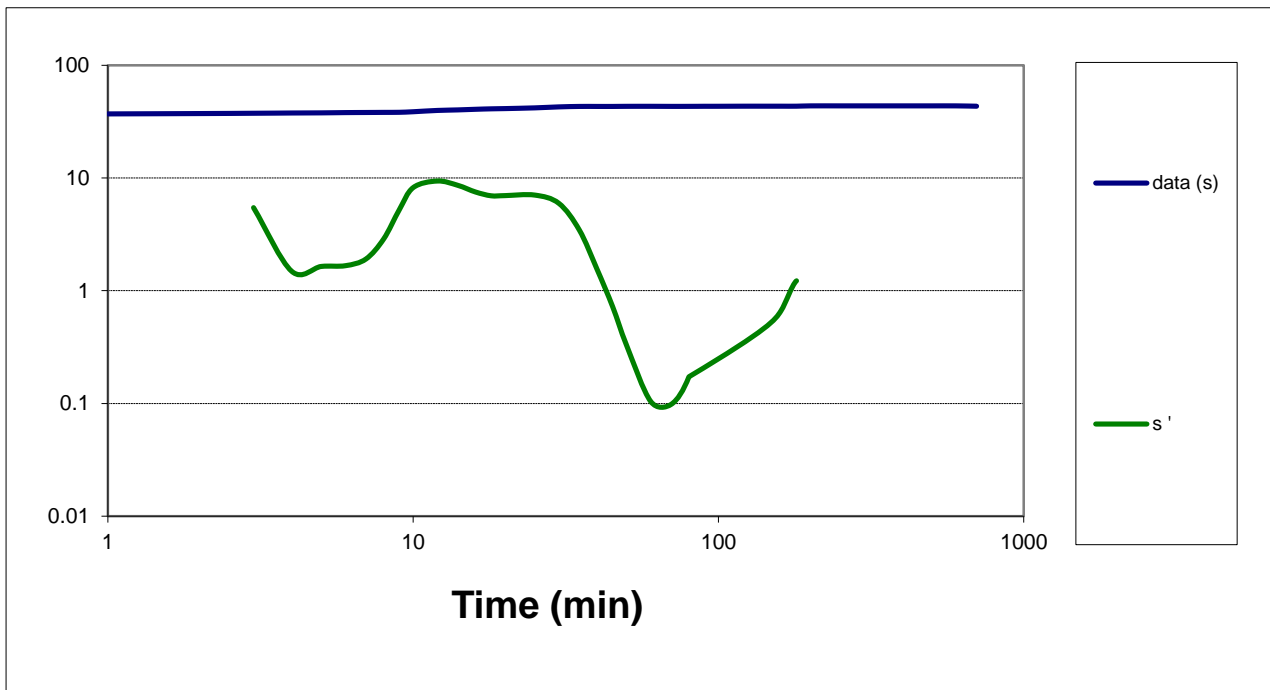
Figure 21: Log-log plot of drawdown derivative against time for Athalia Monitoring Borehole

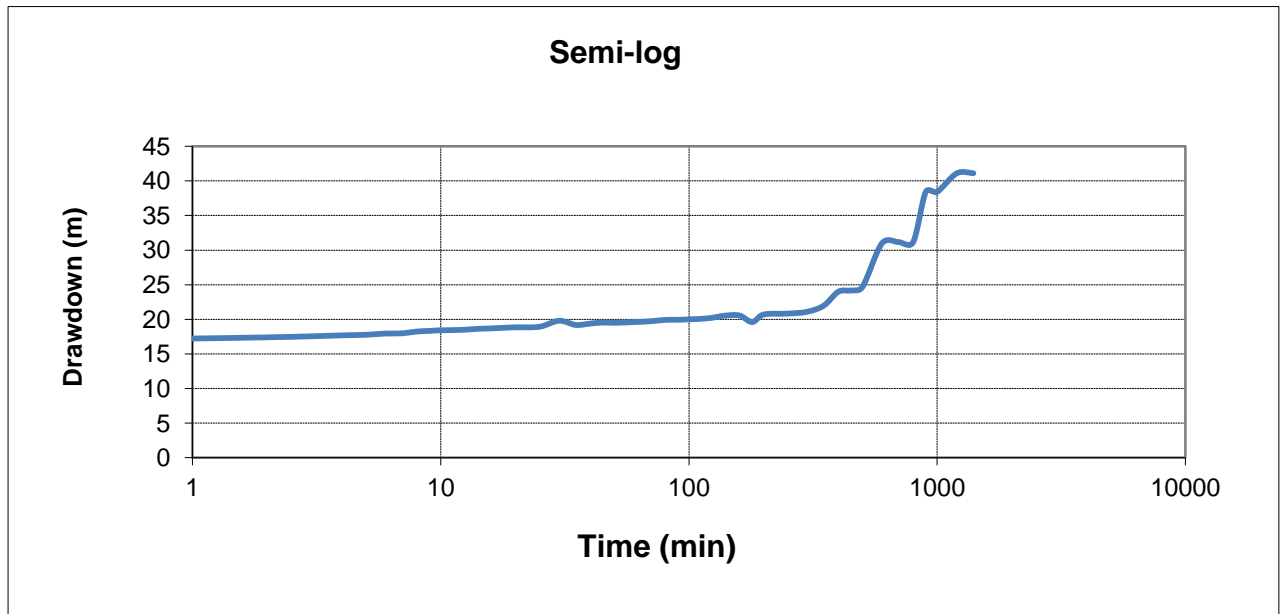
Figure 22: Semi-log plot of drawdown against time for Cangaza Monitoring Borehole

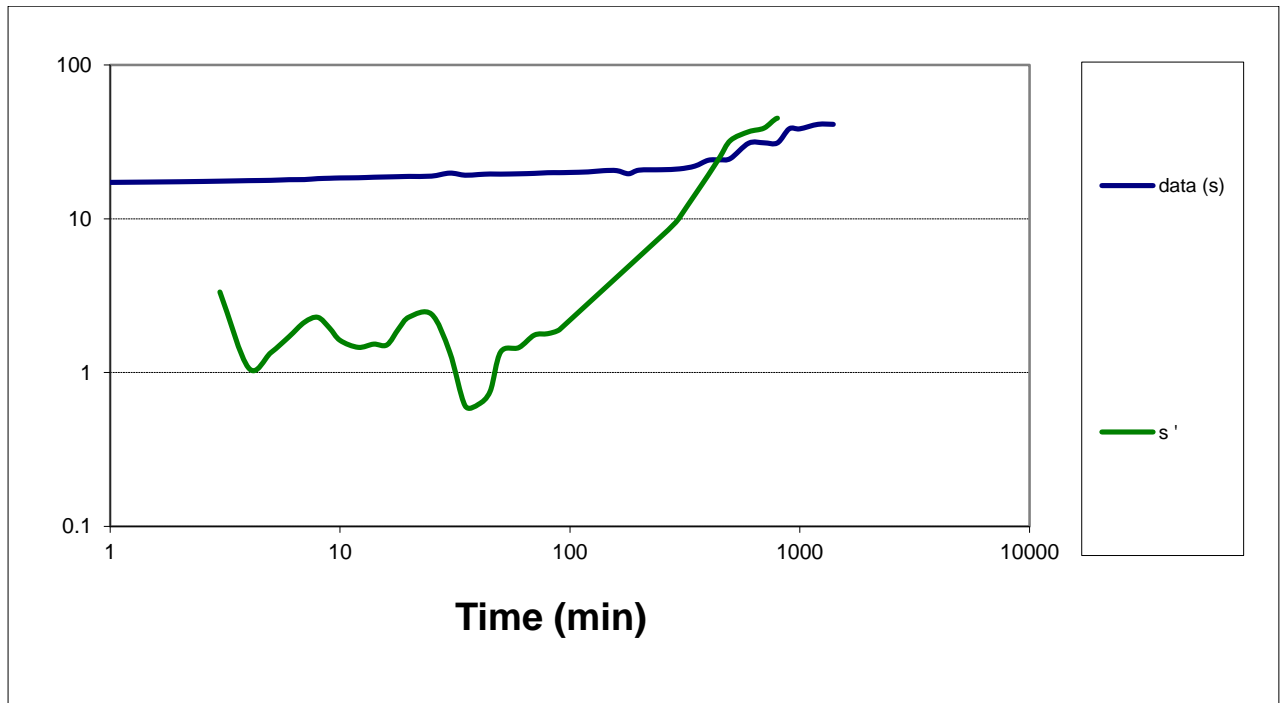
Figure 23: Log-log plot of drawdown derivative against time for Cangaza Monitoring Borehole

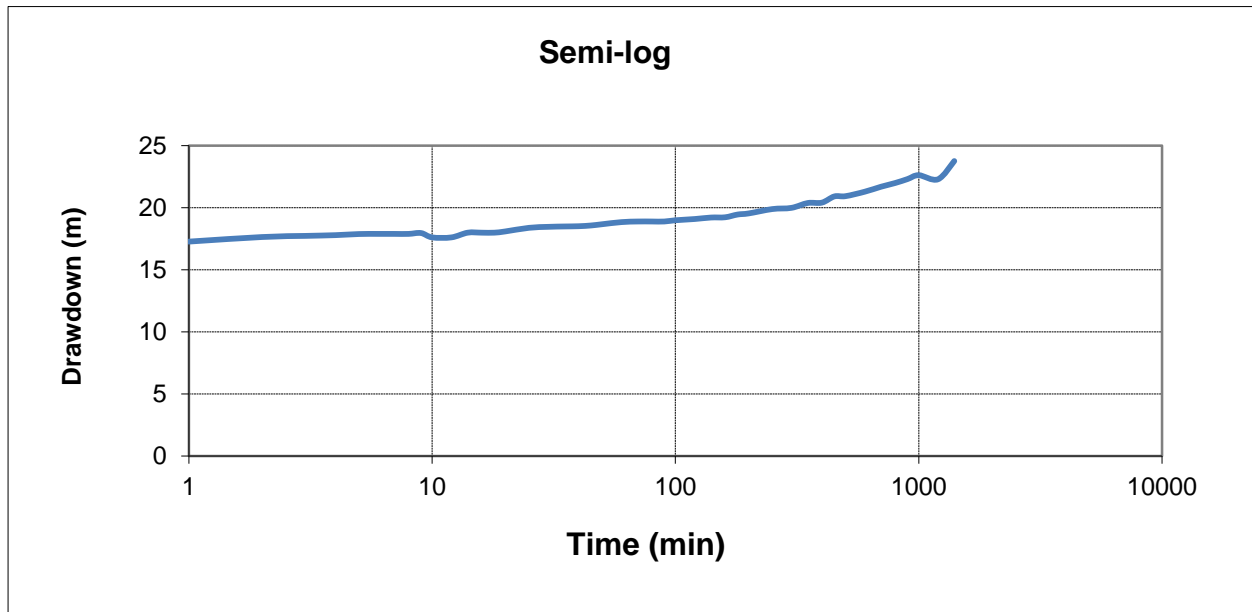
Figure 24: Semi-log plot of drawdown against time for Amsterdam Monitoring Borehole

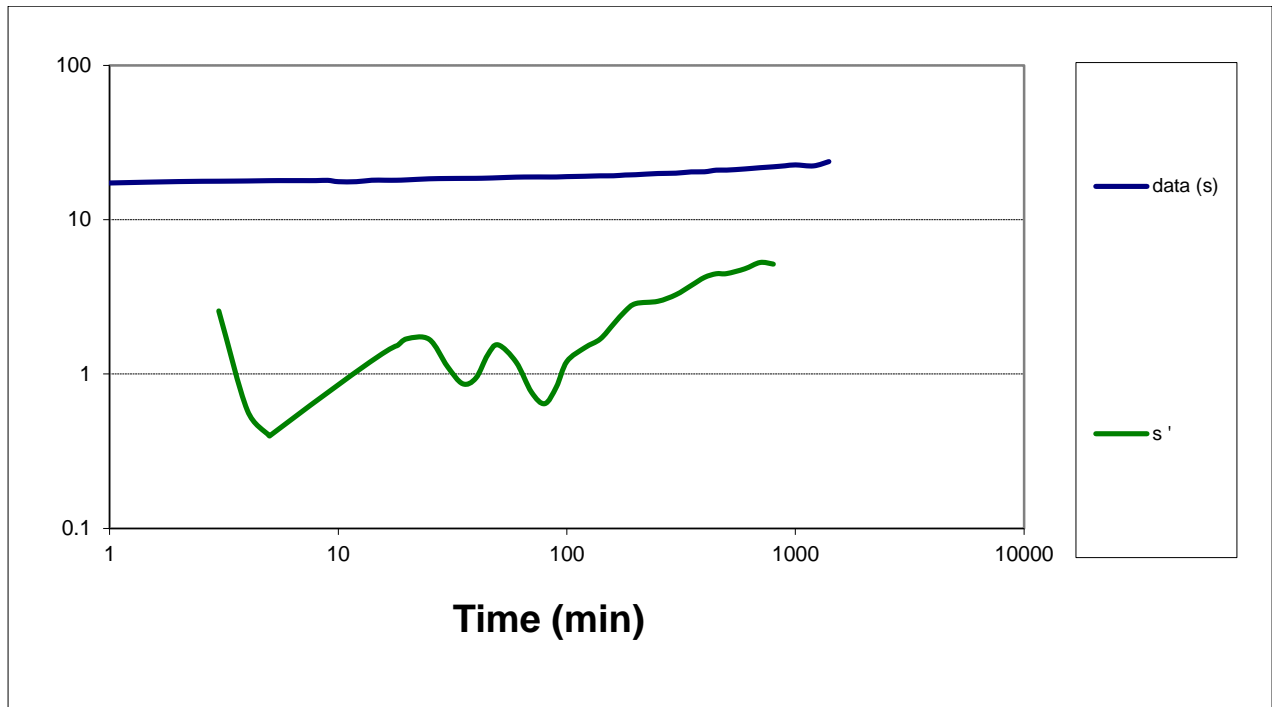
Figure 25: Log-log plot of drawdown derivative against time for Amsterdam Monitoring Borehole
