INKOMATI-USUTHU WATER MANAGMENT AREA GEOHYDROLOCAL DESKTOP STUDY

Client: Inkomati-Usuthu Water Catchment Management Agency

Date: February 2016

Prepared by: Thoka Geosciences cc

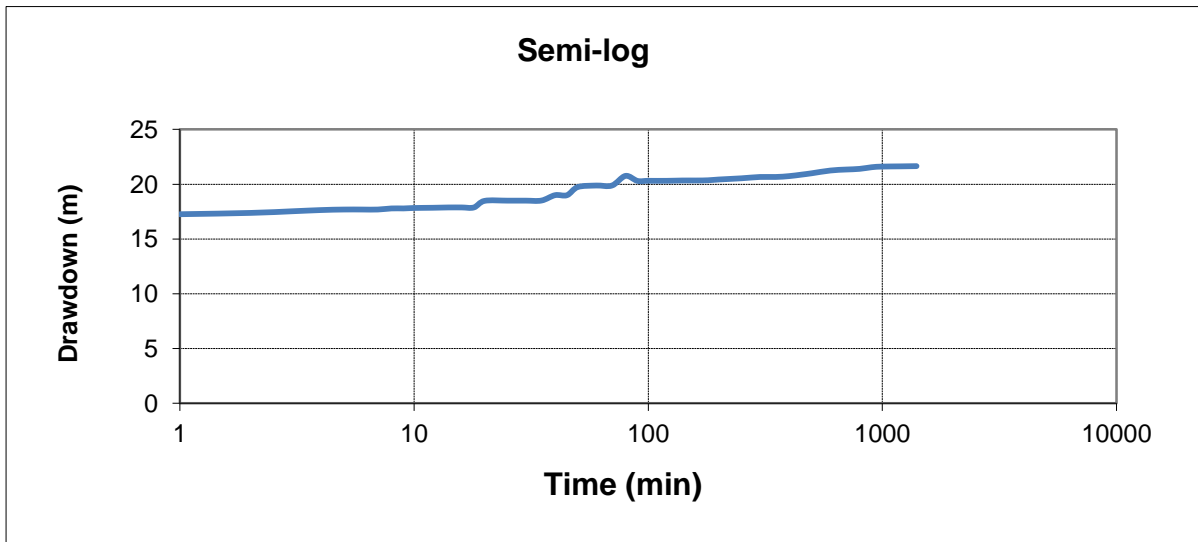
Figure 26: Semi-log plot of drawdown against time for Mayflower Monitoring Borehole

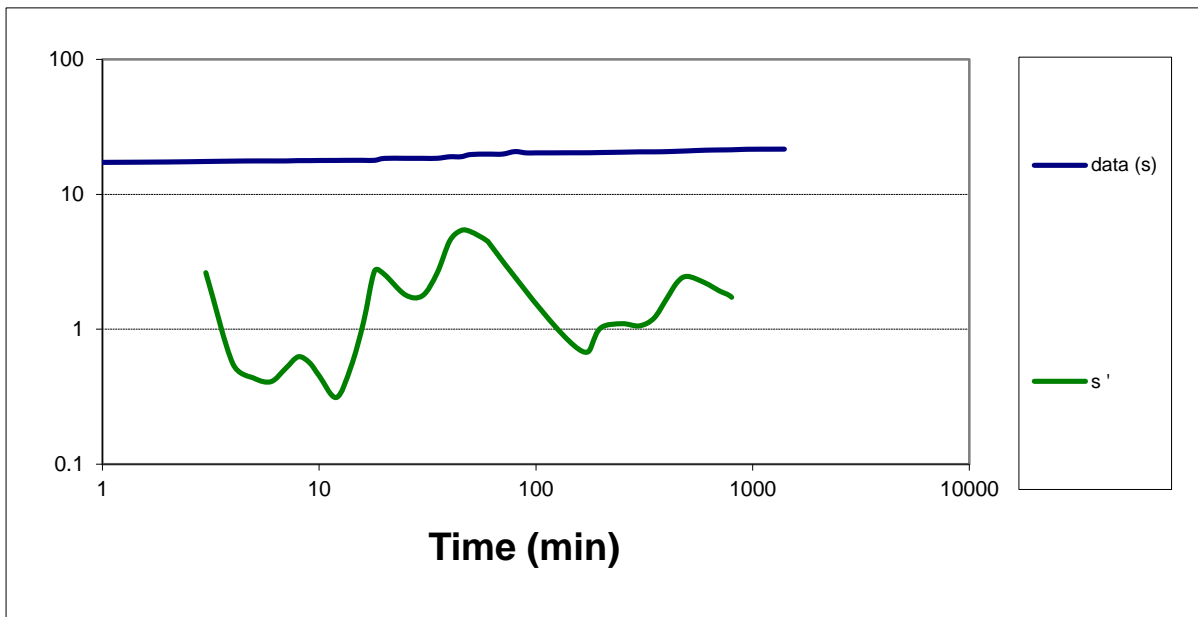
Figure 27: Log-log plot of drawdown derivative against time for Mayflower Monitoring Borehole
