Attention: Mr. Tony Kriel  
Port Ferry 71 (PTY) LTD  
Author: A.J. van Rooyen  
Date: 31 July 2003  
Technical Report No: AD/012/03  
Project No: AD/006/03

**KHAMANGA BAY RESIDENTIAL DEVELOPMENT  
BULK WATER SUPPLY STUDY  
REPORT FOR THE PROPOSAL CALL  
FOR THE FEASIBILITY STUDY AND PILOT PROJECT  
ON THE GROUNDWATER POTENTIAL  
AMATOLE DISTRICT MUNICIPALITY (DC13)  
GREAT KEI LOCAL MUNICIPALITY  
EAST LONDON MAGISTERIAL DISTRICT**

**REPORT TITLE: The Potential for Exploiting Groundwater**

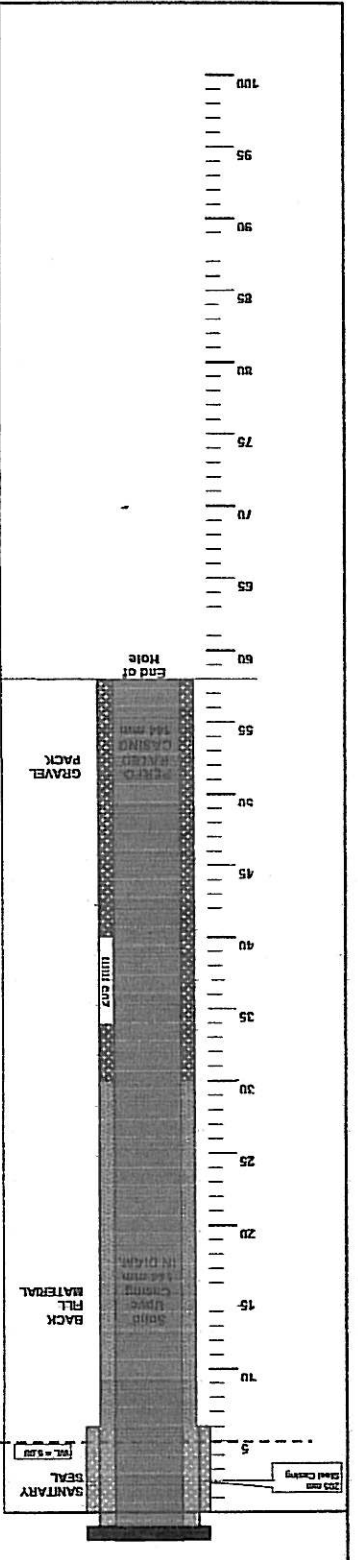
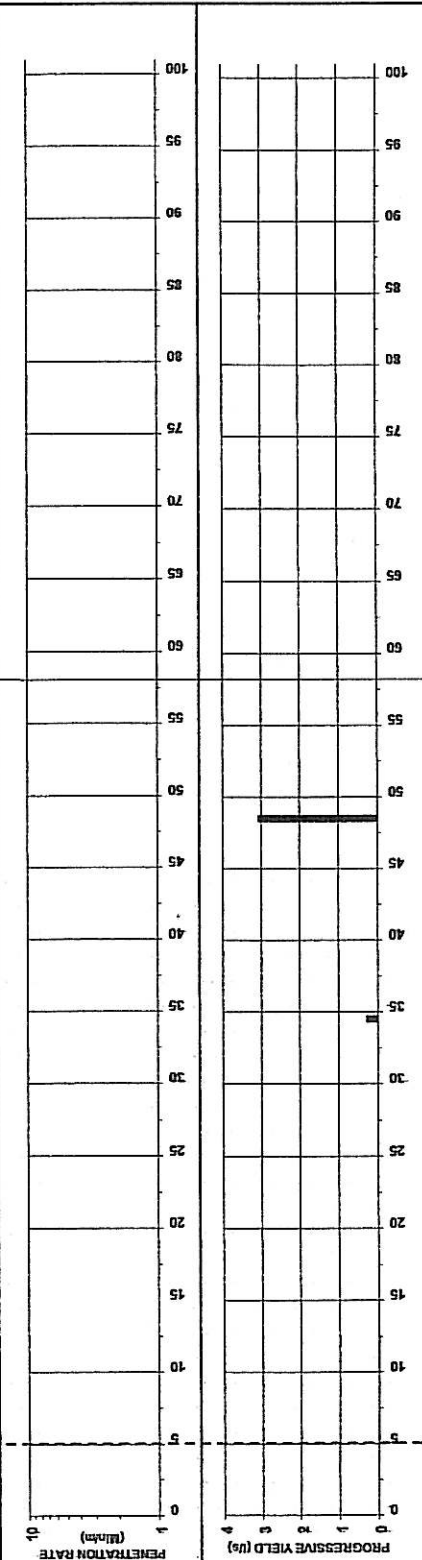
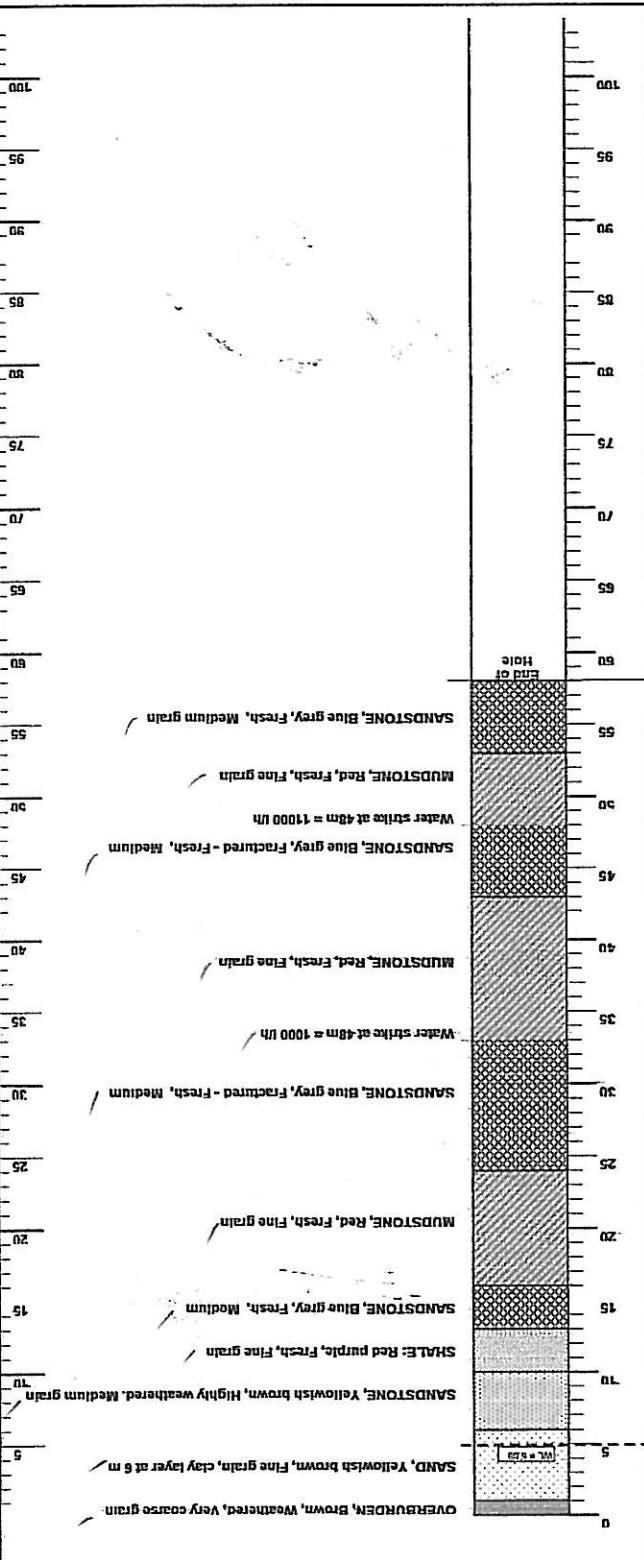
METHOD:  
 BOREHOLE NR: KHAM 6  
 GEOPH PEG NO.:  
 LATTITUDE : 32° 50' 19.0"  
 LONGITUDE : 28° 06' 50.4"  
 BOREHOLE DEPTH: 58  
 BLOW YIELD: 3.06 ALTITUDE:  
 LITHOLOGY

BOREHOLE CONSTRUCTION DETAIL		Casing Detail		LITHOLOGY	
To:	6	To (m):	58	Geology:	BEAUFORD GROUP, TARKASTAD SUBGROUP,
From:	0	From (m):	0		Burgersdorp Formation (Grey, brown, red mudstone,
Diam	256	Material	165		sandstone, Dolerite dykes and sills
	205	Thickness	6		Bedding plane fractures
	205		8		
	205		144		
	58		144		
	6		43		
	0		58
