**GROUNDWATER MONITORING OPTIMISATION WITHIN  
THE UPPER VAAL SUB-CATCHMENT AREA –**

**PART A: EVALUATION AND RECOMMENDATIONS ON THE  
PROPOSED NETWORK AT BOSKOP NATURE RESERVE AREA**

**September 2023**

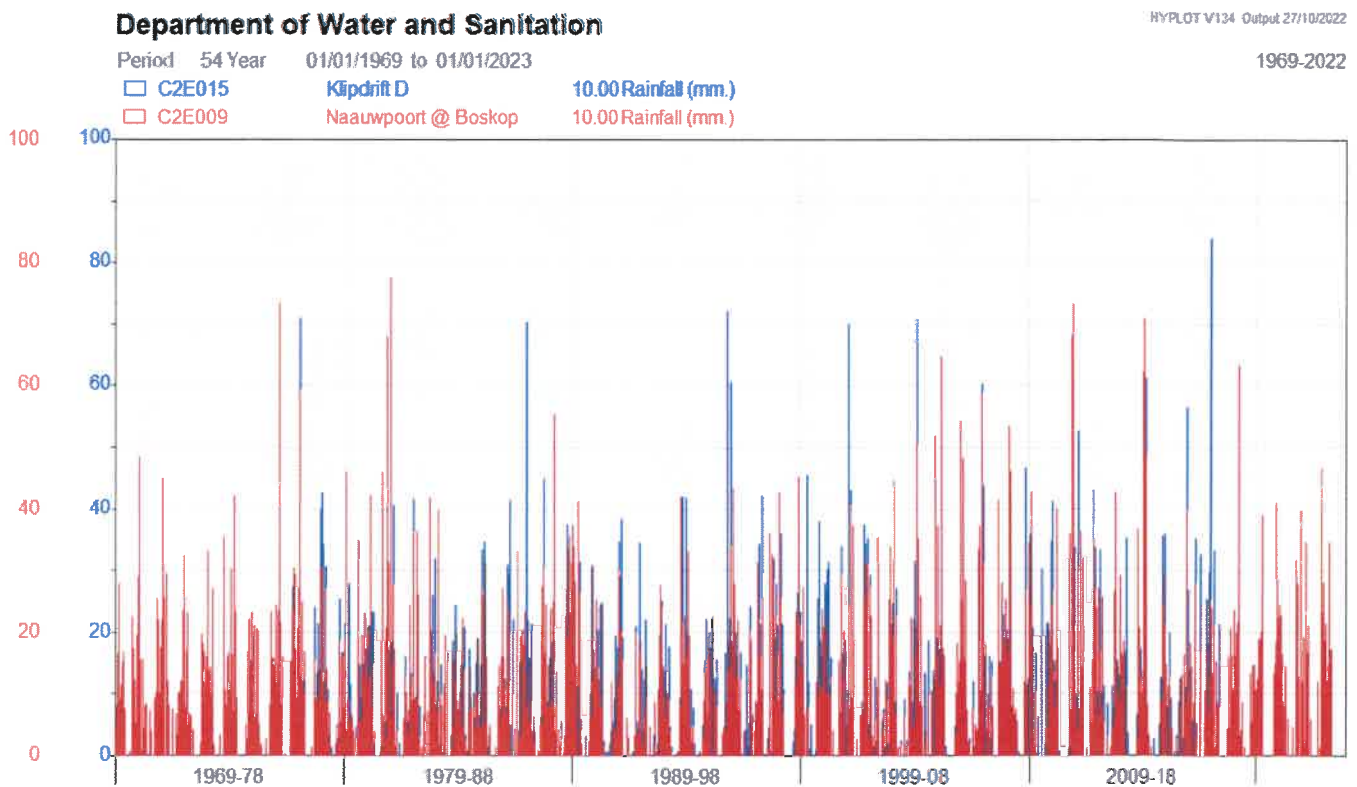
Precipitation, namely in the form of rainfall, provides the raw input of water to a catchment but its availability for supporting river flows, replenishing aquifer storage and supporting water supplies depends on catchments conditions such as soil type, geology, climate and land use that affect catchment runoff properties (Brassington, 1998). The climate in the C23F sub-catchment area is sub-tropical dry savanna, with the mean annual evaporation at ~ 900 mm and far exceeding the rainfall of ~600 mm (Jury 2016). The average temperature in this area range between 15 - 21°C in summer and drop to 12°C in the winter (DWAF2, 2002). The C2E009 DWS meteorological station (situated in Boskop Dam) recorded the highest rainfall event of 145.73 mm on the 25 -26 January 1981. The second highest rainfall recorded was 141.33 m on the 02 - 03 January 2011 (Figure 2). The lowest rainfall records were observed during the drought event of 2016/17. The rainfall records also show a very correlation with the nearby C2E015 station at Klipdrift Dam.

Figure 2: Continuous rainfall data from at C2E009 and C2E015 meteorological stations

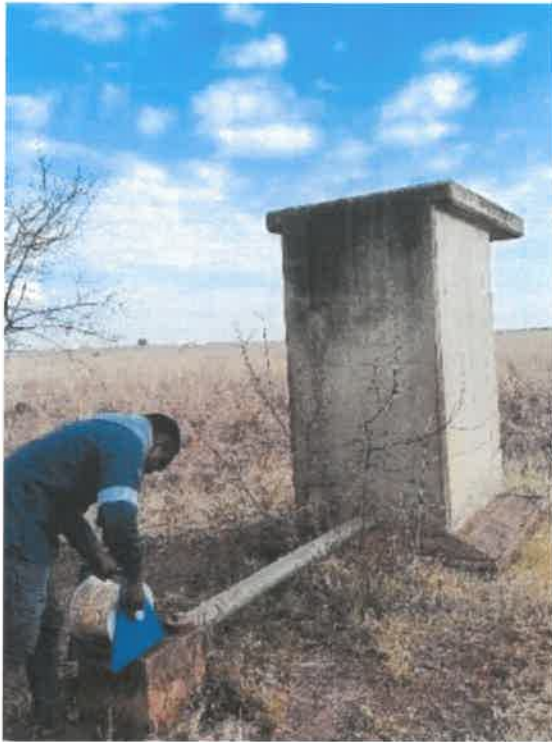
The Malmani Formation in this area (C23G) is well represented by the C2N0003 borehole station on the eastern side (*Photo 1*). The Timeball Hill Formation is also monitored by C2N0002 and C2N0104 borehole stations (*Photo 2 & 3*). The construction of the boreholes is durable and reliable since it lasted for more than four decades (see photo 1, 2, 3 & 2). There are currently no instrumentations installed inside the monitoring station. However, in the past some of the boreholes were installed with the autographic chart recorders which are no longer functioning, but data is stored safely in the archives. Since the dolomite is unstable the boreholes were cased all the way down with a steel pipe casing. It should be not that Farmers took advantage of some of DWS borehole by installing windmills (some submersible pump) but it is still possible to carry out quantity monitoring. As a result, the boreholes are not sealed tops and thus making it very difficult from prevent bees/termites from building shelter inside the wells. The sanitary seal of concrete slaps is still good condition to supports the sides of the holes and protecting water from contamination. The new proposed baselines and trendlines groundwater monitoring sites will be a good representative of the geological formation network once implemented.

*Photo 1: View of C2N0003 existing site.*

- The last point visited on this day was C2N0003, which is also an existing DWS monitoring point, located at 26.507419 S and 27.136772 E. The borehole is located inside the private farm. The entrance to the borehole must be arranged with the owner. The permission was granted after two hours of waiting and upon his arrival he mentioned that going forward he is going to utilise the borehole for water production. This is because the farmer thinks the borehole belongs to him and not the department. The groundwater level was recorded as 26.29m at 16:10 pm.

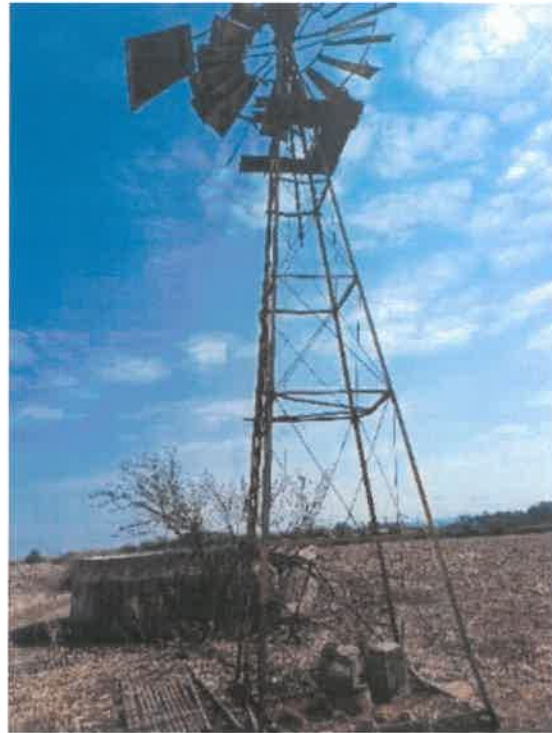
*Photo 2: View of C2N0002 existing site.*

- The first point visited was C2N0002 borehole station, which is an existing DWS monitoring point, located at -26.510108 S and 27.152371 E. This site is located inside a farm and during the field visit a submersible pump was installed inside the well and therefore we were unable to monitor the groundwater level.

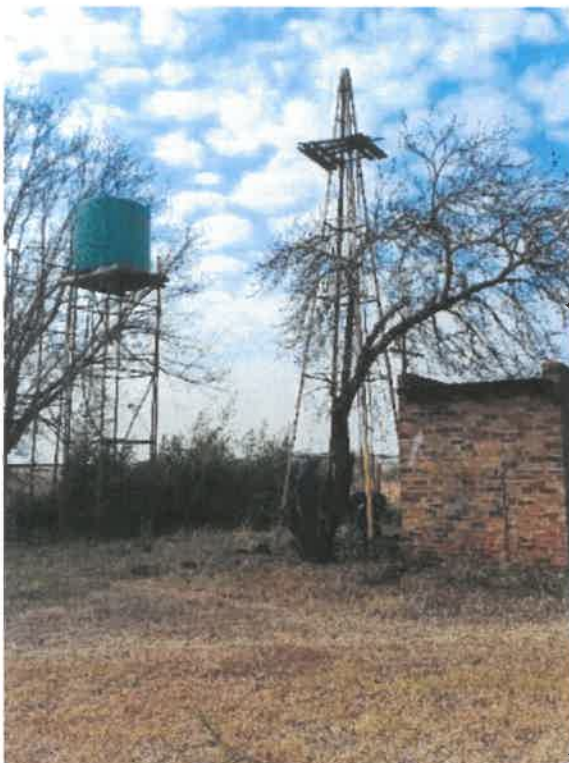
*Photo 3: View of C2N0104 existing site.*

- The second point inspected was C2N0104 borehole station, which is also an existing monitoring point, located at -26.400919 S and 27.215302 E. The borehole is also located in a private farm and the owner is aware of the monitoring taking place in his premises. The water level was recorded as 10.88m at 14:09 pm.

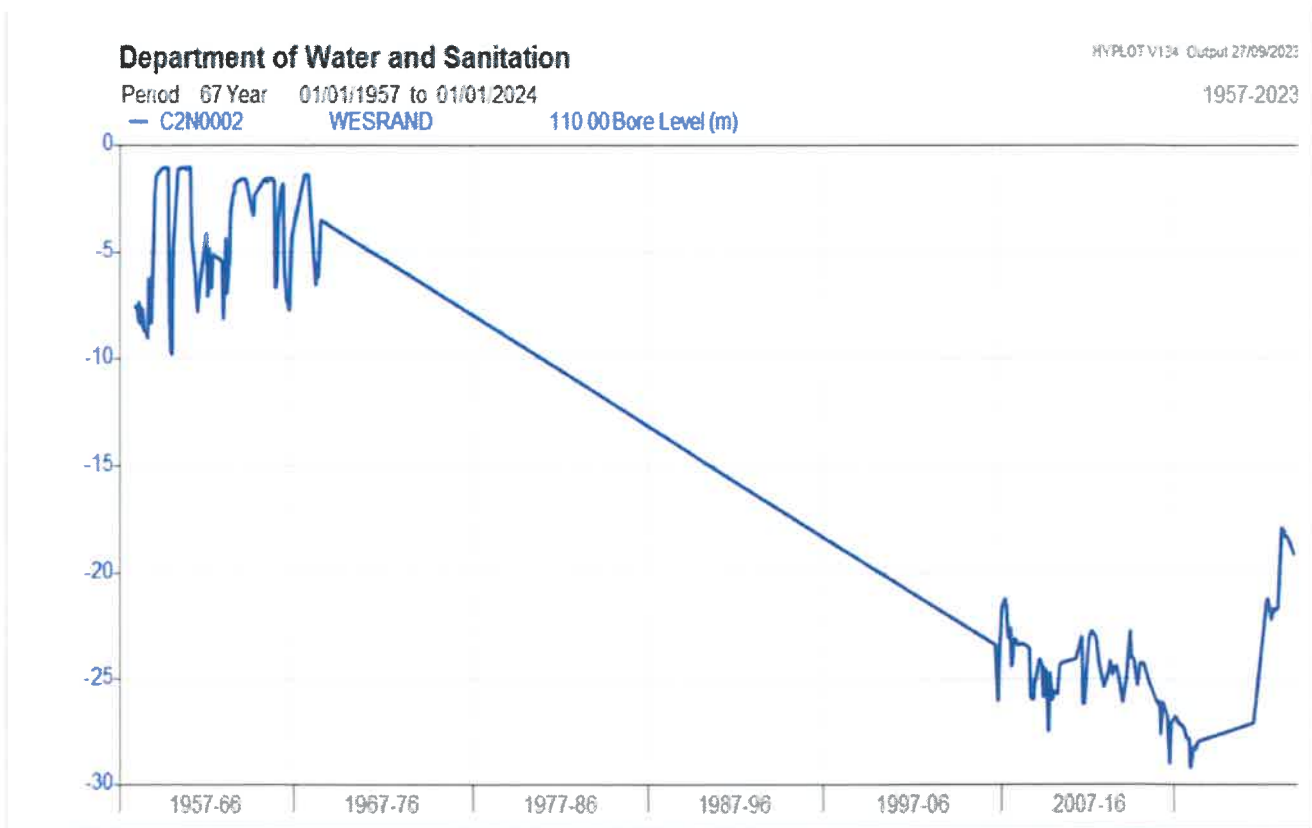
The groundwater level measurements are collected monthly at the three existing geo-sites. The **C2N0002** station has been monitored since 1957, water level was ranging between -1 to -9m until June 1968. This borehole once experienced the gap from 1968 to 2006, after the gap period water levels started to decrease from -18 to -29m. The **C2N0003** has been monitored since 1961 and the autographic chart recorder was installed to early 1970. The groundwater table fluctuates between -15 to -28m. The monitoring at this borehole also experiences massive gap from 1967 to 2006 and the automatic recording was reduced to monthly monitoring after the gap. The water levels started to decrease -23 to -29m. The reduction could be due to agricultural abstraction as these areas entirely using groundwater for production. The **C2N0104** station has undisturbed monitoring records from 1963 with no gap, water level is ranging from -13 to -18m. The variation in data can also be attributed to groundwater abstraction from the windmill.

Figure 4: Showing continuous groundwater level series of the C2N0002 station

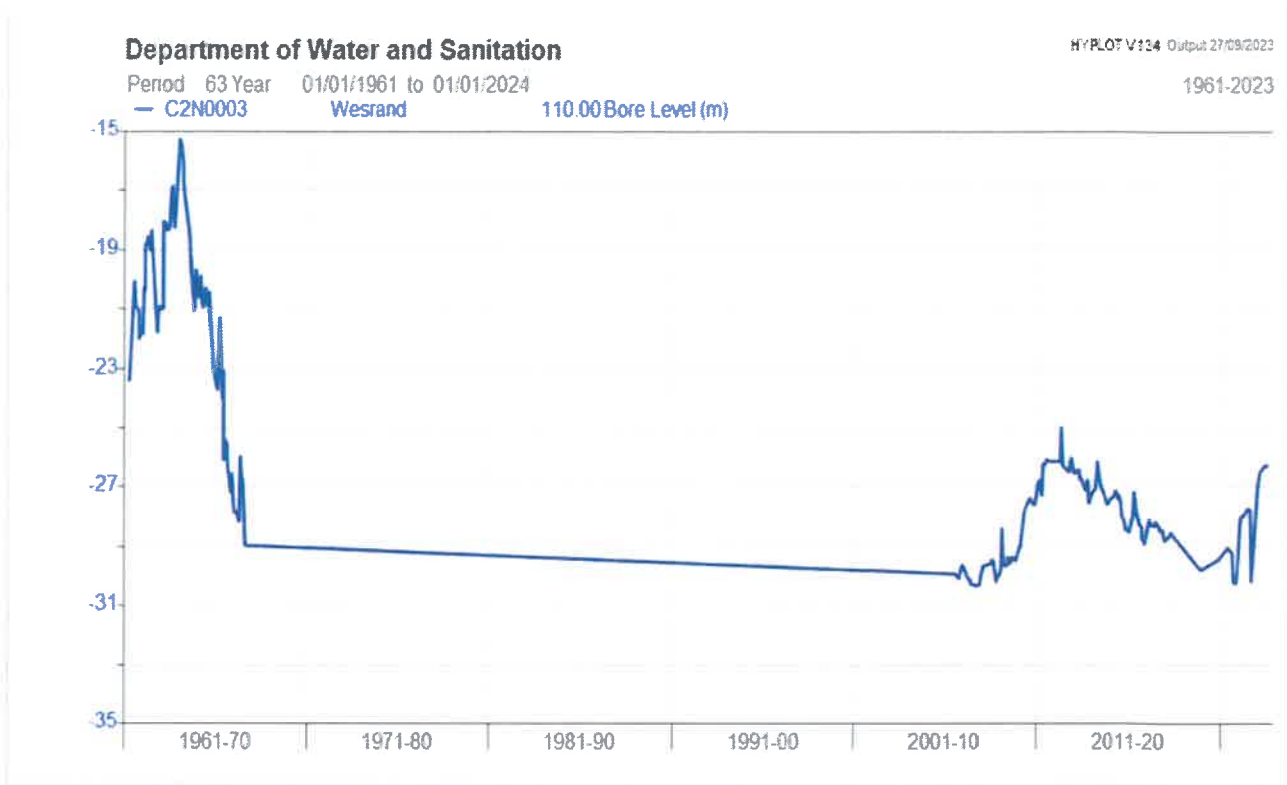
Figure 5: Showing continuous groundwater level series of the C2N0003 station

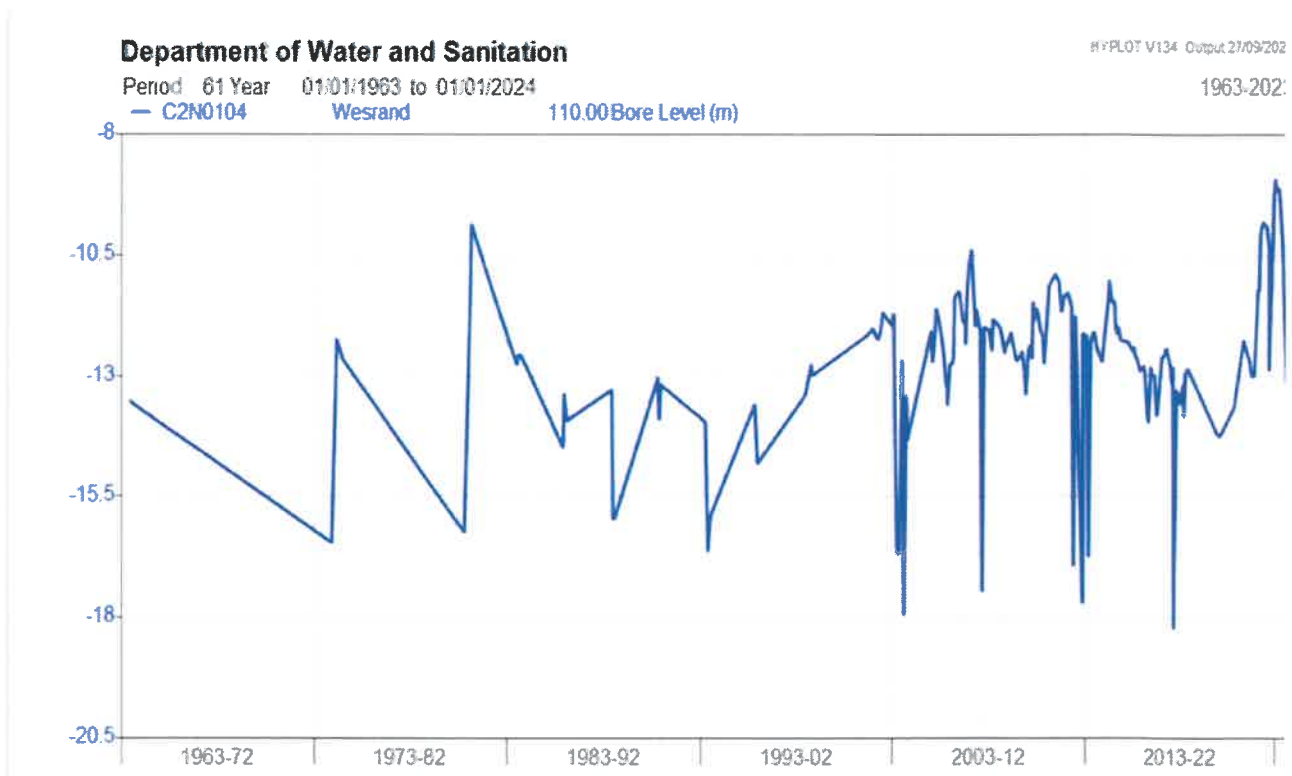
Figure 6: Showing continuous groundwater level series of the C2N0104 station

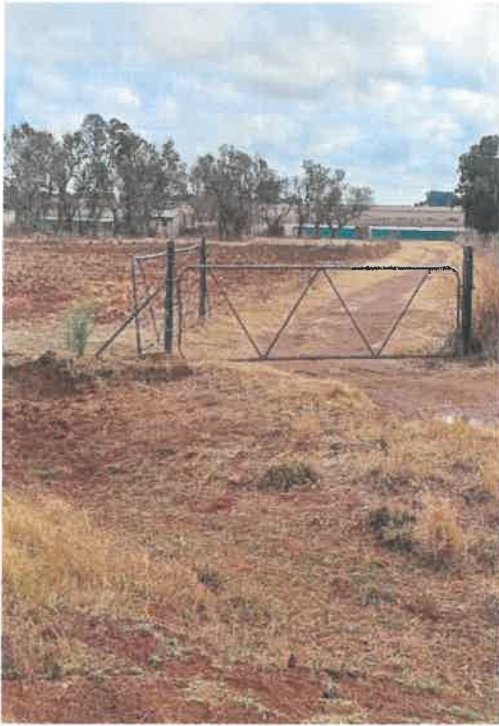
- The first point visited was **263**, which is a proposed for trendline monitoring and it is located at -26.3863 S and 26.995434 E. This site appeared to be not suitable for trendline monitoring since it is located inside the locked private property (*Photo 4*). However, the monitoring point can be established outside the property not far from the gate next to the road for easy access at -26.394140 S and 27.007241 E, at an elevation of 1511 mMSL. There is no NGA borehole near this proposed site.

*Photo 4: View of 263 proposed site.*

- Proposed point number **263** is not suitable for trendline monitoring mainly because it is located inside the private farm. However, the monitoring point can be established outside the property not far from the gate next to the road for easy access at -26.394140 S and 27.007241 E, at an elevation of 1511 mMSL.

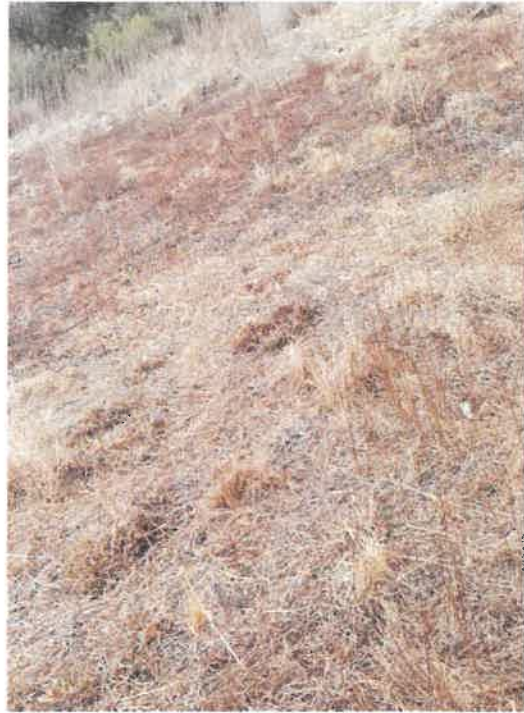
- The second point visited was **264**, which is a proposed for trendline monitoring and it is positioned at -26.386219 S and 27.093124 E. The point is located inside a farm and there was no problem with access road. There is suitable open area within the farm at -26.382271 S and 27.100929 E at an elevation of 1481m where a monitoring point can be established (*Photo 5*).

*Photo 5: View of 264 proposed site.*

- Proposed point number **264** is located inside a farm and there was no problem with access road and there is suitable open area within the farm at -26.382271 S and 27.100929 E at an elevation of 1481m where a monitoring point can be established

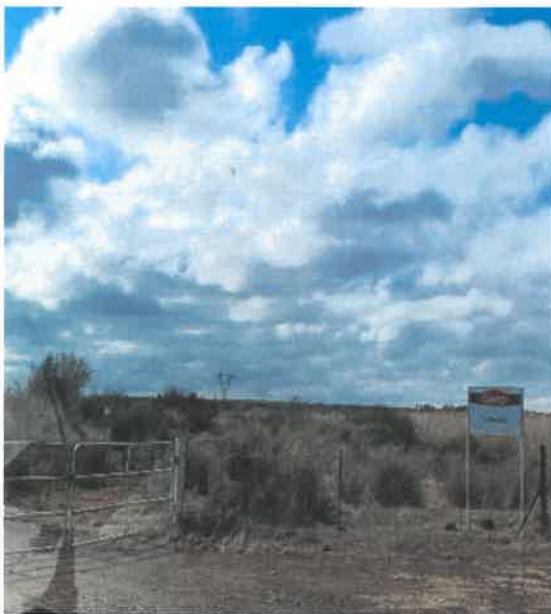
- The next point visited was **262**, which is proposed for baseline monitoring and it is placed at 26.4144 S and 27.16775 E. This point is not suitable for establishing a groundwater monitoring because it is positioned inside the private property (*Photo 6*). The alternative position to establish the monitoring point is recommended at 26.435702 S and 27.149212 E. at an elevation of 1413 mMSL. There is NGA boreholes located nearby but is currently in use for livestock production (*photo 7*).

*Photo 6: View of 262 proposed site*

- Proposed point number **262** is not suitable for trendline monitoring because it is located inside the private property (*Photo 6*). The alternate position to establish the monitoring point is recommended at 26.435702 S and 27.149212 E. at an elevation of 1413 mMSL.

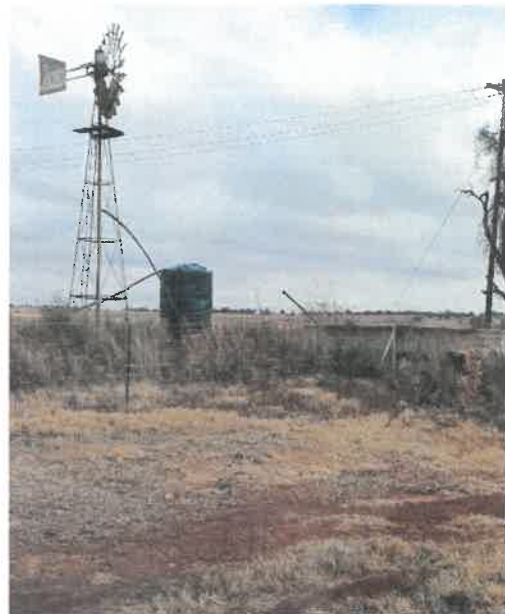
*Photo 7: View of NGA near 262 proposed site*

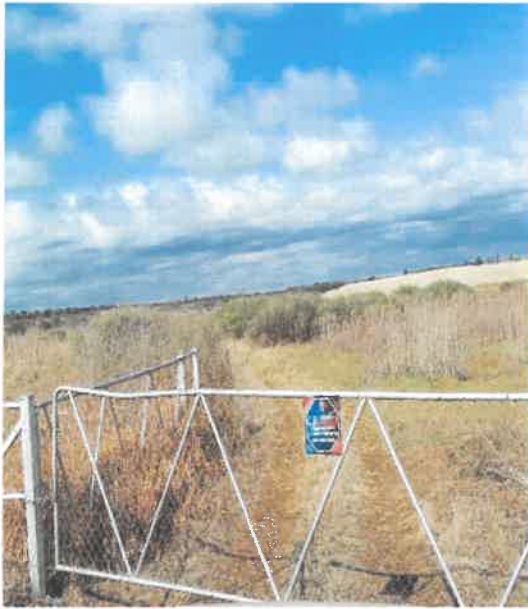
- The next point visited was **259**, which is proposed for baseline monitoring and is located in a private property. This site is not suitable for baseline monitoring due to accessibility (*photo 8*). There is no new recommended point for this proposed site as it is less than a kilometre distance from the 262 proposed site.

*Photo 8: View of 259 proposed site*

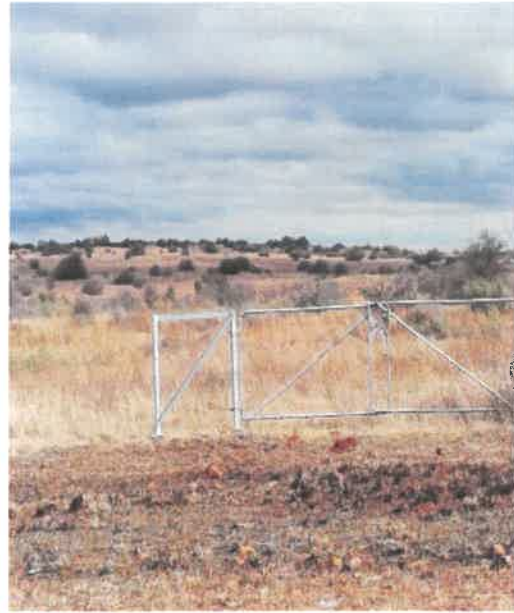
- The next point visited was **260**, which is a proposed baseline monitoring and is located inside private property with locked gates (*photo 9*). This site is it not suitable for baseline monitoring mainly due to accessibility. However, new a monitoring point can be established outside the facility across the road at -26.464908 S and 27.115036 E, at an elevation level of 1411 mMSL, but the distance of how far from the road can be determined during the geophysics with the consultation with Sanral/Municipality for their standards not to be compromised. There is no NGA borehole located close to the proposed site.

*Photo 9: View of 260 proposed site*

- Proposed point number **260** is not suitable for baseline monitoring because it is located inside the private property. However, new a monitoring point can be established outside the facility across the road at -26.464908 S and 27.115036 E, at an elevation level of 1411 mMSL.

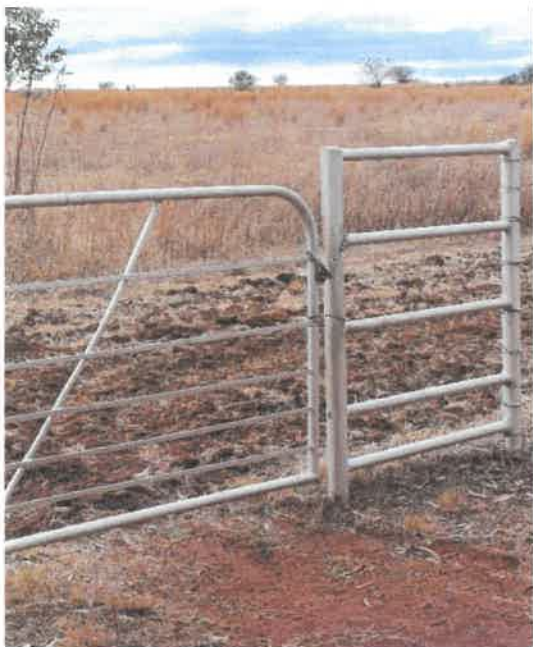
- The next point visited was **261**, which is a proposed for trendline monitoring and it is located inside the private property with locked gates, at -26.478923 S and 26.995517 E. The site appeared to be not suitable position for trendline monitoring due to accessibility (*photo 10*). There is also an NGA borehole observed closer to the proposed site, but it is currently in use for water supply in the farm (*photo 11*)

Photo 10: View of 261 proposed site

- Proposed point number **261** is not a suitable trendline monitoring because it is located inside the private property with locked gates (*photo 10*). New monitoring point can be established outside the property for easy access at -26. 26.482506 S and 26.994266 E, at an elevation level of 1479 mMSL.

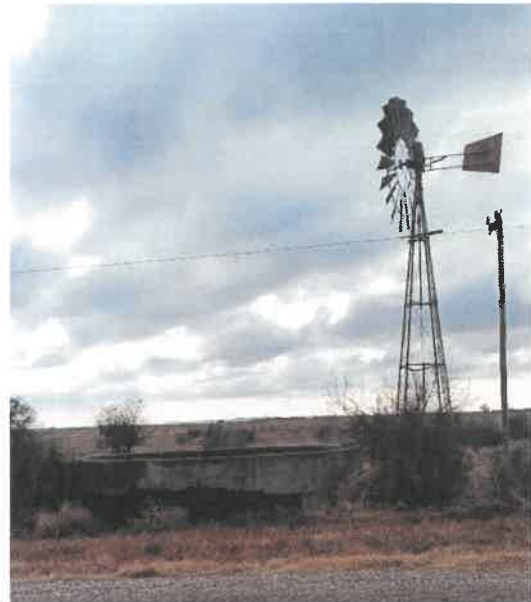
Photo 11: View of NGA site near 261

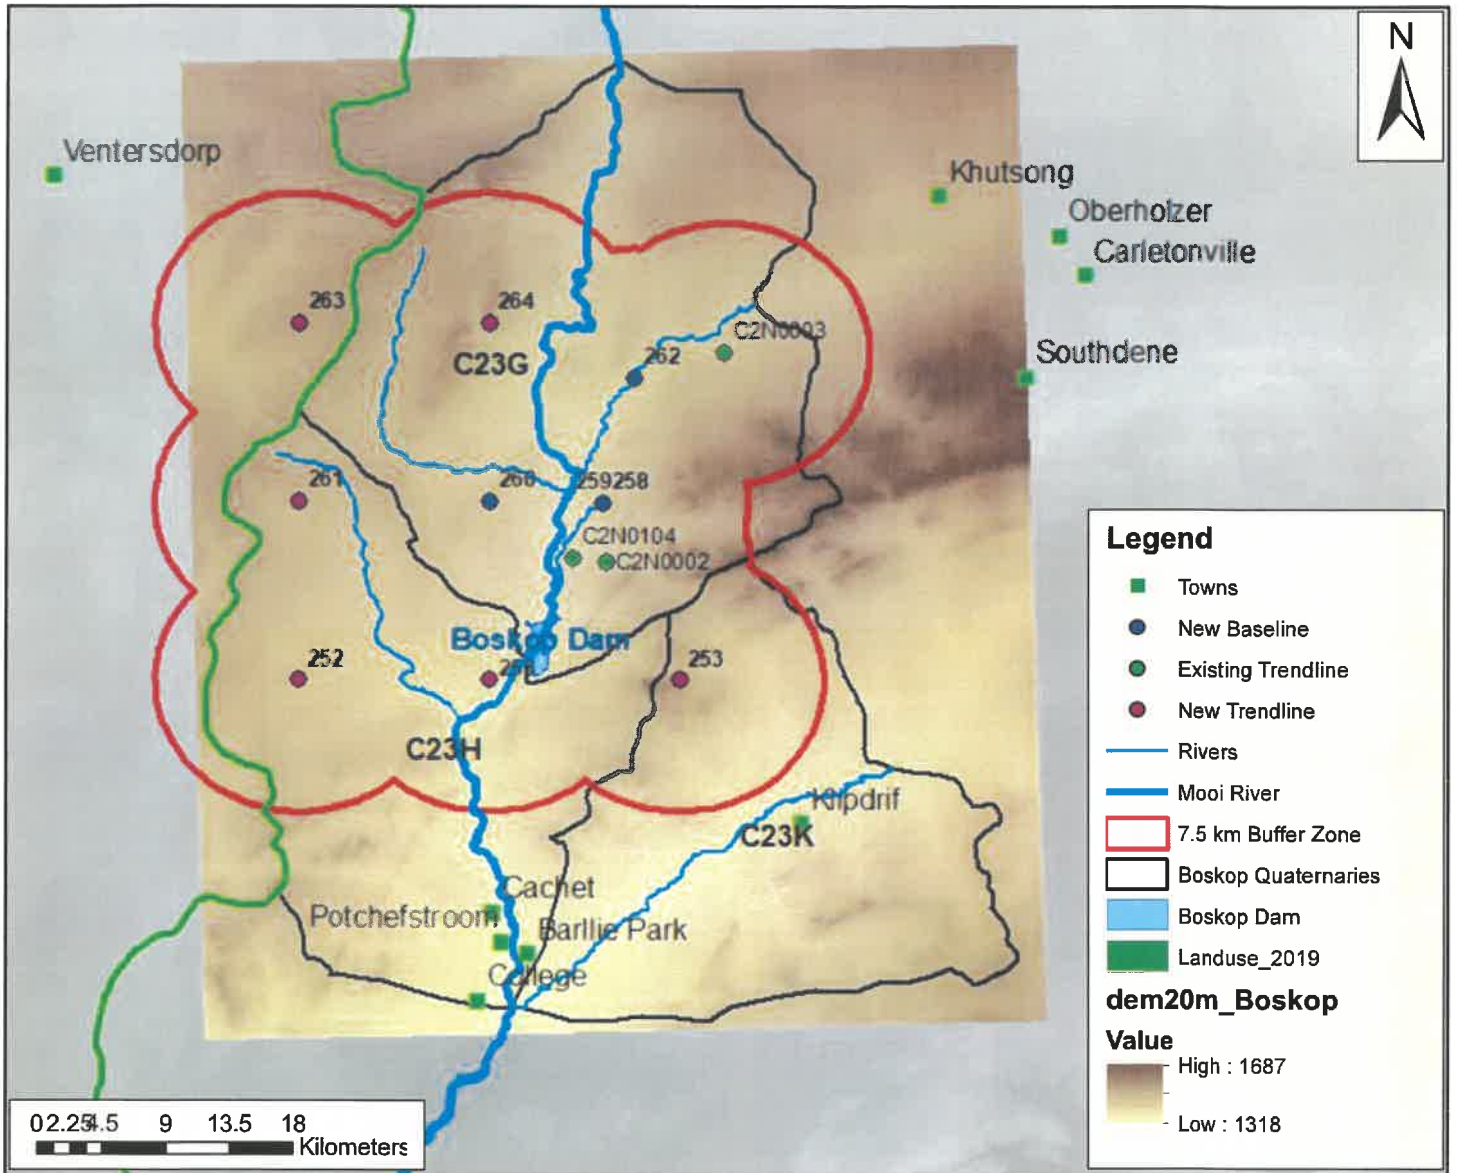
# Appendix A

A total of 10 new baseline/trendline proposed geo-sites were visited on 20 - 21 July 2023 within the Boskop Nature Reserve Area. These consist of 4 new baseline, 3 existing DWS borehole and 3 new trendline monitoring sites. The proposed sites are identified by numbers (e.g. 252, 253, etc.), see *Appendix A*. The sites were placed within a 7.5 km radius from each other. Each proposed site was evaluated for factors such as accessibility to site and drill, long-term accessibility for monitoring purposes, applicability for the type of monitoring and possible existing replacements. It should be noted that three proposed monitoring points, namely: 252, 253 & 254, were unable to be inspected mainly due to lack of time.
