The water quality of Bospoort Dam

DE Mogakabe and CE van Ginkel

TITLE: The Water Quality of the Bospoort Dam
REPORT NUMBER: N/0000/00/DEQ/0108
PROJECT: National Eutrophication Monitoring Programme (NEMP)
STATUS OF REPORT: Final Draft
DATE: January 2008

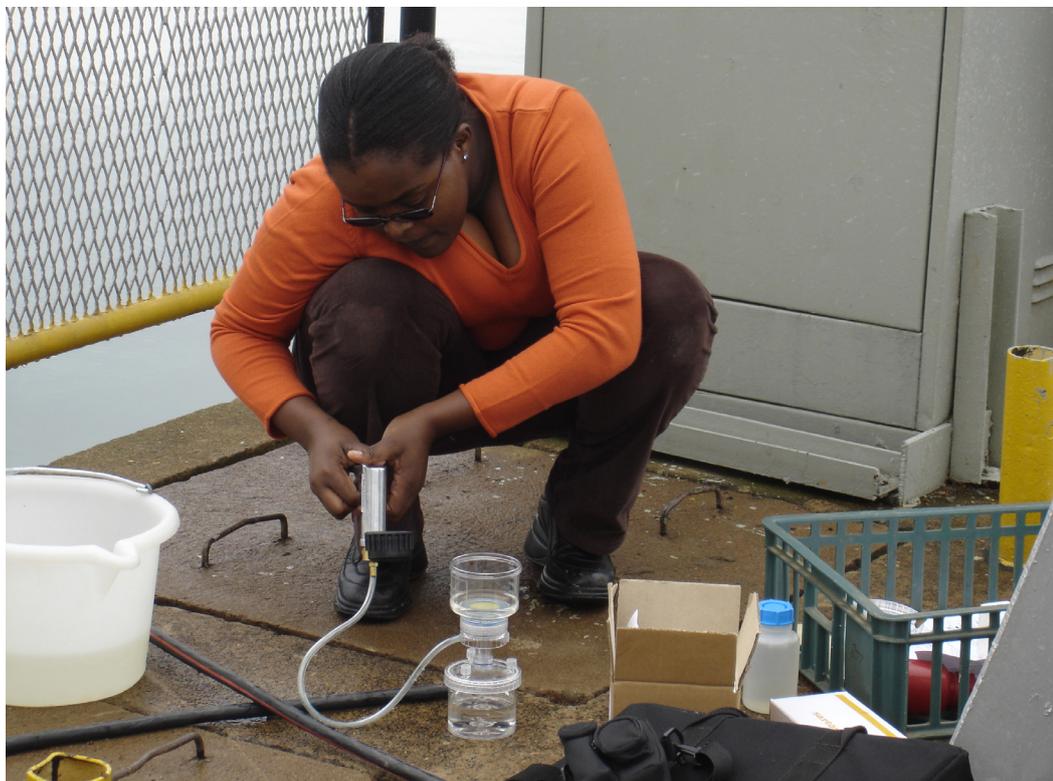
Figure 2.1. Field preparation of samples

For physical parameters, depth profiles for pH, temperature and dissolved Oxygen (DO) were measured in the field using digital automatic temperature, oxygen and pH meter (YSI). The instrument was pre-calibrated appropriately prior to use. The Secchi disk was used to measure light penetration into the water column. The disk consists of a round plate divided into alternate black and white sections. The disk is attached to a graduated rope divided into measuring units of 0.1 m apart, lowered into the water and the measurement recorded when it becomes immediately invisible.

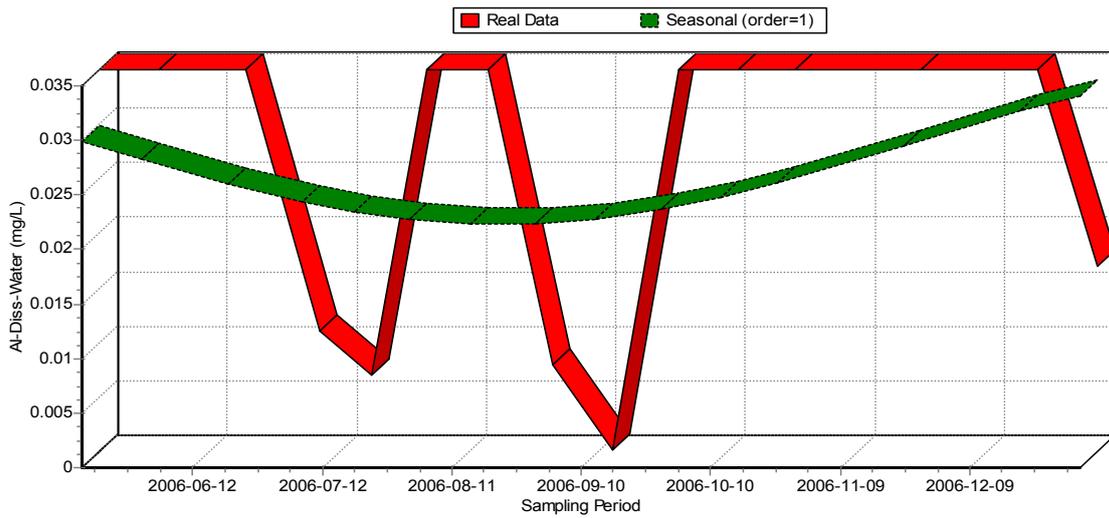
ALUMINIUM

2006-05-17 to 2007-01-03
