TITLE: Water Resources Management Plan in the Diep River Catchment: A Situation Assessment

REPORT NUMBER: N/G210/REQ/1200

DATE: APRIL 2002

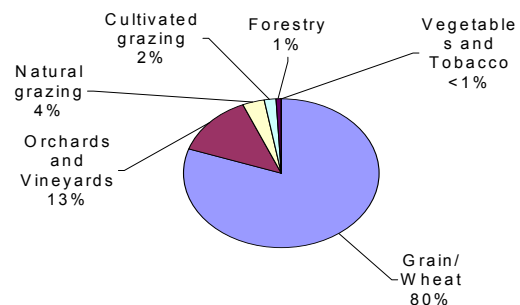
Figure 7. Areas (km²) under crops within the Diep River Catchment

Vines make up most of the irrigated land surface area (70%) and are found in the upper catchment area of the Diep River and its tributaries. Fruit (10%) and vegetables (20%) comprise the rest of the irrigation demand and are found in the middle and lower catchment areas of the Diep River, where wheat is also grown. The cultivation of wheat utilises dryland-farming techniques and does not require irrigation.

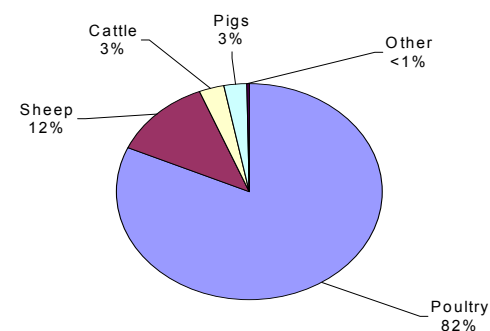
Livestock farming is practised most in the upper catchment area of the Diep River. Livestock farmed are mostly cattle, chicken, and sheep. Runoff from the farmlands in the catchment contains fertilisers and pesticides. These add to the nutrient levels in the river, for example, adding dissolved nitrate, ammonia, and reactive phosphate. Runoff from activities especially dairy farming along the Diep River also adds nutrients to the system.

Figure 8. Livestock types within the Diep River Catchment

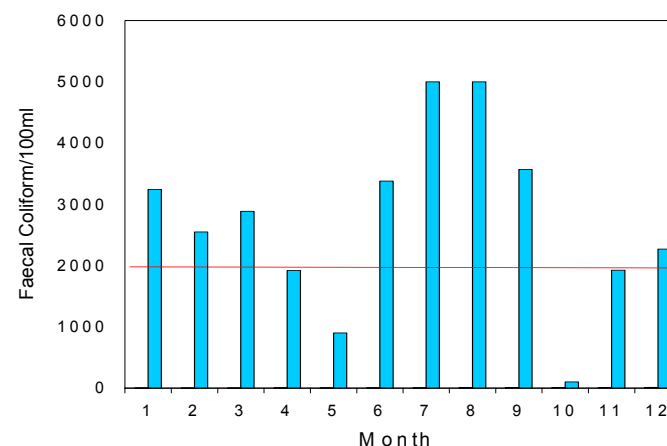
Figure 13. A Plot of Faecal Coliform in units / 100ml at the Diep River Estuary Monitoring Station (1995 to 2000)

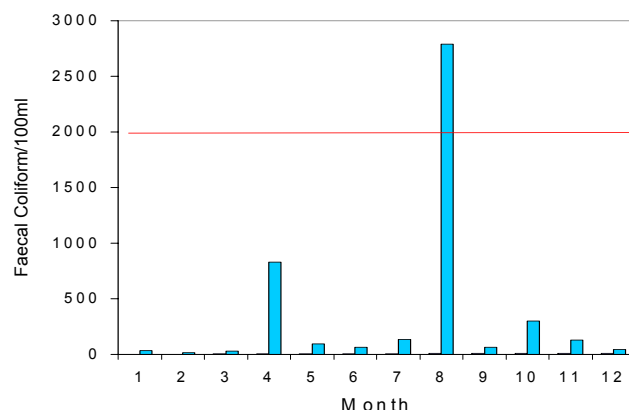
Figure 14. A plot of Faecal pollution Coliform in units / 100ml at the Milnerton Lighthouse Monitoring Station (1995 to 2000)

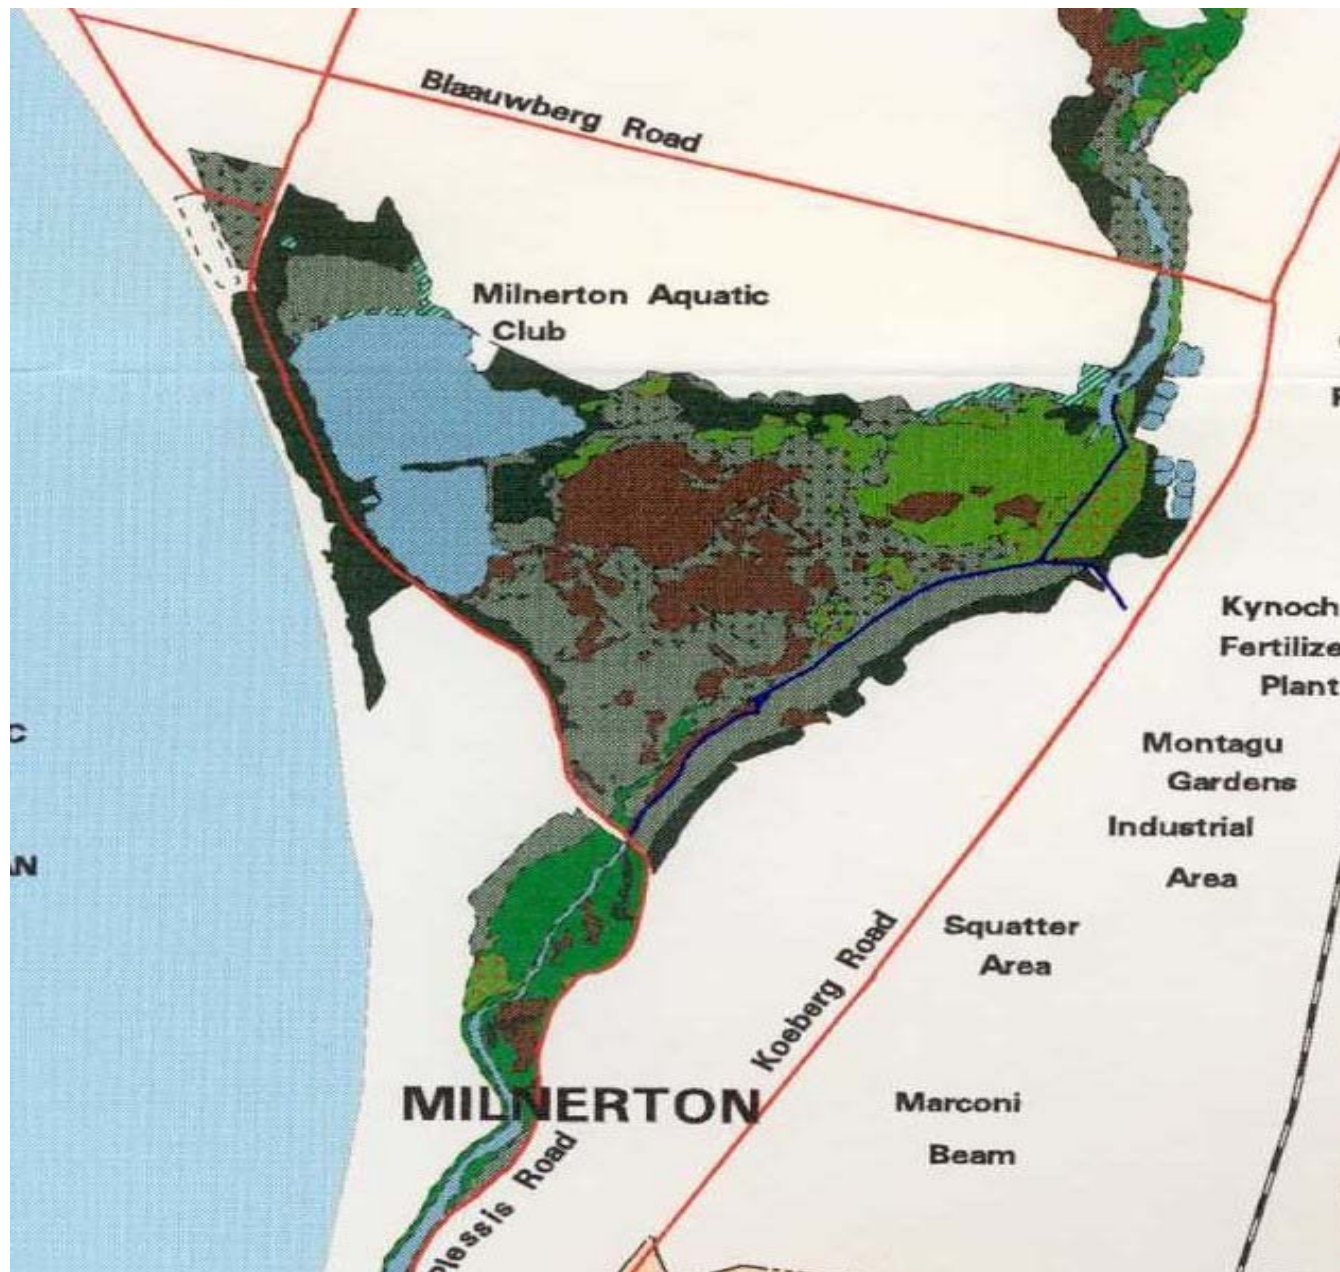
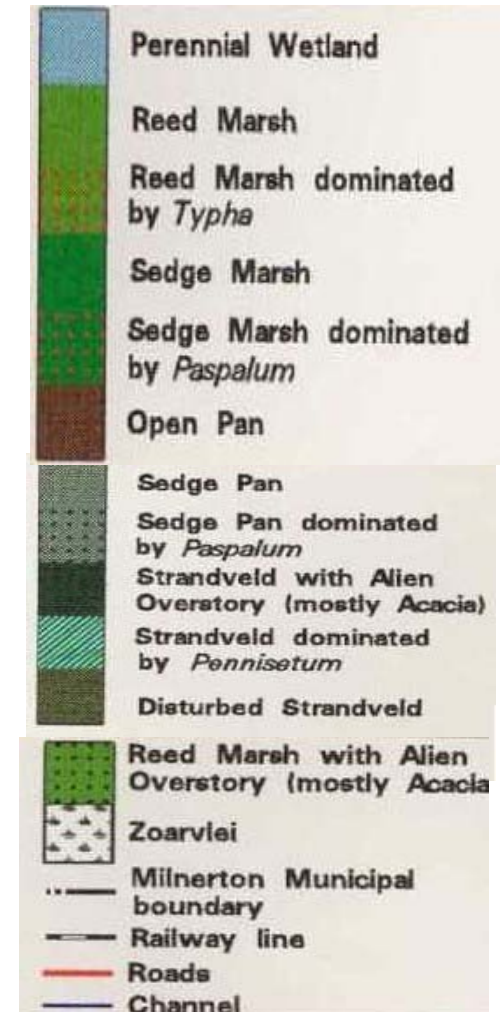
Fig. 18 PLANT COVER IN THE ESTUARY

A. Perennial wetland: It has scant aquatic vegetation. Surprisingly, the characteristic aquatic sea grass appeared to be absent at the estuarine end of the study area. The only other angiosperm in evidence appeared to be fonteingras (identification in need of confirmation). Abundant (mainly microscopic) algae and phytoplankton are also an undoubtedly important component of the ecosystem processes.

- B. Reed Marsh: This community consists of virtually monospecific stands of fluitjiesriet invaded in parts by monospecific intrusions of bulrush. Where the stands are more open, the alga like aquatic fonteingras may be present (identification to be confirmed) at the base of this tall reed. Occasional clumps of lower reeds are also to be found mainly on the fringes. Medium height reeds, such as matjiesgoed and papgras, show sporadic occurrence on the fringes of the Phragmites stands. This is the tallest of the community types, one to four metres in height.
