WATER QUALITY IN THE ELANDS RIVER AND THE LINDLEYSPOORT DAM, 2001

TITLE: WATER QUALITY IN THE ELANDS RIVER
AND THE LINDLEYSPOORT DAM, 2001

REPORT NUMBER: N/A220/05/DEQ/0201

PROJECT: Eutrophication Project

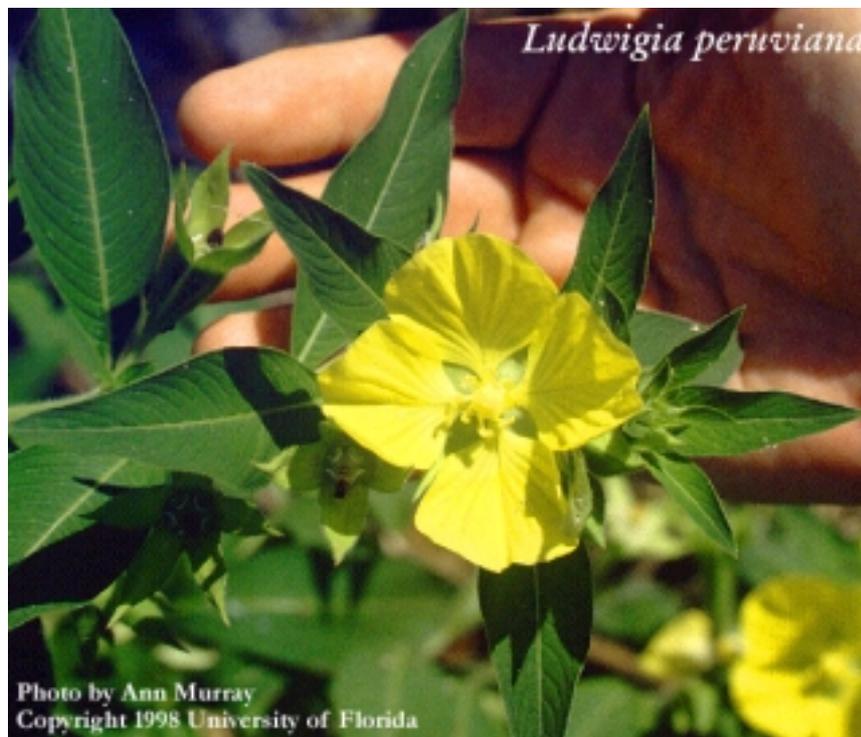
The macrophyte growth sample taken at the inflow of the Lindleyspoort Dam was identified as water primrose (*Ludwigia* species) (Figure 3). There are many shrubby species, some large and some small. They commonly grow in shallow marshy areas, borrow pits and ditches. They flower in all seasons except winter.

Water primroses grow to five or six feet tall. Stems are branched and sometimes have long hairs. The leaves are ovate to lance-shaped, and up to six inches long. Leaves are covered on both sides by minute soft hairs. Most water primroses have conspicuous yellow flowers. The flowers have four or five petals.

Figure 3. A water primrose (*Ludwigia peruviana*) (Photo from WWW1, 2001)

- 6.1 Farmers downstream of the Lindleyspoort Dam should be informed of the fact that the water quality of the Lindleyspoort Dam does not pose a hazard to moderately sensitive crops.
- 6.2 The monitoring of the macrophytes should be done on a regular basis, so that management options (e.g. chemical control, available biological control or integrated control) can be considered when the macrophytes become a problem in the impoundment.
