# TOXIC ALGAL INCIDENT IN THE GROOTDRAAI DAM, 2001

**TITLE:** TOXIC ALGAL INCIDENT IN THE  
GROOTDRAAI DAM, 2001

**REPORT NUMBER:** N/C110/02/DEQ/0401

**PROJECT:** Eutrophication Project

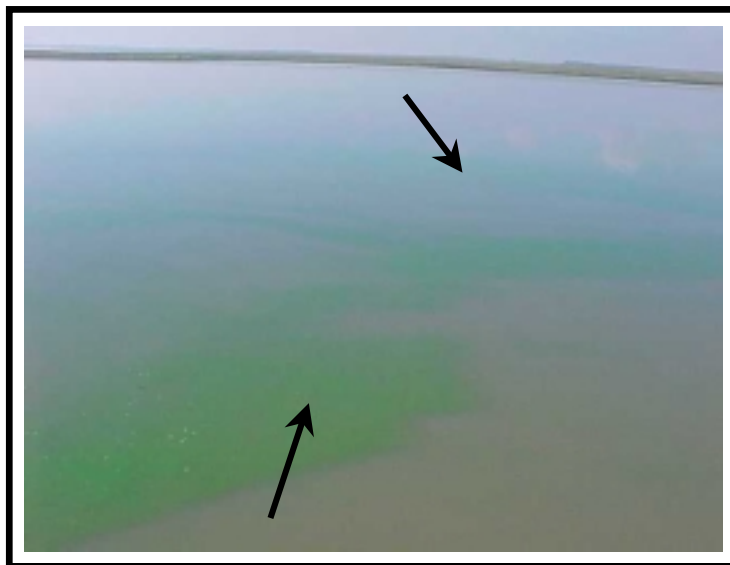
The Grootdraai Dam had a clear phytoplankton (algal) bloom that was established at the dam wall (Figure 3 A & B) on the day of the investigation. The main basin only showed streaks of algal biomass at the surface, while the rest of the water showed the high turbidity present in the water column (Figure 4).

Figure 4. The water surface of the main basin of the Grootdraai Dam showing the streaks of the phytoplankton bloom.
