# **DOCUMENTATION OF THE SEPTEMBER 1987 NATAL FLOODS**

TECHNICAL REPORT TR 139

DOCUMENTATION OF THE SEPTEMBER 1987 NATAL FLOODS

March 1989

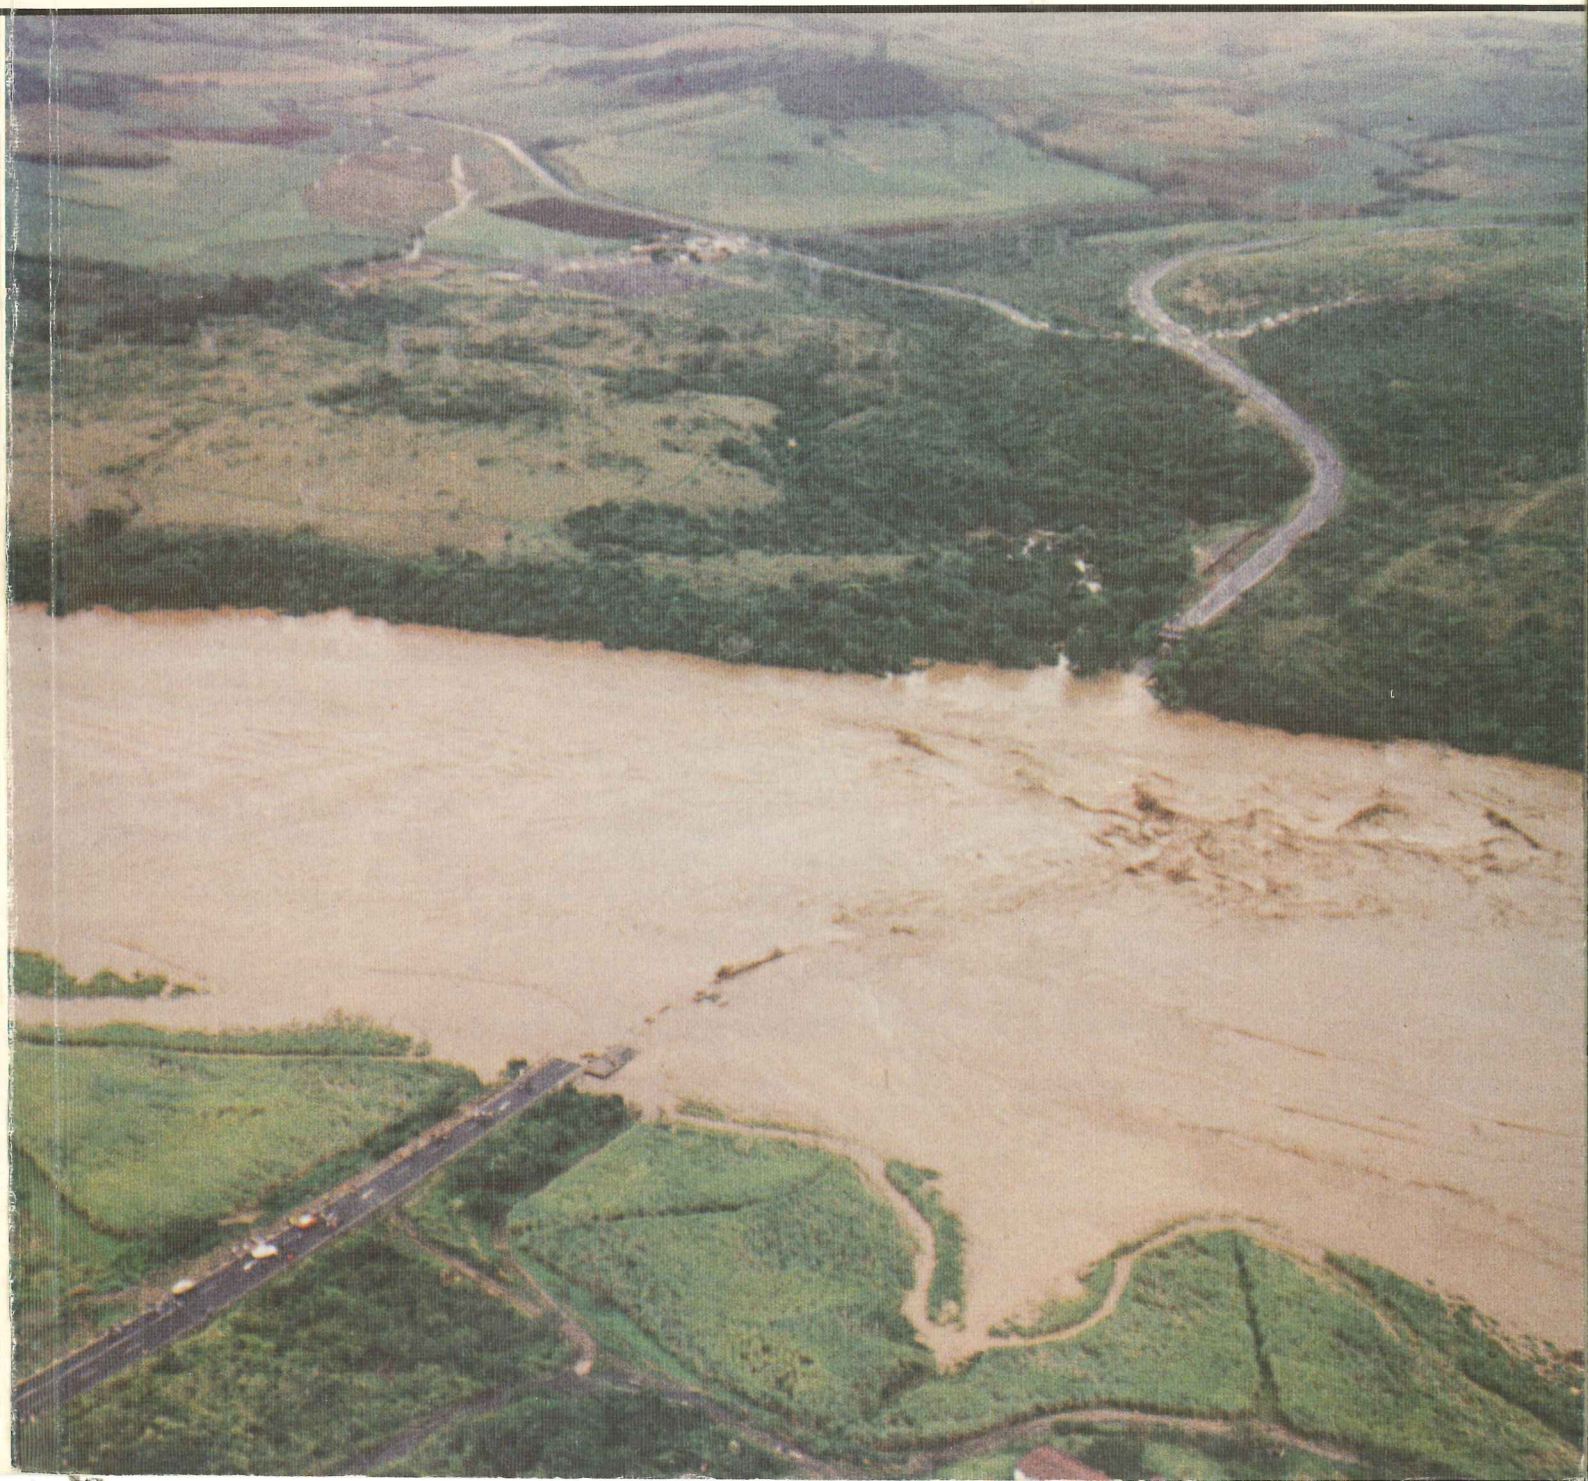
Cover: Tugela River showing the failed John Ross bridge  
on 30 September 1987

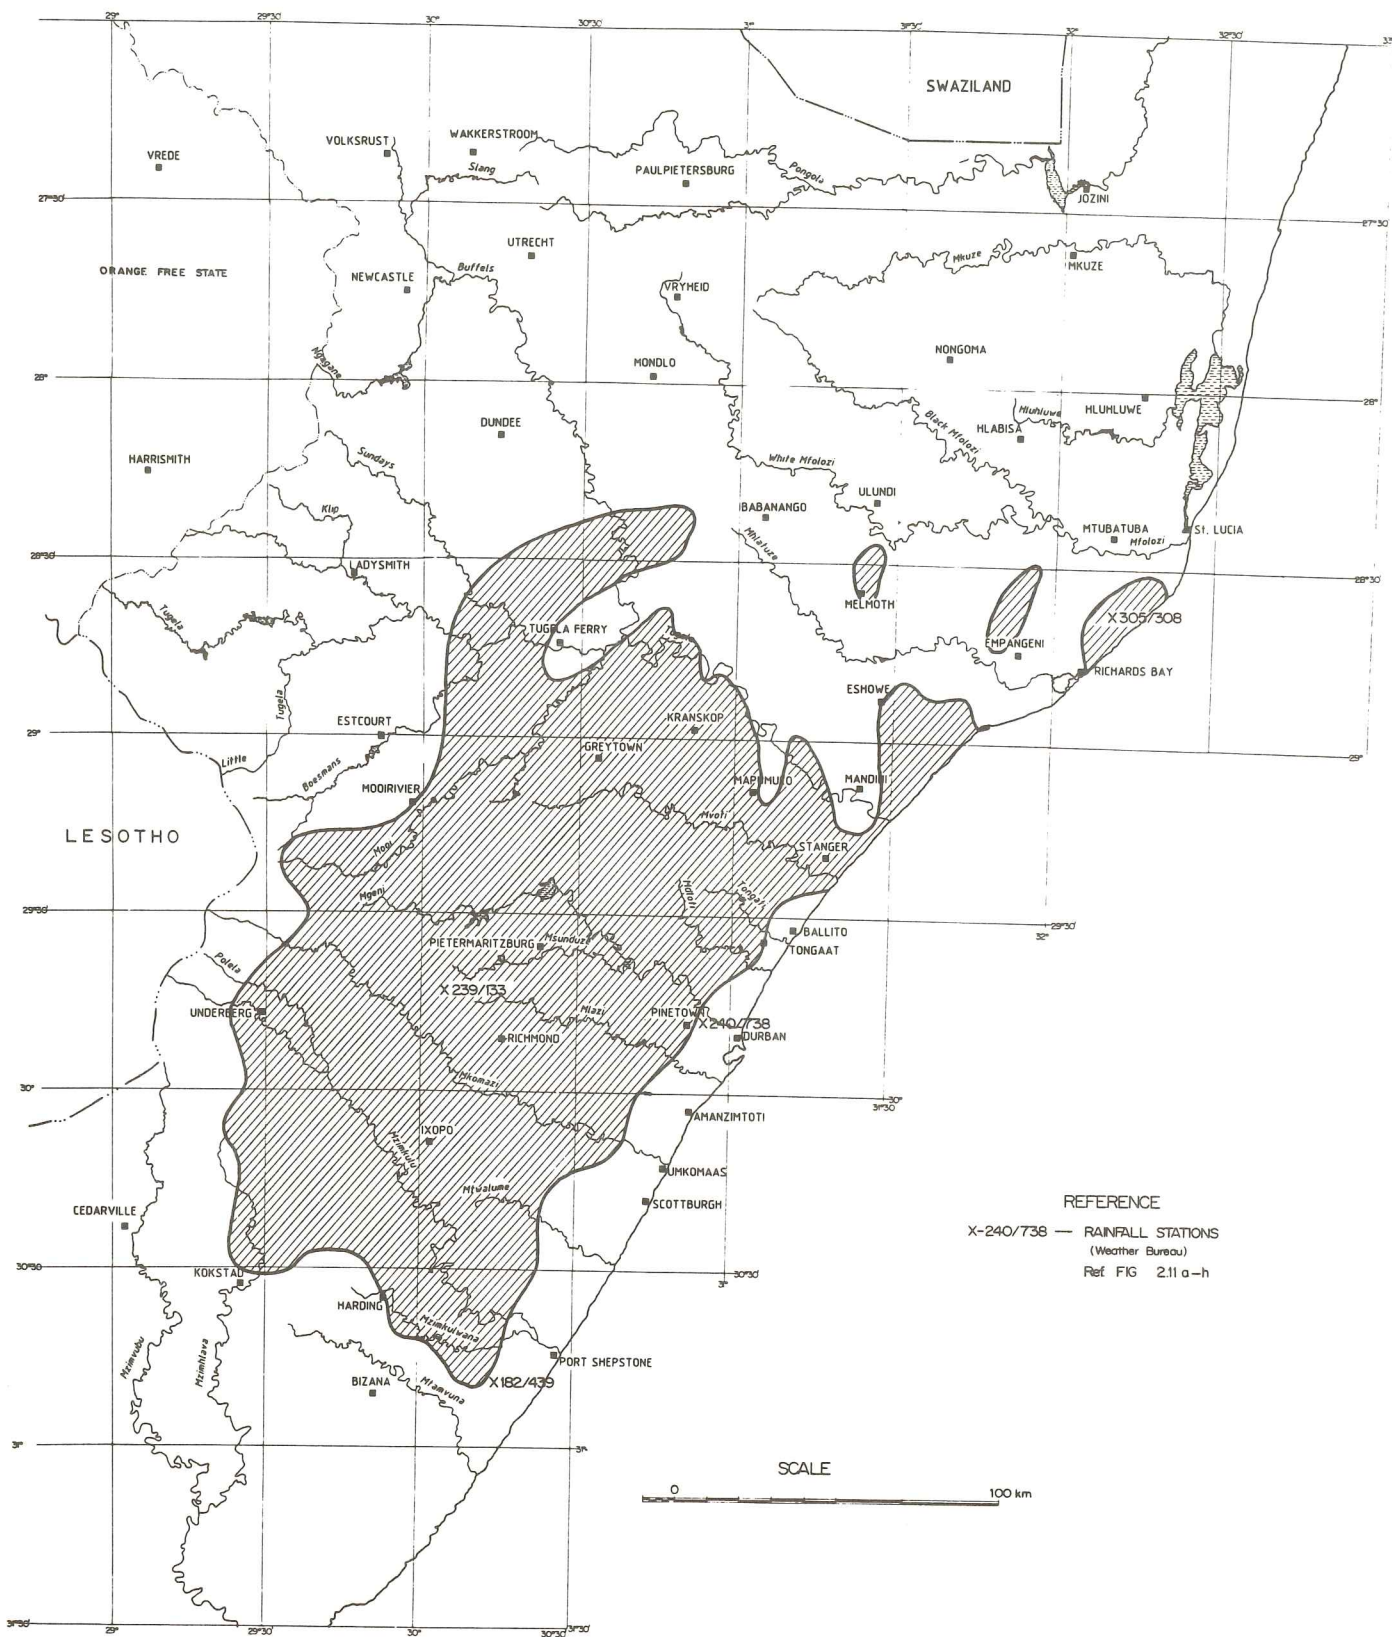
FIG. 2.10 AREA WHERE THE 3-DAY RAINFALL DURING THE STORM OF SEPTEMBER 1987 EXCEEDED THE 3-DAY 200 YEAR POINT RAINFALL

Fig. 2.10 shows the area where the maximum 3-day rainfall during the storm of September 1987 exceeded the 3-day 200-year point rainfall indicated by the shaded part of the map. This area measures some 21 740 km<sup>2</sup> which is somewhat less than the area determined for the flood caused by Cyclone Domoína using the same parameters: that area was calculated to have been 32 000 km<sup>2</sup> (6). The use here of the 3-day storm rainfall is valid since the majority of the total precipitation in fact fell during a period of 3 days. The 3-day 200-year point rainfalls have been extracted from Adamson's analysis of Southern African storm rainfall (4).

The consequence of this is that these commonly used distribution curves may suggest a longer return period for a given rainfall by failing to take cognizance of outliers, thus implying that the recorded rainfall is more extreme, or rare, than in reality. This, in turn, suggests that the area where the 3-day rainfall exceeded the 3-day 200-year value (Fig. 2.10) is, in reality, much smaller.

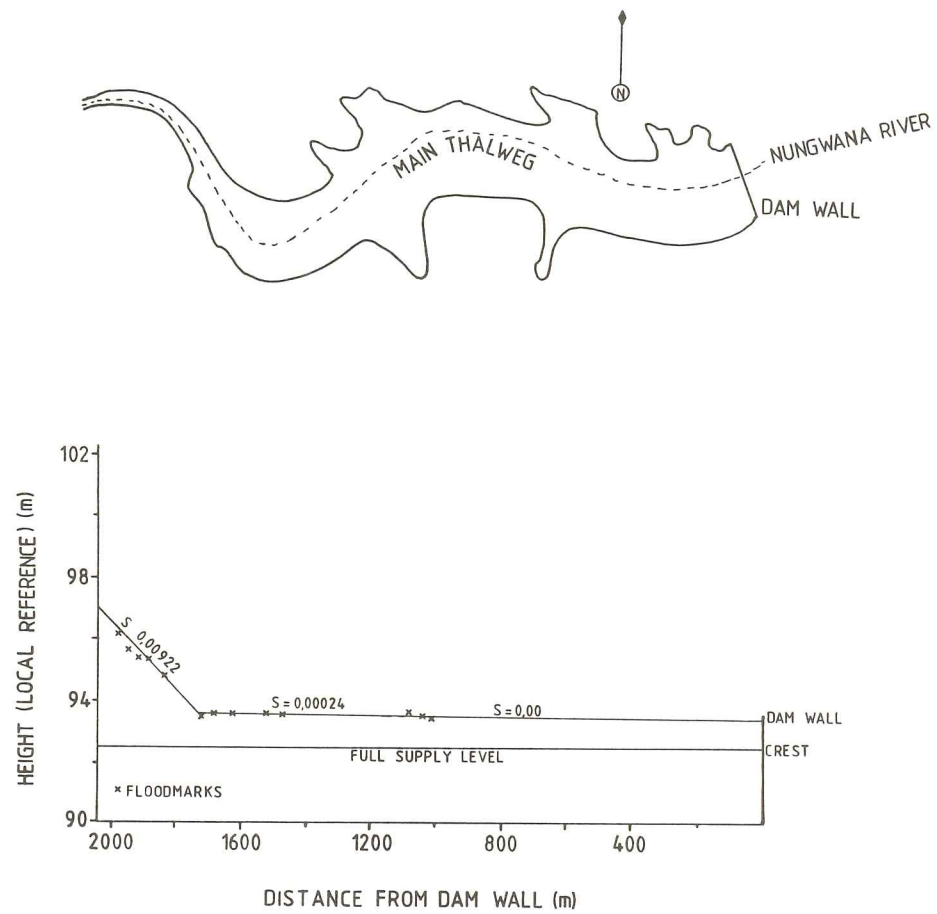
FIG4.4 RESERVOIR BASIN FLOOD LINE SURVEY AT SITE 18b NUNGWANA DAM

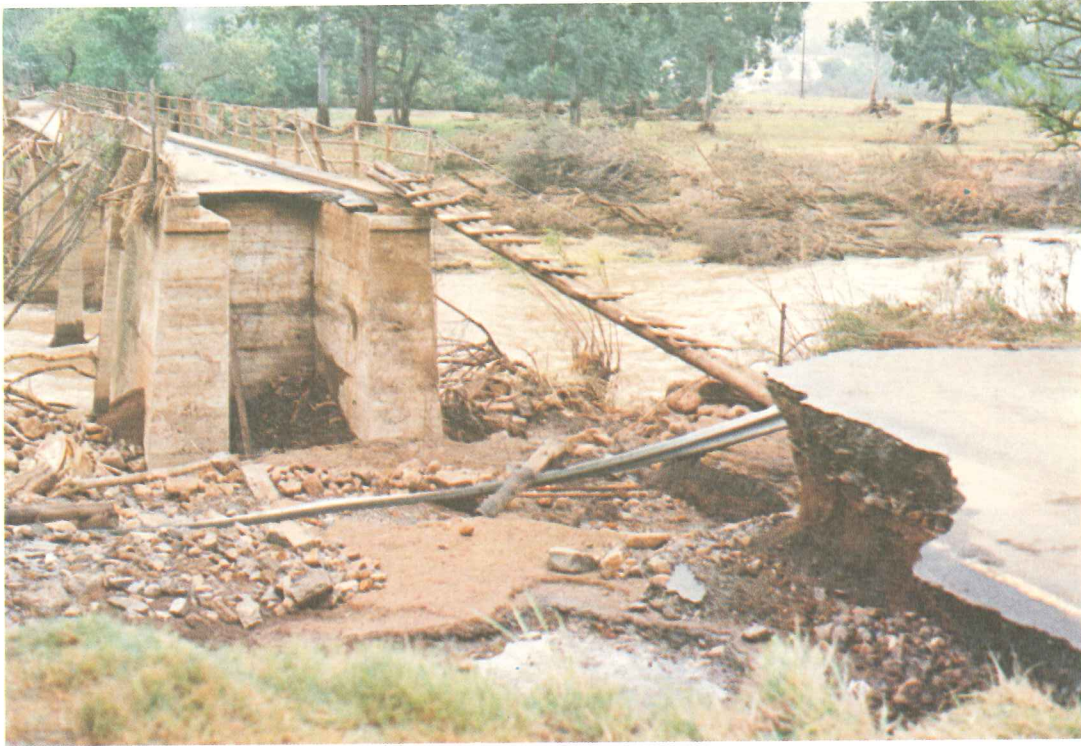
33. Single carriage bridge downstream of Albert Falls Dam, on the Mgeni River. Although both approaches were breached, the main structure did not suffer any significant damage

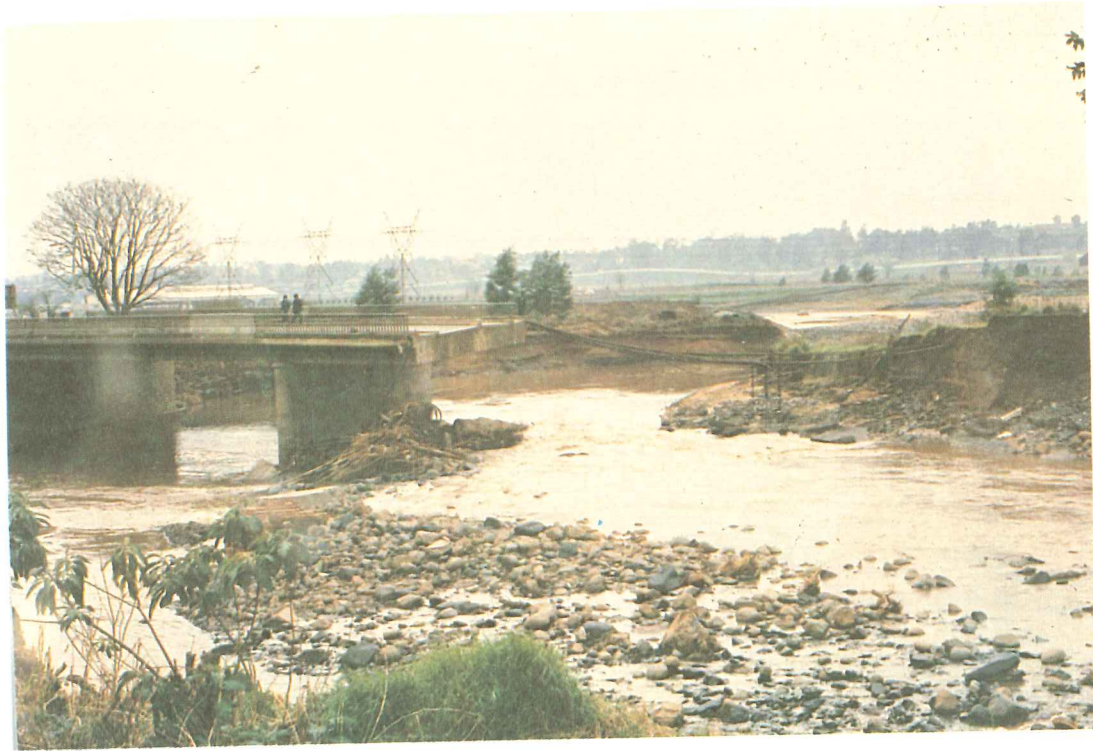
37. Msunduze River: Edendale bridge in Pietermaritzburg, failed due to river course change

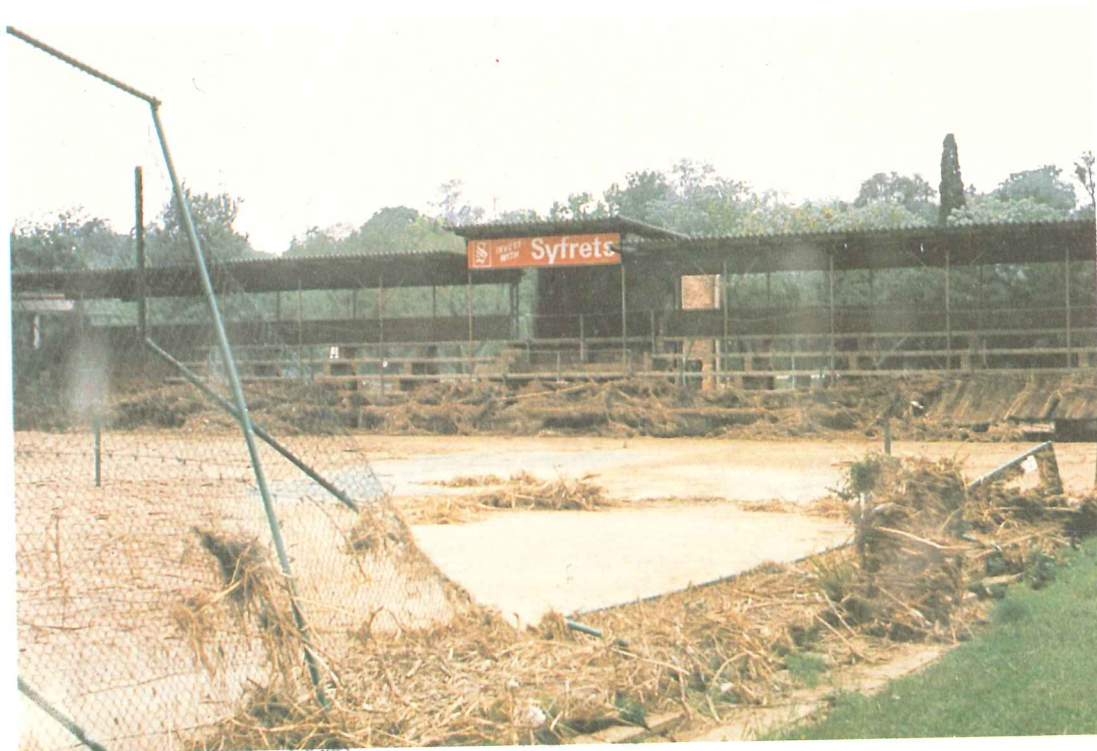
38. Damage to main tennis court in Pietermaritzburg, flooded by the Msunduze River

The floods that ravaged the central and southern parts of Natal from 28 to 20 September 1987, were among the most devastating to have occurred in South Africa to date. The destruction of property was the most catastrophic, in that it affected major metropolitan areas. Some 388 people were killed and 140 000 were left homeless. Damage to agriculture, communications, infrastructure and private property amounted to R 400 million (Photos 38, 40, 46 and 47).

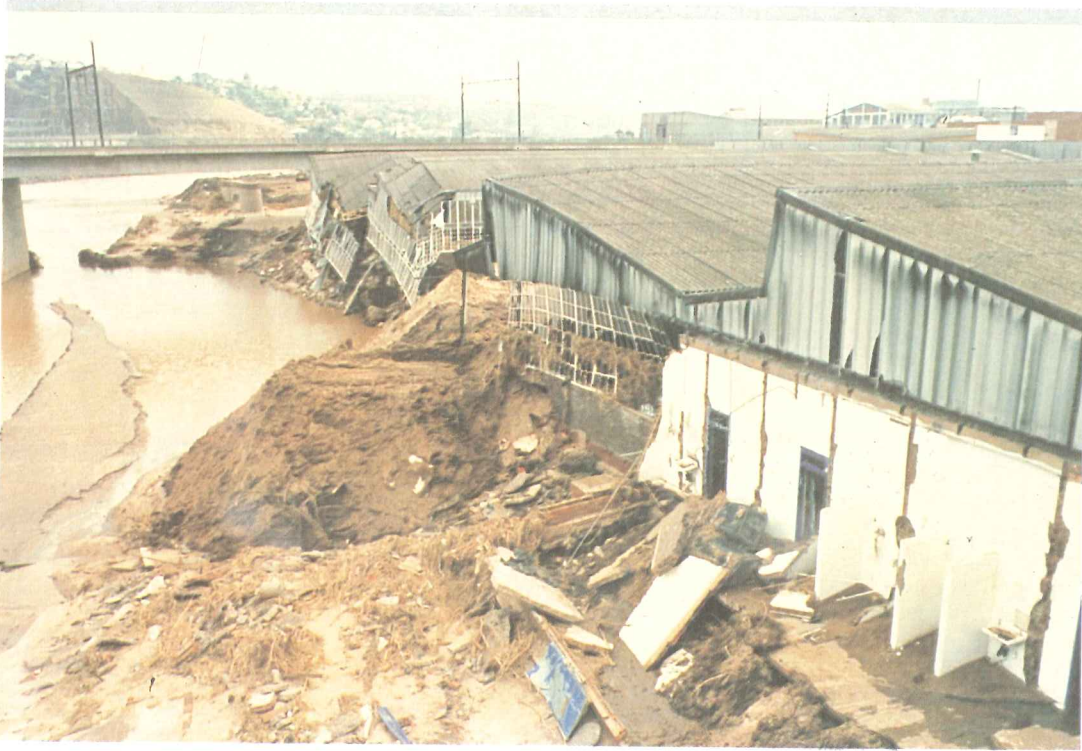
47. Damaged factory premises adjacent to the Mgeni River. Damage due to collapse of river banks. Deposition in factory was approximately 2m deep

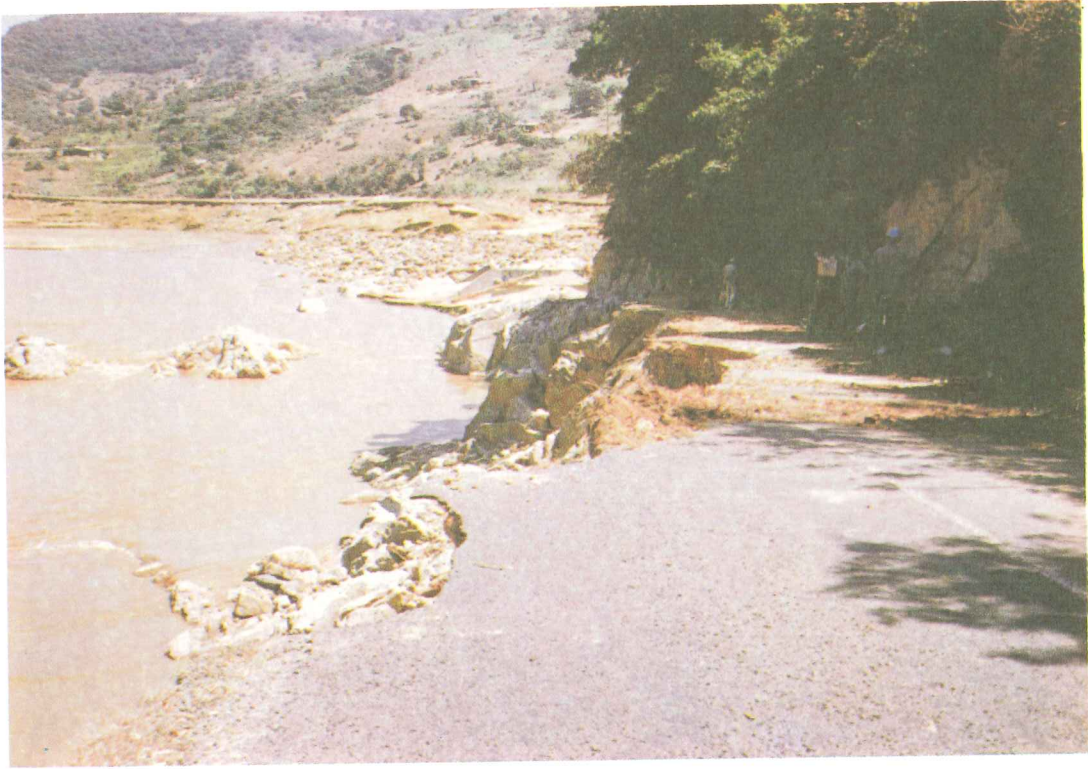
53. Mvoti River: lateral bank erosion on the outside of a bend, destroyed the road

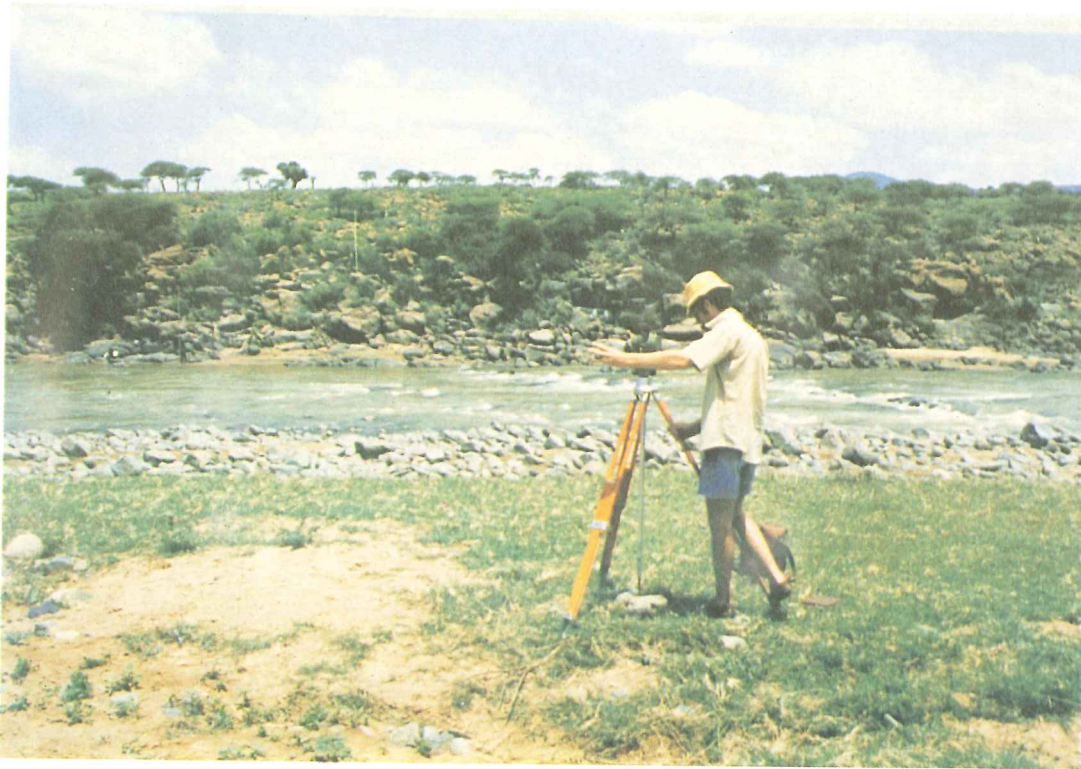
59. Mooi River: Site 68, at Keates Drift, view of cross section 3 from left bank, of an excellent slope-area site. Representative roughness = 0,7 m

Photos 20, 28, 31, 35, 41-42, 44, 50, 52, 54, 58-59, 64, 69 and 71-73 illustrate the conditions at some of the slope-area sites.

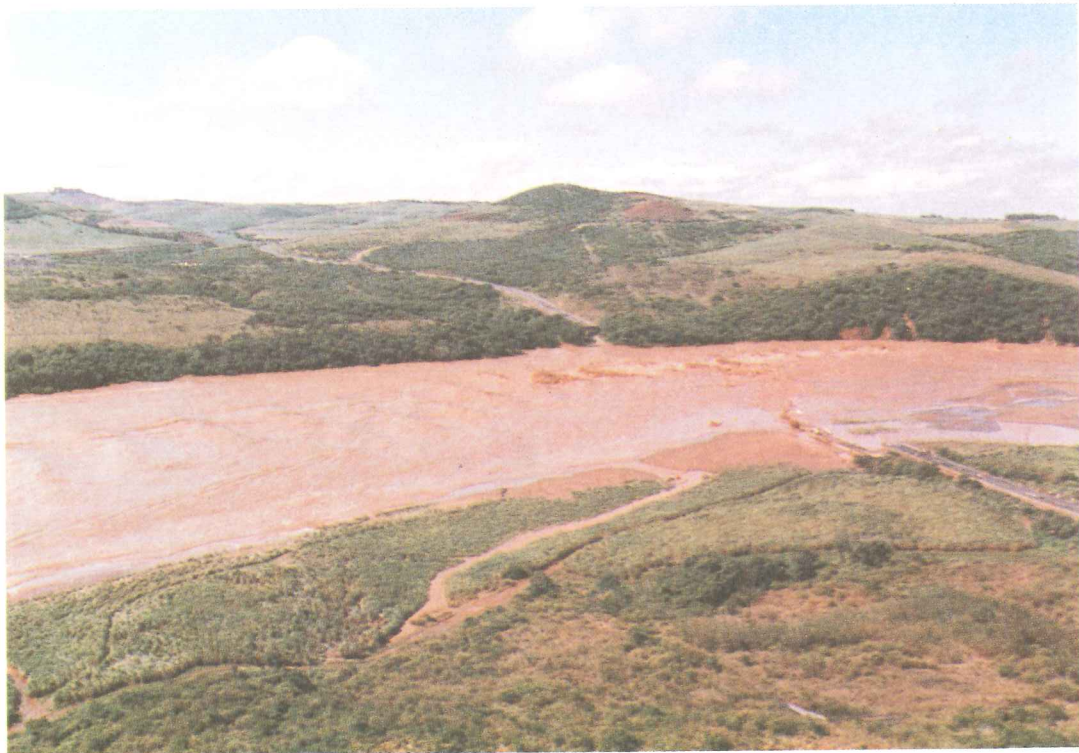
62. Tugela River: one day after the failure of the John Ross Bridge on 30 September 1987, during receding flood (SATS)
