TR122

# DOCUMENTATION OF THE 1984 DOMOINA FLOODS

Technical Report TR 122

Subdirectorates Flood Studies

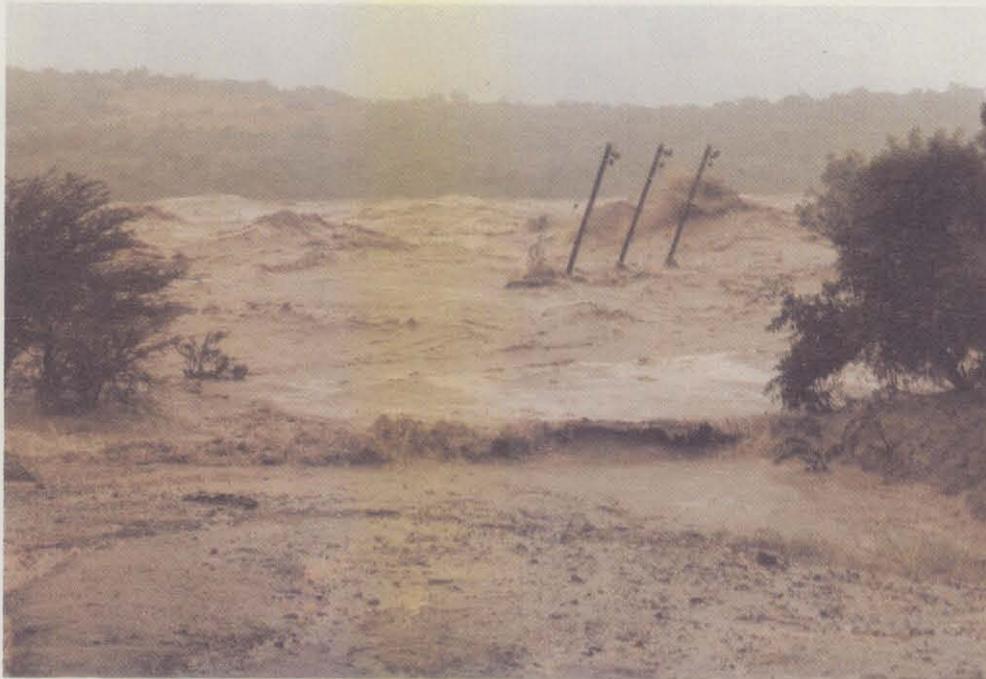
3. White Mfolozi River: flood peak conditions with waves of ~ 2 m near Site 12  
(P. Berridge, KwaZulu, Department of Agriculture and Forestry)

In estimating the absolute roughness in the main channel of rivers where extreme floods occurred, the existence of huge surface waves during peak flow proved to be the most reliable help. Photographs (3, 38), video-films and eye witnesses have confirmed that during high flood conditions in the Mfolozi, Mkuze and Pongolo Rivers waves of 1 to 3 m height were characteristic in the main channel in the regions of maximum velocities. (At or near fixed obstacles, such as bridges or weirs, the wave height reached in some cases 5 m (Photo's 5, 6, 28)). The basis for the estimation of absolute roughness is provided by the specific energy curve which defines the changes in water level that occur if bed elevation changes locally [11]. In practical terms this means that in subcritical flow, surface waves are an indication of bottom roughness of nearly the same height. In the case of supercritical flow the bottom roughness is 0,5 to 0,6 times the height of the surface wave.

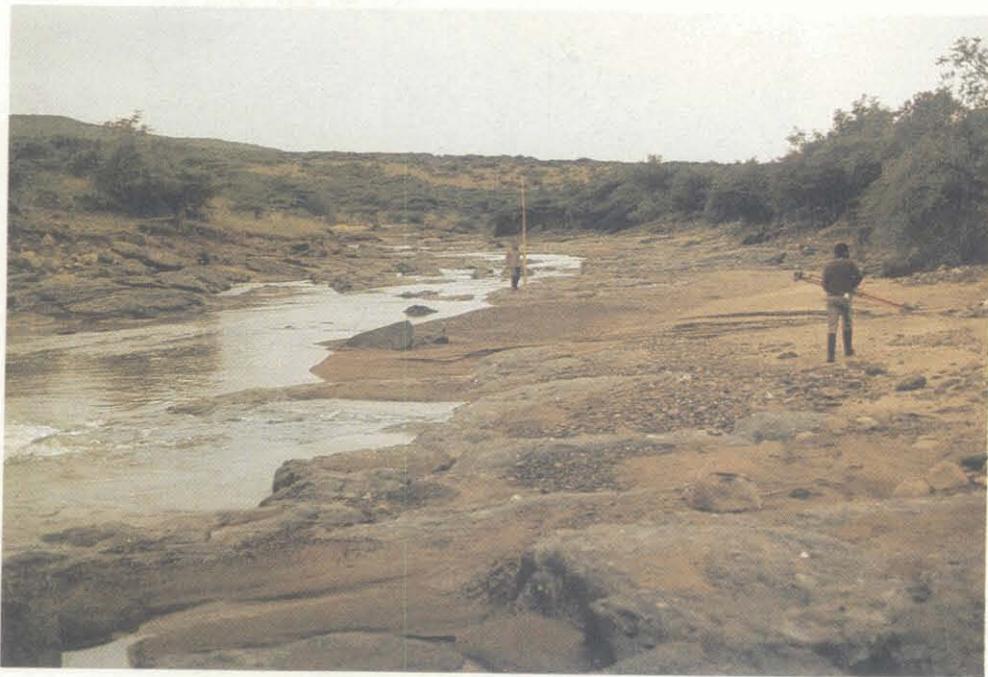
10. Bizamkulu River: channel roughness  $\sim 0,75$  m, Site 15

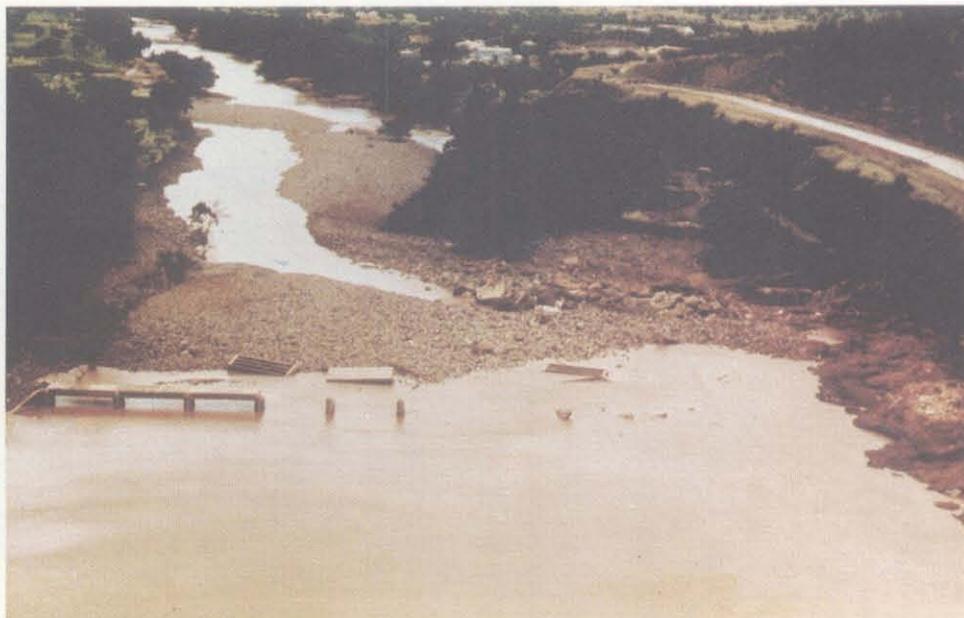
42. Pongolapoort Dam: downstream view of jet plunge pool with damage caused by release, Site 32  
(W.S. Croucamp, Chief Engineer Design, Department of Water Affairs)

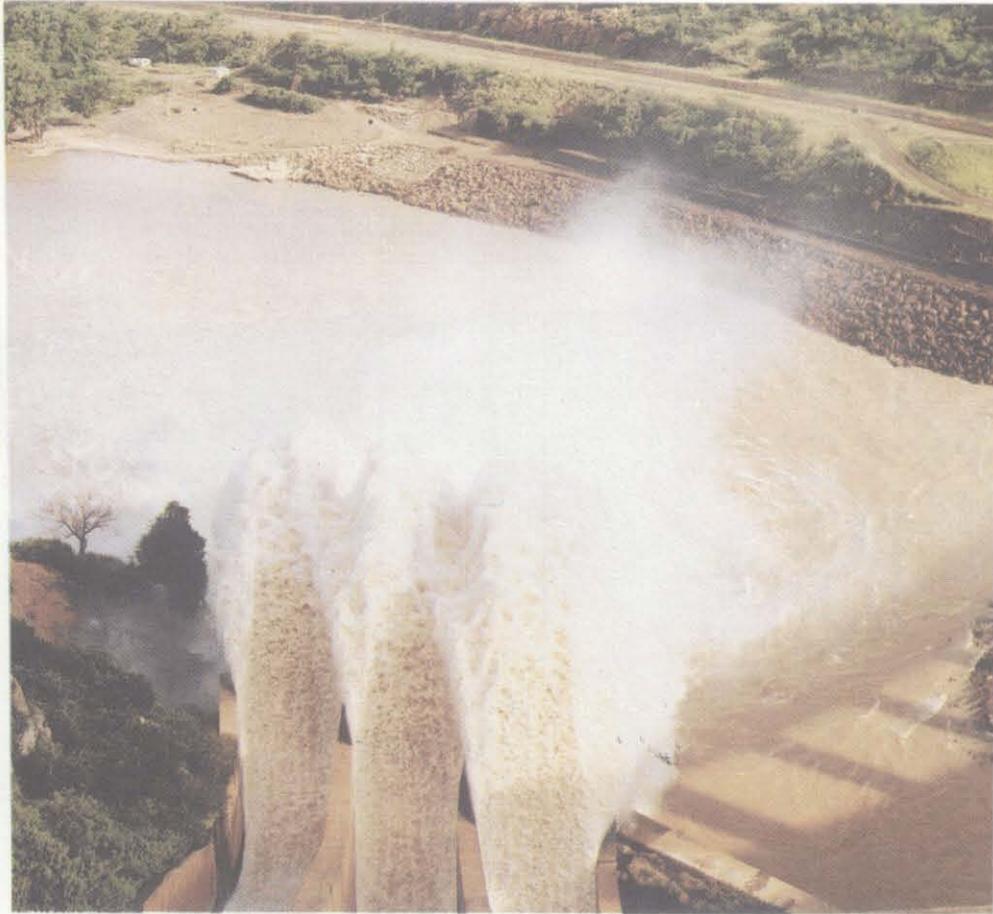
43. Pongolapoort Dam: testing of modified chutes with a release of  $400 \text{ m}^3/\text{s}$  and rip-rap protection of damaged right-bank, Site 32 (D.R. Clark, Engineer, Department of Water Affairs)

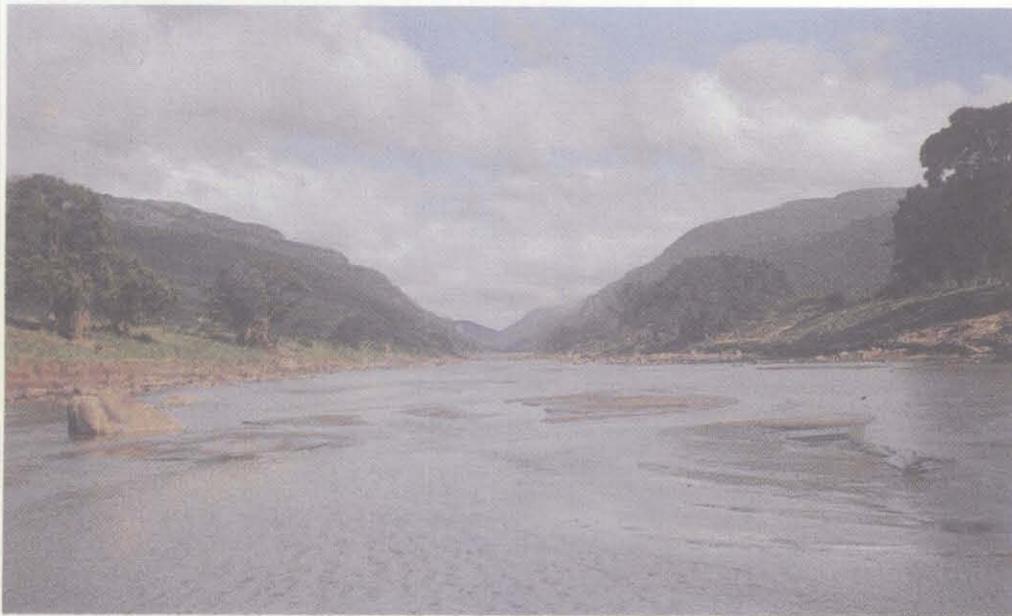
44. Ngwavuma River: upstream view of an ideal slope-area reach, Site 33
