CONTRACT NO. WP 10592

RIVER HEALTH PROGRAMME IN CROCODILE WEST MARICO WMA

TECHNICAL REPORT 3

JULY 2015

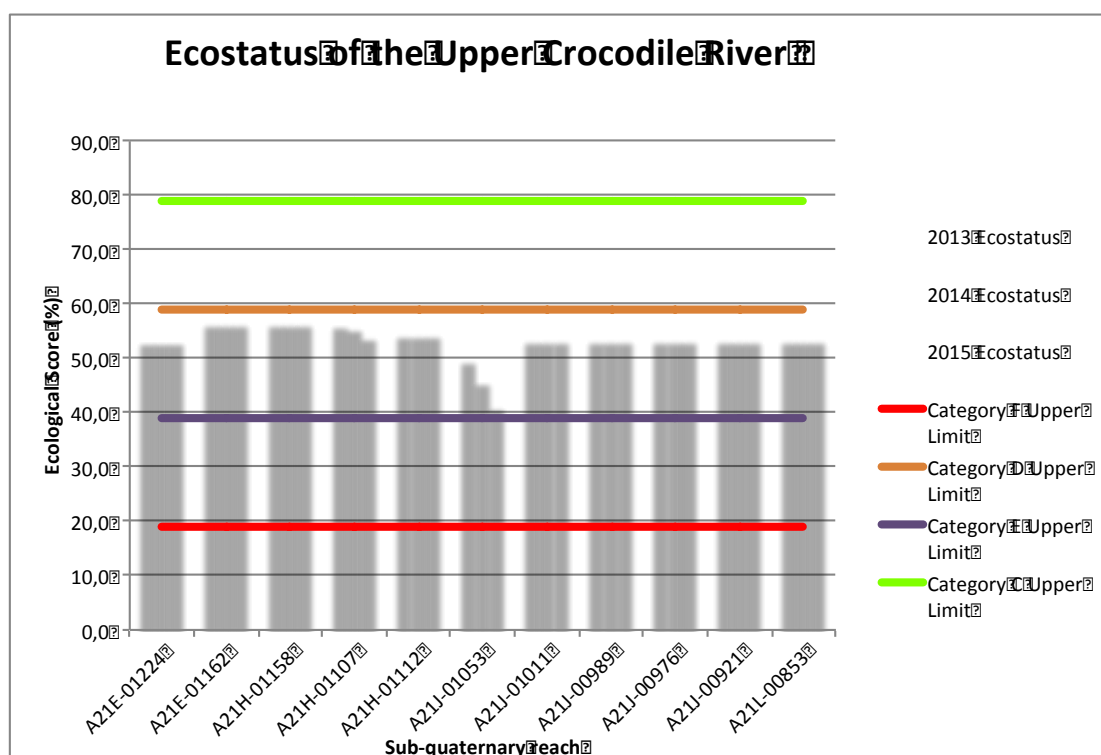
FIGURE 5-2. ECOSTATUS OF THE UPPER CROCODILE RIVER FROM UPSTREAM (LEFT) TO DOWNSTREAM (RIGHT)

The overall ecological health of the Upper Crocodile River is largely modified (Figure 5-3). It can be seen that the condition of the river deteriorates as it flows further into the sub-area, due to various land-use activities. There is a large loss of natural habitat, biota and basic ecosystem functions. The river is in a D ecological state. The sites monitored, namely A21H-01107 (in SQR A2CROC-HARTB) and A21J-01053 (in SQR A2CROC-MOUNT) (Figure 5-2) show a steady decline in ecological condition over the 3 years of sampling.

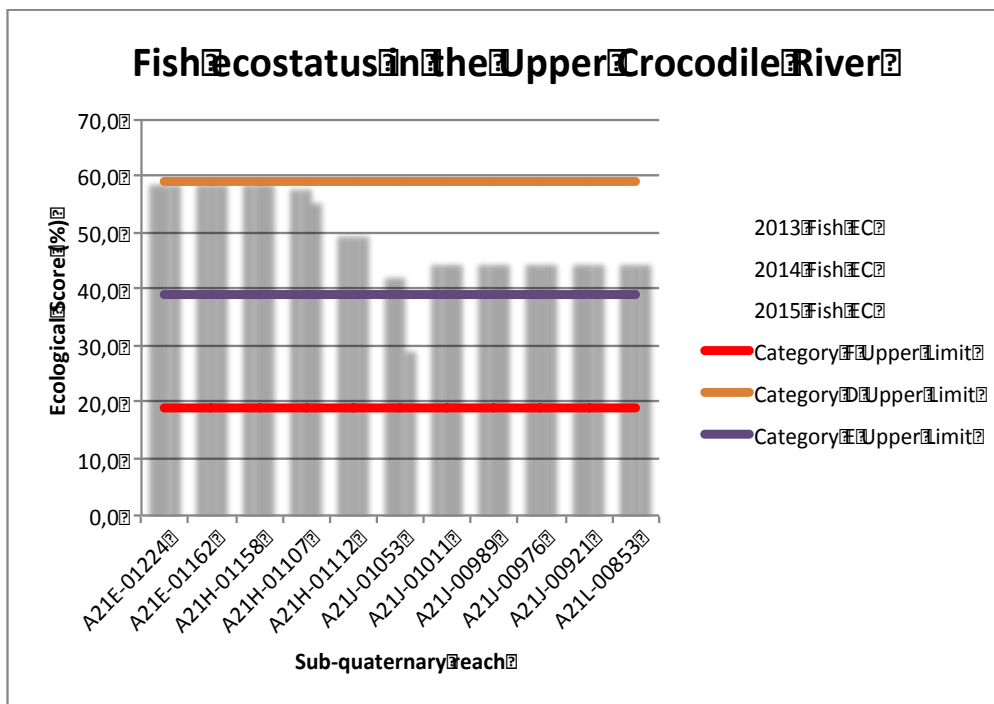
FIGURE 5-4. ECOLOGICAL STATE OF THE FISH IN THE UPPER CROCODILE RIVER

An assessment of the biota and instream conditions was conducted at the 2 monitoring sites. The results are shown in Figure 5-4 - Figure 5-7. From these figures it is clear that the biological condition of the river is consistently deteriorating . The fish in particular show a marked decline, particularly at the reach downstream of the Hartebeespoort Dam (A21J0-1053). The instream condition is bordering on unsustainable. Indications are that it is seriously modified, with extensive loss of natural habitat, biota and basic ecosystem functions.

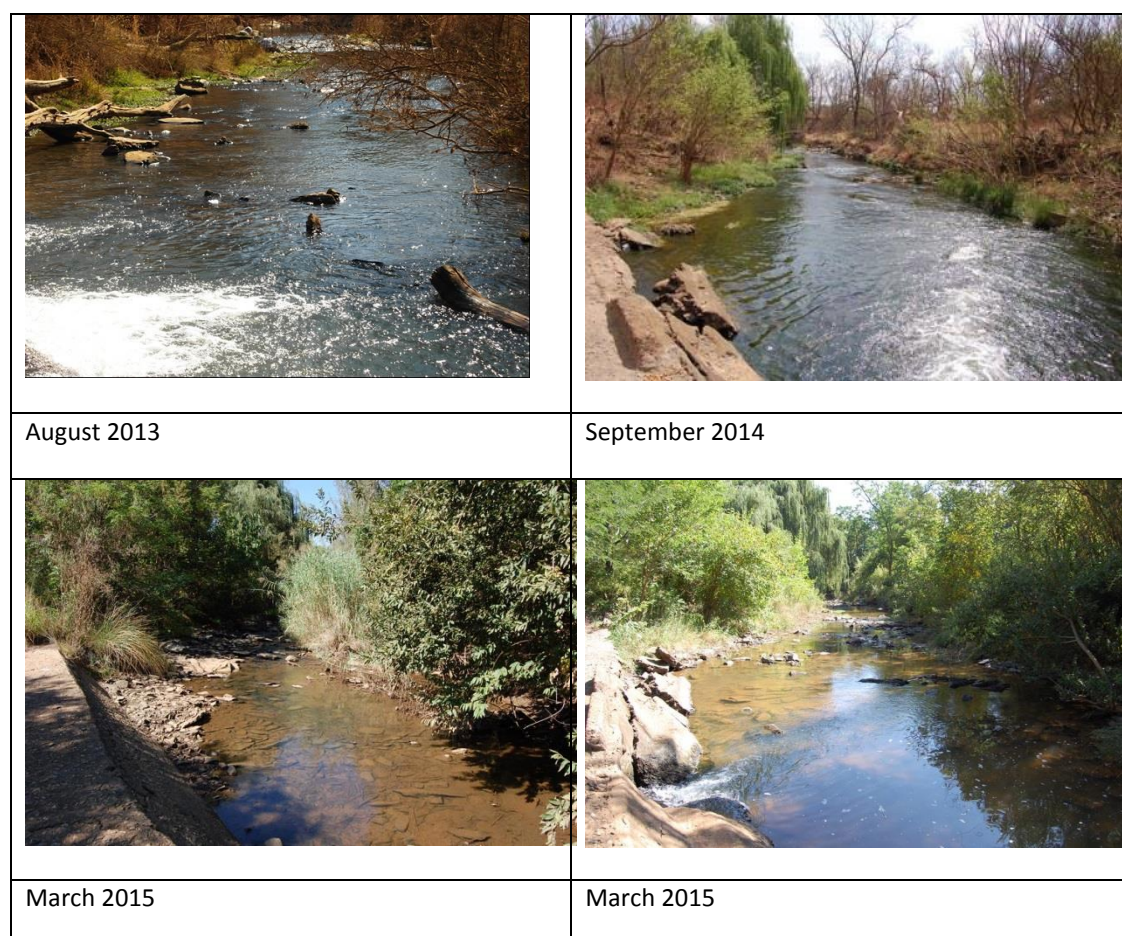
FIGURE 5-29. A2MAGA-HARTE (A21F-01116)

Excessive filamentous algae growth was observed during September 2014 (knee deep in areas) resulting in extreme habitat loss. Less filamentous algal growth was observed during the March 2015 fish survey, but the habitat conditions remain the same as for the previous surveys.

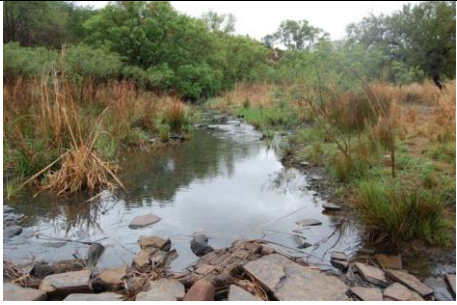
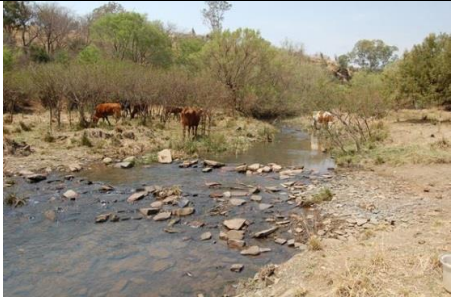
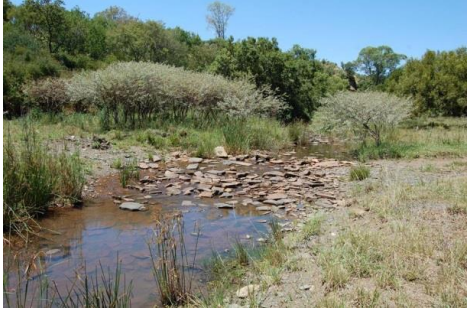
FIGURE 6-8. A2ELAN-KLIPB (A22A-01001)

August 2013	September 2014

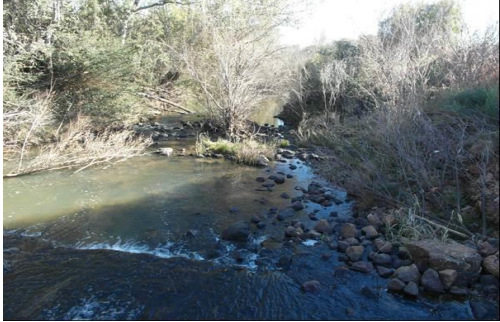
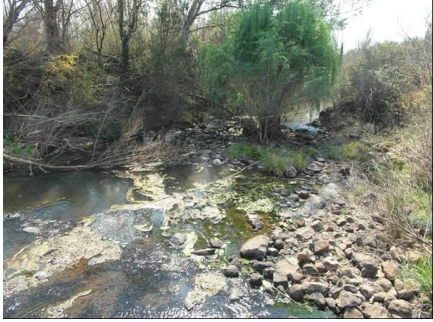
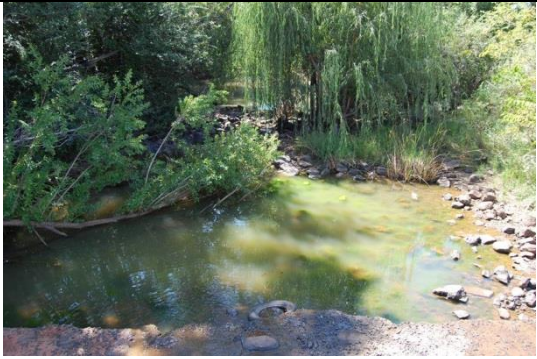
FIGURE 6-9. A2ELAN-NOOIT (A22A-01001)

June 2014	September 2014 (After a sewage spill)

The ecological water quality at Site A2 ELAN-NOOIT is in a category C (Moderate quality) with a moderate amount of organic content in the system (26 %PTV) as reflected by the presence of dominant taxon *Gomphonema parvulum*.

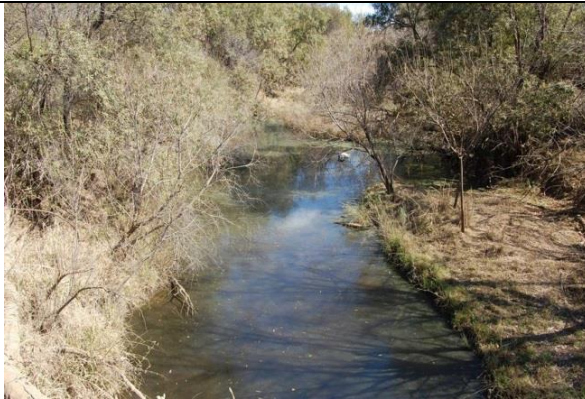
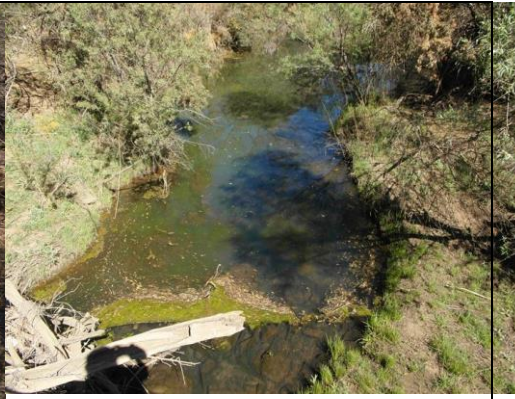
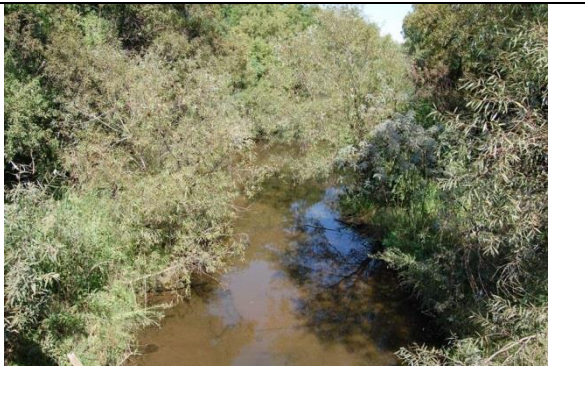
FIGURE 6-10. A2ELAN-BESTE VISUALS

<p>August 2013</p>	<p>September 2014 (algal growth)</p>

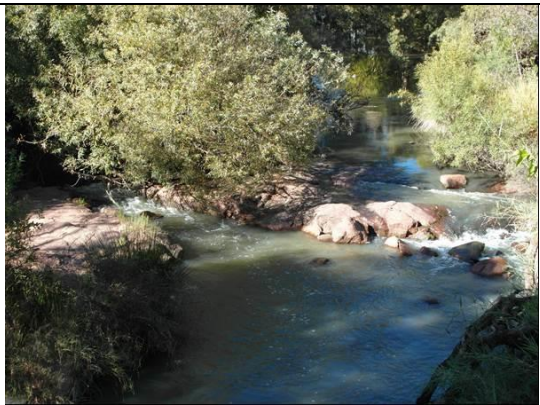
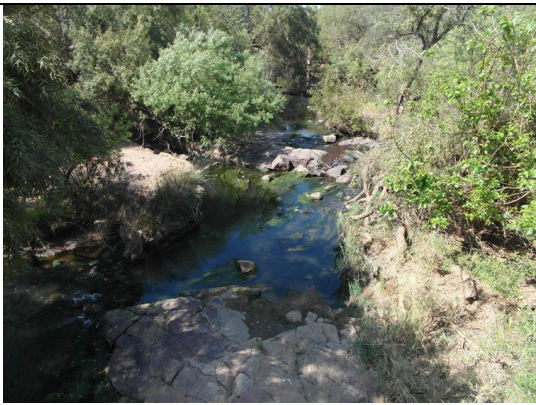
April 2013	September 2014 (Filamentous algae)

The water quality at Sites A2PIEN-DINOK is, according to OMNIDIA, classified as an Ecological quality B/C (Good quality). Yet the species compositions at the site is dominated by taxon *Cocconeis placentula* var. *placentula* a species indicative of heavy nutrient enrichment when prevalent. Also recorded is dominant *Amphora pediculus*, *Navicula cryptotenelloides* and sub-dominant *Navicula tripunctata* and *Navicula gregaria* which combined with *Cocconeis placentula* var. *placentula*, suggest impacts related to eutrophication, often a result of fertiliser runoff and urban wastewaters. For reasons outlined above, the water quality at this site should be allocated a category D (Poor quality).

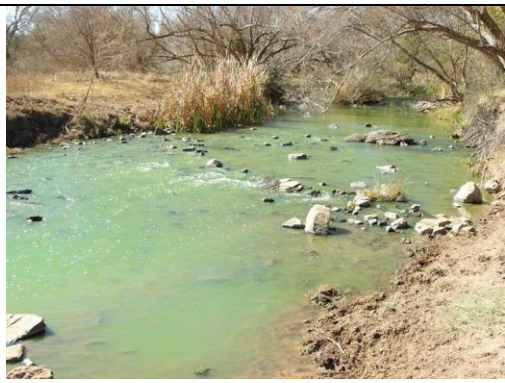
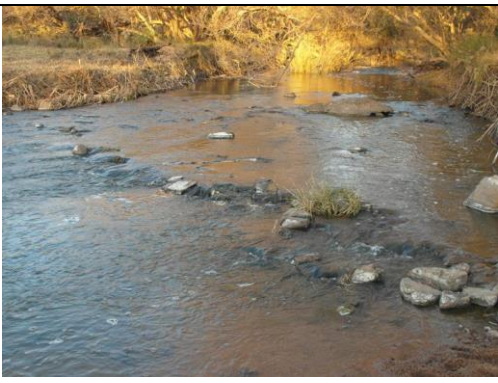
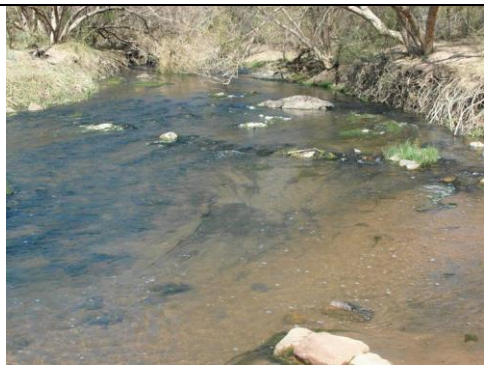
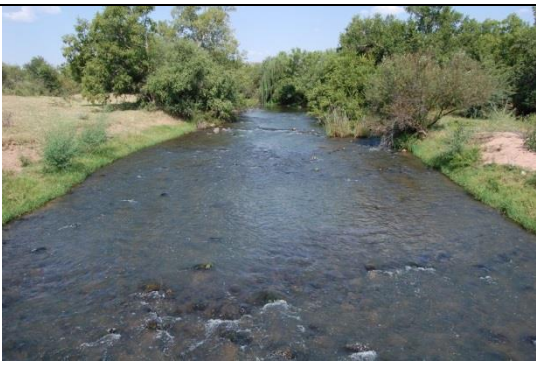
FIGURE 7-10. A2PIEN-BUFFE (A23L-00706)

August 2013 - Note the green colour of the water	June 2014

September 2014 (Filamentous algae present)	March 2015

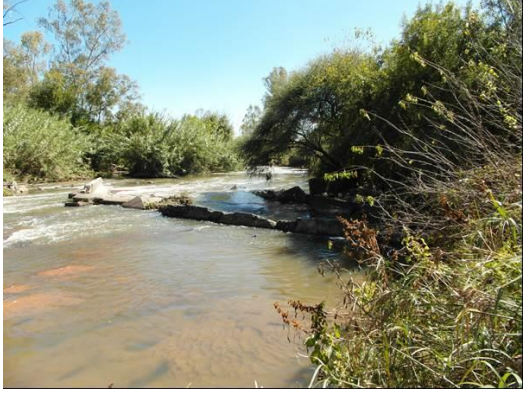
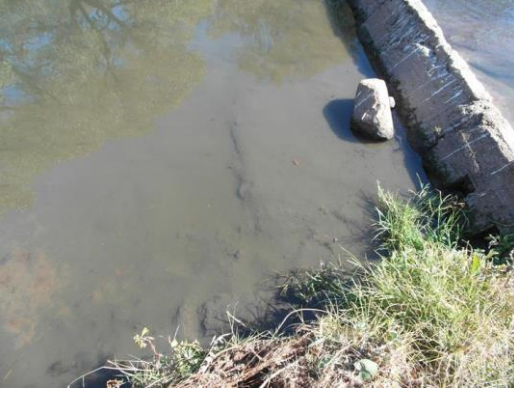
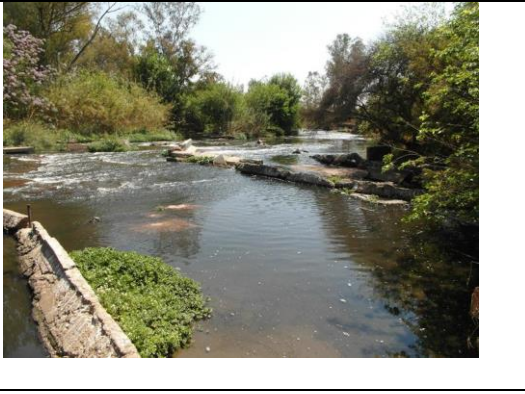
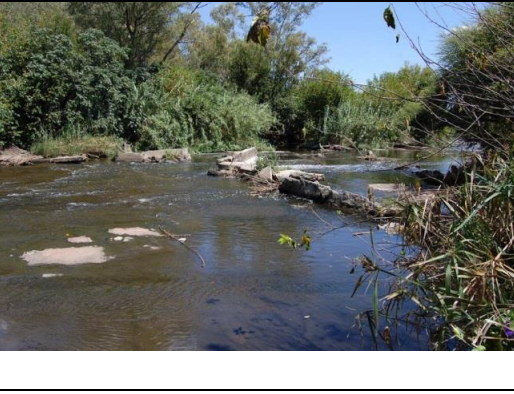
FIGURE 7-17. A2APIE-VASTF (A23F-00827)

August 2013	June 2014 (indicates sediment build up in slow shallow habitats)

September 2014	March 2015

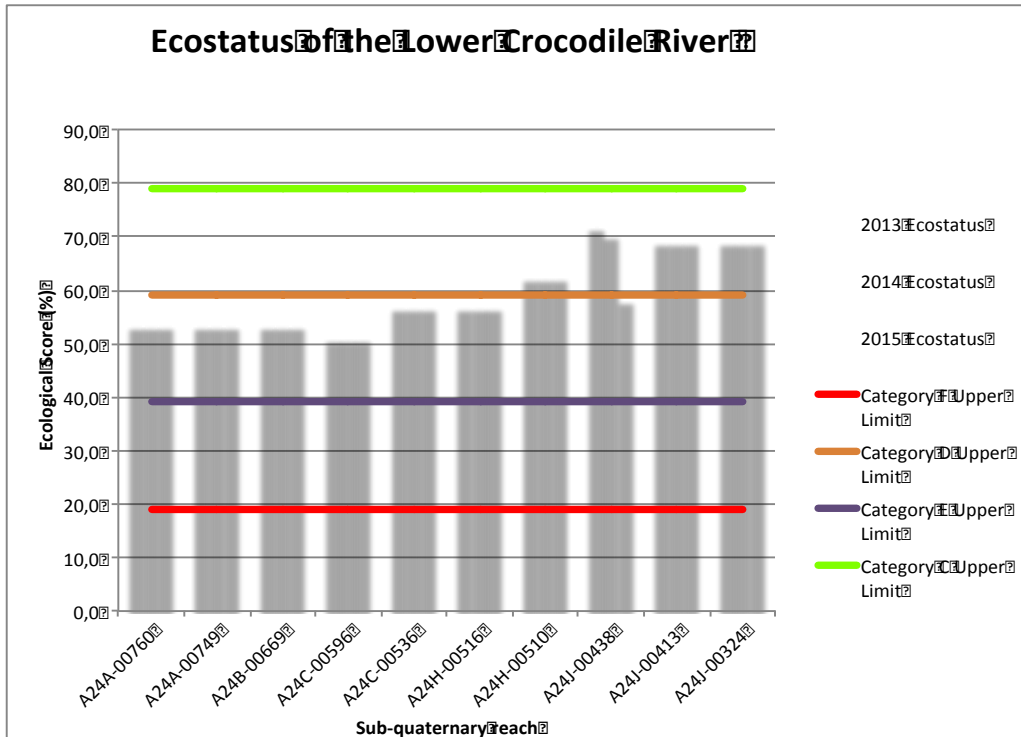
FIGURE 8-3. ECOSTATUS OF THE LOWER CROCODILE RIVER FROM UPSTREAM (LEFT) TO DOWNSTREAM (RIGHT)

The assessment of the remaining reaches in the Lower Crocodile River were based on a desktop analysis of the Habitat Integrity, using Google Earth imagery. The assessment method was not sensitive enough to pick up deterioration within these reaches (Figure 8-3).

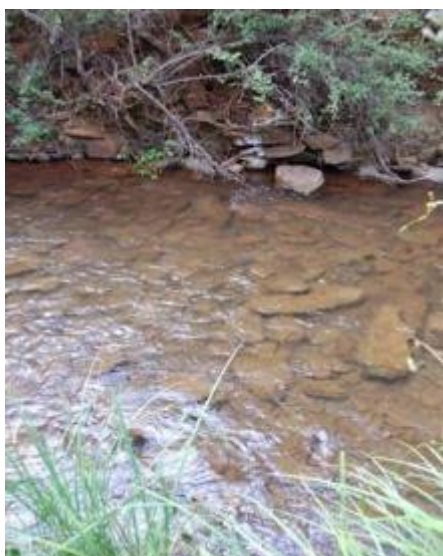
This site was assessed on five different occasions from 2013 – 2015. Two cross-sections were measured, both in the run GHU, numbered 1.01 and 1.02 respectively.

FIGURE 12-2. CROSS-SECTION 1.01 IN THE RUN GHU, A3KAAL-RIETS

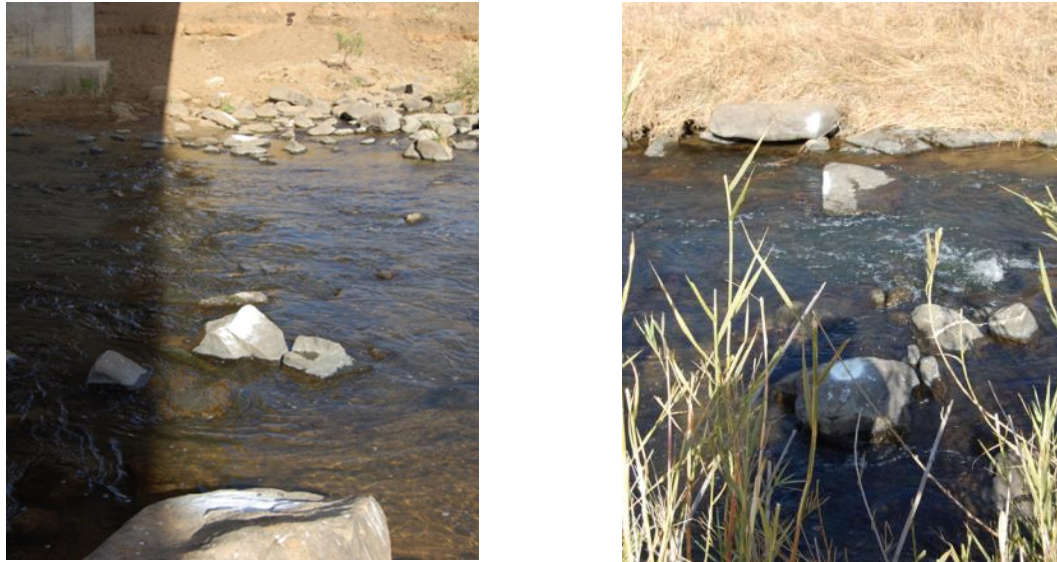
This site was assessed on four different occasions from 2013 – 2015. Two cross-sections were assessed in the run GHU, numbered 1.01 and 1.02 respectively.

FIGURE 12-12. CROSS SECTIONS 1.01 AND 1.02 AT A2 HEXR-ROOIW

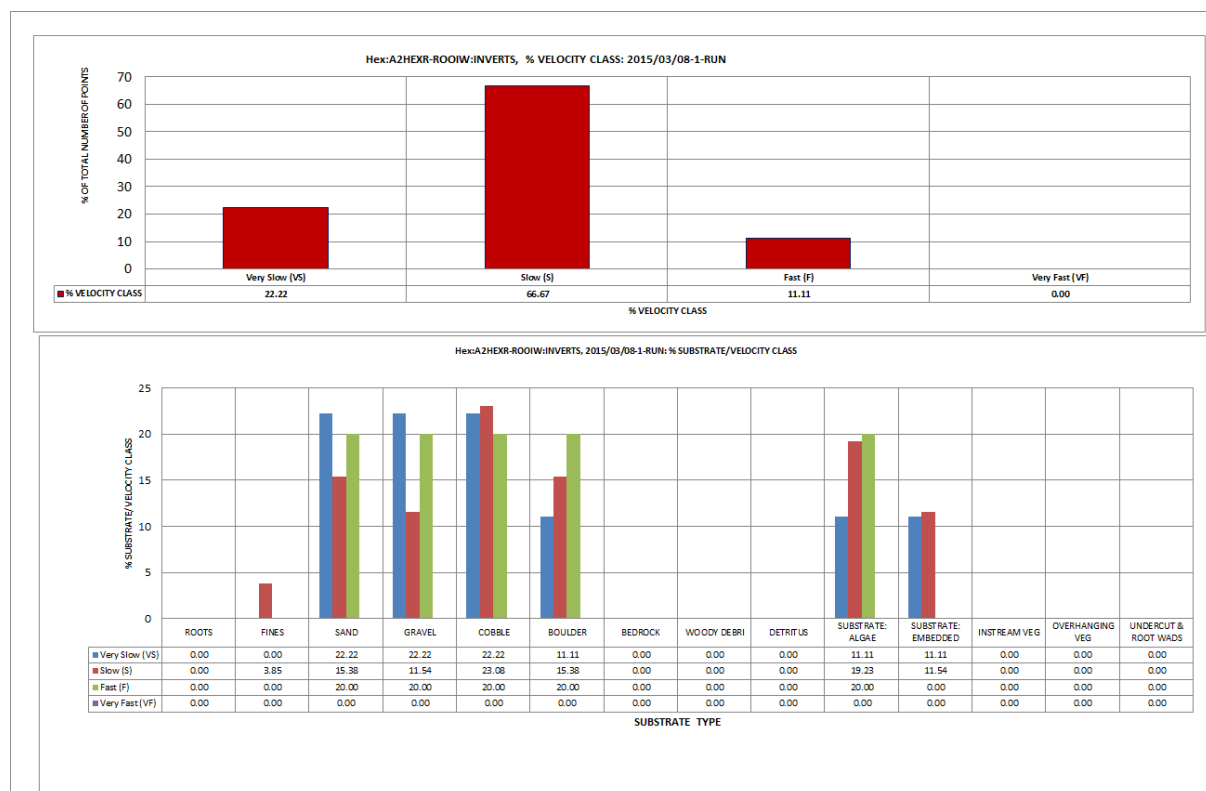
FIGURE 12-16. VELOCITY-DEPTH CLASSES AS A % OF ALL CROSS-SECTION POINTS (TOP GRAPH) AND % SUBSTRATE PRESENT PER VELOCITY-DEPTH CLASS (BOTTOM GRAPH), FOR MACROINVERTEBRATES AS AT MARCH 2015

The slow class dominates at 66.67%, followed by very slow at 22.22% and fast at 11.11%. The cobble substrate is dominant at the cross section, followed by the gravel, sand, boulder and fine substrates. No instream vegetation or bedrock is present. Algae is present, with embedded substrates present in the very slow and slow velocity-depth classes.

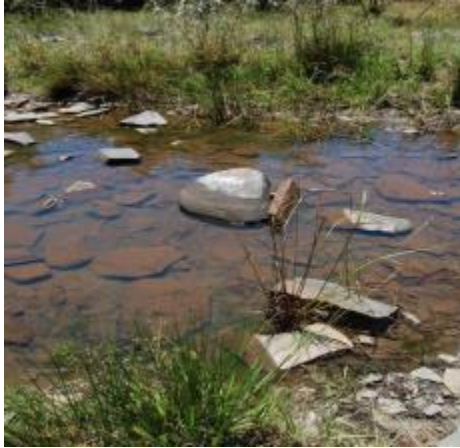
This site was assessed on three different occasions from 2014 – 2015, with two RHAM measurements taken at a single cross-section in a run GHU.

FIGURE 12-17. CROSS-SECTION AT A2ELAN-KLIPB

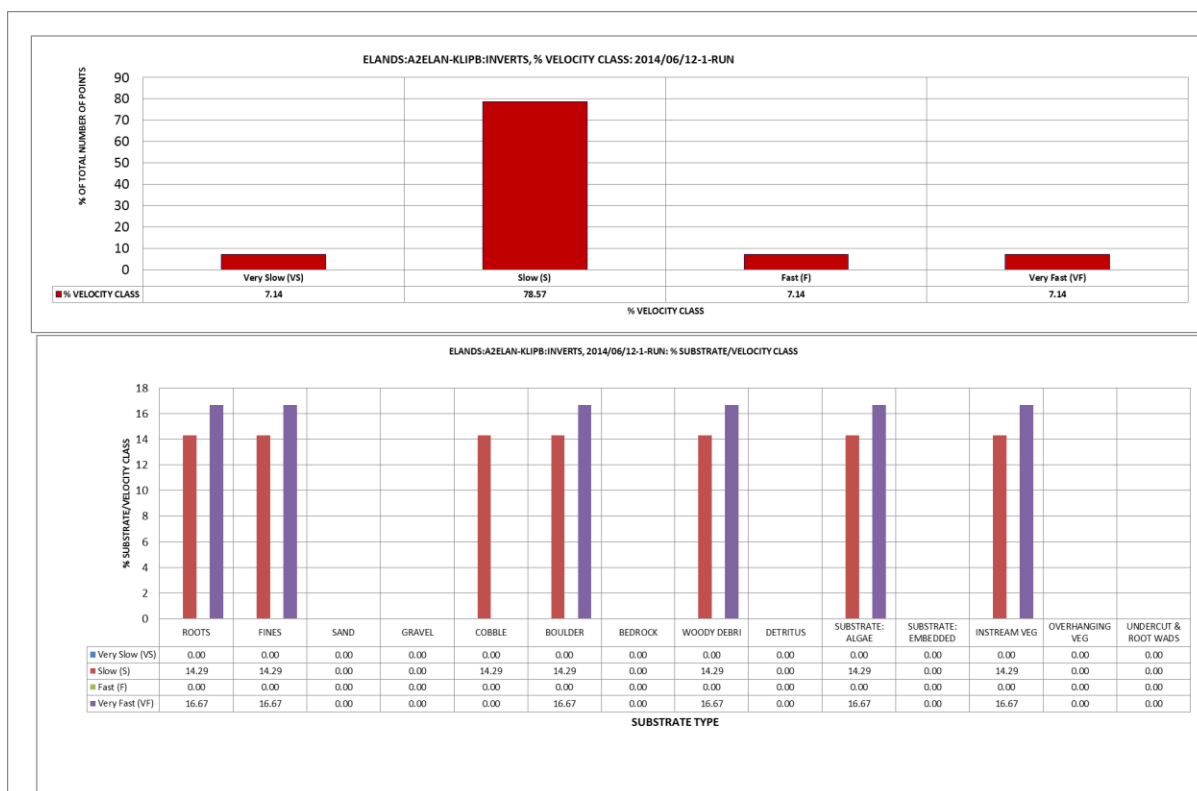
FIGURE 12-20. VELOCITY-DEPTH CLASSES AS A % OF ALL CROSS-SECTION POINTS (TOP GRAPH) AND % SUBSTRATE PRESENT PER VELOCITY-DEPTH CLASS (BOTTOM GRAPH), FOR MACROINVERTEBRATES AS AT JUNE 2014

The slow class dominates at 78.57%, followed by very slow, fast and very fast at 7.14%. Roots, fines, cobble, boulder and woody debris substrates occur. Algae are present, as well as some instream vegetation.
