EASTERN CAPE RIVER HEALTH PROGRAMME

DRAFT TECHNICAL REPORT: BUFFALO RIVER MONITORING, 2002 - 2003

Coastal & Environmental Services
PO Box 934
Grahamstown
6140

March 2004

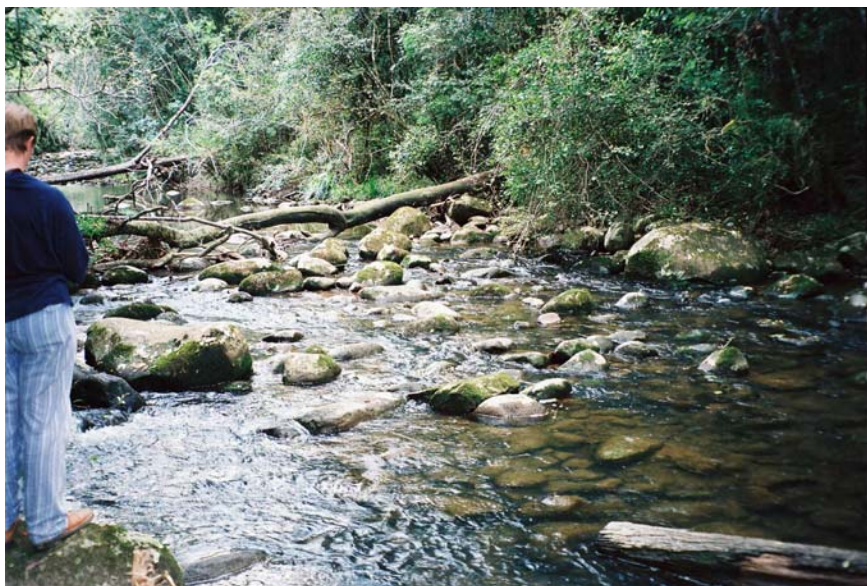
The average width of the stream was 12-14 metres. Banks were mostly vegetated by indigenous vegetation, although little marginal vegetation was present. Water was clear with medium flow. Substrate was mainly in the form of pebbles and cobbles, with fallen trees and logs providing additional habitat.

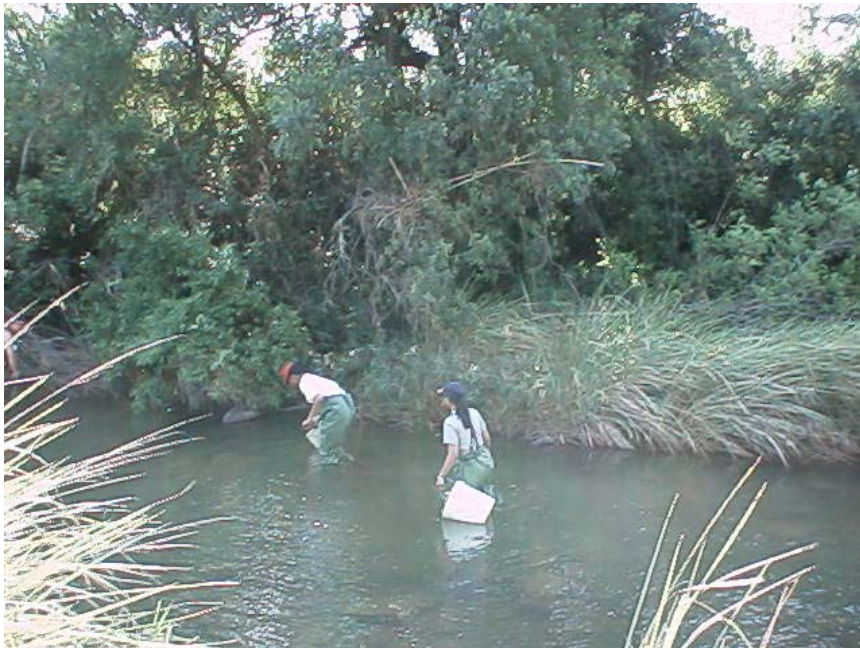
Site 2 – Buffalo River at Horseshoe Bend

The average width of the stream was 8 – 10 metres. Substrate was mostly cobbles, with a small riffle area and large pools up- and downstream of the site. Marginal and fringing vegetation was approximately 2 m in width. There was evidence of sand-mining on the left bank, with a low-water bridge and cattle crossing across the stream.

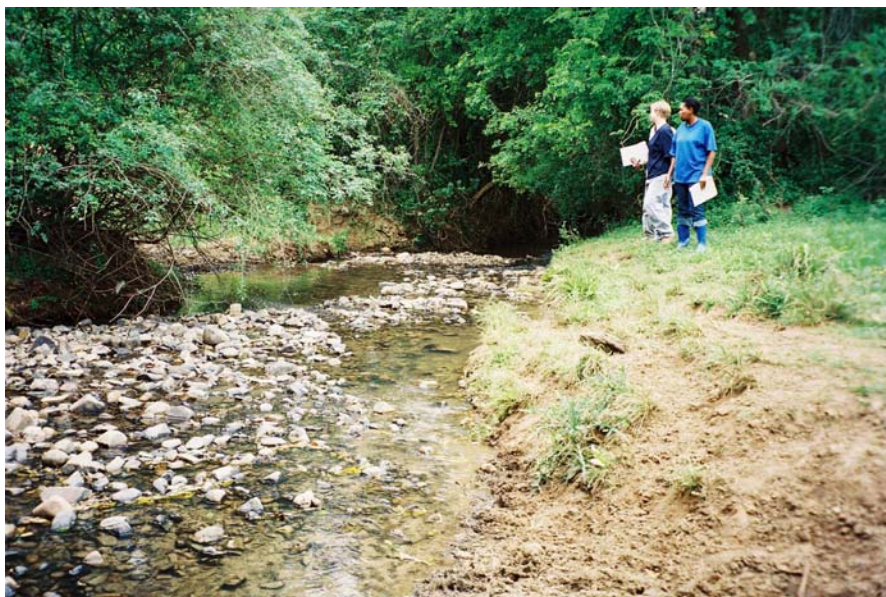
Site 3 – Mqgakwebe tributary

The river is sinuous and meandering, with average width 4 m. Cobbles and pebbles were found in long stretches of riffle. Marginal vegetation was dominated by trees and shrubs, and pools were shallow. There is a major cattle crossing in the area, with a cemetery 50-60 m from the site.

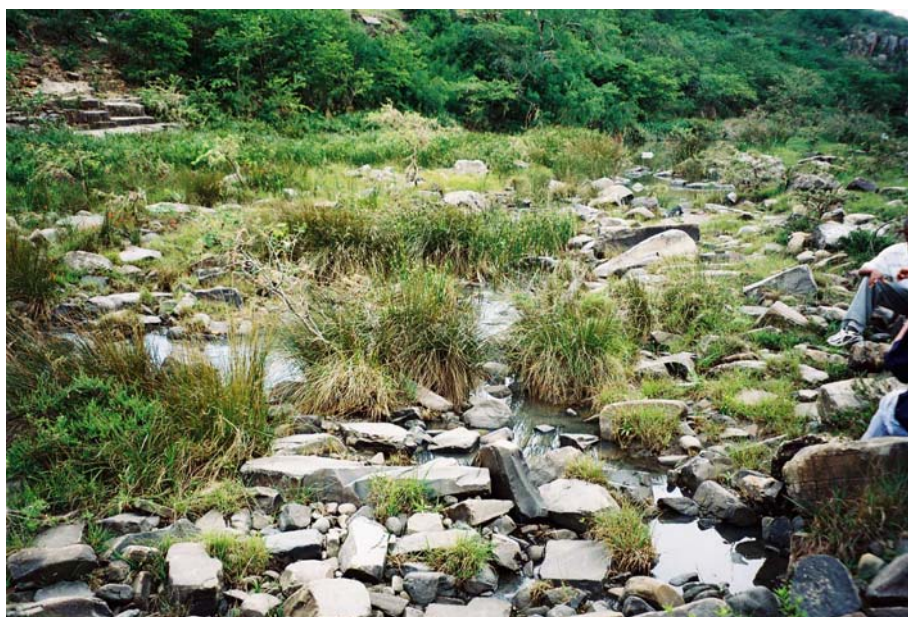
Site 4 – Ngqokweni tributary

The average width of the stream was 10-15 m. Substrate was mostly bedrock and boulders, with small patches of riffles. Deep pools were present. Aquatic and marginal vegetation was present. *Acacia* in the riparian zone is used by surrounding communities as a source of firewood.

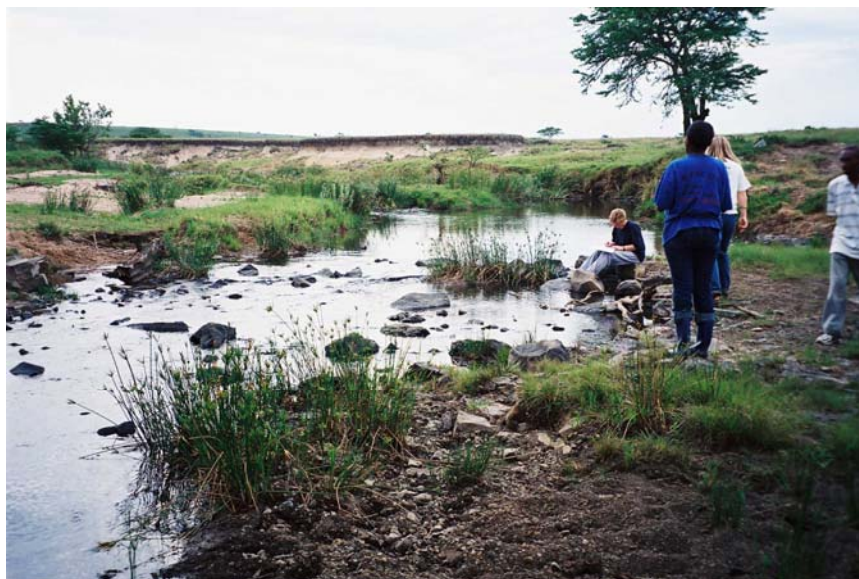
Site 5 – Yellowwoods River at Lonsdale bridge

The average width of the stream was 8-10 m. The water was discoloured with low flow. The substrate varied from cobbles, gravel and sand. Sedges and reeds dominated aquatic and marginal vegetation. Pools were shallow and livestock have eroded the banks and formed gullies.

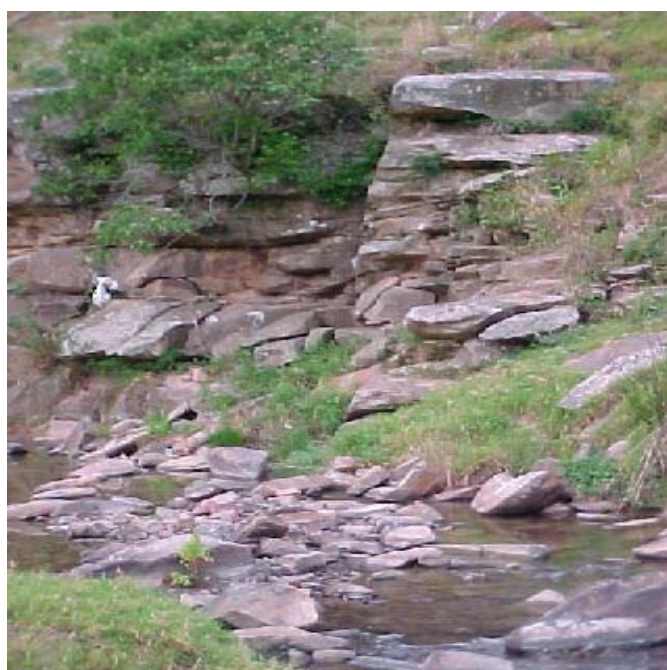
Site 6 – Yellowwoods River 2

The average stream width was 8-10 m. Substrate was mainly bedrock and boulders, with small riffle areas. Marginal vegetation was minimal and found in pool areas. Small waterfalls were seen upstream.

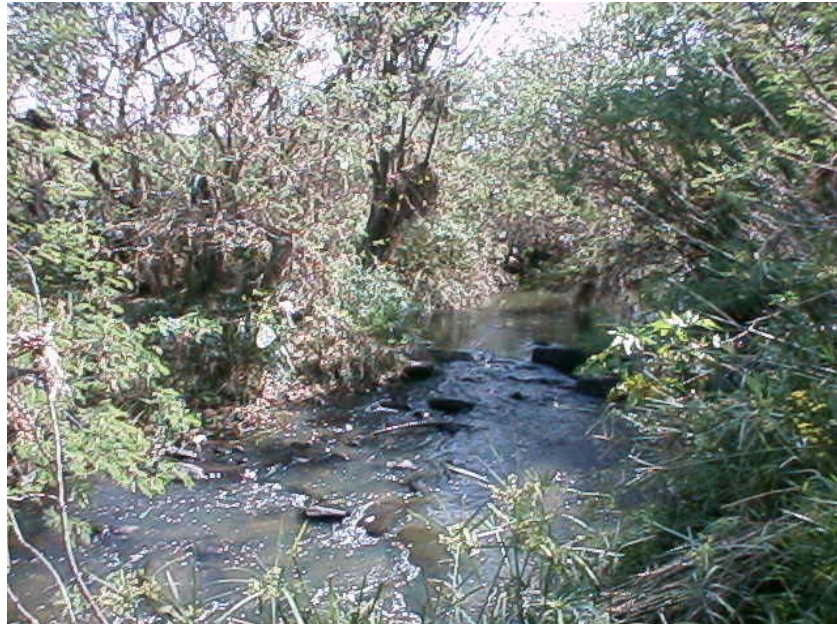
Site 7 - Buffalo River below KWT, and above Zwelitsha town

This is a braided section of the river, with suitable riffle areas for invertebrate sampling. Pools for fish sampling are available. Downstream of the site is a pipeline crossing so as to deliver water to Bonke town. Sweetwater stream, which drains Zwelitsha, joins the Buffalo River downstream of the site. Sand mining and bulldozing is evident on left bank; builders rubble can also be seen on this bank.

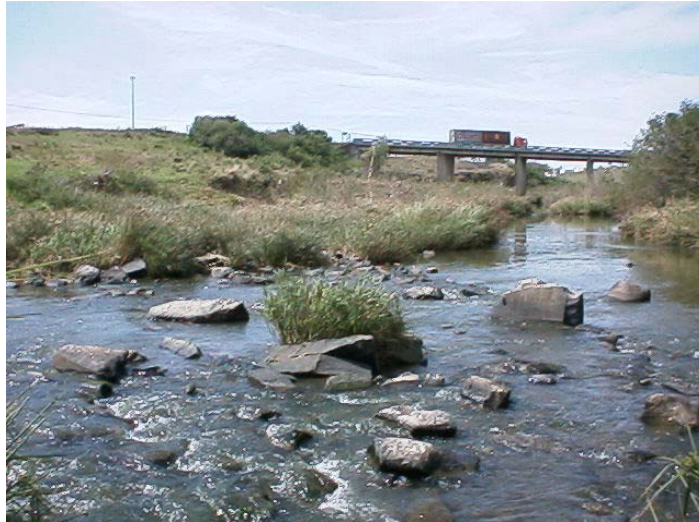
Site 8 - Buffalo River below Zwelitsha town, but above Zwelitsha sewage treatment works.

This site is found upstream of the Denis Radue bridge. The average width of the river is 8-10 m. The water was green and eutrophication levels were high. Substrate was sand, cobbles and boulders.

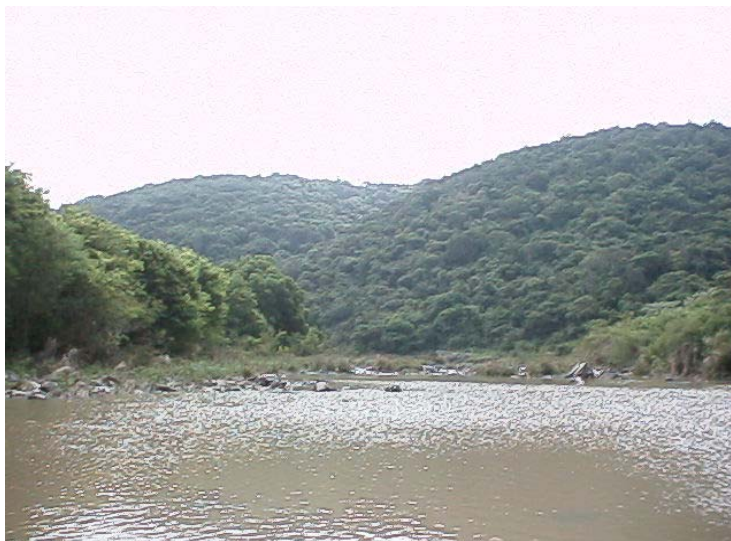
Site 9 - Buffalo River at Buffalo Pass

This is a very good site for monitoring all indices, and is a site used during the Amatole study. The site is located at the Umtiza Nature Reserve. The average width of the stream is between 40 and 50 m. The water was murky, turbid and fast-flowing in all seasons. Substrate was predominantly bedrock with few cobbles.

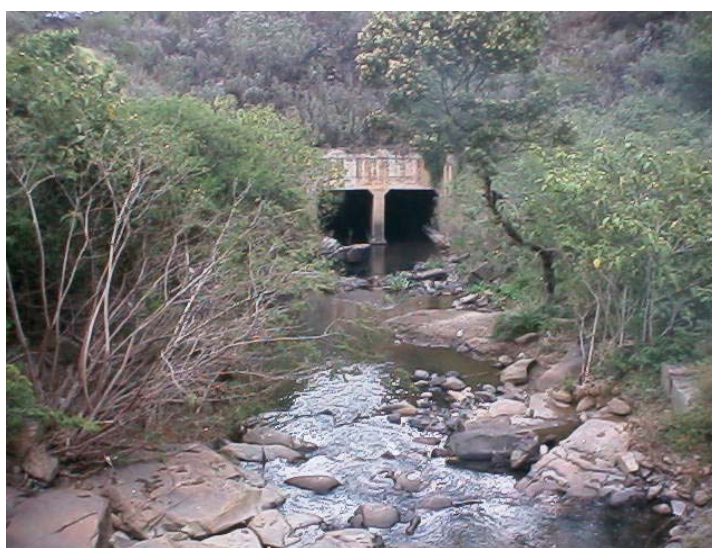
Site 11 – Shangani Stream draining Mdantsane

A good riffle area was found upstream of the bridge and sand road. Potsdam Sewage Treatment Works pumps failure overflows into this stream, which also drains Mdantsane.

The site is located downstream of Bridle Drift Dam. The average river width is 3-5 m. Substrate was predominantly bedrock and boulders.

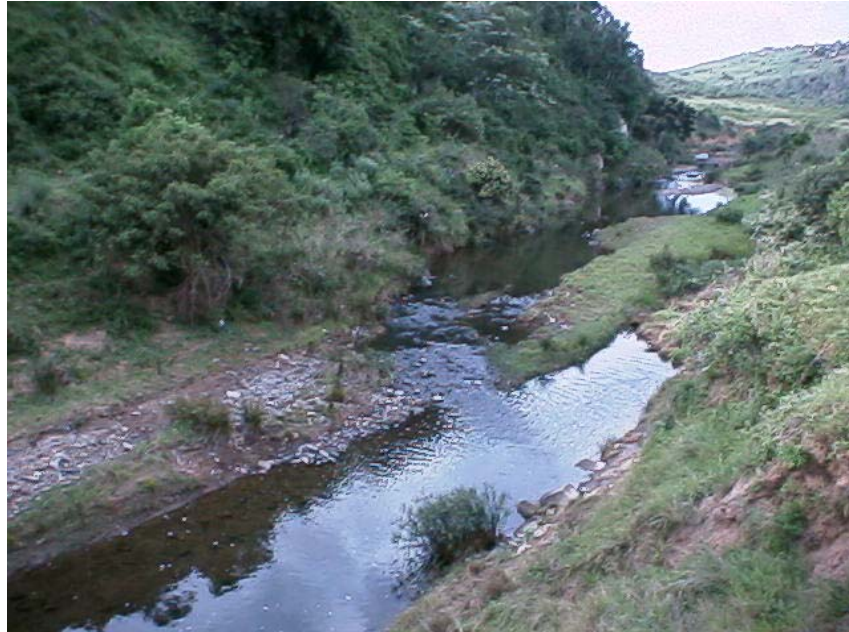
This stream drains into the Buffalo River further downstream. The average river width is 4-6 m. A long area is present. Grass and sedges dominated the marginal vegetation; the riparian zone was mostly indigenous, with cemeteries present further up the banks.

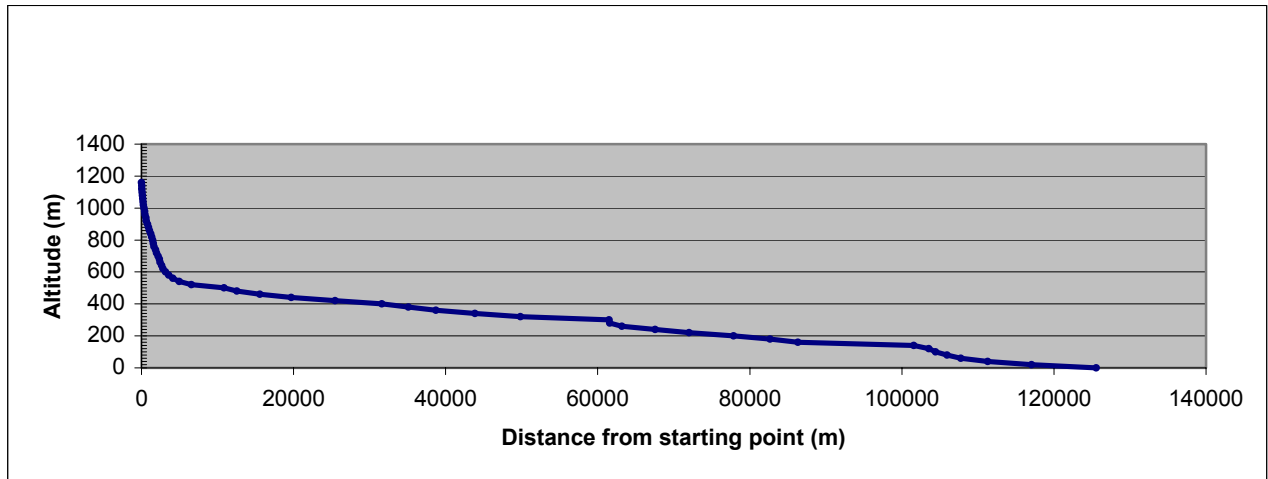
Figure 6.1 Longitudinal profile of the Buffalo River.

The zones identified along the Buffalo river are as follows:

- 1160 – 620 m.a.s.l. - Mountain Headwaters
- 620 – 480 m.a.s.l. - Mountain Stream (*)
- 480 – 280 m.a.s.l. - Foothill Gravel Bed/Foothill Cobble Bed (***)
- 280 – 240 m.a.s.l. - Mountain Stream
- 240 – 120 m.a.s.l. - Foothill Gravel Bed/Foothill Cobble Bed
- 120 – 40 m.a.s.l. - Mountain Stream
- 40 – 0 m.a.s.l. - Foothill Gravel Bed/Foothill Cobble Bed (*)
