## Summer 2009 – Tyolomnqa River Assessment

**Prepared for**  
**Department of Water Affairs and Forestry**  
**Resource Protection**  
**East London Region**

**Prepared by L. Gaulana and E. Weni**  
**23 April 2009**

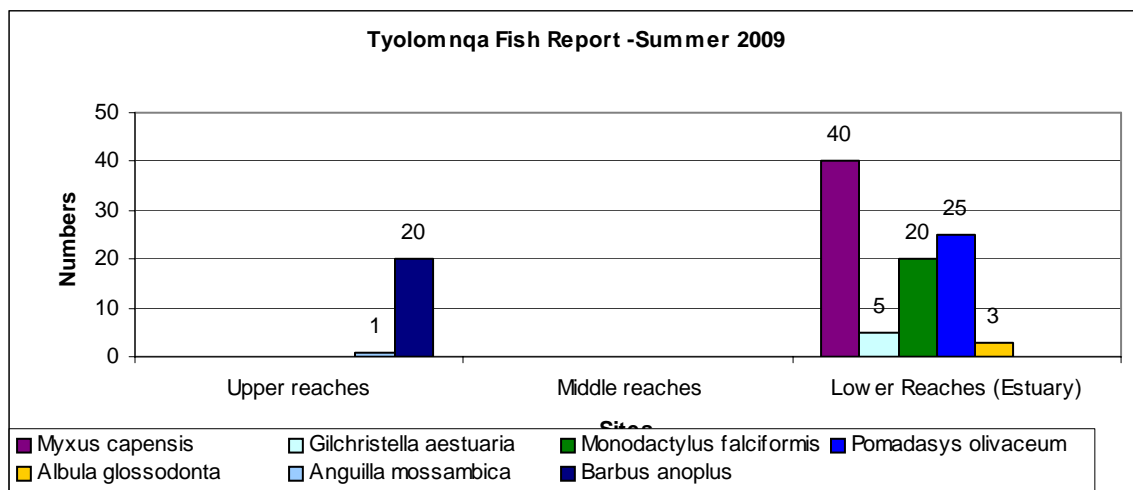
Fig 7: Illustrating fish distribution within the Chalumna system in Summer 2009.

There were no flows in the river during the time of site assessment. A big abstraction weir is constructed just 100 m upstream of where we sample and this blocks the natural flows. Fish caught here were the estuarine fish (see the histogram in figure 7). This is the estuarine site and there was a large biodiversity of species caught in it, compared to the freshwater. The FFI indicates that the site is in **B** class, implying that there is little or no modification on the site.

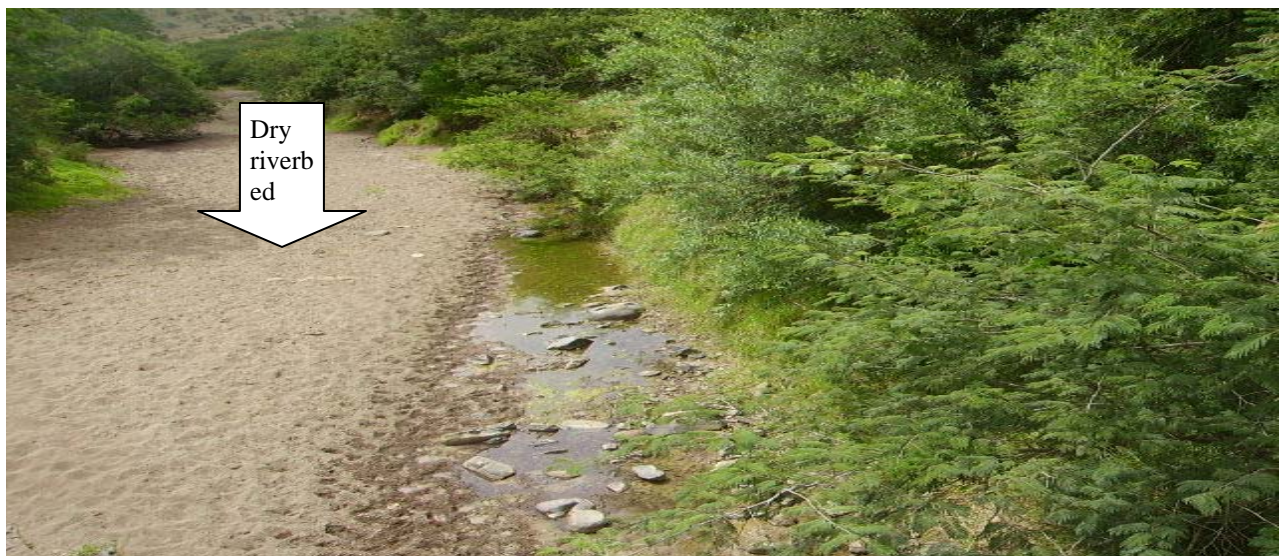
During the time of site assessment the river was completely dry (see plate 2), due to the absence of rain. That implies that there was no sampling in this site.

Plate 2: Dry riverbed in middle reaches of the river in Summer 2009.
