Department:
Water Affairs and Forestry
REPUBLIC OF SOUTH AFRICA

BIOMONITORING OF THE GREAT KEI RIVER SYSTEM

APRIL 2010

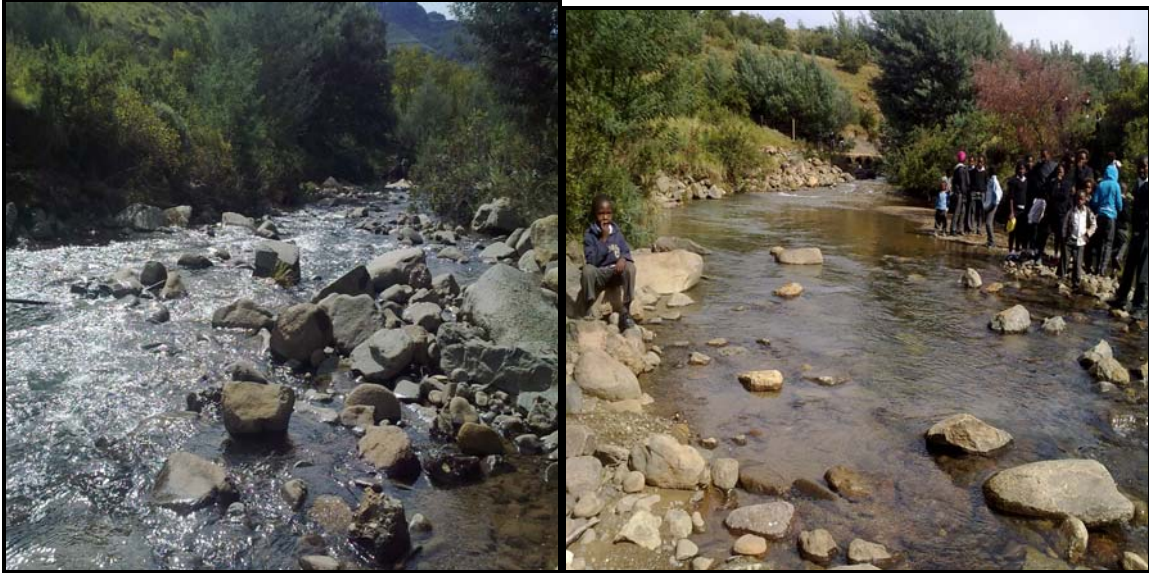
The site is in a single- thread, pool-riffle system of which its river bed consists of boulders as pre-dominant substrate types (Plate 1). Forty-five percent of morphological units were observed at a site. These units form habitat abundance and diversity for aquatic flora and fauna. A road curvet at the site deprives the migration route towards the upper most part of the river reach. The Geomorphological Assessment Index (GAI) reveals that the river at a site is on A condition in terms of Present Geomorphological State, suggesting that there were minimal changes on that part of the river reach. In fact alien invasion, few developments and commercial farming (mainly lucerne) as well as water abstraction (pipes observed) were those minimal changes thereof. In addition, the confidence in terms of classification of South African rivers was low due to inaccessibility towards the upper most part of the reach due to dense overhanging vegetation along the riparian zone.

Plate 1(a) Water was very clear during site visit.

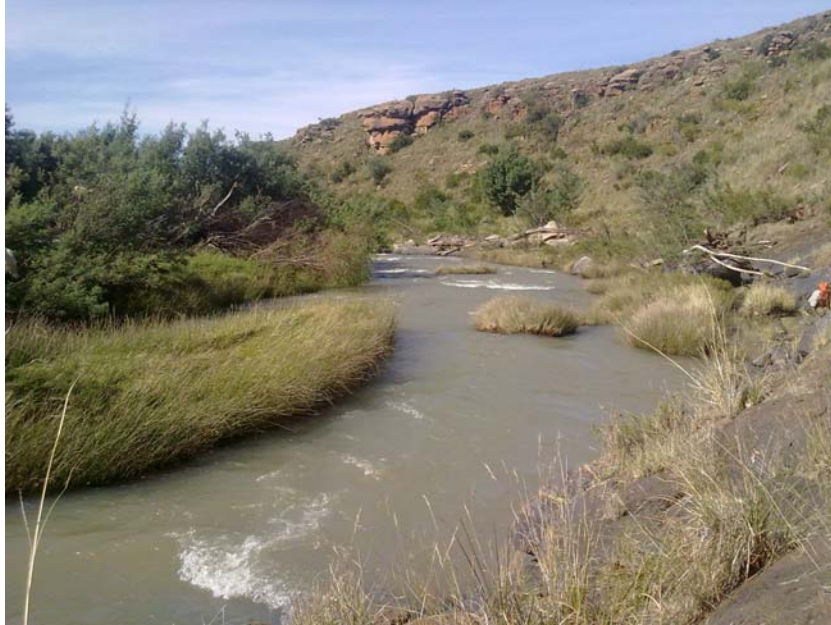
The river at a reach is a multiple thread, straight, pool-rapid and a mixed channel dominated by bedrock and boulders. It is a braided channel with about 62% of morphological units described on the Geomorphological Assessment field sheet. The GAI model shows that the site is an A class in terms of its Present Geomorphological State . Sediment sampling could not be done due to the site's fluvial morphological state of fixed boulder and bedrock material, as well as high flows (Plate 2).

Plate 2. Black wattle is a major setback at a site area.

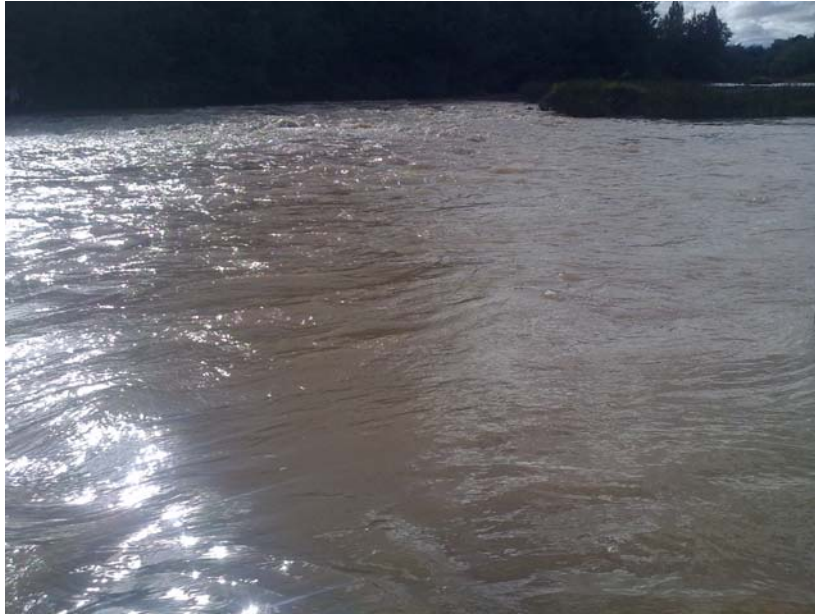
No sampling could be done due to extreme high flows (Plate 3).

Plate 3. Tsomo at Komkhulu during Autumn survey, 2010, note the dark clouds at a distance; an evidence of on-coming rain. This is the tributary of the Great Kei !!!

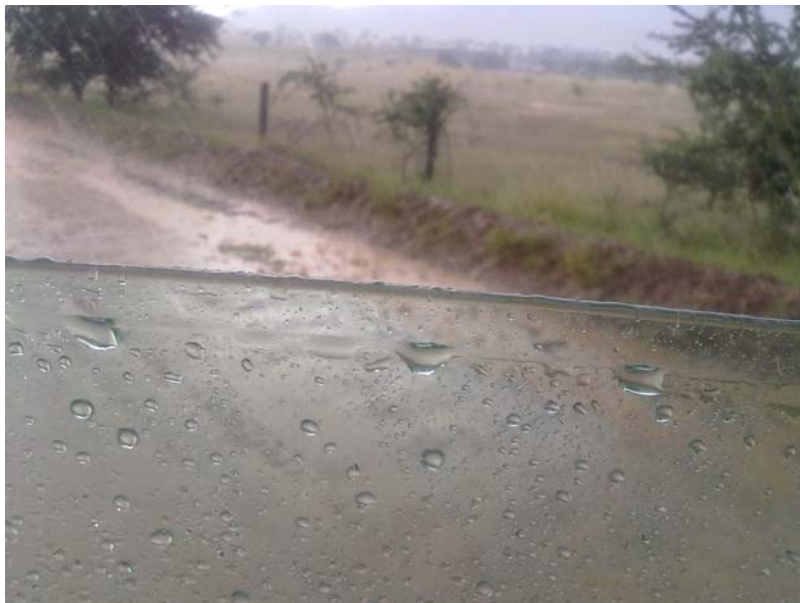
Plate 4. Heavy rain with hailstones in action.

The team could not make it to the site area due to hail, heavy rainfall and muddy road (Plate below).

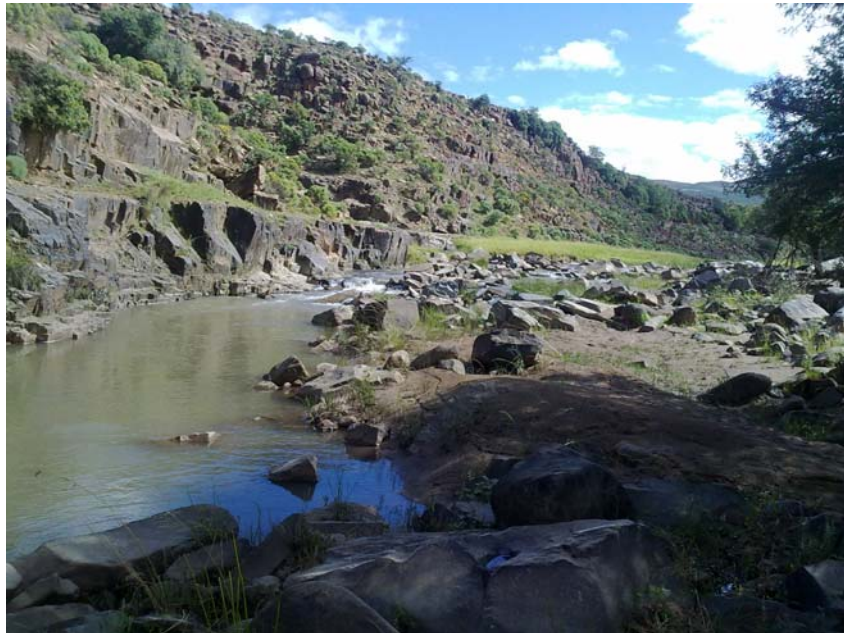
The dominant substrate material at a site is a fixed boulders and a bedrock material (Plate 5). Irregular shape of boulder/cobble shows that the material is directly from localized adjacent hillslopes. Fine sand deposits along the river bank and a point bar were observed. This fine material should be from suspension and could be deposited as the result of reduced energy of the water from the dam release. Morphological units observed dropped to 50% as compared to 63% of 2009 summer survey, but GAI indicates that the site is still at C class. The plate below shows the White Kei River 'horn' below Xonxa Dam.

Plate 5. Shape of alluvium at a site indicates that the material is directly from adjacent hillslope.

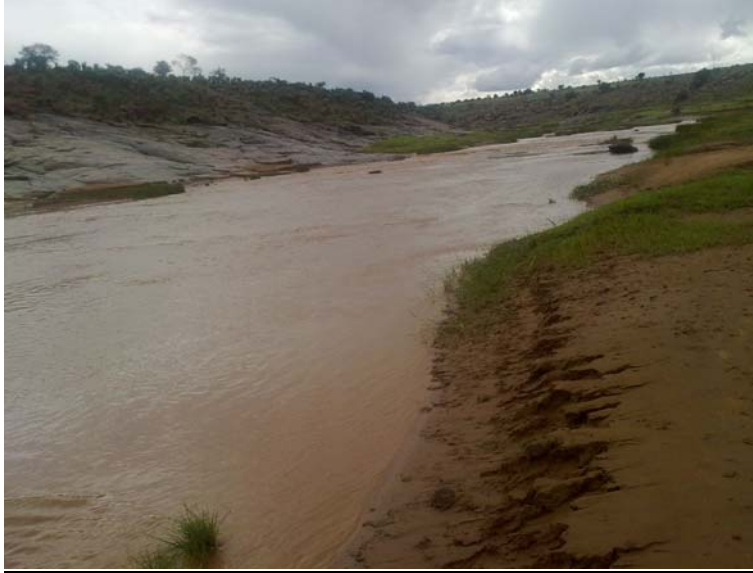
No adequate assessment at a site could be done due to extremely high flows (sediment assessment not done). There was also evidence of recent floods; a lot of debris deposited on a floodline. About 79% of morphological units observed as compared to 67% of previous surveys. This was due to flowing waters on the overflow (secondary) channels.

Plate 7. High flows and water very turbid due to suspended fine sediments. Sand deposits along the river bank are mainly from catchment processes dominated by erosion. The cumulus clouds with rain can be seen at a distance.

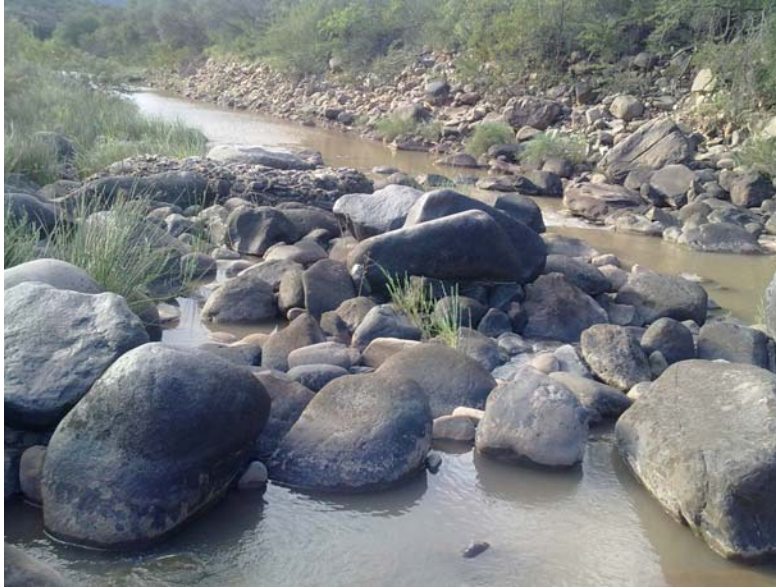
The GAI model shows that the site is at B class in terms of its Present Geomorphological State. No changes observed as compared to previous surveys except minimal increase in turbidity and increased levels water levels. Plate 8 shows Black Kei at Turstream.

Plate 8. Black Kei at Turnstream. No change as compared to previous surveys.

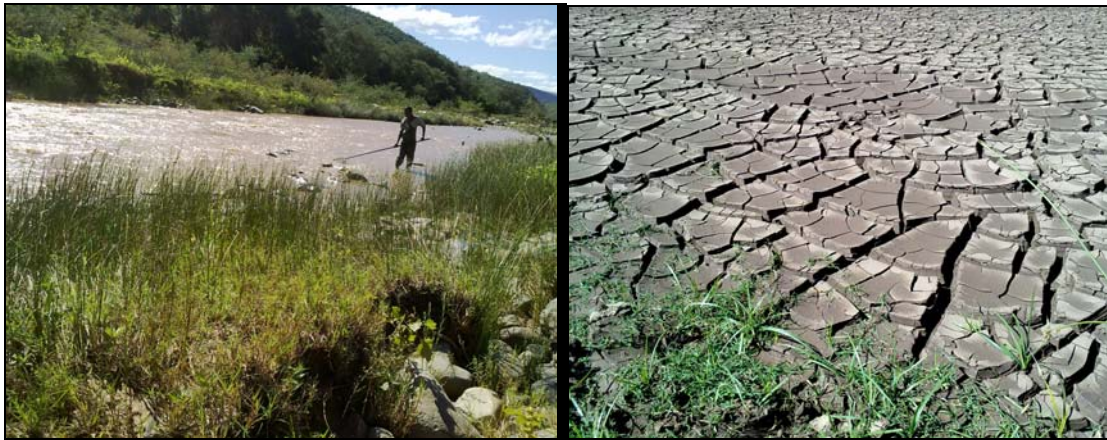
High flows and high levels of sedimentation were observed in the Great Kei at Gaika Fort. Plate 9 below shows the Gaika Fort site of the Great Kei River catchment below the confluence of the two 'horns', that is, the White Kei and the Black Kei. Specific changes in terms of substrate characteristics were observed at the site. Dangerous fine sediments were observed at the river reach (plate 9 b). These fine sediments should due to catchment processes. In fact most of the sediment sources are the gullies, especially on the first order streams at the catchment level (refer also to satellite images: Google Earth). Other fine sediments are due to fluvial deposits from upstream as well from the river banks and the river bed. The GAI model shows that the site is at C class in terms of its Present Geomorphological State. No sediment sampling was done at a site due to high flows.

Plate 9(a). High flows and water very turbid. (b) High volumes of sedimentation on the right bank

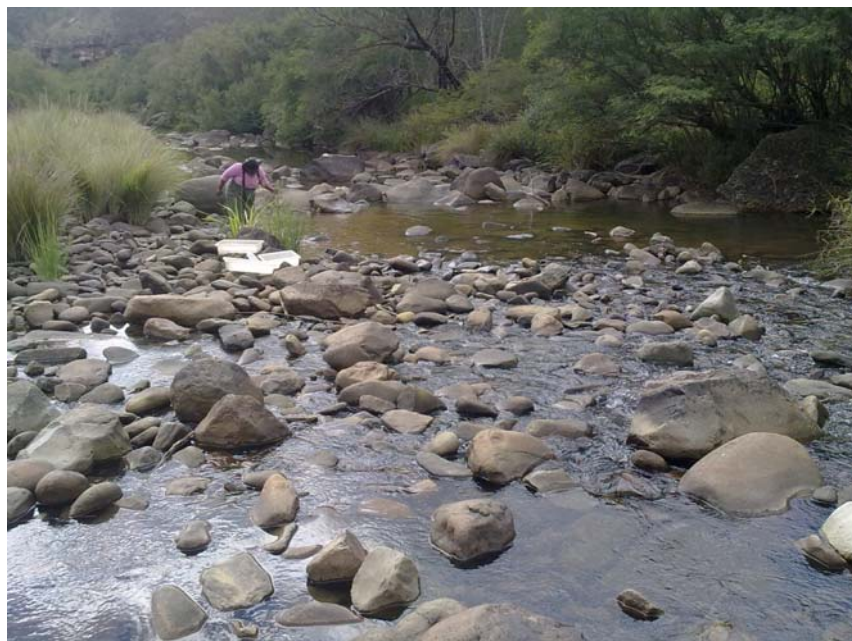
No significant changes as compared to previous surveys. Morphological units (biotopes) observed comprise about 57%, that is, small decrease as compared to previous surveys, mainly due to small increase in base flows. For example, the bedrock pavement was covered by the water. Dominant features in the channel are fixed boulders and some few cobbles together with bedrock. Plate 11 shows the Kubusi River bridge site.

Plate 11. A typical alluvial channel with coarse and rough sediments.

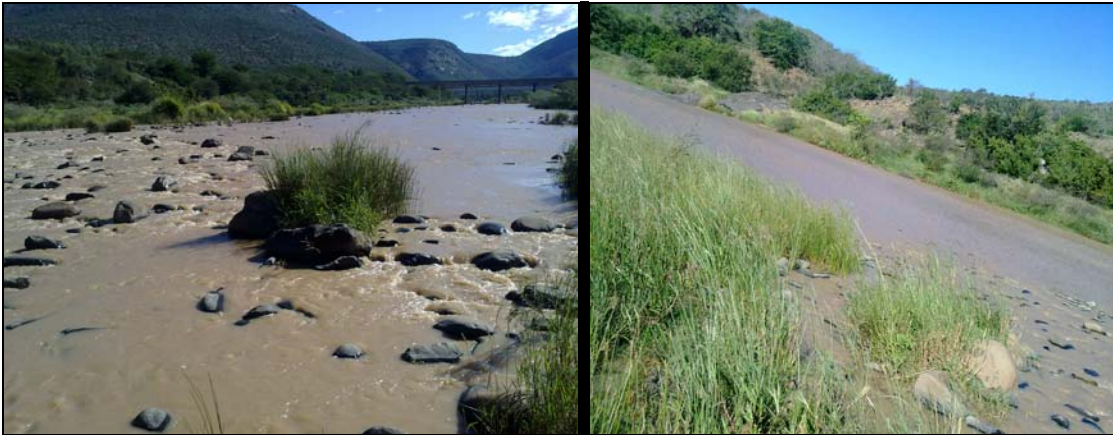
The GAI model shows that the site is at C class in terms of its present state. Some few of *Lantana spp* were still uncontrolled. Excessive sediment mining still taking place on the riparian zone. Plate 12 shows the Great Kei River at N2 Bridge.

Plate 12 (a). Kei River bridge site during high flows.

Plate 12.(b) Note the shape of grasses showing blowing winds.

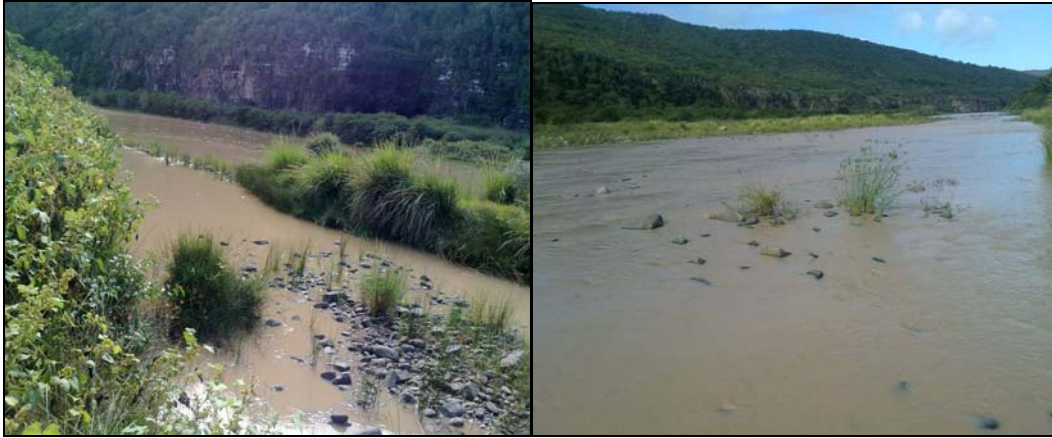
No proper assessment could be done in the Great Kei River site at Glen site due to high flows, very deep pools and poor access along the river reach. Transects accessed previously were inundated by the water.

Plate 13.(a): Note alien invasion.

Plate 13.(b): Alluvium almost submerged by the water.
