Department:  
Water Affairs and Forestry  
REPUBLIC OF SOUTH AFRICA

## **BIOMONITORING OF THE GREAT KEI RIVER SYSTEM**

FEBRUARY 2009

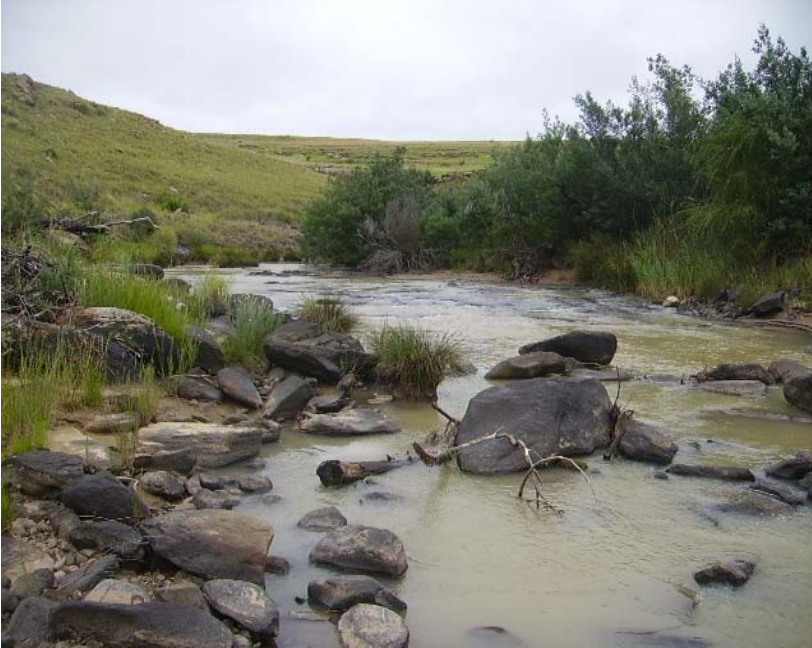
The site is located at Tsomo River at S31° 22' 02.2" and E27° 40' 14.6" at an altitude of 1178 masl. The site is located within the South Eastern Uplands Level I Ecoregion at S50C Quaternary catchment (refer to Figures 4 and 5). The site is located at an incised channel with flood benches. Therefore beside the sediment from upstream, the sediment from the hillslope can be trapped only on flood benches before it reaches the river channel. The river at a reach is a multiple thread, straight, pool-rapid and a mixed channel dominated by bedrock and boulders. (Pate 1). It is also an anastomosing channel, suggesting that numerous channels have developed as a result of sediment deposition accompanied by vegetation growth within the active channel itself. The site has about 80% of morphological units described on the Geomorphological Assessment Index (After Du Preez and Rowntree, in press). This means that there is a variety of habitat types for aquatic biota. The Geomorphological Assessment Index (GAI) model shows that the site is at A class in terms of its present geomorphological state. Sediment sampling could not be done due to the site's fluvial morphological state of fixed boulder and bedrock material.

Plate 1. Note the alien vegetation encroachment on the right bank.

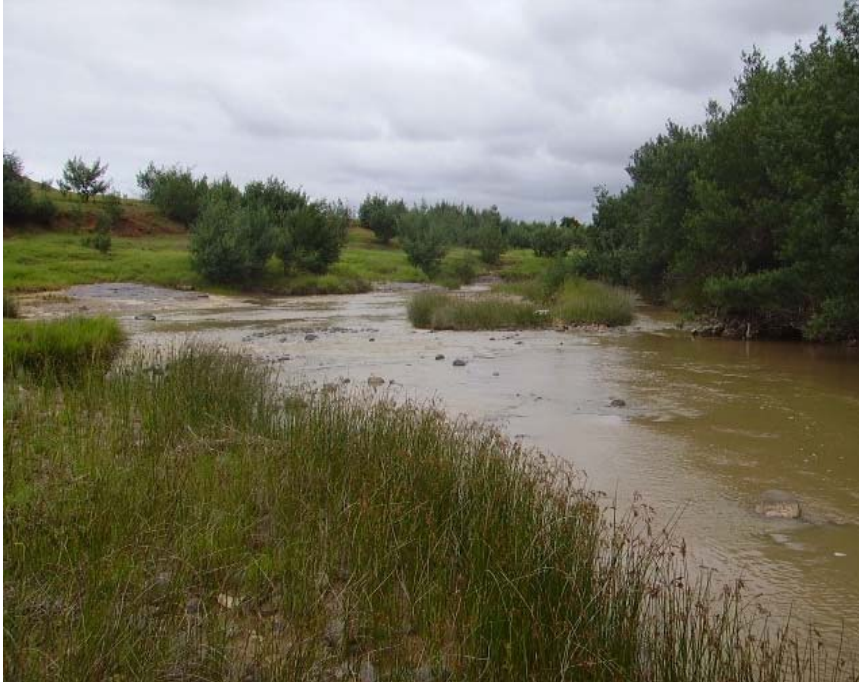
The site is geographically situated at Tsomo River at  $S31^{\circ} 36' 33.3''$  and  $E27^{\circ} 40' 35.4''$  at an altitude of 1108 masl. This is basically within the South Eastern Uplands Level I Ecoregion at S50D Quaternary catchment (Figures 4 and 5). It is situated at confined valley floodplain. Most of the sediment from the hillslope can be fascinated only on floodplains. In other words, the colluviums from adjacent slopes cannot easily reach the river channel, especially if the floodplain could be rich in natural vegetation. The river at a reach is a multiple thread, sinuous, mixed, pool-riffle system, often in a flat bed reach type (Plate 1). This means that meandering at a reach scale is active, that is, alternative erosion and deposition occurs on both the river banks. The reach type is a flat bed which means a lot of fine material can be trapped in a river bed especially during periods of low flows. The river at a site has about 75% of morphological units of where the aquatic fauna and flora can survive. The Geomorphological Assessment Index (GAI) model shows that the site is at B class in terms of its present geomorphological state.

Plate 2. *Acacia meansii* is an invasive alien that occupies most of the river banks and the riparian zone.

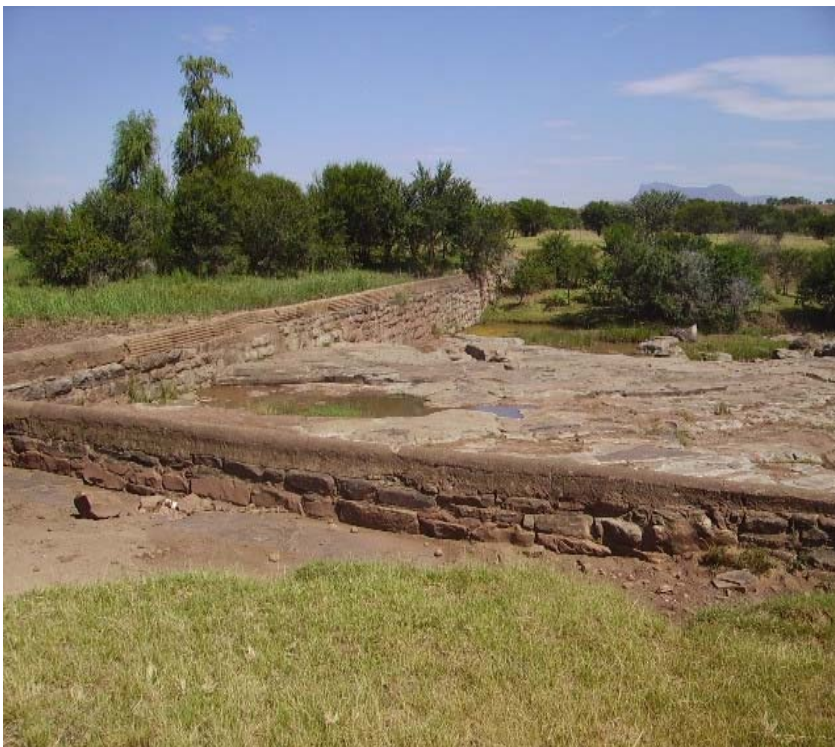
This site is located at Klass Smith River at S31°52' 35.68" and E°26 23.67". The site is located Quaternary catchment S31E. The major idea to select the site was to ground truth the reference condition of the Drought Corridor Level I Ecoregion. Unfortunately the site is located on poor vicinity with seriously modified condition. Plate 3 below shows the weir further downstream of the proposed site (S31°54' 30.83" and E°26 37'59.58"). In addition the river has become a non-perennial one due to abstraction of groundwater and surface water (a lot of windmills and dry farm dams could be observed). Thus no assessment was done there.

Plate 3. The river was no longer flowing and a weir was designed to collect any droplet of the water.

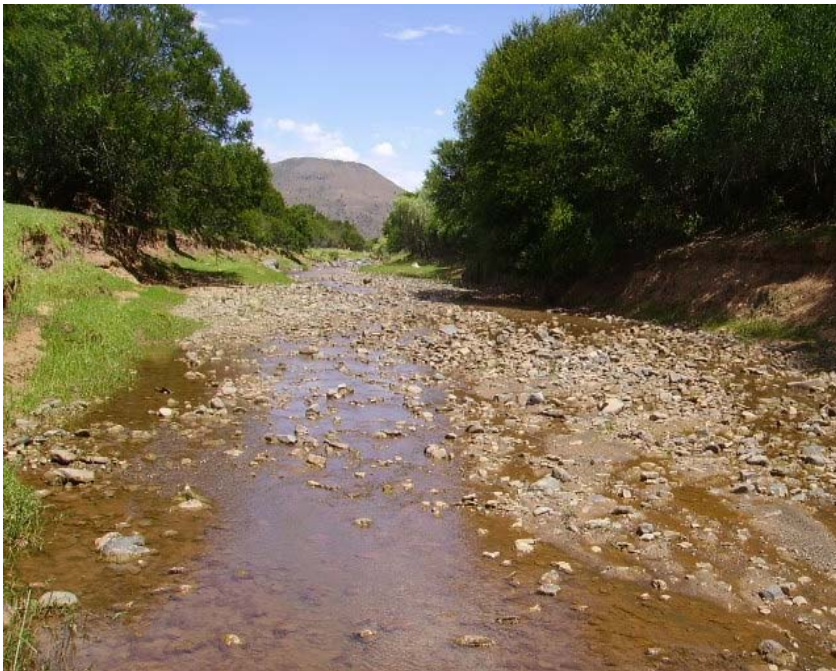
It is situated at incised channel, often with flood benches. The sediment from the hillslope can be deposited directly to the river channel with minimal resistance of flood benches. The river at a reach is a single thread, straight, mixed, pool-riffle system

dominated by cobbles (Pate 1). Most dominant features are cobbles that were not submerged by the water due to low flows at the period. Due to this and embededness by the fine material from eroded river bank, upstream and the hillslope, no sediment sampling could be done whatsoever. Only about 42% of morphological units could be examined for the habitat of the living freshwater plants and animals. The Geomorphological Assessment Index (GAI) model shows that the site is at A class in terms of its present geomorphological state. Therefore no significant change and human impacts could be noticed from both the hillslope and the river channel.

Plate 4. Indigenous vegetation was present along the river reach (mainly *Acacia Karoo*)

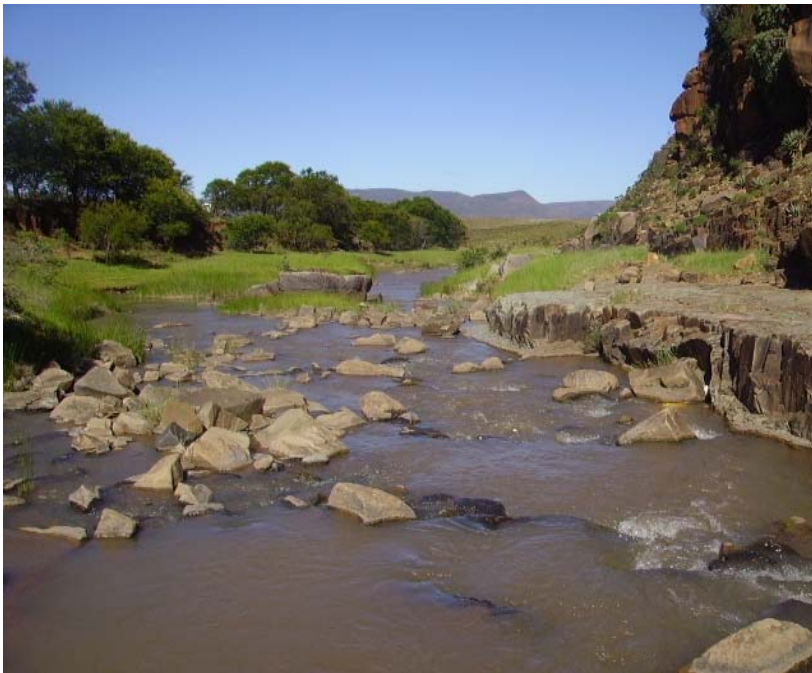
Plate 5.

The main idea of selecting the site below the Dam was to assess ecological impacts of impoundment. In addition, a weir immediately below the Dam could also be seen upstream of the site. The site is geographically situated in a Drought Corridor Level I Ecoregion at S10H Quaternary catchment. It is located in the White Kei River at S31° 51' 18.9" and S27° 11' 22.5" at an altitude of 886 masl. The site is positioned where the floodplain is confined on one side. Therefore most of the sediment from the hillslope can be entrained alternatively on floodplains and flood benches on both the river banks. On a reach scale, the river is a multiple thread, straight, mixed, pool-riffle system and also an anastomosing river bed. Because the site is located right below the Dam, the

sediment observed was directly from the hillslope and the Dam acts as a trap for any material from upstream.

At the same time, the sediment hungry waters from the Dam release could remove most of the fine sediments from the river bank and the hillslope. Due to this, the dominant material at a site is a fixed boulders and a bedrock material (Plate 5). However, about 63% of morphological units could be noticed at a site. The Geomorphological Assessment Index (GAI) model shows that the site is at C class in terms of its present geomorphological state.

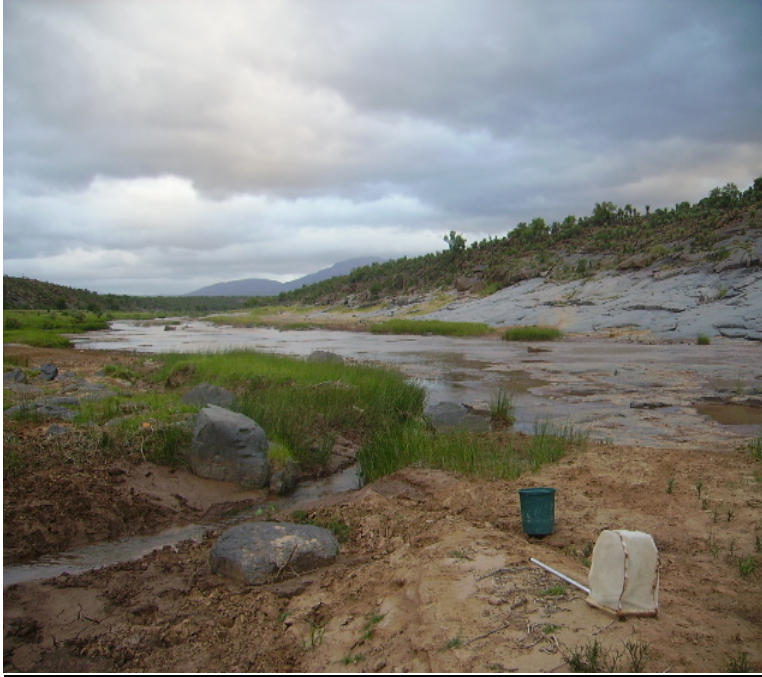
The site is situated in a Drought Corridor Level I Ecoregion at S10J Quaternary catchment. The site is in the middle reaches of the Kei River Basin in the incised channel and flood benches along the river system. The river at a site basically is a multiple thread, flat bedrock system (Plate 6). It could be observed that at a catchment scale lot of the sediment is from the hillslope and upstream of the river. Impacts of both the Lubisi (Indwe tributary) and the Xonxa dams (White Kei) both upstream of the site could have tremendous impacts on the river reach as well. This could be the result of catchment hardening due to vegetation removal occurring along the river system.

However, about 67% of morphological units could be perceived at a site. No sediment sampling could be done at a site due to its locality on a bedrock pool-rapid system.

The Geomorphological Assessment Index (GAI) model shows that the site is at B/C class in terms of its present state.

Plate 6. Note vegetation clearance on the hillslope.

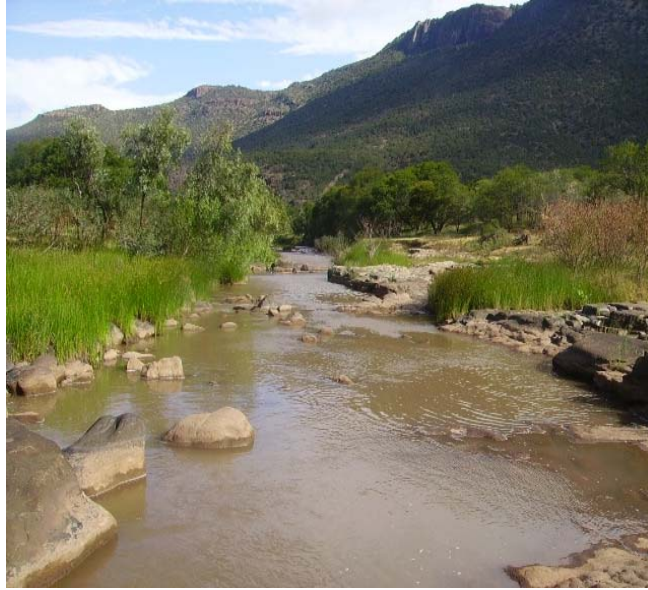
It is geographically located where the floodplain is confined on one side. The site is geographically situated in a Drought Corridor Level I Ecoregion at S32M Quaternary catchment (see Figures 4 and 5). The site consists of about 71% of morphological units described on the Geomorphological Assessment Index. The sediment from the hillslope can be deposited directly to the river channel with minimal resistance that occurs alternatively by the flood benches of both the right and left river banks. The river at a reach is single thread, straight, bedrock with some cascades. Interestingly, it could be noticed that the river channel at a site is a braided one, that is, numerous channels occurring at a site area. The Geomorphological Assessment Index (GAI) model shows that the site is at A class in terms of its present geomorphological state. Therefore no significant change might have occurred as compared to the reference condition (which is

difficult to determine). No sediment sampling could whatsoever occur due to the site's identity as being dominated by bedrock and some fixed boulders.

Plate 7. Black Kei at Mandalay.

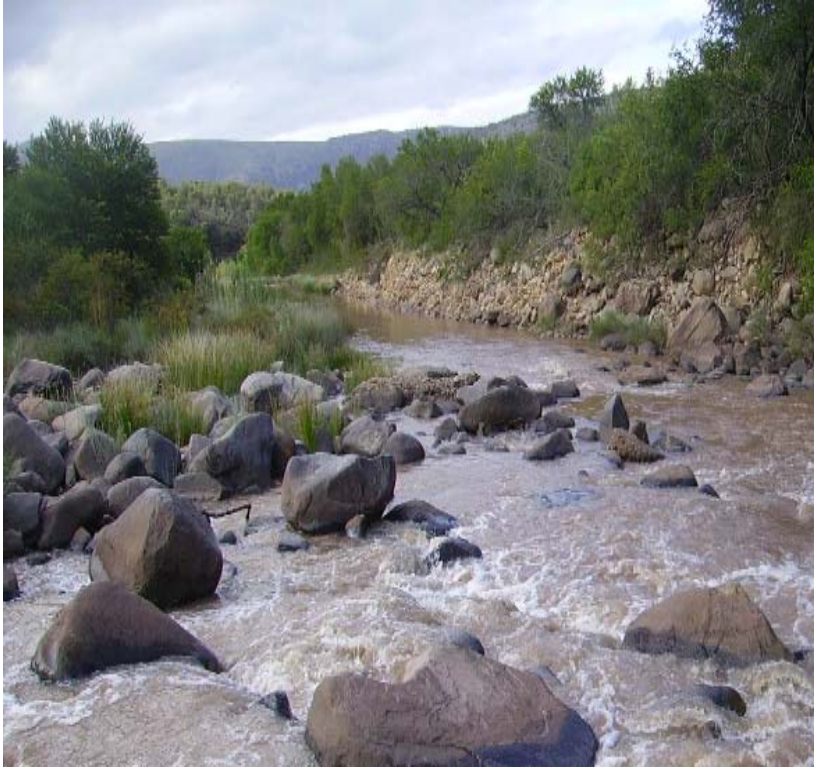
The site is located at Black Kei River at S32° 10' 43" and E27° 19' 49.3" at an altitude of 690 masl. It is geographically located where the floodplain is confined on one side. The site is geographically situated in a Drought Corridor Level I Ecoregion at S32M Quaternary catchment (see Figures 4 and 5). Its geographical location is where the floodplain is confined on one side. Morphological units (biotopes) observed comprise about 50%. The sediment from the hillslope can be deposited directly to the river channel with minimal resistance that occurs alternatively by the flood benches of both the right and left river banks. The river at a reach is single thread, straight, alluvial channel with boulders as dominant features. A weir immediately upstream of the reach could trap some fine sediments from upstream of the river system. The Geomorphological Assessment Index (GAI) model shows that the site is at B class in terms of its present geomorphological state. Therefore minimal local changes might have occurred as compared to the reference condition (mainly the weir). The river at a reach consists of fixed bedrock and thus no sediment sampling could be taken.

Plate 8. Black Kei at Turnstream: a typical alluvial scene that can be detected below impoundments.

However, the base flows for maintaining the recommended EMC could be considered, that is, for both development and ecosystem requirements (the Reserve).

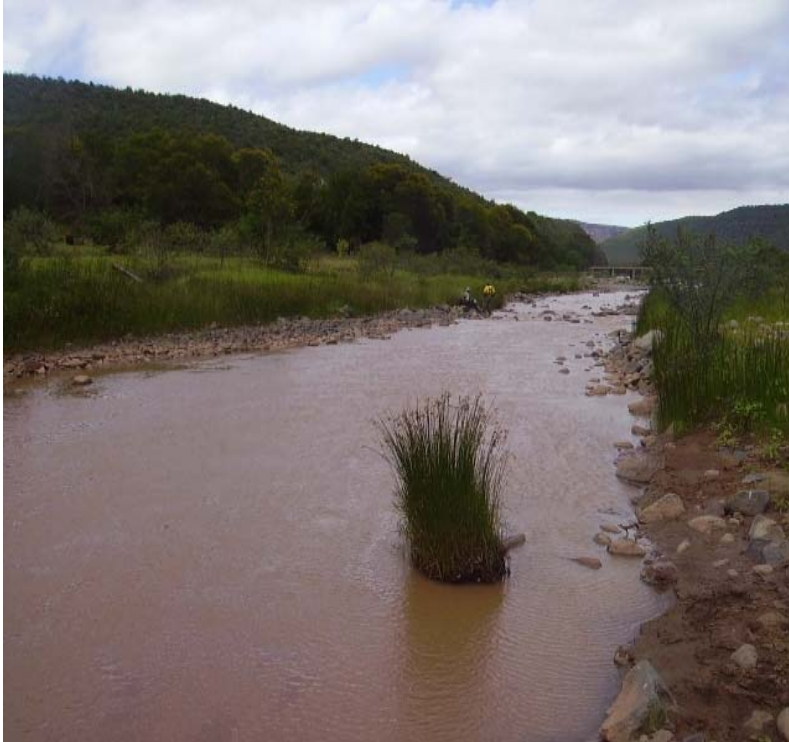
The site is located at upstream of the bridge at S32°16' 59.8" and E27° 39' 09.1" at an altitude of 596 masl. Using the Geographical Information Systems, it can be noticed that the site is geographically situated in a Drought Corridor Level I Ecoregion at S40E Quaternary catchment (see Figures 4 and 5). Furthermore, the site is right below the confluence of the two giant horns; the Black Kei and the White Kei. The river channel at a reach is incised with flood benches. Morphological units (biotopes) observed comprise about 83%. The sediment from the hillslope can be deposited directly to the river channel with negligible resistance by the flood benches of both the right and left river banks. The river at a reach is multiple thread, straight, mixed braided channel (flat bed on upstream), with a mixture of fixed boulders and bedrock as dominant features. Plate 9 below shows the Gaika Fort site of the Great Kei Basin.

Plate 9. Note down the turbidity of the water and a vegetated mid channel bar.

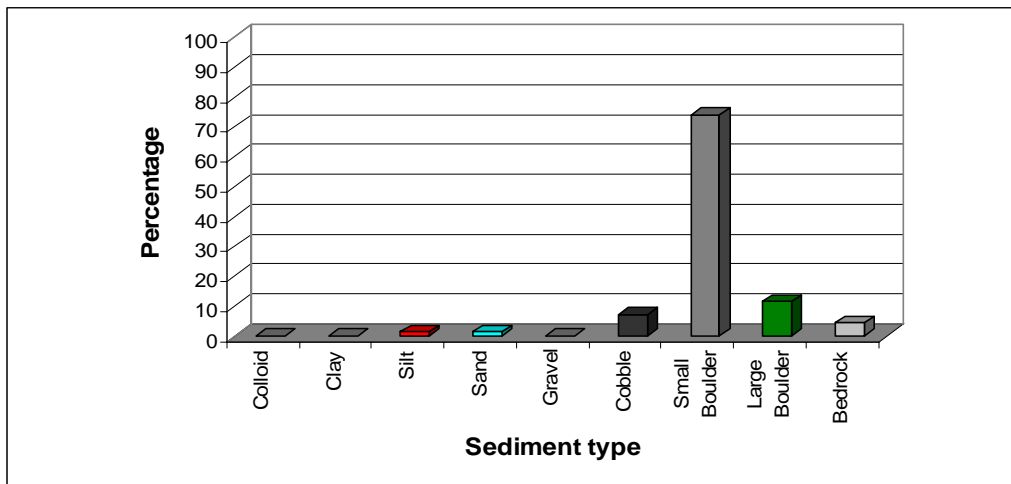
Sediment sampling was done at a minimal scale where there were few cobbles available at a riffle. It could be observed that the some fine material, probably mostly from upstream could be also be obtained. The figure below shows the distribution of sediment in the Great Kei River at Gaika Fort.

Figure 8. Percentage sediment distribution in Great Kei at Gaika Fort site.

The Geomorphological Assessment Index (GAI) model shows that the site is at B class in terms of its present geomorphological state. Therefore minimal local changes might have occurred as compared to the reference condition, possibly due to the impacts of landuse on the Black Kei and the White Kei 'horns'.

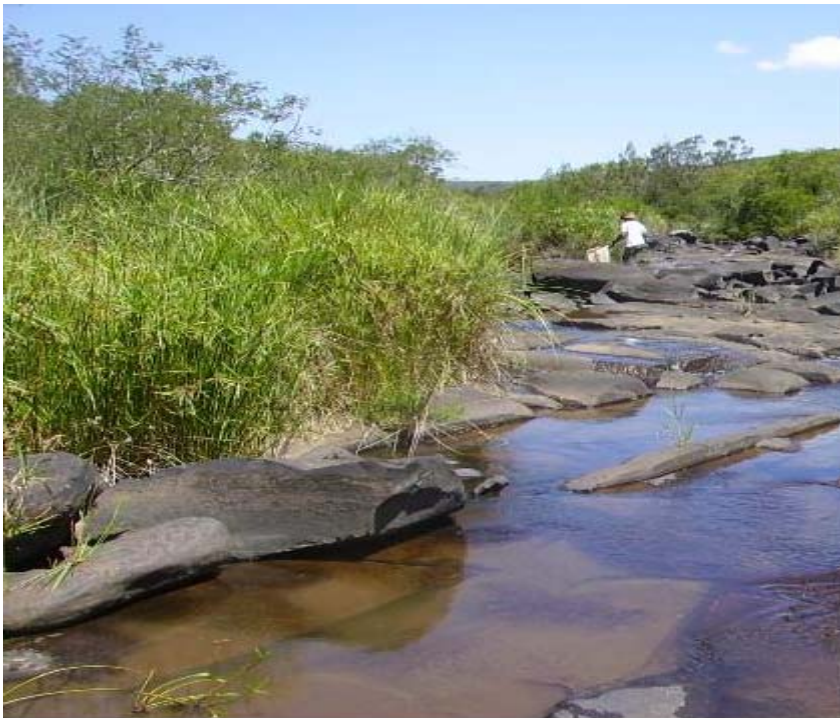
The site is located at Kubusi River at S32° 33' 44.5" and E27° 37' 13.4" at an elevation of 635 masl. The site is in the South Eastern Uplands Level I Ecoregion at S60B Quaternary catchment. The river at a reach is an incised channel with flood benches. Thus the sediment from the hillslope can reach the channel after it has been resisted locally by the flood benches. Morphological units (biotopes) observed comprise about 58%. In terms of morphology, the river at a reach is single thread, straight, bedrock pool-rapid system channel, with bedrock as dominant feature. The geomorphology at the site area is influenced by the impacts of the Wiggleswade Dam (less than 10 km upstream).

These include the morphology of a site area being a bedrock channel, which is not a normal feature of a river on its middle reaches. Plate 10 below shows the Kubusi River at Hammerhead.

Plate 10. Bedrock dominated Kubusi River at Hammerhead.

Therefore it is not astonishing to discover that the Geomorphological Assessment Index (GAI) model shows that the site is at C class, which is almost certainly that this was due to dam impacts. Due to the bedrock and fixed boulder material downstream, no sediment sampling could be done at a site.

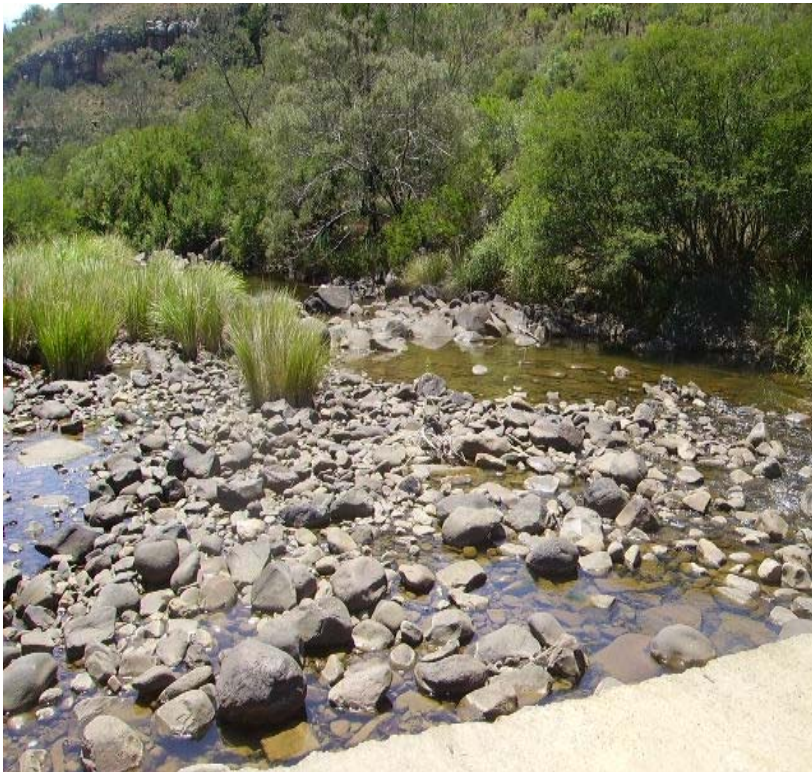
Plate 11.

The site is located at Kubusi River at S32° 30' 26.3" and E27° 43' 53.6" at an elevation of 438 masl. The site is in the South Eastern Uplands Level I Ecoregion at S60E Quaternary catchment. This is in a rejuvenated foothill. The river at a reach is found where the floodplain is confined on one side. Thus the sediment from the hillslope can reach the channel after it has been resisted locally by the floodplain on one side and by the flood-bench on the river bank alternatively down the river reach. Morphological units (biotopes) observed comprise about 58%. In terms of morphology, the river at a reach is multiple thread, straight, mixed alluvial pool-riffle system. Dominant features in the channel are fixed boulders and some few cobbles together with bedrock. Plate 11 below shows the Kubusi River bridge site.

The GA index shows that the river at a reach is at B class and therefore impacts of the dam further upstream still exist, together with the impacts of the bridge at a site area.

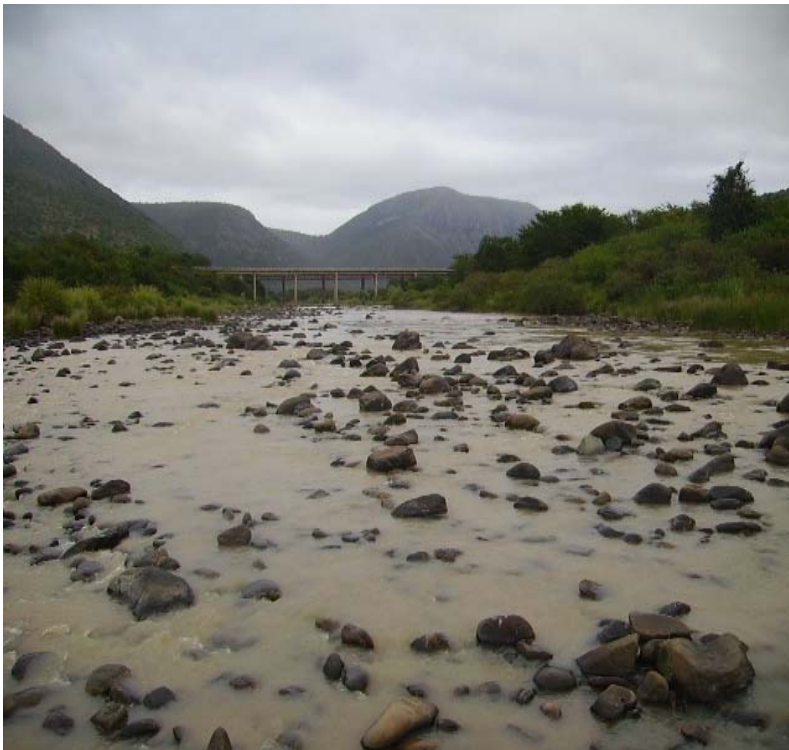
The site is located downstream of the bridge at S32° 30' 26" and E27° 43' 53.4" at an altitude of 148 masl. The site is in the South Eastern Uplands Level I Ecoregion at S70B Quaternary catchment (Refer to Figures 4 and 5). Its geographical location is where the floodplain is confined on one side. Morphological units (biotopes) observed comprise about 50%. The river at a reach is single thread, straight, mixed alluvial channel with boulders and cobbles as dominant features. Three bridges and a weir immediately upstream of the site could have significant impact on the river at a site (refer also to plate 12 below). The Geomorphological Assessment Index (GAI) model shows that the site is at C class in terms of its present state. Therefore a lot of local changes might have occurred as compared to the reference condition (mainly due to the weir, bridges and intensive local sediment mining). However, the natural vegetation at a reach scale is still in its near natural state, except some few of *Lantana spp.* Plate 12 shows the Great Kei River at N2 Bridge.

Plate 12. Kei River bridge site.

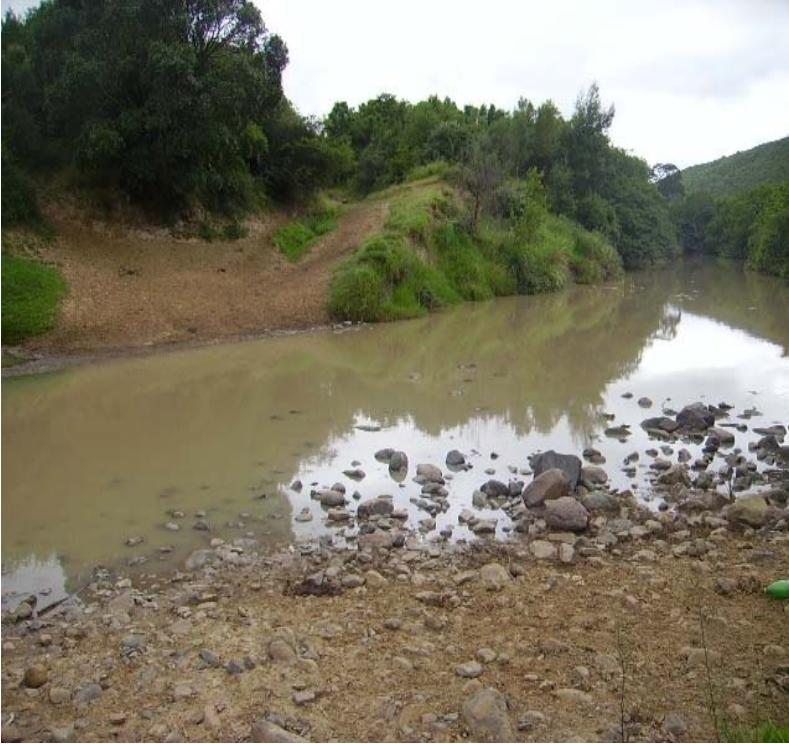
The site is located upstream of the Gcuwa River S32° 16' 58.8" and E28° 59' 7.2" at an altitude of 154 masl. The idea to select the site was to obtain to ground truth the ecological state of the Gcuwa River system before being impacted by the urban settlement of Butterworth. If possible, the reference state could be recorded on at a site. However, due to its poor condition, no assessment was done there. In fact the site was not fully accessible due to its dense vegetation along the river banks, as well as very deep pools both upstream and downstream of a site (Plate 13).

Plate 13. Showing dense indigenous vegetation and deep a pool.

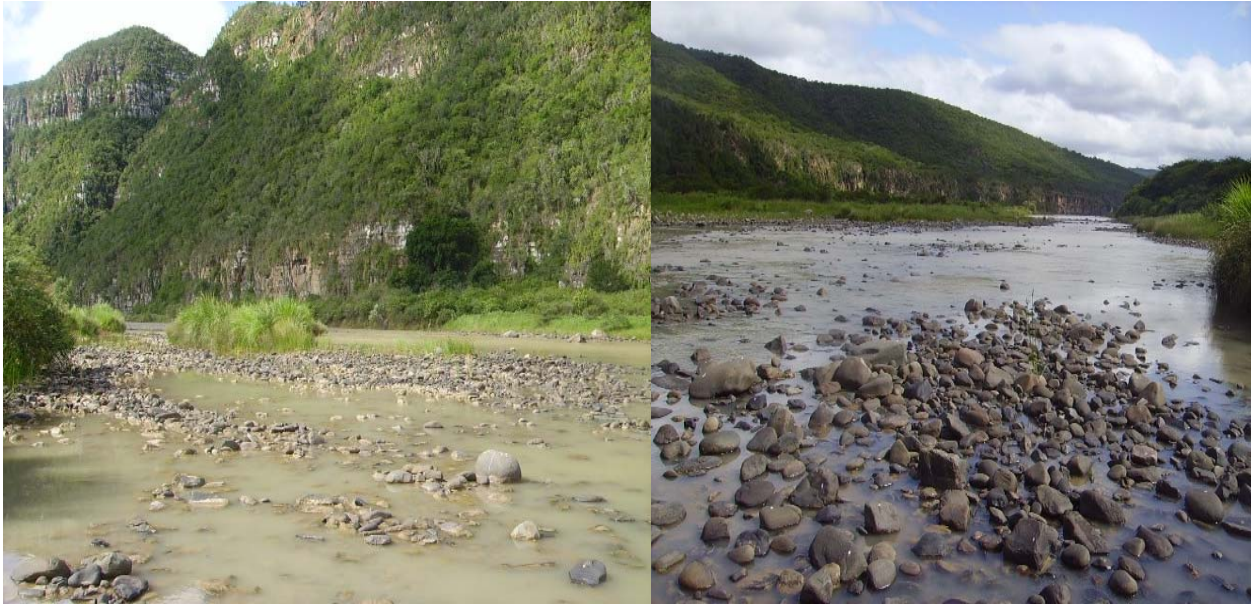
The site is located at the Great Kei immediately below the confluence of the Great Kei and the Gcuwa tributary at  $S32^{\circ} 32' 41.1''$  and  $E28^{\circ} 11' 37.9''$  at an elevation of 65 masl. The site is in the South Eastern Uplands Level I Ecoregion at S70E Quaternary catchment. The site is in the lower reaches immediately above the estuary in about 24 kilometer distance (refer to 1:50 000 toposheets and Google Earth). Landuse involved at a catchment scale is a small scale commercial agriculture and stock farming, as well as a game reserve on the hillslope. The idea of selecting the site at that reach was to assess the present state of the river system after the Great Kei has been joined by the Gcuwa River, with the latter having significant impacts of the urban settlement of Butterworth (mainly sewage works, agriculture, settlements, dams etc). The river at a reach is an incised channel with flood benches. Morphological units (biotopes) observed comprise about 54%. In terms of its morphology, the river at a reach is multiple thread, sinuous, mixed alluvial, pool-riffle system, often with flat bed. Plate 14 below shows the Great Kei River site at Glen.

Plate 13.1: Note algae and turbidity of the water.

Plate 13.2: A typical alluvial channel.

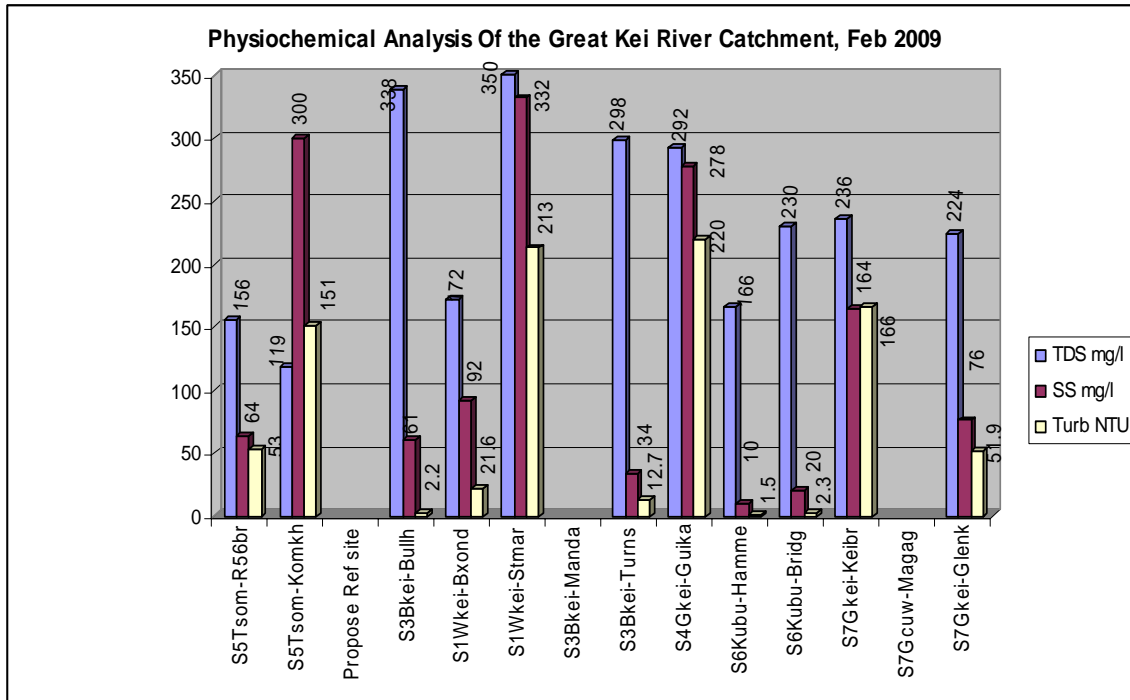
Figure. 13. Physiochemical analysis of the Kei River Basin (Total Dissolved Solids, Suspended Solids and Turbidity).

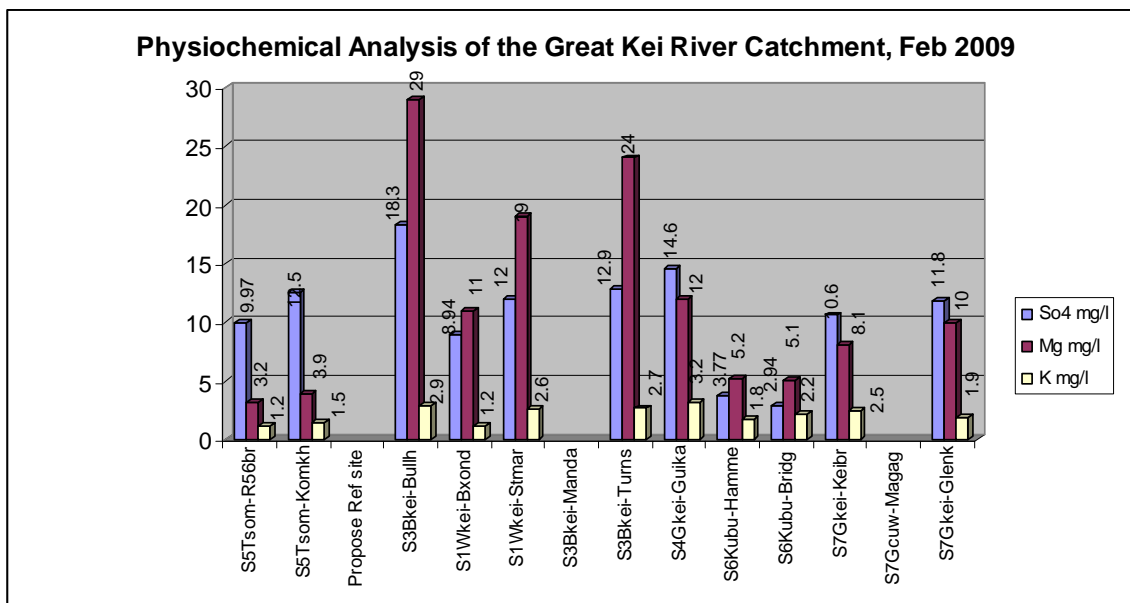
Figure. 14. Physiochemical analysis of the Kei River Basin (Sulphates, Magnesium and Potassium).

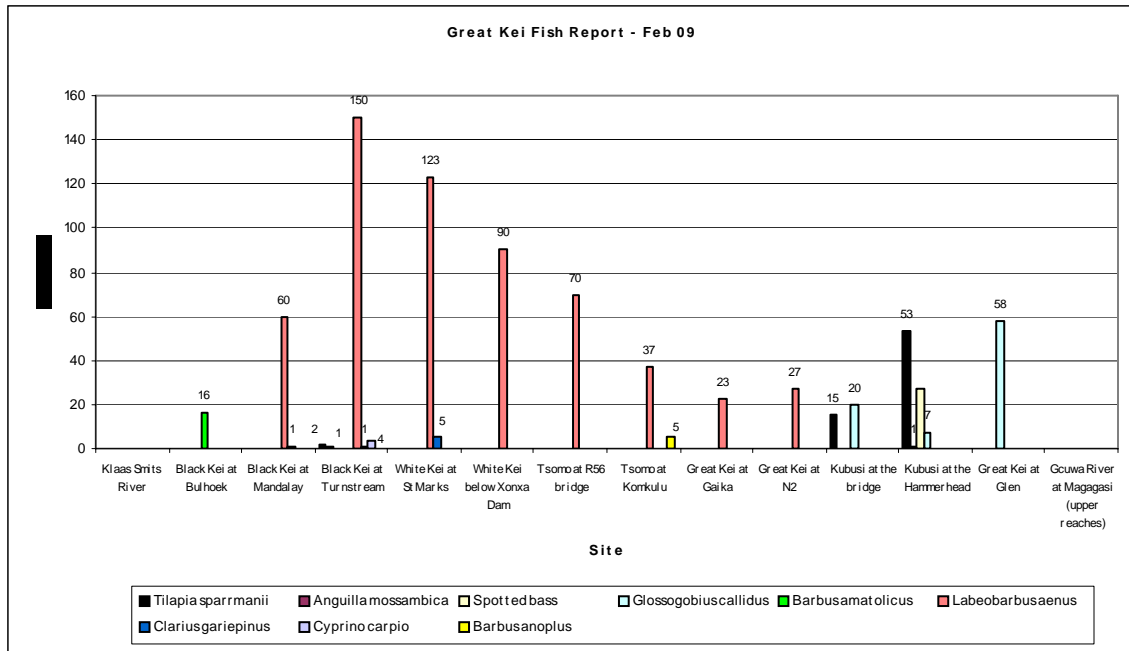
Fig 16: Histogram indicating the fish species distribution within the Great Kei River.

In terms of the fish data, it could be noticed that the Great Kei River Basin the whole catchment is dominated by an alien yellow fish hence most of the sites are in E –class. The indigenous species were mainly caught on the 'near natural, sites like the Tsomo Bridge (Table II). The indigenous species were mainly caught where no significant changes in the geomorphology and water quality of the river. For example, the *Barbus amatolicus* was caught at Black Kei at Bulhoek (upper reaches). It can be observed that the middle reaches of the Great Kei River Basin are in a poor ecological state in terms of fish. In fact no indigenous species were caught on the middle reaches where most human landuse changes occur, accompanied by the alien fish invasion. The indigenous fish species were also caught in the lower reaches where the river starts recovering from most perturbations (landuse and alien invasion). For example, a lot of the species of

*Glosogobius callidus* were caught in the Kei River at Glen Figure 16) though none were found on the Kei Bridge site probably due to yellowfish invasion together with deprived migration of fish by the upstream weir and bridges.
