BIOMONITORING OF THE KIESKAMMA RIVER SYSTEM (R 10 CATCHMENT)

EXECUTIVE SUMMARY

This report provides the results of the biomonitoring survey that was undertaken in November 2007. Field indices used for data collection included the South African Scoring System version 5.0 (SASS5) for Macro invertebrates and the Fish Assemblage Integrity Index for fish (FAII).

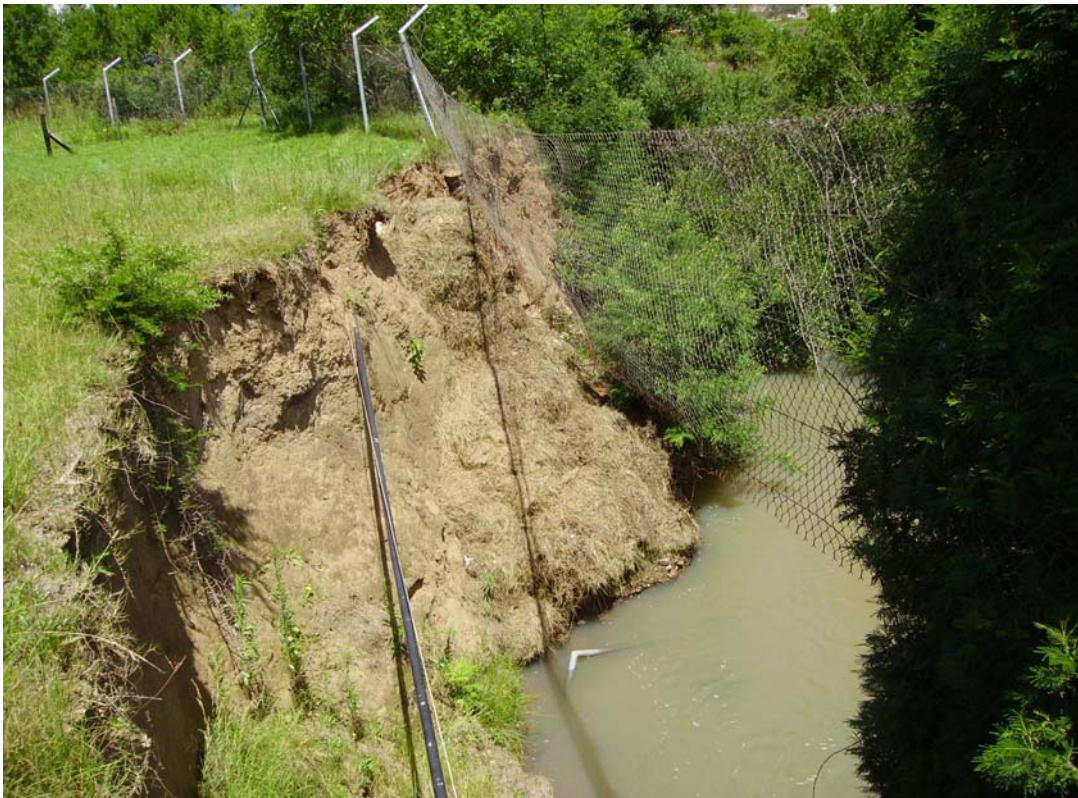
Figure 3. Badly eroded Keiskamma river banks just next to S.S Gida Hospital. The erosion is so bad that a substantial mass of S.S Gida land has been lost, leaving exposed

Power lines and a portion of the property fence hanging in the air.

If one looks at figures 3 and 4, it would be noticed that the hospital property is well fenced and the river is deeply incised and forms intervals of fairly deep pools, this means live stock cannot graze easily on the eroded river bank. The duplex and sandy soil nature is clearly visible on these two sample pictures taken along the Keiskamma River. The abundance of this soil type through out this catchment and live stock grazing would lead silting of the river and this could have an effect on the estuarine environment. From an engineering perspective most major dams (if not all) Sandile Dam included are not equipped to have continuous environmental flows. It must also be noted that a recent study of hydrological flows in the R 10 catchment reveals a huge surplus of water available and the fact that the Keiskamma estuary is a permanent open system.

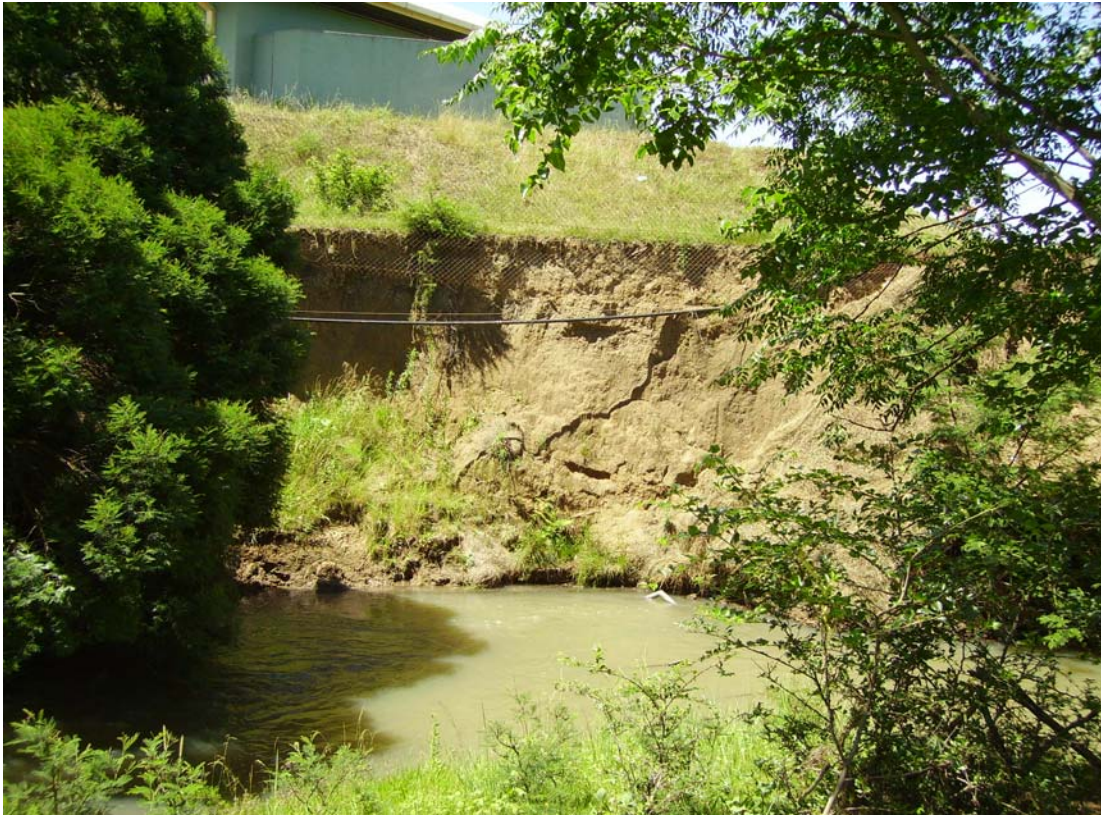
Figure 4; The erosion around the back of this hospital was so severe and progressive that it threatened taking down some of the hospital buildings.

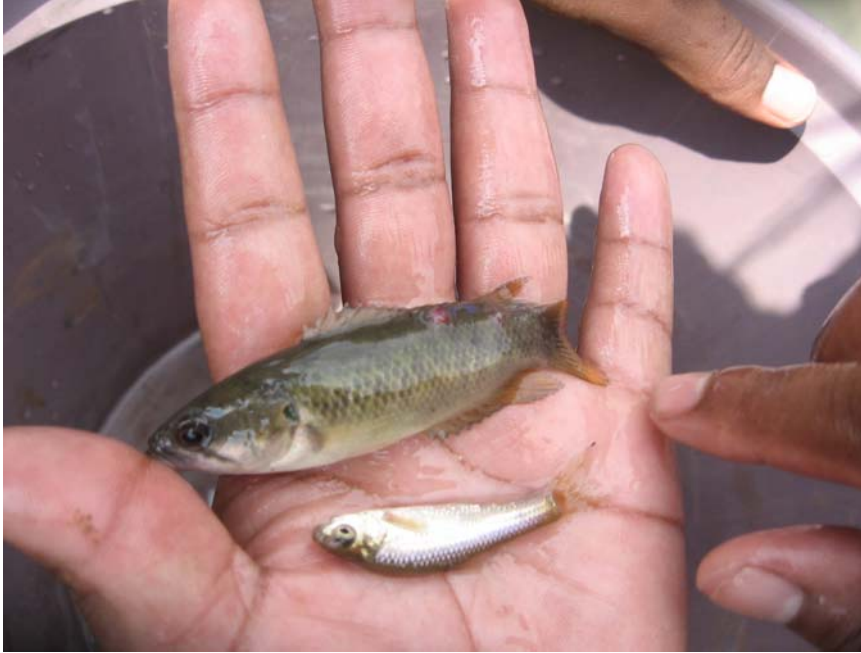
Fig 2: *Sandelia bainsii* and *Barbus anoplus* caught in Keiskamma below the church

According to the Fuzzy Fish Index (FFI) Site 2 is at Category B, there were indigenous fish, in a healthy condition, although very few individuals were caught. This indicates that the site is in good condition. Two out of four expected species were found in this site, that is, *Sandelia bainsii* and *Barbus anoplus*. *Sandelia bainsii* is an endangered species in the Eastern Cape Province. The other expected indigenous species are *Barbus trevelyani* and *Glossogobius callidus* but were not found.

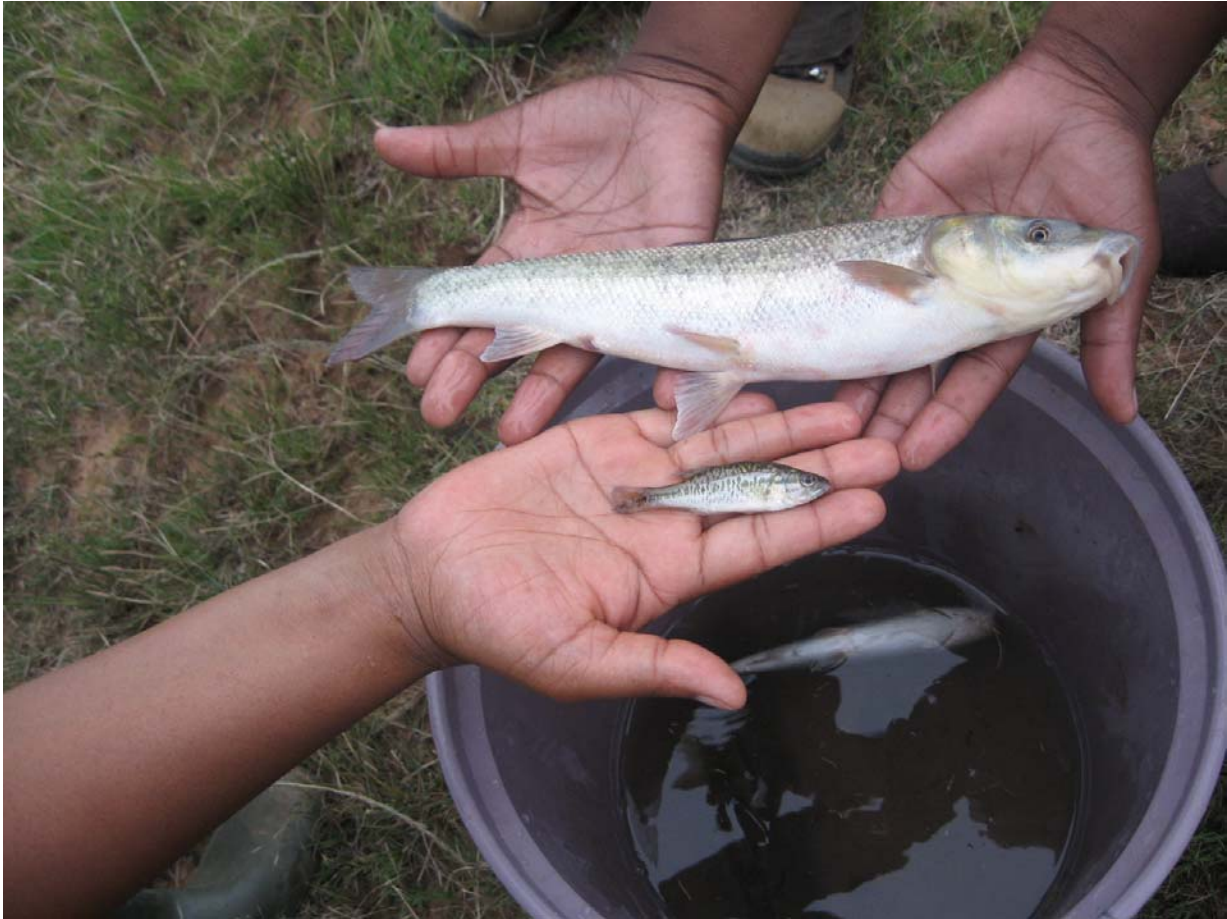
Fig. *Labeo umbratus* and *Micropterus salmoides*, alien species caught in Keiskamma river below Sandile Dam

In this site only the alien species *Labeo umbratus* and the largemouth bass *Micropterus salmoides* were found. This results in this site sitting at category E (FFI) due to alien infestation. As a result of this infestation by aliens, indigenous species were not found.

The team that conducted the fish assessment has started removing the alien species by not returning to the site. This will continue until a suitable procedure is found for removing these alien species. An option of using a fish shocker needs to be exploited. It will be more helpful in sites where big rocks hold the net, some fish live/hide well under rocks, deep flows, slow or no flows.

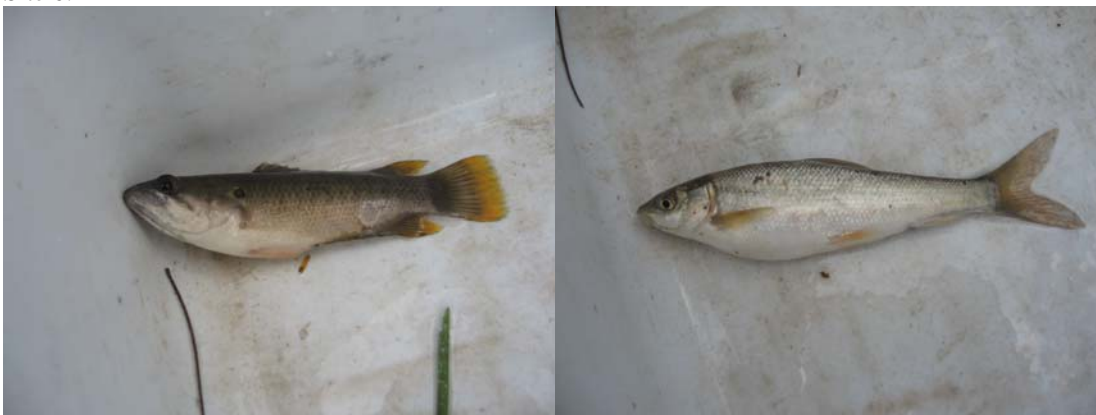
Fig. *Sandelia bainsii* and *Labeo umbratus* caught in Tyume river at Fort Hare

This site is at Category D, meaning that it is in poor condition. Only two individuals of indigenous, endangered species were caught in this site, and double the number of alien species. That is why this site is in a poor condition.

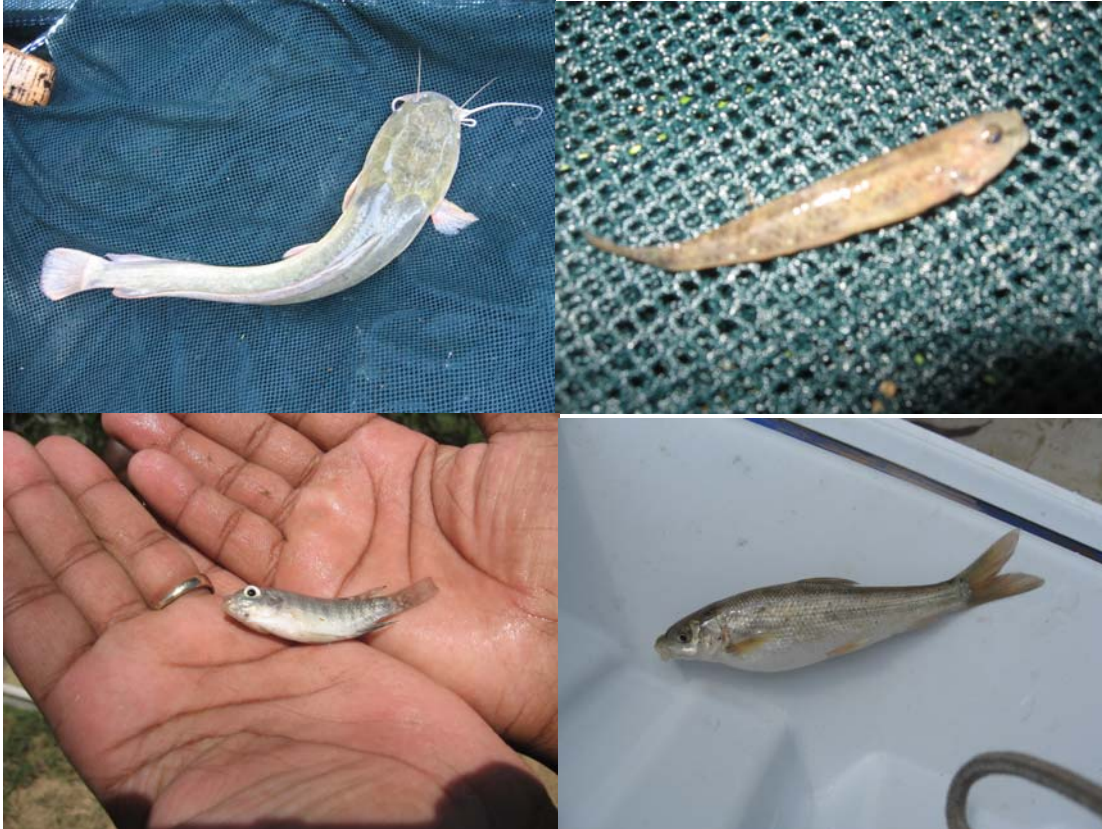
Fig Top right: The alien *Clarias gariepinus*, Top right: The indigenous *Glossogobius callidus*, Bottom left: Alien *Tilapia sparrmanii*, and Bottom right: The alien *Labeo umbratus*. All were caught in Tyume river before the confluence with Keiskamma river.

According to the Fuzzy Fish Index (FFI) this site is at Category D, due to the presence of alien fish species, the *Labeo umbratus*, *Clarias gariepinus* and *Tilapia sparrmanii*. The *Clarias gariepinus* is a predator of fish. *Glossogobius callidus* is the only indigenous species found in this site. This site is in a poor condition.
