MONITORING OF THE BUFFALO RIVER

Report prepared by M. Nduna, S. Mzileni, L. Gaulana and E. Weni

February 2010

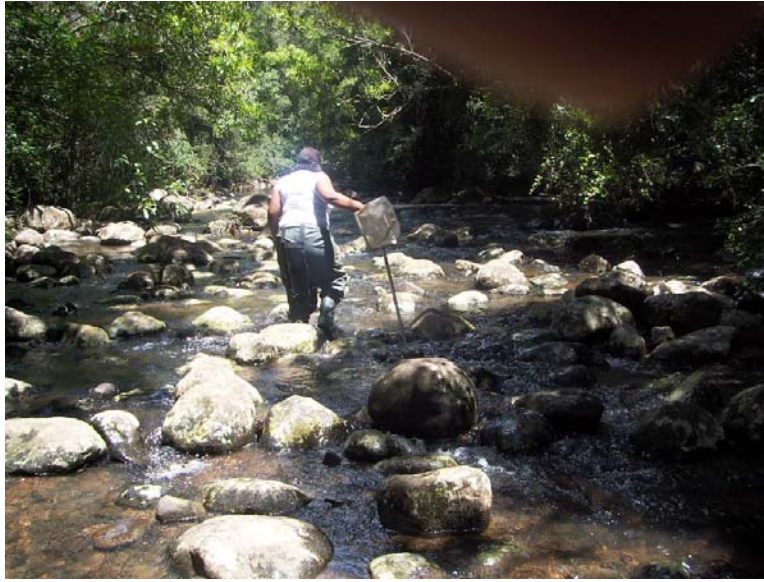
1. Above Maiden Dam

Species diversity was low and abundance was very low at this site and the SASS 5 results put this site at **fair** condition. The samples were mostly dominated by Betidae. There is no vegetation at this site and the samples were only collected from two biotopes, namely, the stones and the GSM (gravel, sand & mud). The low species diversity at this site may be associated with the lack of habitat, thus leading to the absence of species inhabiting in such areas.

Plate :1. A picture showing biotopes sampled at site Above Maiden Dam.

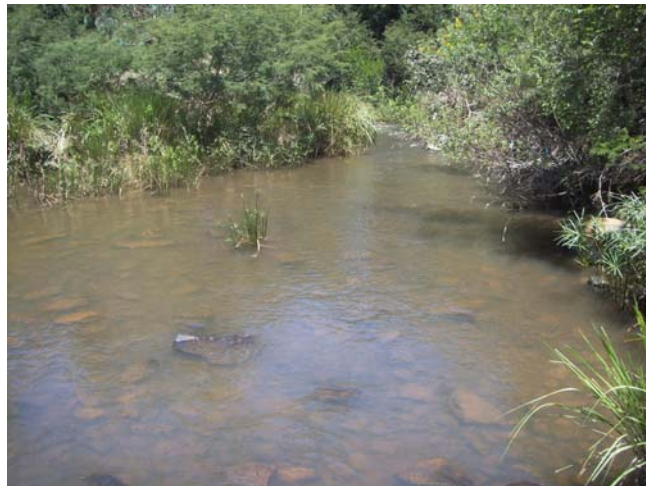
2. Mgqakwebe River

This site is a tributary of the Buffalo River and the species diversity was very high. According to SASS 5 results this site is at a **Good** condition. Vegetation inverts are not included here due to the absences of this biotope at this site. Only the submerged vegetation was present.

Plate 2. A picture showing biotopes sampled at the site at Mgqakwebe River.

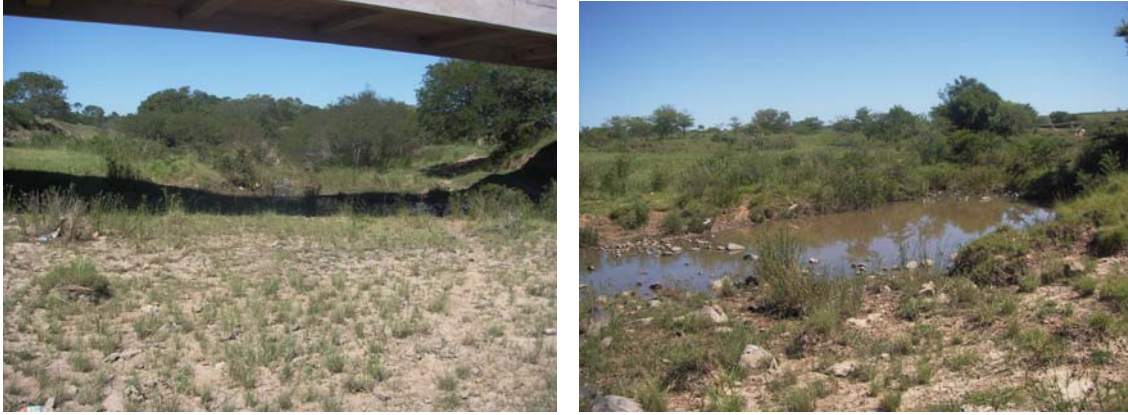
3. Buffalo@ Lonsdale Bridge

There was no water under the bridge and the only area that had water was a small shallow pool below the bridge (see Picture below).

Plate 3. A picture showing low flows at the Lonsdale Bridge (left =Upstream; Right = Downstream).

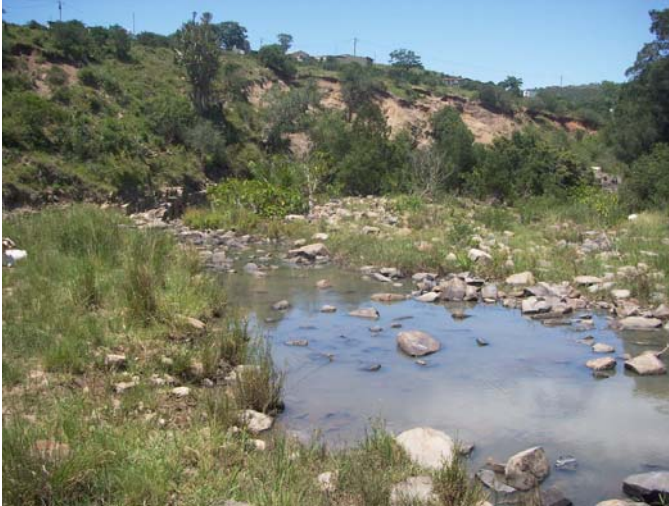
5. Buffalo@Nxamkwane

This site is at a **fair** condition and the species diversity was low. The site is mostly dominated by stones; therefore low species diversity might be associated with the lack of habitat.

Plate 5. A picture showing biotopes sampled at Nxamkwane River

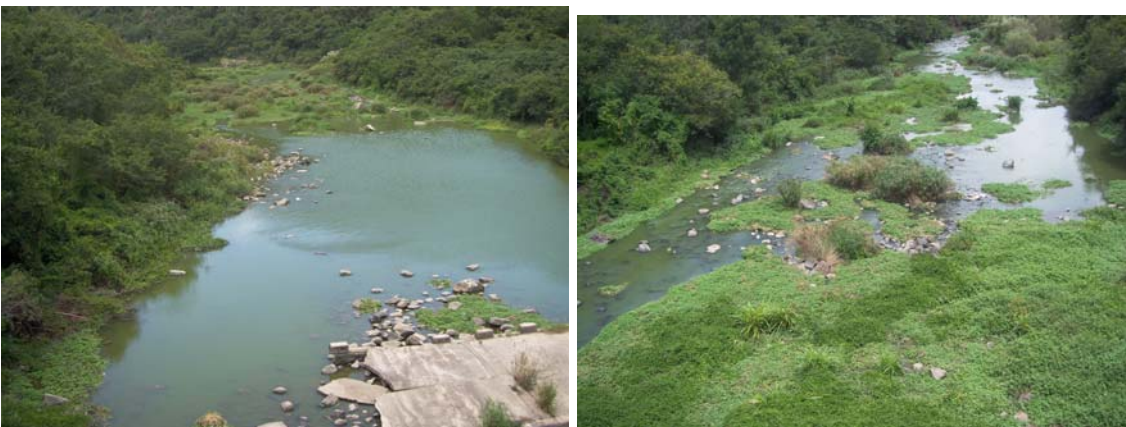
6. Buffalo Pass

Plate 6. A picture showing the condition of the Buffalo Pass (left = Upstream; Right = downstream).

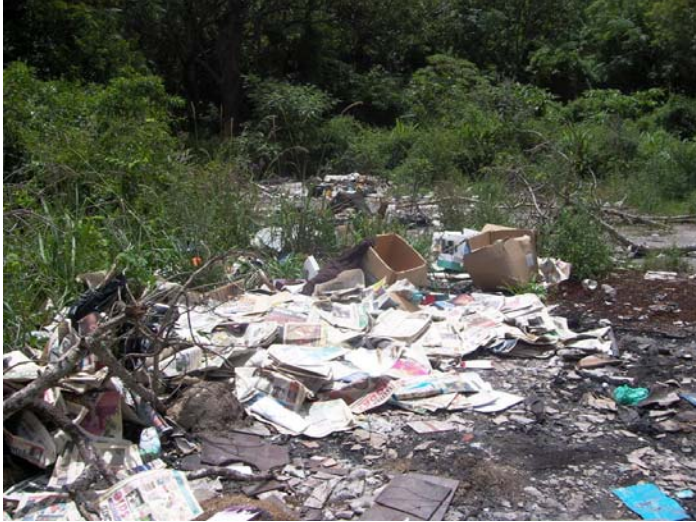
There was no access to this site and the entrance to the site is used as the dumping site (see fig 11).

Plate 7. A picture showing an illegal dumping site at the buffalo Pass.

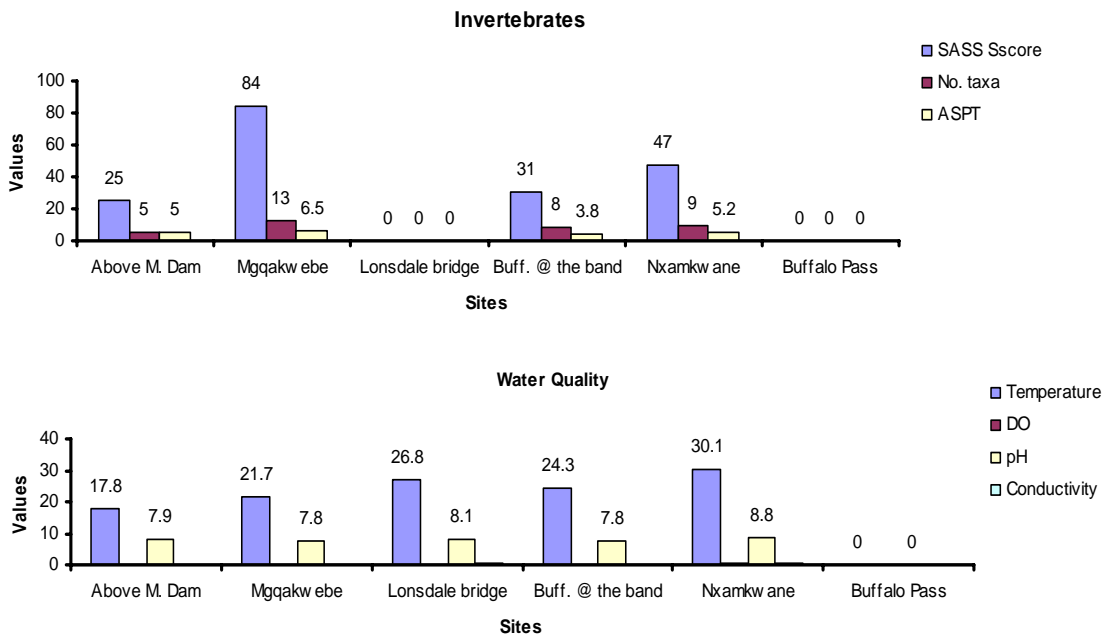
Temperature was high throughout the river ranging from 17.8oC to 30.1oC. Dissolved oxygen was low in the entire sites and the pH was constant throughout the river.

Fig. 1. Graphs showing the invertebrate and the water quality results at the Buffalo River.
