MONITORING OF THE BUFFALO RIVER

FEBRUARY 2009

Department:
Water Affairs and Forestry
REPUBLIC OF SOUTH AFRICA

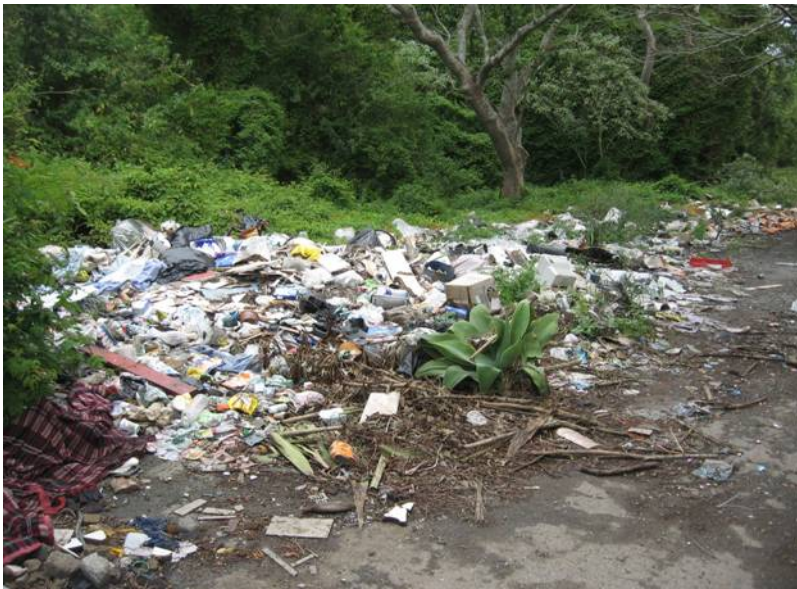
At Buffalo pass the site is being again being used as a dumping site. **See evidence below:**

A letter requesting operational clean up at Buffalo pass should be submitted to Municipality to avoid solid waste being flushed down to the river and it is also blocking access to the river.

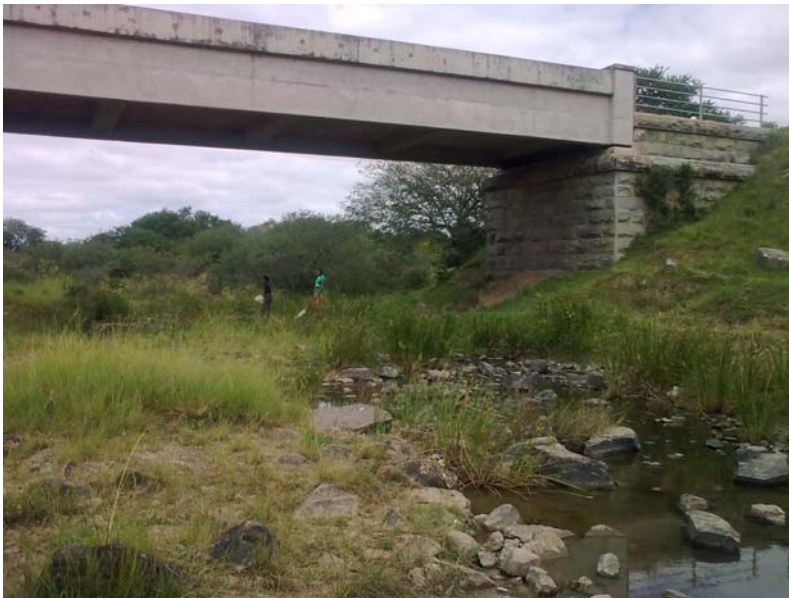
Site 3: Lonsdale Bridge

At this site the flows were very low and there was a lot of Algae.

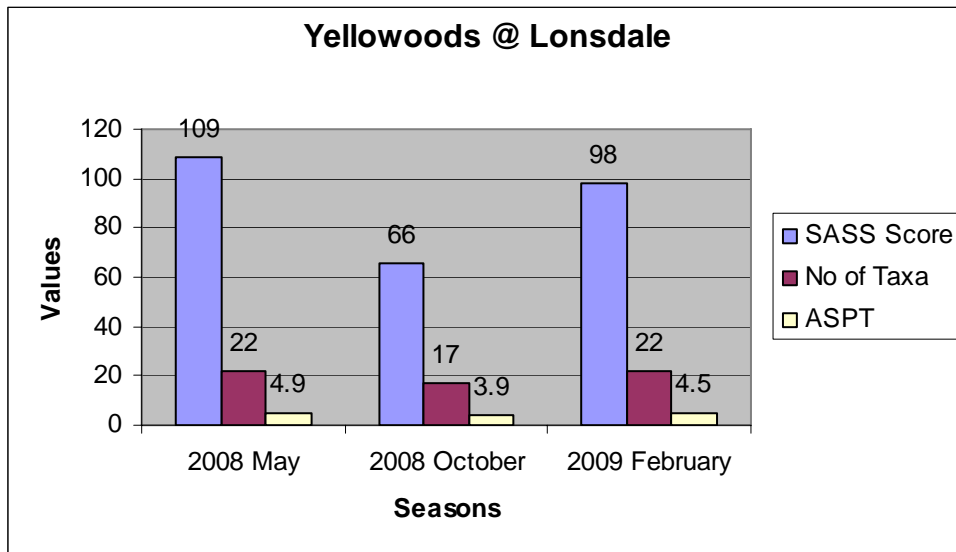
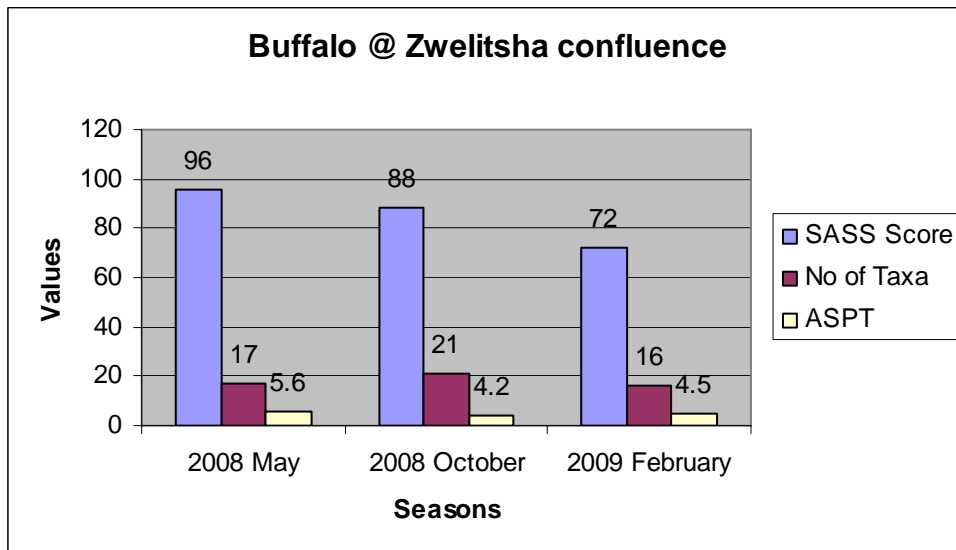
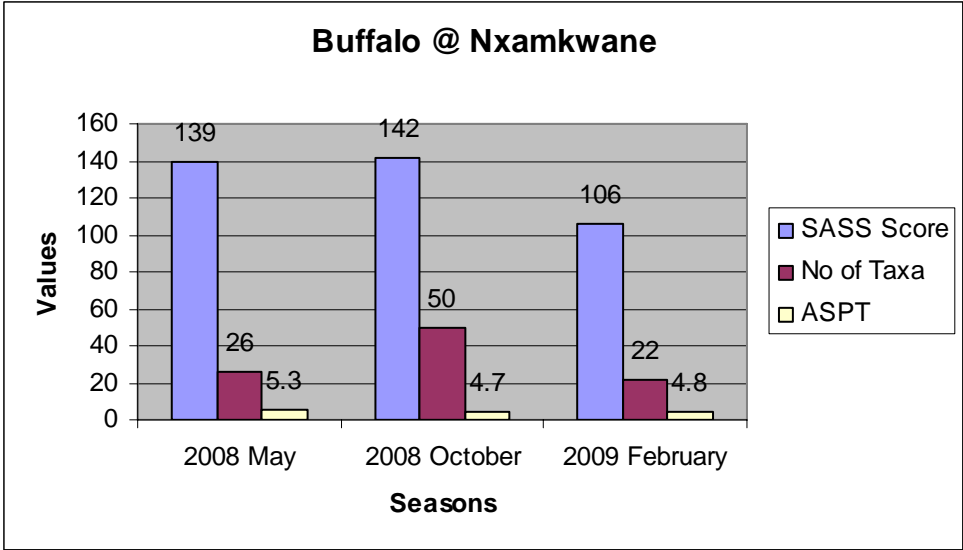
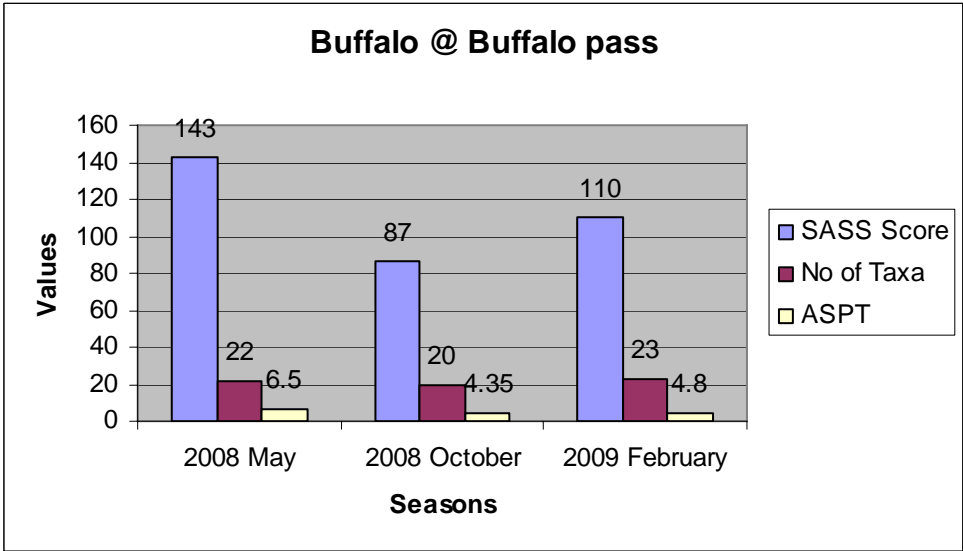
Figure 3: showing SASS 5 surveys in different seasons

During October monitoring; at Lonsdale bridge algae was a huge problem and flows were also extremely low; this made it difficult to identify macro inverts and more tolerant species were sampled as compared to February monitoring, at the confluence the water quality was very poor possible due to urban run-off from Zwelitsha town. This has affected the SASS score (Leeches-very low scorers were sampled in great numbers). At Nxamkwane flows were very low and a lot of algae; this has affected diversity of intolerant species.

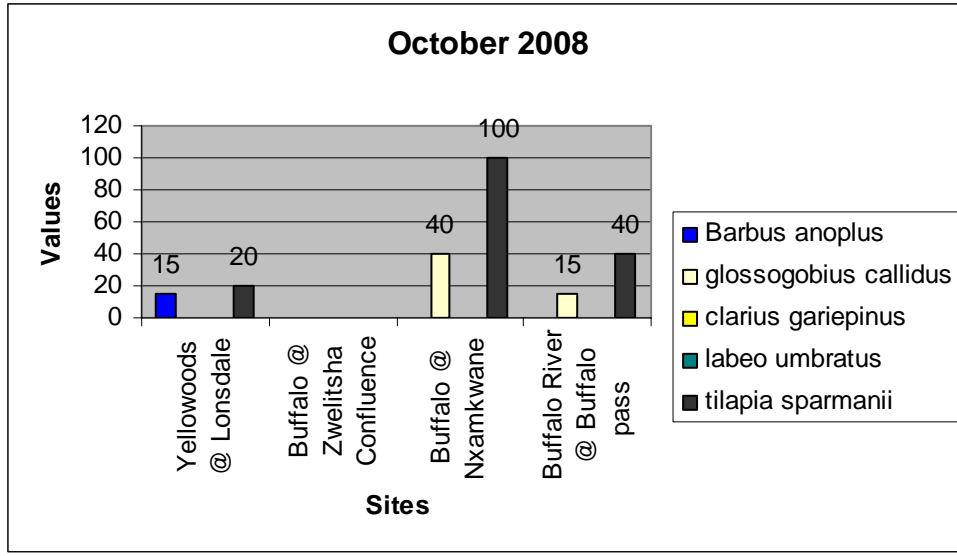
Figure 7: showing fish caught in October 2008.

The Buffalo River is dominated by *T sparmanii*. These species are affecting the abundance of indigenous species. At Lonsdale bridge b. anoplus was infected due to poor water quality. At the confluence the catfish that was caught there indicates signs of pollution. This may be possible from the sewage treatment works that is above this site.
