MONITORING OF THE GONUBIE RIVER

SUMMER 2009

**Prepared for:
Department of Water Affairs and Forestry
River Health Program
P.O. Box 7019
East London
5201**

**Prepared by L. Gaulana and E. Weni
21 April 2009**

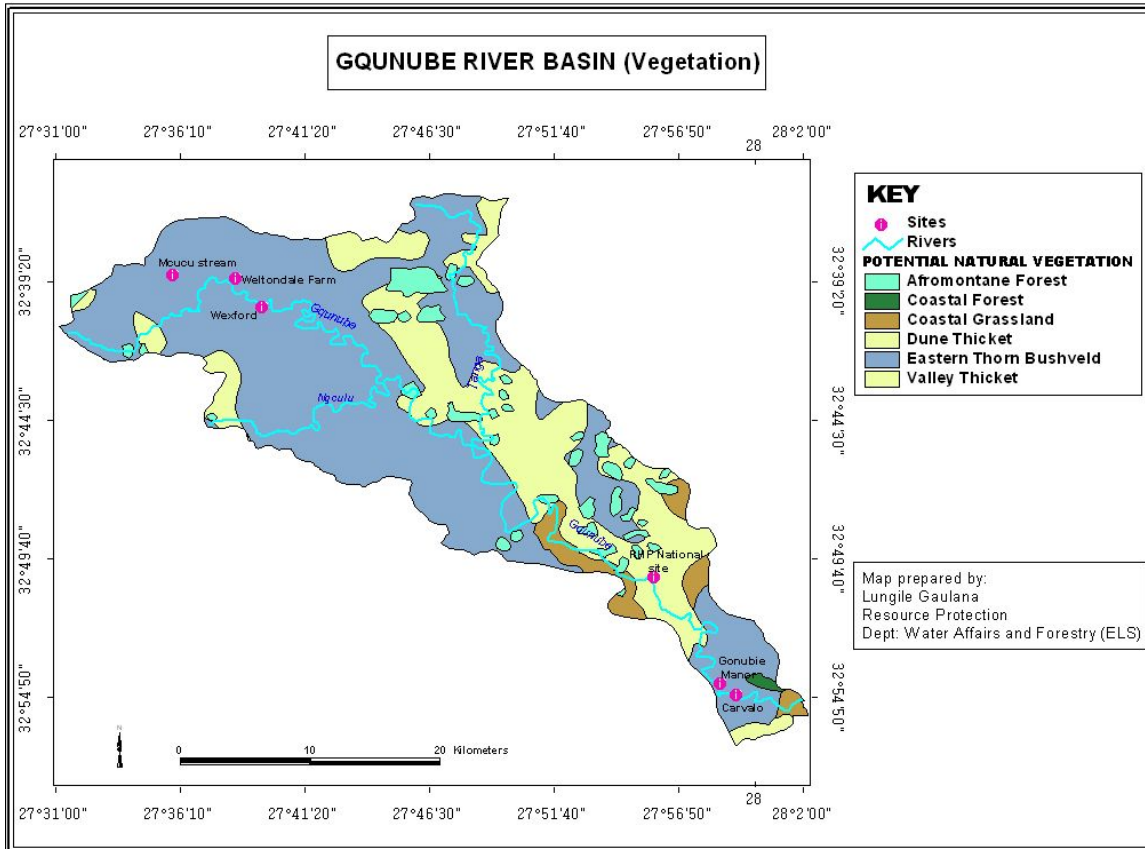
The Gqunube River drainage region is dominated by the Eastern Thorn Bushveld on its plains and the Valley Thicket on its valley. Some patches of vegetation types present include the Afromontane Forests, the Coastal Forest, Coastal Grasslands and the Dune Thicket found along the coast. (See figure 4 below).

Figure 4: Vegetation of the Gqunube River Basin (After Louw and Rebelo, 1996).

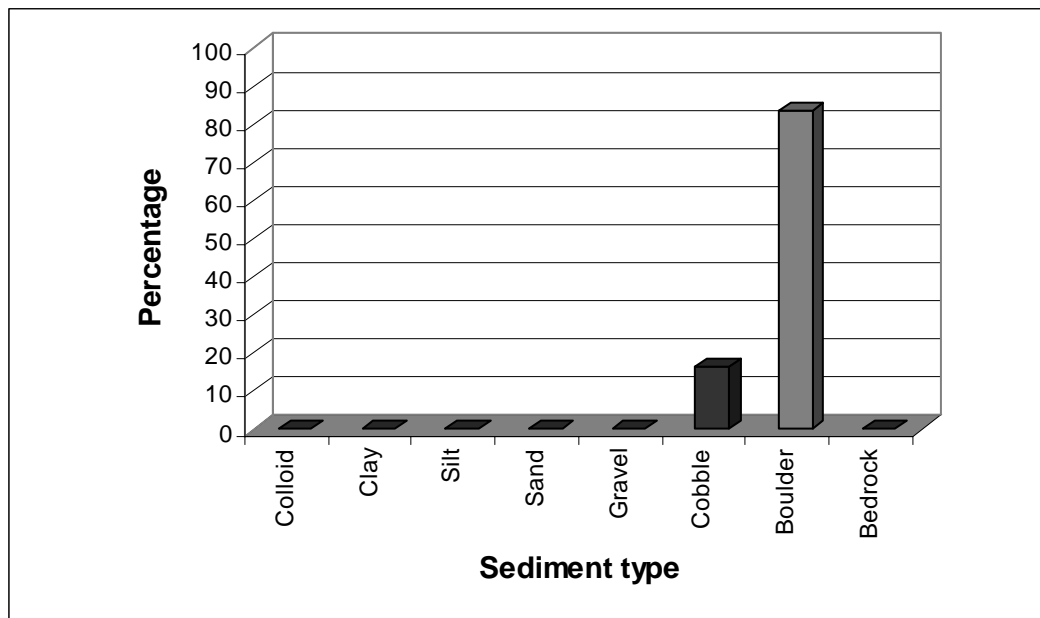
The Gonubie Minor site is located in an incised channel with flood benches, that is, areas along the river channel often inundated by annual floods. Thus beside the sediment from upstream, the sediments from the hillslope in the form of colluviums can be trapped on negligible basis on flood benches before they can be easily eroded downstream during annual floods. The river at a site is a single thread, straight, pool-riffle arrangement, with boulders and cobbles as pre-dominant attributes. Morphological units observed comprise about 42%, that is, the biotopes for the aquatic flora and fauna. A broken weir at a site was observed, which would contribute to increased sediment transport towards downstream to the Ocean. Sediment sampling, though in poor conditions upstream and downstream of the weir, was done at a site. It could be found that the major features were the boulders and cobbles (with boulders gaining the highest percentage). The figure below shows the result of sediment sampling in the Gonubie Minor site of the Gqunube River.

Figure 6. Distribution of sediments in the Gonubie Minor site. Note the unavailability of fines.

The Geomorphological Assessment Index reveals that the river at a reach is at C class, meaning that the reach is moderately to highly modified (geomorphology).

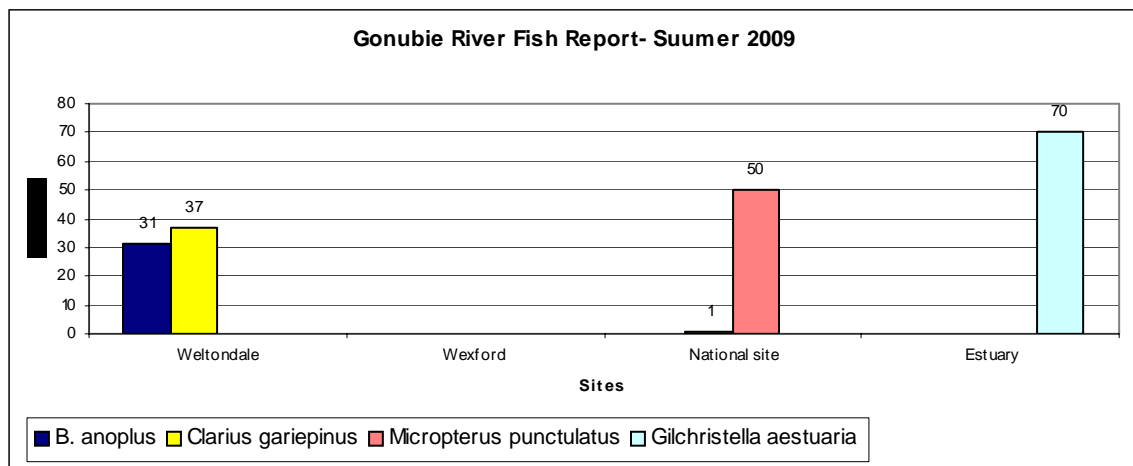
Fig 7: Illustrating fish species distribution within the Gonubie Catchment in Summer 2009.

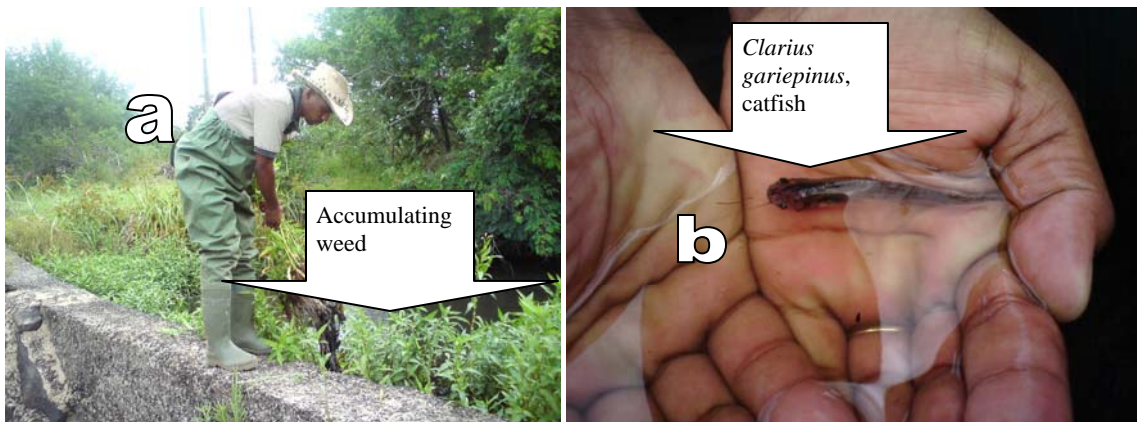
Plate 1: Showing the accumulating weed (a) and the catfish (b) at Weltondale Farm site.

This site is at the low water bridge at E.V. Krull Farm or Weltondale, along R63 Komga Road which connects N2 and Bisho. During the monitoring, there were no flows. Just below the weir/bridge, the water was turbid and we spotted a water skink. Also in this site, there was an accumulating waterweed at the weir wall. A shoal of predacious alien catfish larvae were noted in this site, habiting under this weed. The Fish Fuzzy Index (FFI) for this site was **D**, indicating a largely modified site.

Working for Water (WfW) needs to be informed about the aquatic weed, to both identify and eradicate it. Resource Protection officials need to do “operation clean-up” in their next biomonitoring, to remove the catfish larvae which will pose a serious threat to the indigenous fish.

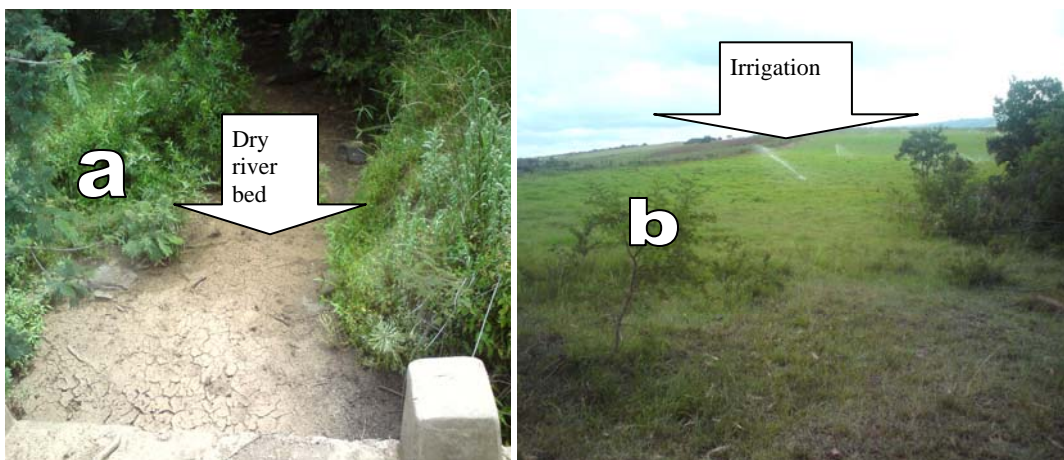
Plate 2: Showing the dry riverbed (a) and irrigation (b) at Wexford site.

There was no fish sampling in this site due to the absence of natural flows (see fig 3). Just above this sampling site are two consecutive instream abstraction weirs for both irrigation and livestock drinking.

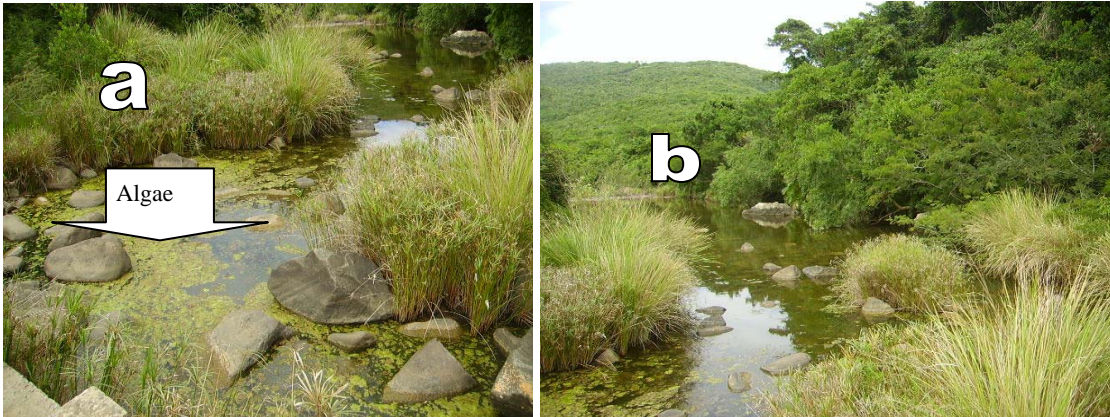
Plate 3: Showing the algae at the Resource Protection National site.

This site was dominated only by the predacious alien *Micropterus punctulatus* (bass, 50) and *Clarius gariepinus* (catfish, 1). No indigenous fish were caught in this site. Also noted in this site was an alga covering the water surface. The FFI for this site was **E**, indicating a seriously modified site.

If the release of water from the Wriggleswade dam, using the Gonubie catchment as a channel, is taken as an option to mimic the environmental flows, the following caution may be noted: Indeed the algae will be flushed down and the salinity at the estuary site will be lower. However, the water lettuce and the predacious alien fish, which exist in the source dam, will eventually be in the Gonubie system. This will pose a serious threat to the habitat, water quality and the aquatic biota as a whole.

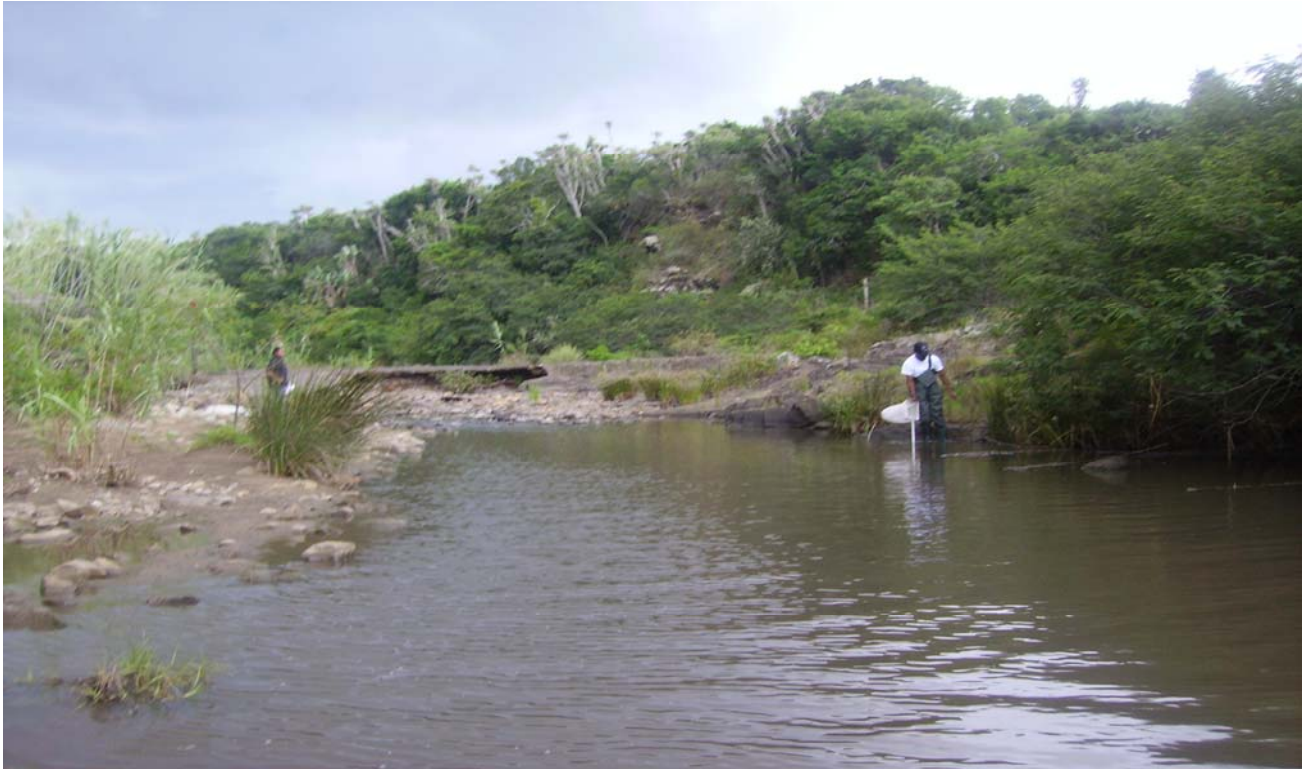
Plate 4: Showing the estuarine site of Gonubie catchment.

Estuarine round herring, *Gilchristella aestuaria*, was the only caught fish in this site. There was no flow of freshwater into the estuary, due to non-raining season. The FFI for this site was a low **C**, indicating a modified site.
