# **BIEMONITORING OF THE NAHOON RIVER SYSTEM**

**FEBRUARY 2008**

**PREPARED BY: Mlondolzi N. Mbikwana**

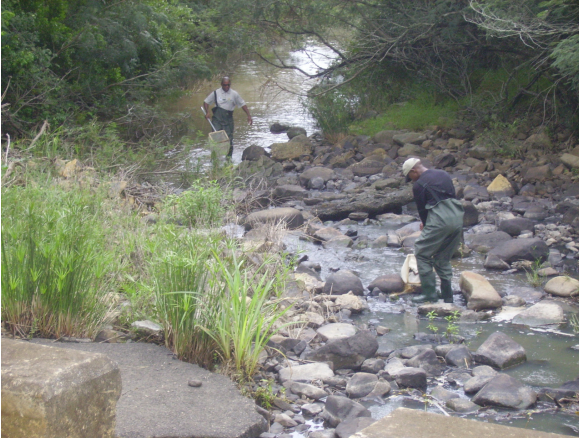
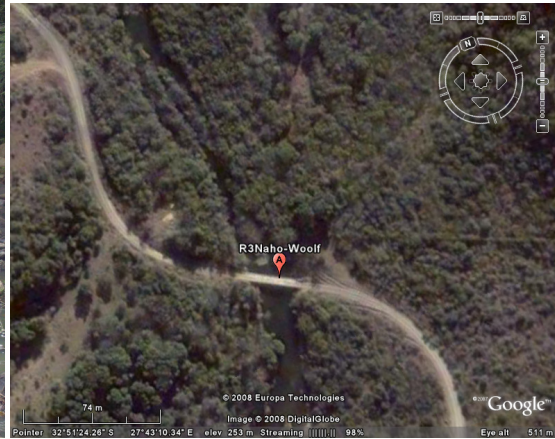
**Site 1:** Ground and satellite photo of Nahoon River, Woolfridge (This is the best River health site in the upper reaches and it is far from being pristine). The riparian vegetation mainly indigenous, few exotic plants such as Lantana were spotted but no Black/Silver Wattle or Eucalyptus trees around this site. No abstraction or gauging weir at least 500 meters upstream or downstream of this site. Site in ecoregion 16.

**Wolf ridge:** Community structure and function less than the reference condition. Community composition lower than expected due to loss of some sensitive forms. Basic ecosystem functions are still predominantly unchanged.

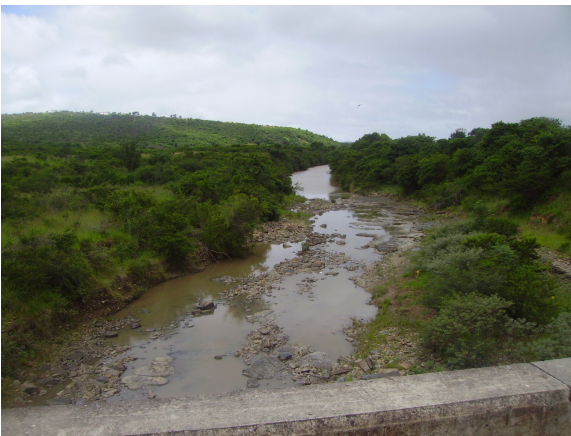
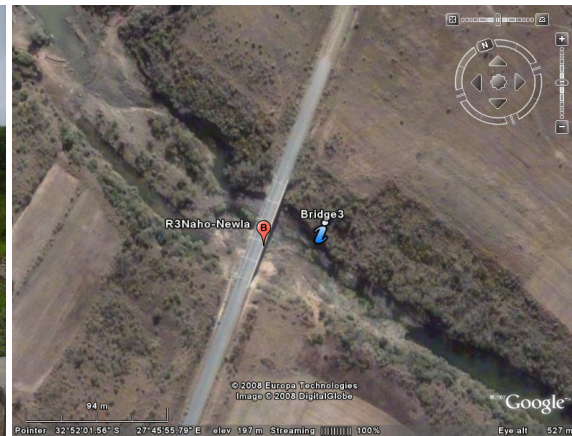
**Site 2:** Ground and satellite photo of Nahoon River, Newlands Bridge. Land use around this site includes several active commercial non commercial farming activities e.g. Poultry farming (Reggie Farm), irrigated crop farming, Dairy farming, Live stock farming, etc. The displacement between site 1 and site 2 is 4.5 kilometers and the present commercial farming activity is concentrated within a small area of just under 20 square kilometers. Rural settlements are the dominant form of residential built up activity in this area. The riparian vegetation is still mainly natural (Acartia trees commonly known; Umga tree) dominates this area, and still no observed black/silver wattle or Eucalyptus trees in this area. Site ecoregion 16.

**Nahoon Newlands Bridge:** Fewer families present, due to loss of most intolerant forms. Basic ecosystem functions have changed. This is to be expected as the site is just below commercial agricultural activities and the presence of rural settlements. Oxygen Absorbed an electrical conductivity has almost doubled and corresponds to the SASS 5 results

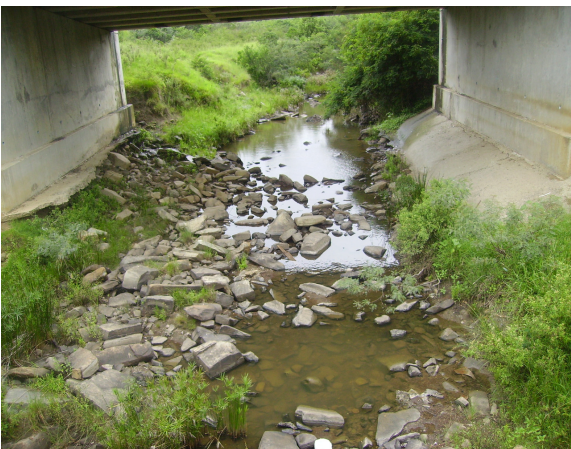
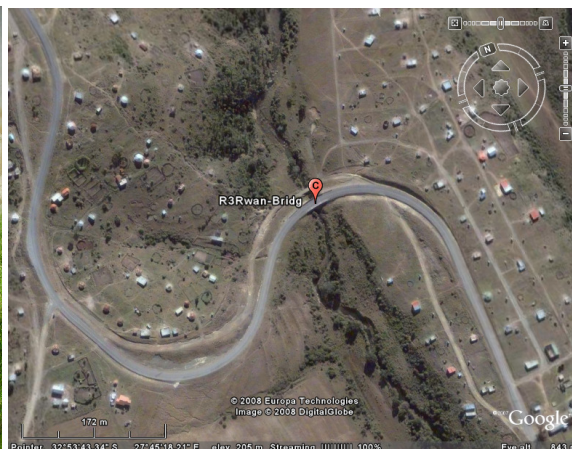
Site 3: Ground and Satellite photos of Rwantsa River at the bridge, this is a Nahoon River tributary. Land use around this site is mainly rural settlements; most of the vegetation around this site has been cleared for residential development. Live Stock subsistence farming is dominant and there are small pockets back yard crop farming that is not even worth mentioning. Access to portable drinking water is in the form of stand pipes and sanitation facilities are that of pit latrines. In terms of alien tree invasion, a tree informally called Queen of the night has established itself above 1 in100 floodline; there were no black wattle or eucalyptus trees around this site. Site in ecoregion 16.

**Rwantsa Newlands Bridge:** Not done due to low environmental flows.

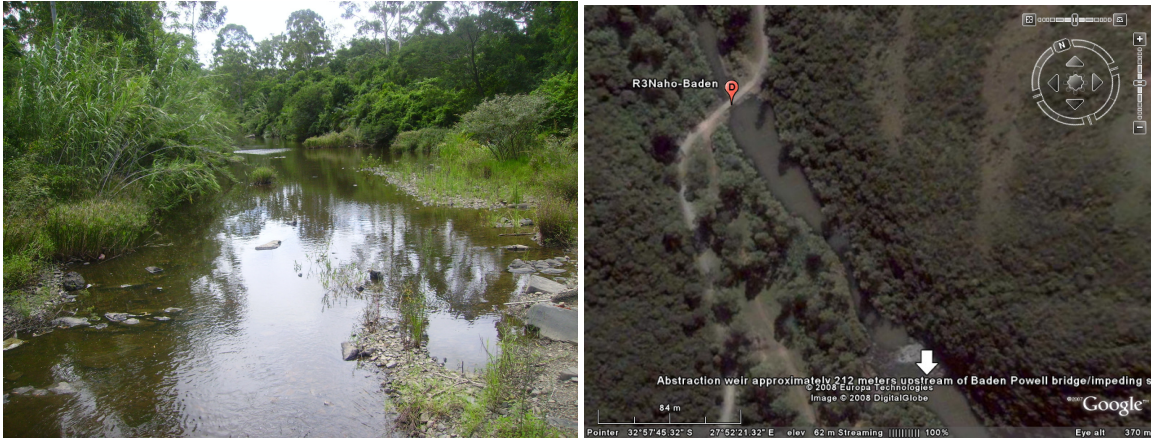
Site 4: Ground and satellite photos of Nahoon River at the Baden Pawell near High Gate. This site is situated in ecoregion 31 (eastern coastal belt). Land use around and upstream this site includes industrial (da Gama factory, Johnson & Johnson, commercial farming (crop irrigated lands, e.g. Pine apples; live stock farming), formal residential town settlement (e.g. Summer pride). This area has access to portable water, but there is also use of boreholes. Sanitation facilities are a mixture of flushing toilets with septic tanks and those that are connected municipality sewage works. Habitat integrity around this site is low; there is an impeding structure that functions as both a low water crossing and an abstraction weir. There is another abstraction weir less than 300 meters upstream of this impeding structure within the same water course. Approximately 30 to 50 adult eucalyptus trees within the riparian zone of this site, in terms of plant physiology

**Nahoon Baden Powell:** Aquatic Biotic modifications are the same as in Wolf ridge site, at this part of the catchment the river. Oxygen absorbed and Electrical conductivity shows a slight improvement, Nahoon dam seldom over flows and there is three impeding structures, flow energy dynamics of this river have been altered tremendously in this part of the catchment, therefore one would not be surprised if there is no strong correlation between SASS 5 and physiochemical constituents.

Removal eucalyptus trees at Baden Pawell and Horse valley sites would lead to the recovery of nearly 15000 liters of river water per day. Inter transfer of bulk river water from other catchments should be evaluated.

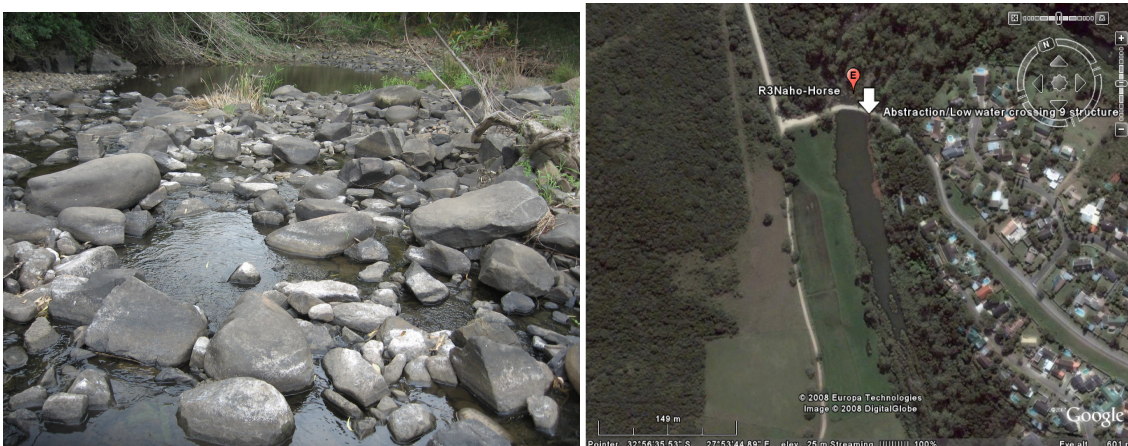
Site 5 Ground and satellite photos of Nahoon River at Horse shoe Valley (Dorchester Heights). The site also sits in Ecoregions 31, Land use around and upstream of this site includes cultivated irrigated, commercial, dry land. Commercial land use activities include a large Transnet/Spoornet Transport Depot, Cambridge Abattoir, Hemingways Casino, Urban built up, residential and formal suburbs. Large patches of indigenous riparian vegetation have been cleared up for commercial farming activities. This area is well serviced in terms of water supply and sanitation services. Satellite picture shows a combination of a low

water bridge and an abstraction weir and this is illegal under the new national water act, act 36 of 1998, but structures are much older than that (older than 20 years). Habitat integrity around this site is low, there more than 20 adult Eucalyptus trees (invader plant) within the riparian zone, invader plant not yet dominant (the situation is still reversible).

**Nahoon Horse shoe Valley:** Biomonitoring was not done due to low flows, but one would expect the class to be the same as that of Baden Powell as the land use and habitat integrity is much the same.

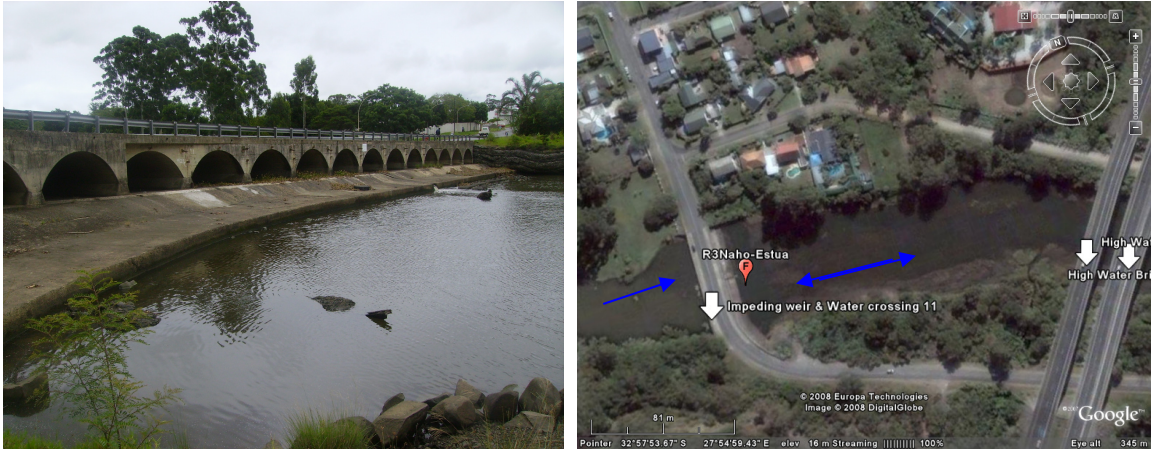
Site 6: This is an estuary not a river health site Ground and satellite photos of Nahoon River at Abordsfort. The site also sits in Ecoregions 31, land use here is mainly urban built up, residential and formal suburbs. Satellite picture shows a combination of a low water bridge and an abstraction weir and this is illegal under the new national water act, act 36 of 1998, but structures are much older than that (older than 20 years). Habitat integrity around this site is low, upstream of this bridge the river is 100 % fresh water and downstream of this structure conditions are estuarine. The tidal /estuarine conditions are supposed to continue much further upstream of this bridge/weir but because of the impeding bridge/weir, the tidal energy or ocean current artificially stops at the weir (see satellite photo of site 6).

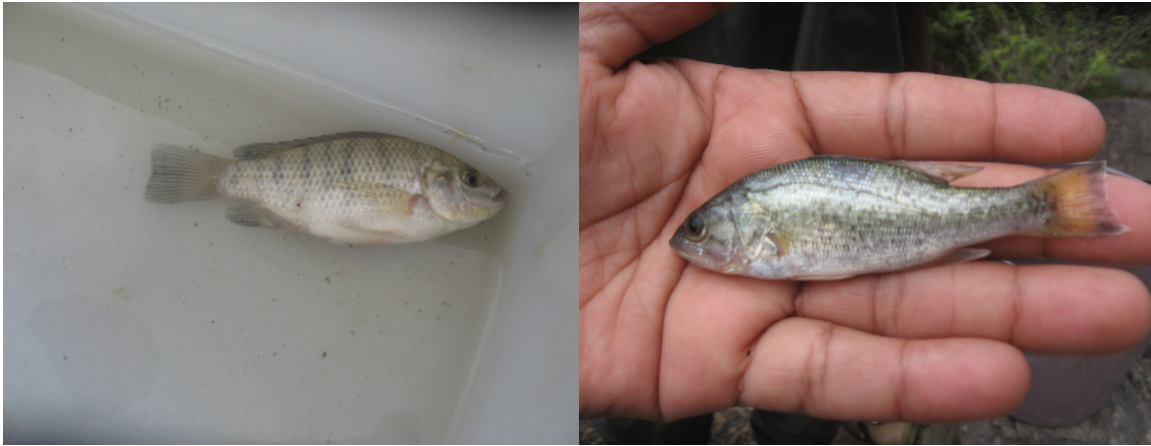
*Tilapia sparrmanii* and *Micropterus salmoides*, the alien fish species found in site 2

According to the Fuzzy Fish Index (FFI) Site 2 is at D, indicating that the site is in fair condition. At least *Glossogobius callidus*, which is an indigenous species was found and in higher numbers than each of the alien species.

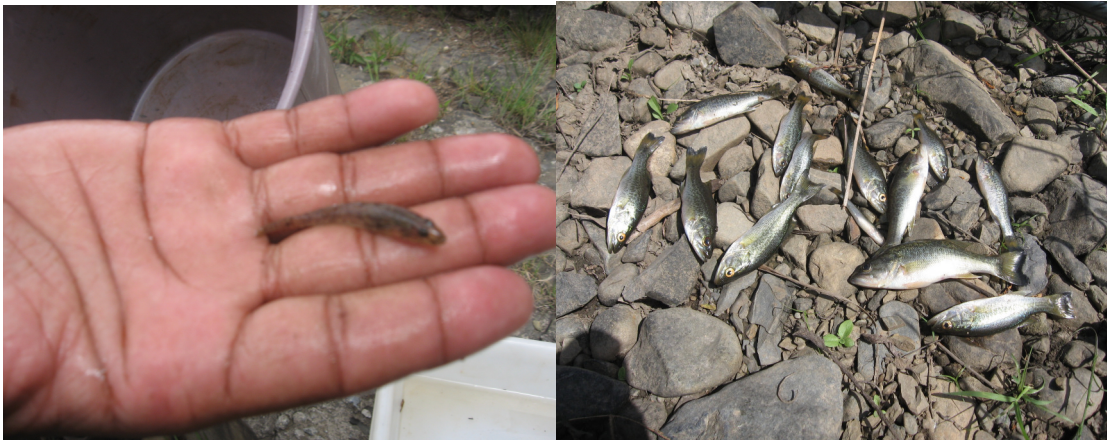
*Glossogobius callidus*, the indigenous river goby. *Micropterus salmoides*, a large mouth bass caught in site 4

Site 4 sits at an E Class. This is in a poor condition as a large number of alien species was found and not a single indigenous species was found.
