Mthatha River System - 2008

The River Health Programme

Context of this Report

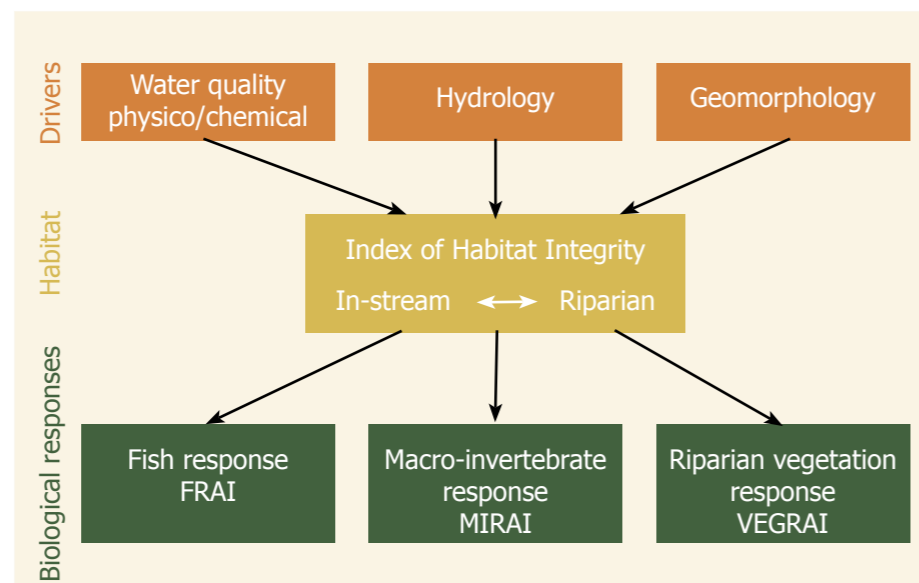
The relationship between the indices used to determine the ecological health of a river according to the EcoStatus procedure.

The EcoStatus of a river system describes the overall condition or health of the system, in terms of its ability to support an appropriate natural fauna and flora, and its capacity to provide a variety of goods (e.g. timber, food, medicine) and services (e.g. purification, degradation of organic matter). It therefore reflects an ecologically integrated state representing a series of:

- Ecosystem Drivers (hydrological, geomorphological, and physico-chemical); and
- Ecosystem Responses (macro-invertebrates, fish and riparian vegetation).

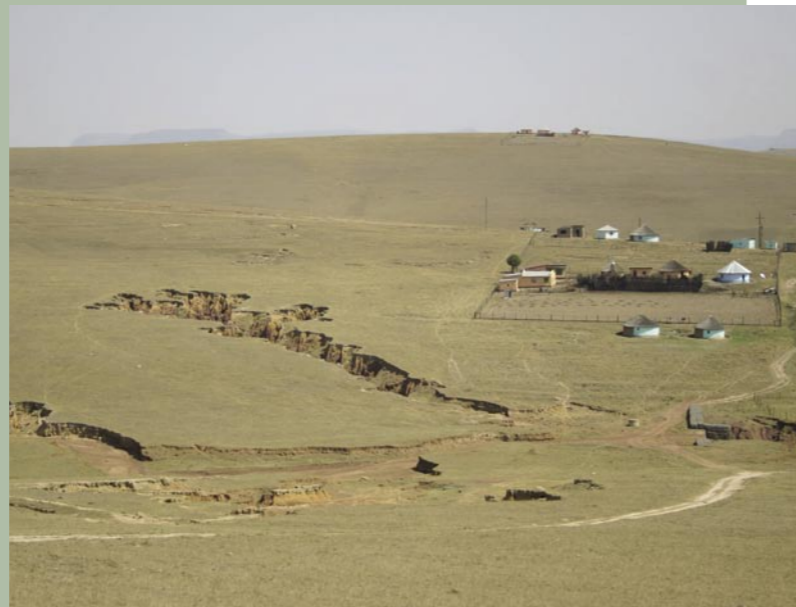
Gully (donga) erosion in the Mthatha catchment

A gully is a landform created when running water removes soil from the land surface. Gullies are ditches that can be metres deep and cover tens of metres in surface area. Common processes for gully formation are when surface flow becomes concentrated into furrows called rills, or when surface flow infiltrates into the soil profile causing cavities or soil pipes underground. Surface flow develops when the soil surface is bare of vegetation cover which may be caused by overgrazing, poor land management and changes in land use. Vegetation helps to prevent erosion by reducing rain drop impact, promoting infiltration of water deeper into the soil profile and providing organic material. Plant roots provide stability by binding soil

particles together. Gullying that occurs even though there is no concentrated surface flow is due to a combination of geology, soil and climatic conditions.

Gully erosion caused by concentrated surface flow and by soil piping can be seen in the Mthatha district. Soils in the area are acidic and contain dispersive clays which cause the soil to crack after wetting and drying. These cracks provide preferential zones of infiltration for water during rainfall events. Water is able to percolate through the profile and remove material which causes vertical cracks to widen which ultimately leads to collapse and gully extension. Some soils contain high concentrations of iron oxides which harden under water-logged conditions or when exposed at the surface of the profile and these can be seen as rough 'popcorn'-like structures on the sidewalls of the gullies. The iron oxide acts like cement and makes the sidewalls less vulnerable to erosion. With time, the angle of the gully sidewalls flattens out and vegetation becomes established, which stabilises the gully and stops further widening.

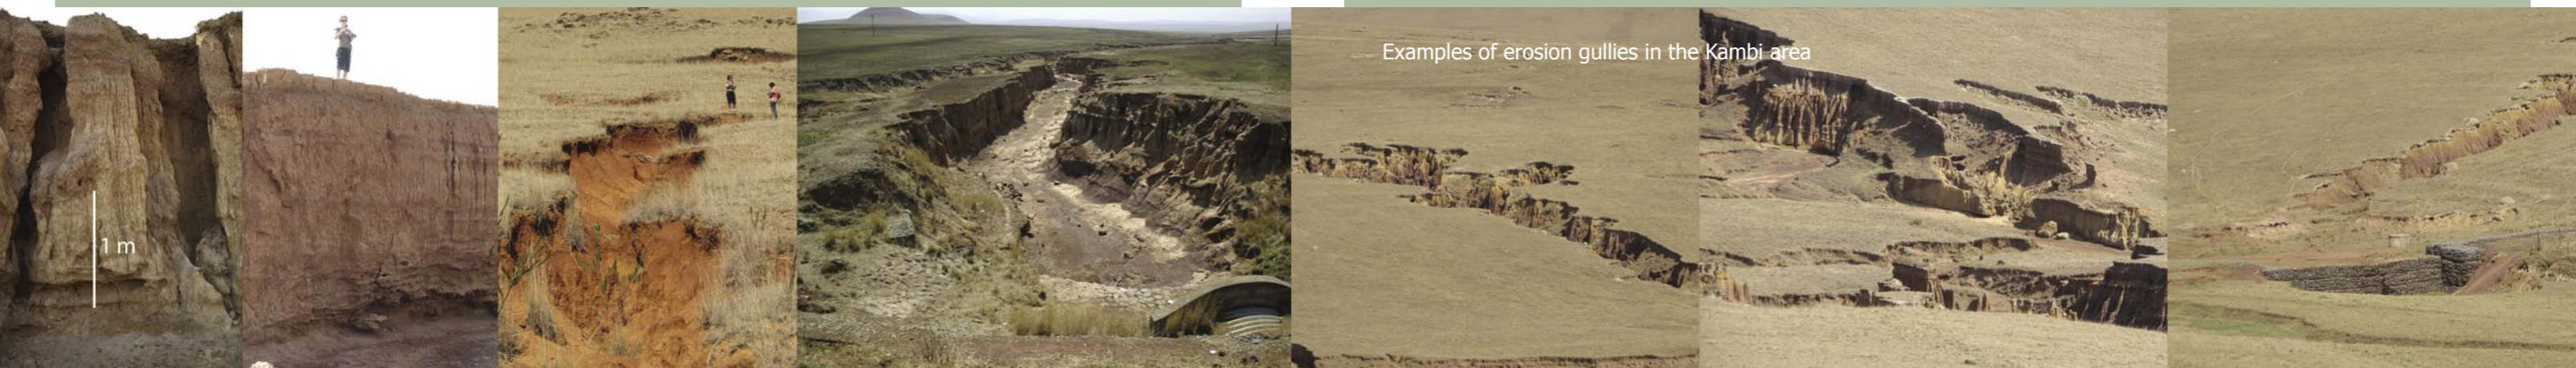
Examples of erosion gullies in the Kambi area

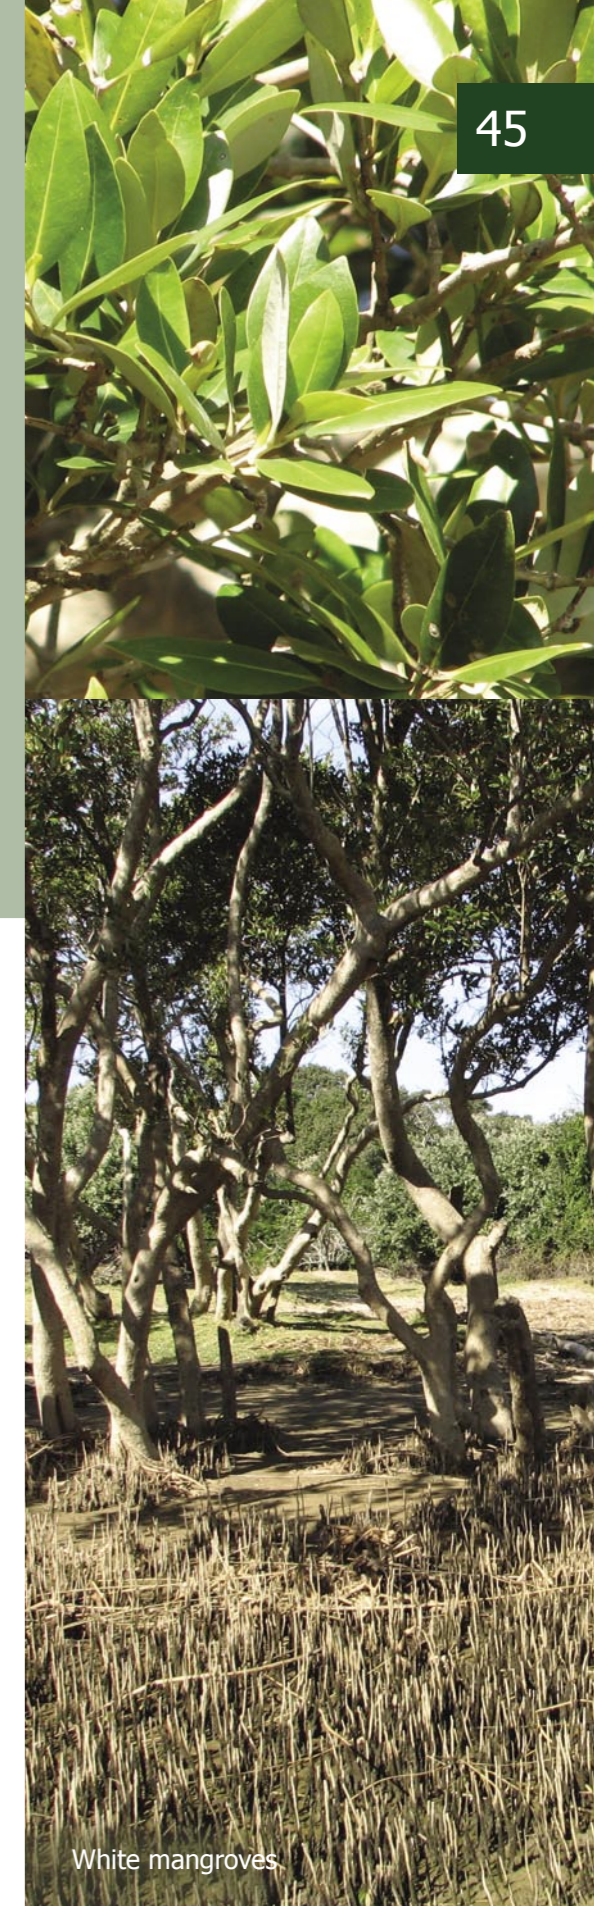
White mangroves

Mangrove forests line both the western (on the photograph) and eastern banks of the Mthatha estuary.

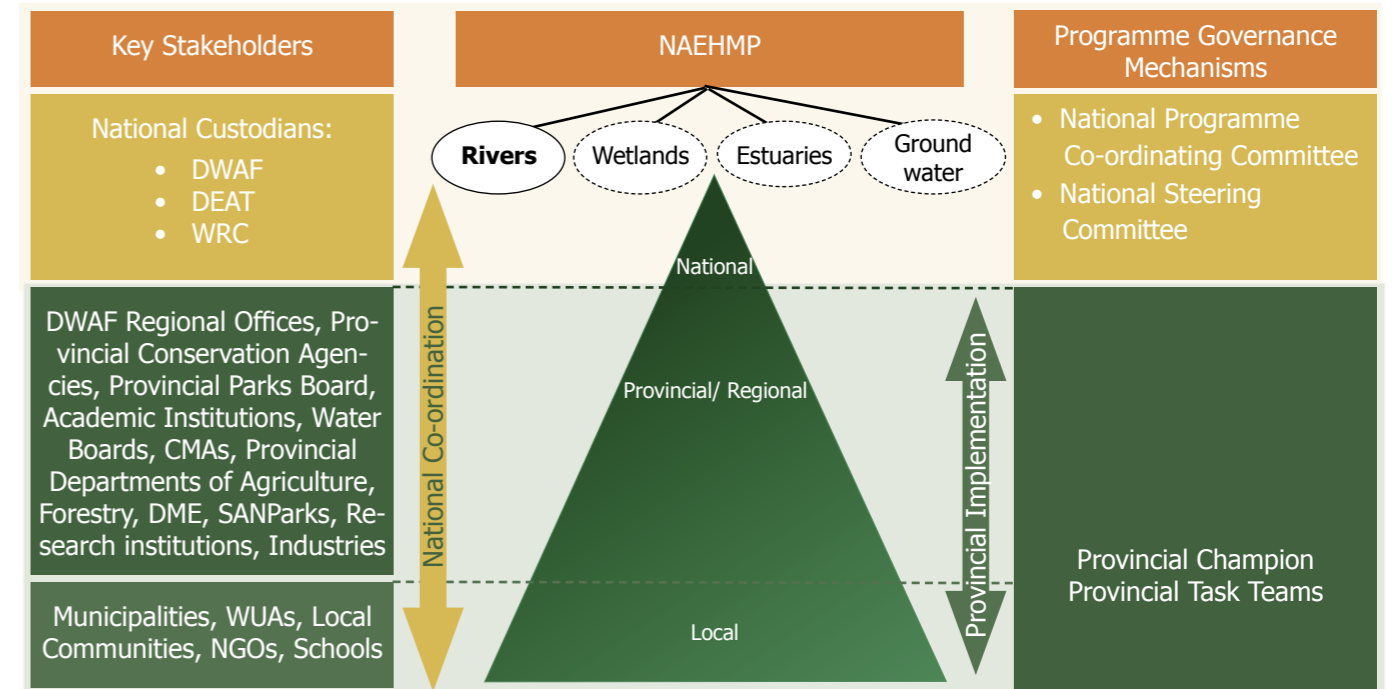
The figure below explains the RHP governance model as described in the RHP implementation manual.
