Buffalo River Biomonitoring

Winter 2010

June 2010

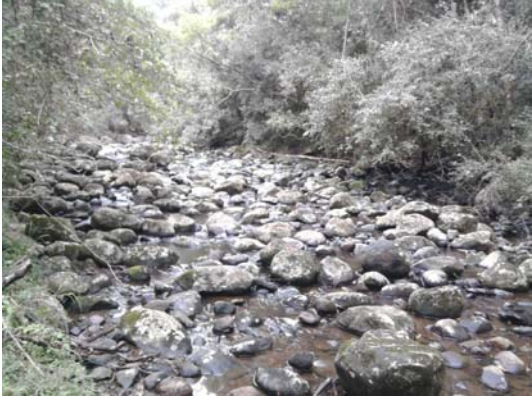
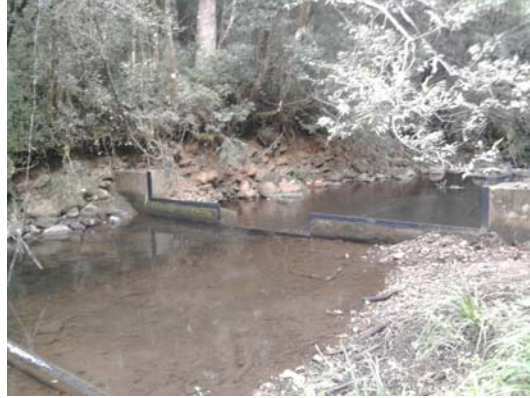
Site 1: Buffalo River above Maiden dam

Plate 1a : Upstream

Plate 1b: Downstream

The river had low to medium flows and the riparian vegetation was intact. The species diversity at this site was high but low in abundance except for the Baetidae species that had highest abundance. The vegetation was absent at this site therefore, samples were collected only from two biotopes (Stones and GSM). The SASS 5 results show a desired good biodiversity and a natural condition.

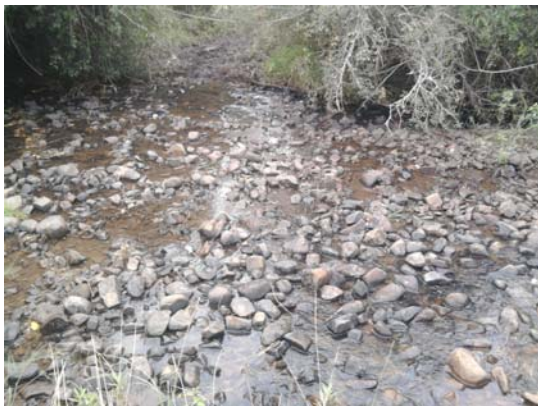
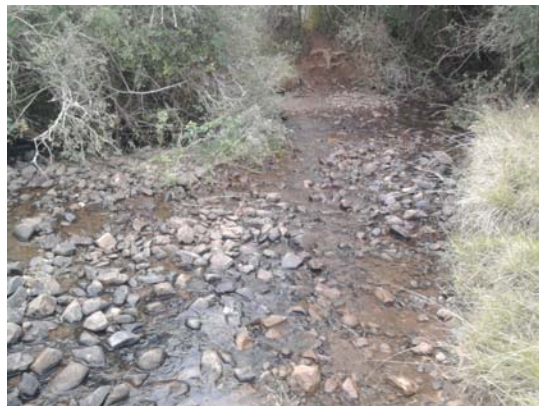
Site 2: Pirrie Mission tributary

Plate 2a Up stream

Plate 2b Downstream

Samples were not collected due to low flows.

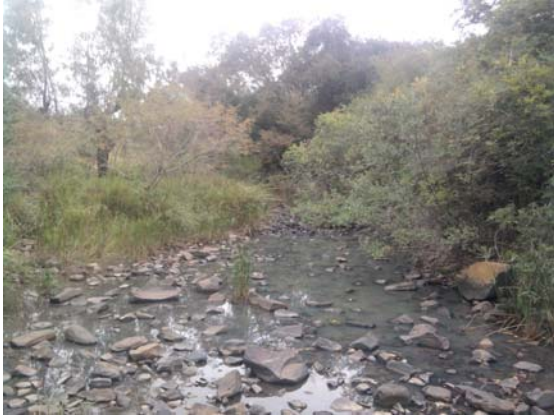
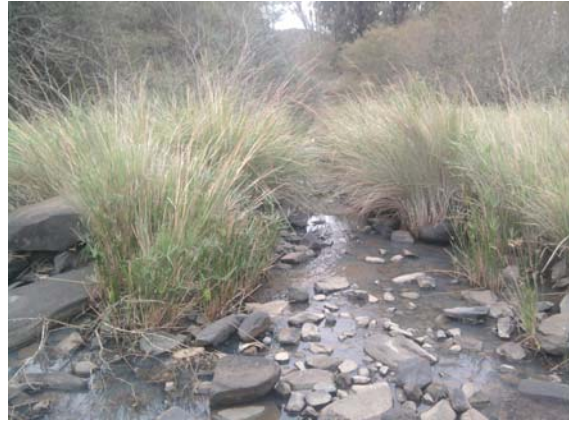
Site 3: Buffalo River at the Horseshoe Bend

Plate 3a Upstream

Plate 3b Downstream

The site had very low flows and due to that, sampling could not be done.

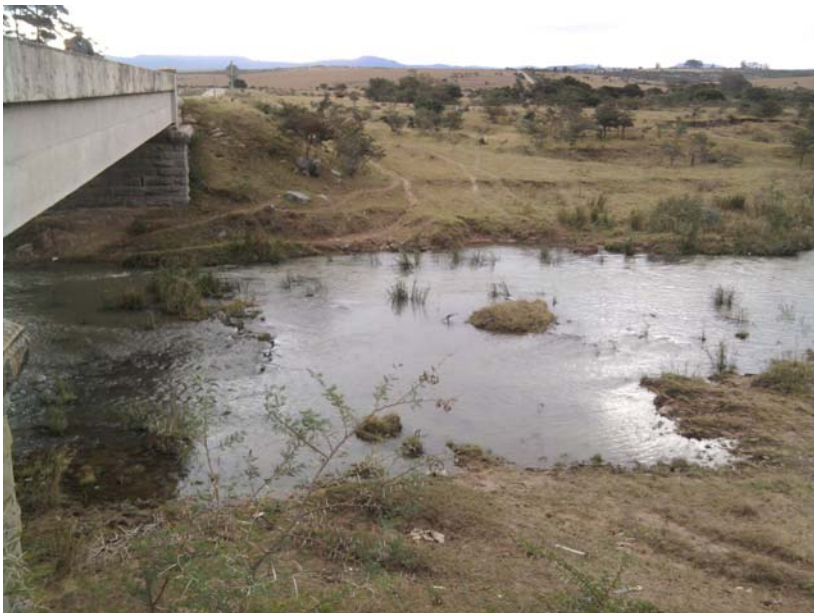
Site 4 Yellow Woods at Lonsdale Bridge

Plate 4: Illustrating high flows at Lonsdale Bridge

During the survey water was being released from the Wiggleswade Dam to Laing Dam, and that was a recommendation from the National Department of Water affairs and other stakeholders to use the Yellow Woods River as a channel, as our rivers are facing the crisis of drying up. Therefore, no samples were collected at this site due to high flows.

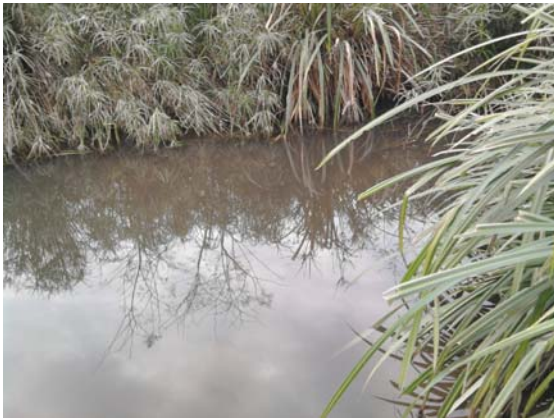
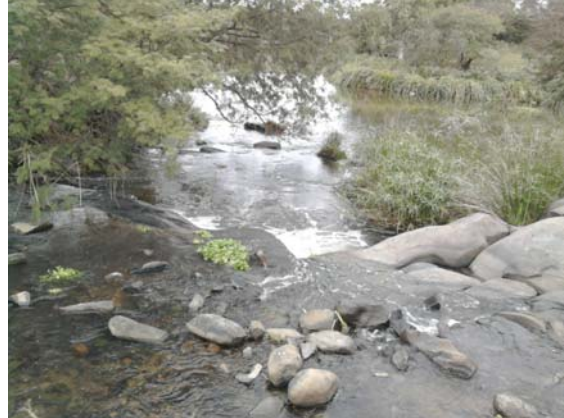
Site 5: Buffalo River above Ngqokweni confluence at Zwelitsha

Plate 5a Upstream

Plate 5b Downstream

The river had medium to high flows because some tributaries have already joined the main stem above. The species diversity and abundance at this site was high and the samples were mostly dominated by the Caenidae, Hydropsychidae and Simuliidae. Although this site had higher species abundances, the overall result obtained showed that this site is at a Poor condition. This is due to high abundance of low scoring species and the presence of Leeches at this site also show that there is contamination occurring at this site.

Although there was high species diversity at Buffalo River above the confluence with Ngqokweni at Zwelitsha, the site was in poor condition due to presence of resistant-to-pollution low scorers, such as leeches, earthworms and simuliids, which are indicative of a polluted environment, although they can be found also in pristine environment. The

nearby workshops discharge their untreated waste water directly into the river, hence pollution.

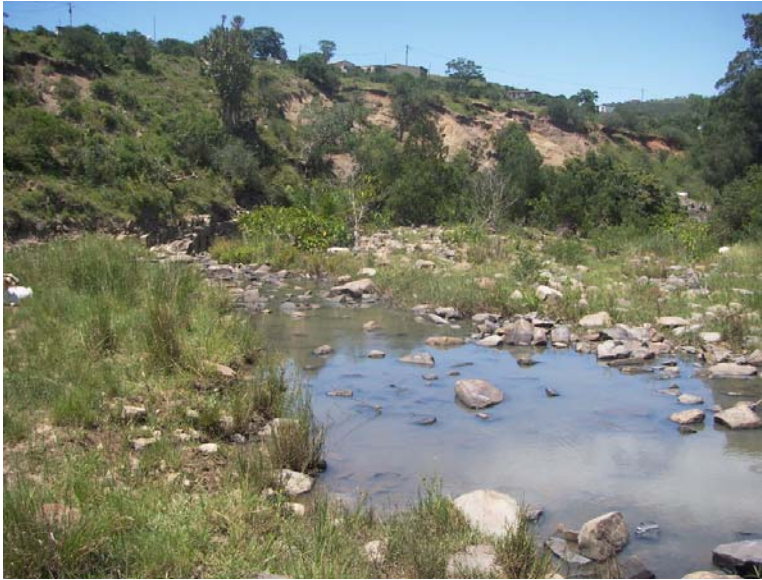
Site 6: Nxamkwane tributary

Plate 6 : Showing Nxamkwane sampling site

The river had medium flows and there were signs of pollution, which was evidenced by the algae coating the stones. Although there is a good invertebrate diversity, SASS 5 results showed that this site is at a Fair to Good condition, and the species abundances were high in all biotopes sampled.

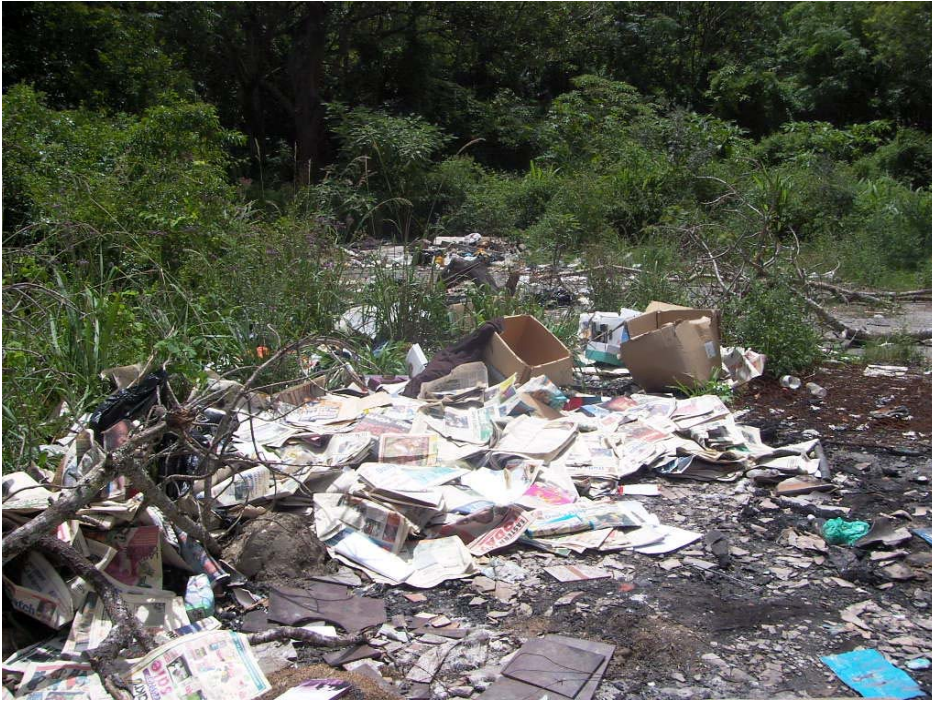
Site 7: Buffalo River at Buffalo Pass

Plate 7: showing an illegal dumping site at the buffalo Pass.

There was no access to this site due to the garbage dumped at the entrance to the site.

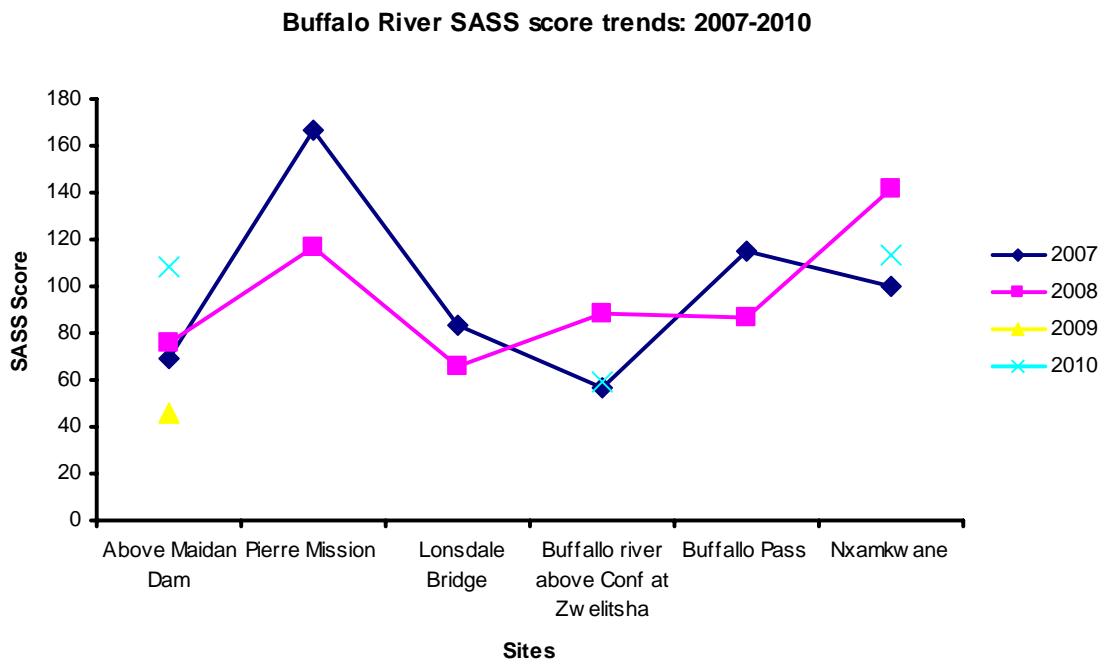
Fig 1. Graph showing the SASS 5 annual scores at the Buffalo River (2007-2010).

The results at Buffalo River above maiden Dam show that there is an improvement in SASS 5 scores to date compared with the previous years. In 2010, 2009, 2008 and 2007 SASS 5 scores were 108, 46, 76 and 69, respectively. Year 2007 and 2008 surveys have complete data which indicate a consistent increase in trends. Both at Pirrie Mission and Nxamkwane, which are tributaries of the Buffalo River, the scores were high during 2007 and 2008 surveys.

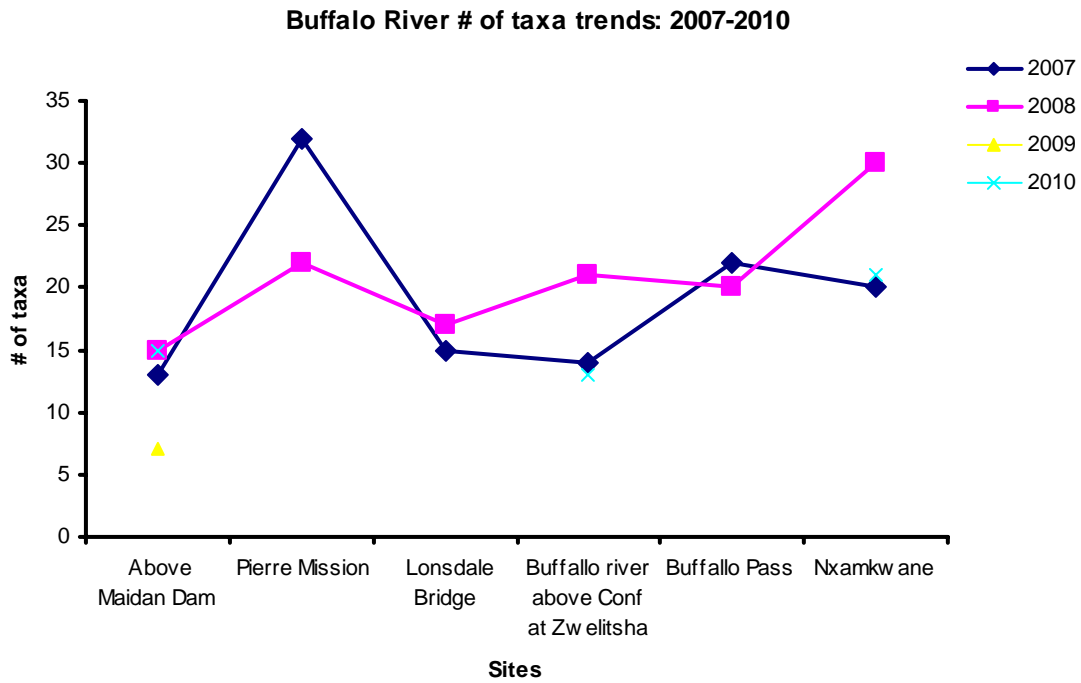
Fig 2. Graph showing the SASS 5 annual number of taxa at the Buffalo River (2007-2010).

Generally, the invertebrate species diversity is consistently increasing over these years (2007-2010). Both at Pirrie Mission and Nxamkwane, which are tributaries of the Buffalo River, the species diversity and abundances were high during 2007 and 2008 surveys.

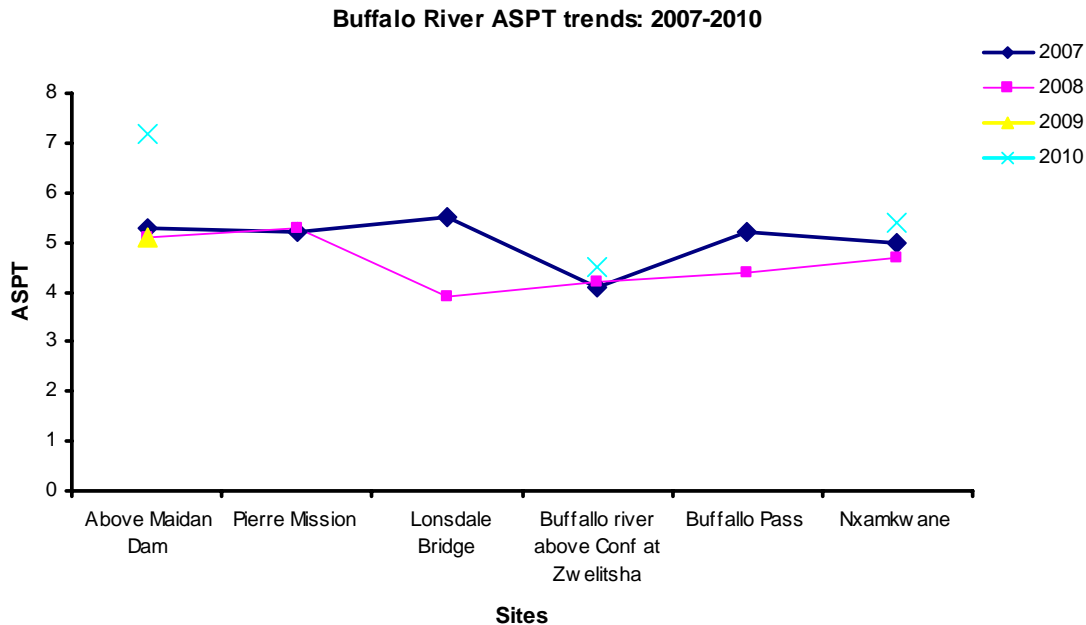
Fig 3. Graph showing the SASS 5 ASPT's at the Buffalo River (2007-2010).

In 2010, only Buffalo River above Maiden Dam improved and was in natural condition. Other sites varied from poor to fair conditions.
