A systematic biomonitoring survey of the Mogol River Catchment, Limpopo Province.

M. K. Angliss¹, P. J. Fouche¹, P.S.O. Fouche², L. du Preez³ and S.S.M. Rodgers¹.

Angliss *et al* (2003) conducted a systematic biomonitoring survey of perennial rivers of the Mogol Catchment. A total of 30 sites were surveyed using standard River Health Programme protocols, between May and September 2002. All sites were assessed for fish, invertebrates, riparian vegetation, and geomorphology. *In situ* water quality was recorded and diatoms were collected.

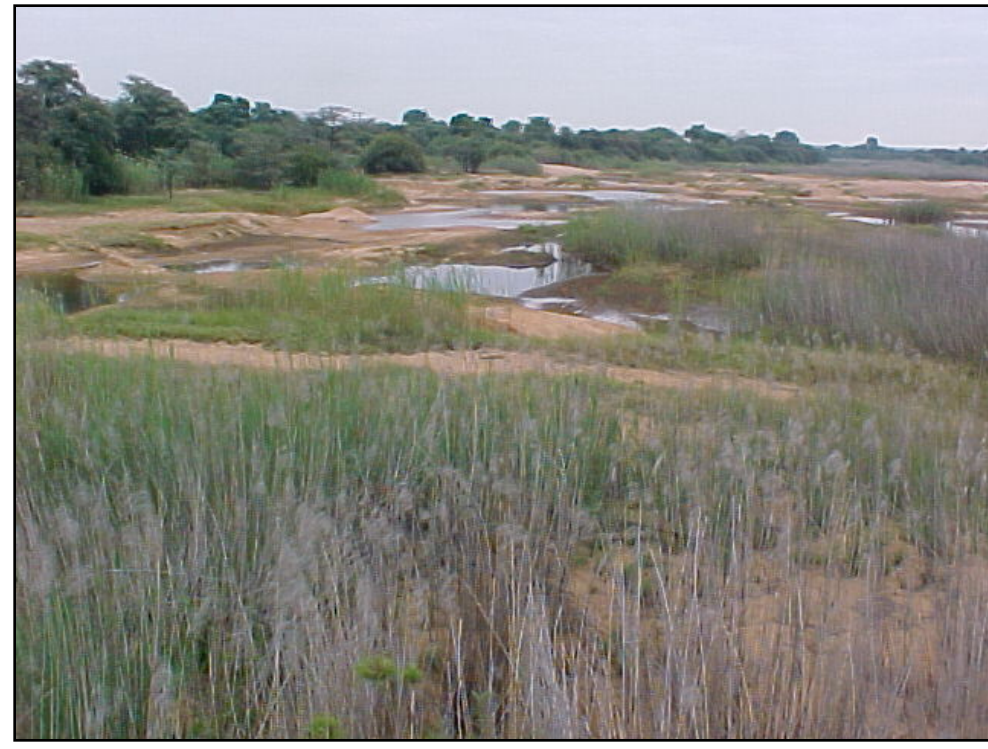
Sand mining has a serious impact on the riverine habitats. Access to the river for mining purposes destroys the natural riparian vegetation, opening this area up for the invasion of alien plants.

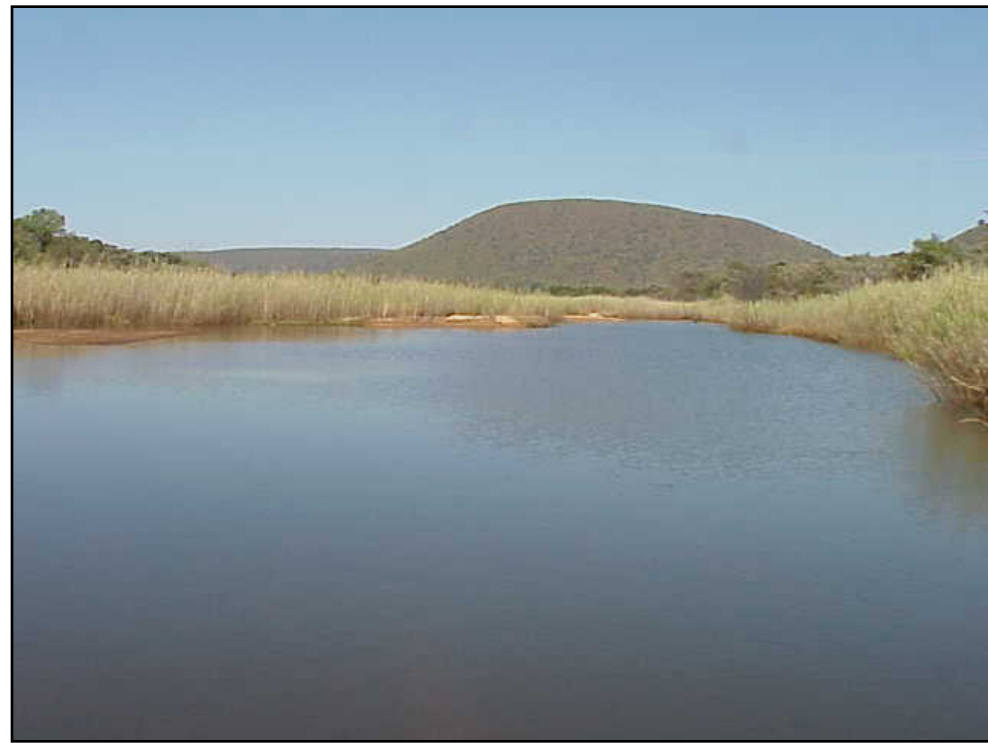
Deep pools in the lower river provide refuge for fish for both the Mogol and Limpopo rivers and habitat for hippos.

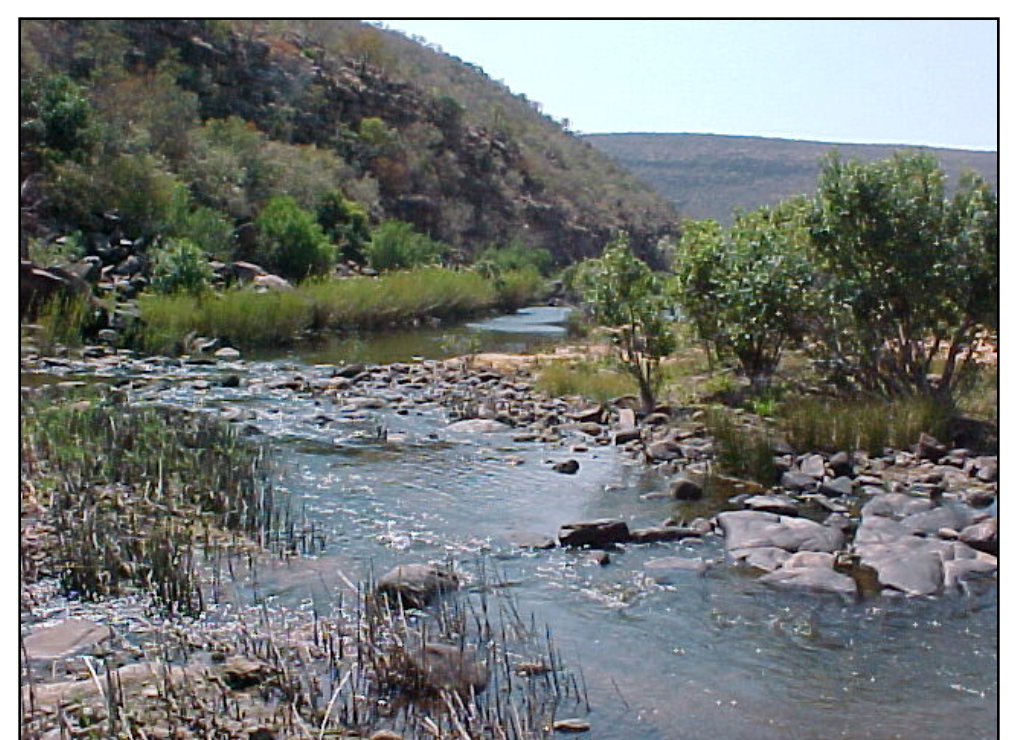
Nature reserves in the middle catchment afford the river protection from regional developments and contribute towards good instream habitat.

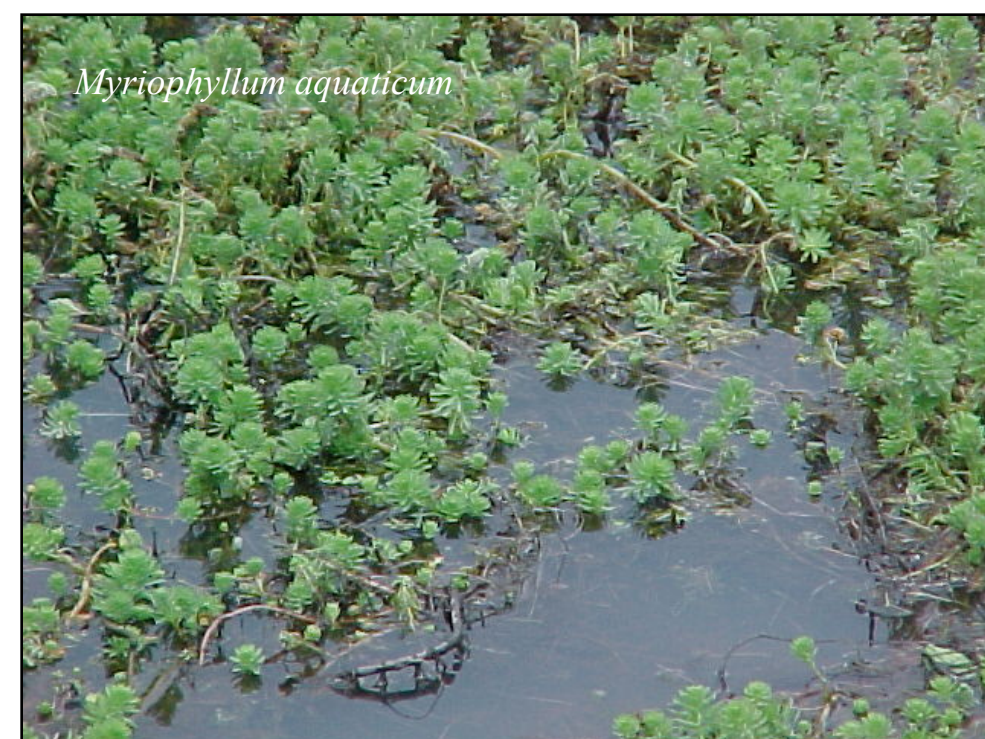
Alien aquatic plants, and in particular, *Myriophyllum aquaticum* are invading standing water habitats. Currently the problem is not regarded as serious, but the situation requires vigilance and frequent monitoring.

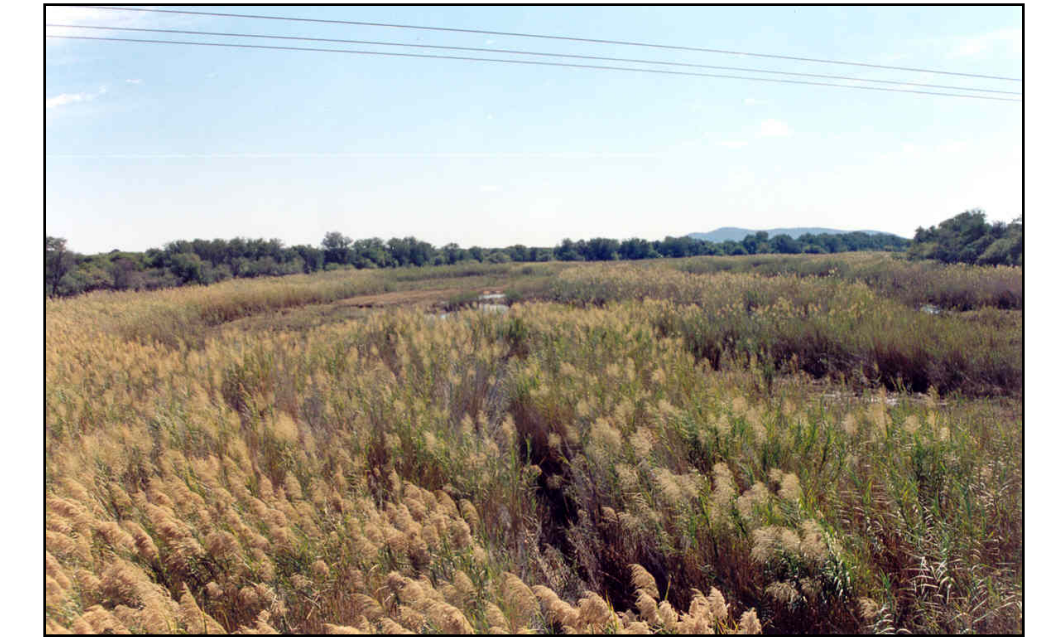
The influence of flow regulation and the absence of the normal flooding regime, caused by the Mokolo Dam, are clearly illustrated by the invasion of the riparian zone by reeds and terrestrial woody species.

In most of the tributaries and the main stream of the Mogol River above the dam the extent of invasion, for both reeds and terrestrials, range from very low to low. Below the dam this situation however changes and the extent of invasion, by both components, is higher at all the sites ranging from medium to high.

Although chemical spraying of the reeds had reportedly been undertaken, no marked effect of the exercise was visible at the sites that were monitored.

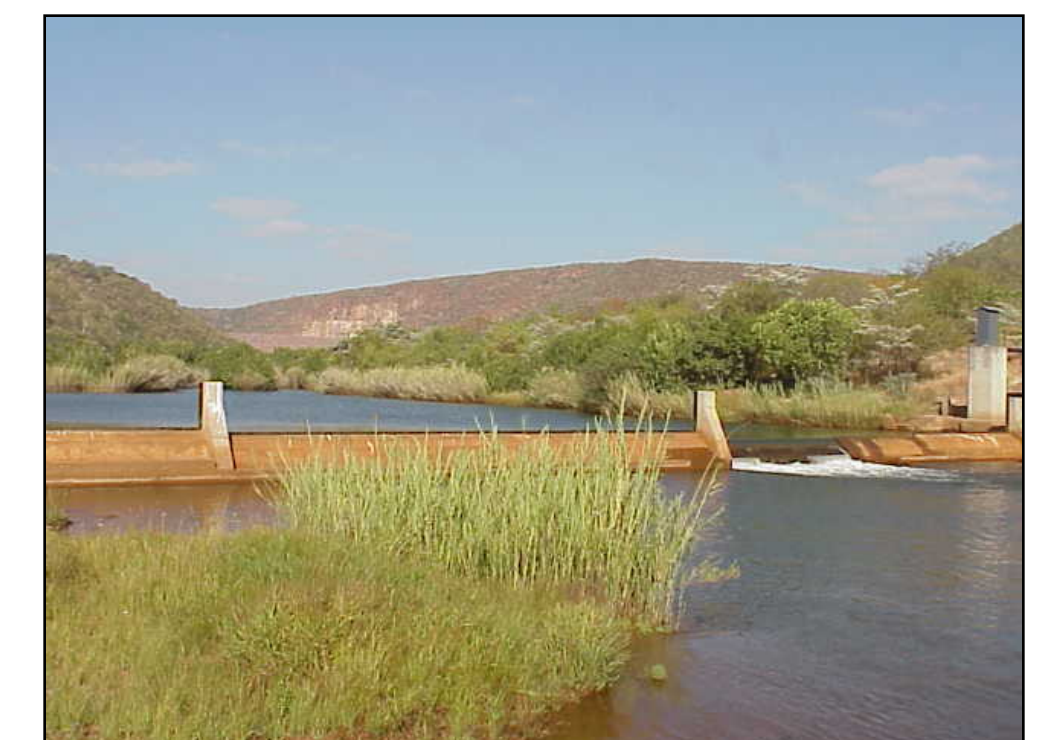
The Mokolo Dam is used as a reservoir to supply water to irrigation farmers in the Ellisras area. Pulsed releases have a large impact on the downstream aquatic biota and do not reflect the natural seasonality of the river.

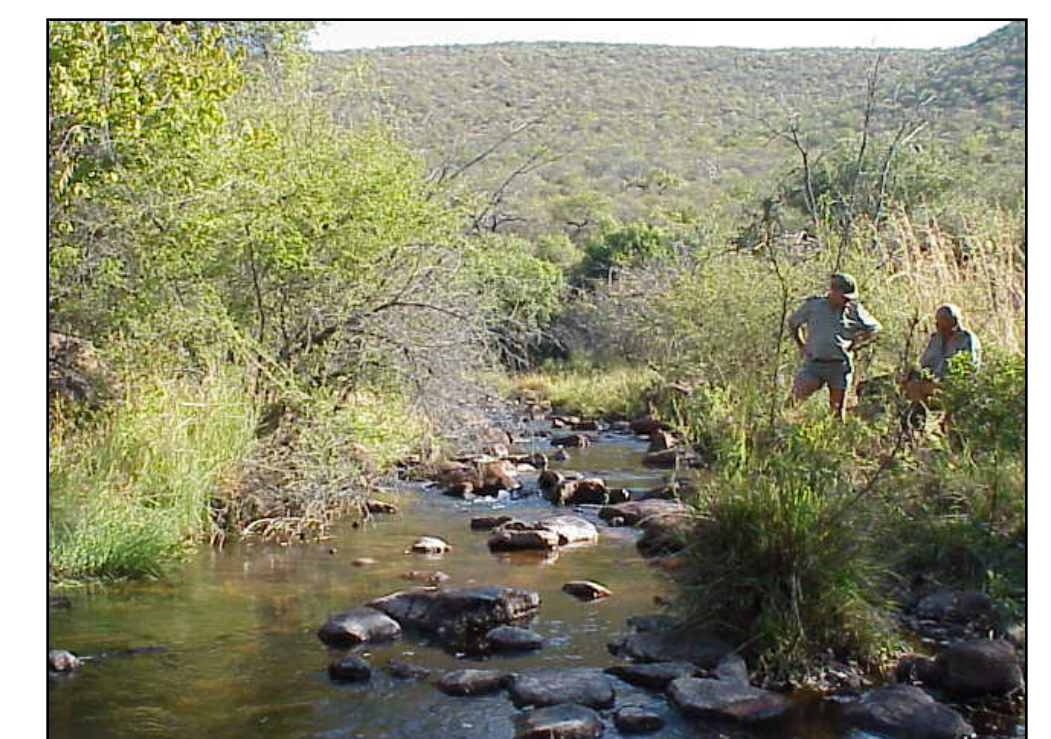
Mountain tributaries provide habitat diversity and refuge for a wide variety of aquatic biota.
