State-of-Rivers  
Report

# the Mokolo River

a Catchment in the Limpopo Province

August 2006

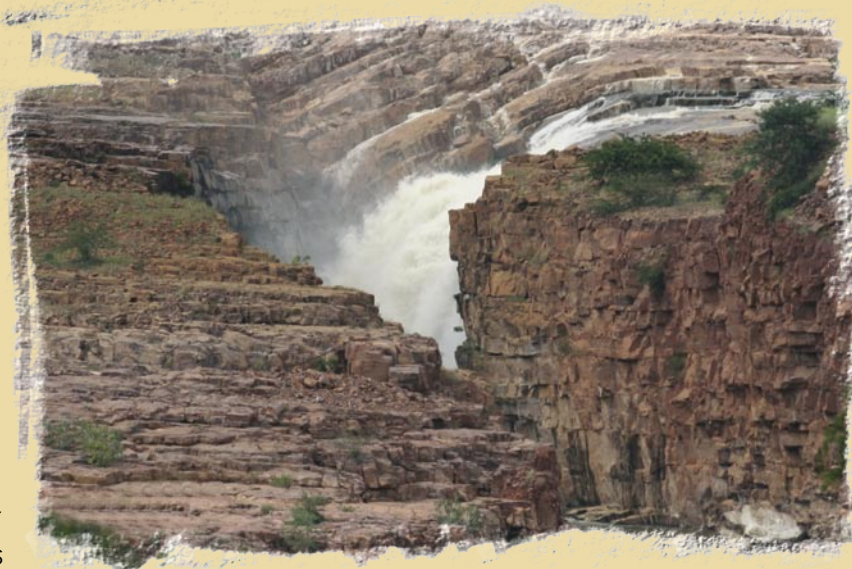
fauna due to the unseasonal nature of the releases. The Mokolo Irrigation Board has, through consultation with DWAF and Limpopo Environmental Affairs, embarked on a regular aerial spraying program of the reeds using a herbicide. While the spraying appears to have a significant impact on the reeds, the effects of decaying weeds on water quality and the cumulative impacts of the herbicide on aquatic fauna, and other flora, have yet to be determined.

*Mokolo Dam outflow*

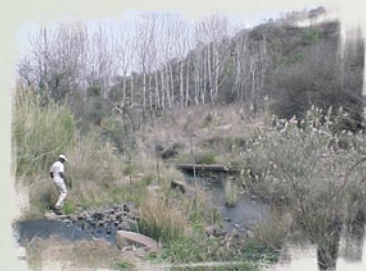
The alien plant species, poplars (*Populus sp.*), the rattlebox (*Sesbania punicea*), and the syringa (*Melia azedarach*) were found at all sites in this study area. In places, poplar trees were growing in large concentrations. There was evidence that some alien vegetation removal had taken place, but tree debris had not been removed. Reed beds were prolific throughout and indigenous vegetation was dominated by the terrestrial species bluebush (*Diospyros lycioides*), common spike thorn (*Gymnosporia buxifolia*), and common wild current (*Rhus pyroides*).

Sand River showing alien vegetation

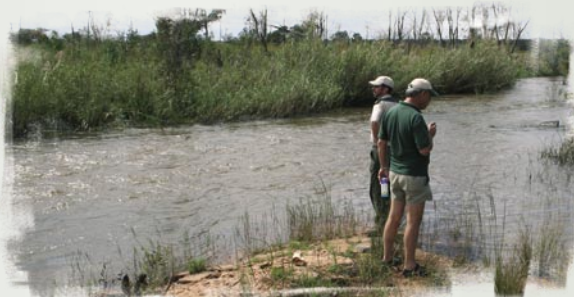
Mokolo River at Vaalwater

The fish community of the Mokolo River main stem was largely intact and all species, (except the two migratory eel species), were recorded. Flow dependent species of fish were recorded in abundance. The alien largemouth bass (*Micropterus salmoides*) was recorded in the Mokolo River near Vaalwater.

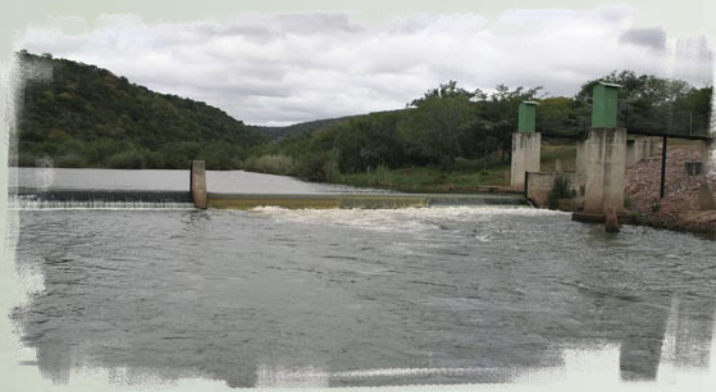
diversity is high, with the dominant bed material being cobble and boulders. Impacts within this study unit are dominated by irregular water releases from Mokolo Dam to the lower section of the river. Causeways, a road bridge and an assortment of riparian impacts also occur away from the gorge area.

Gauging weir below Mokolo Dam

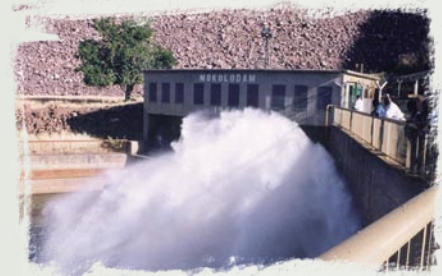
Mokolo Dam sluice gates

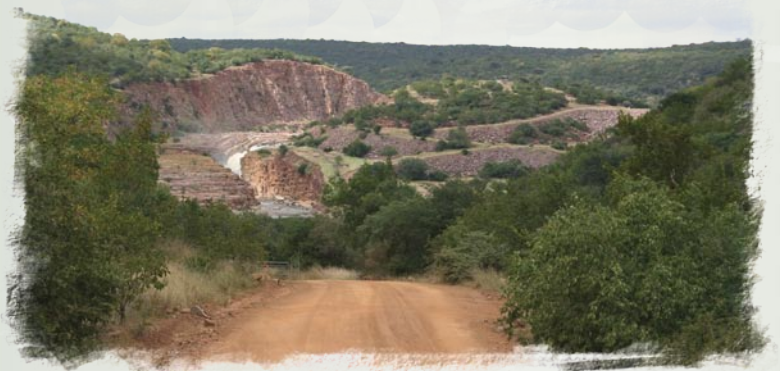
upstream of the Mokolo Dam in this region. The only 2 species absent were the African mottled eel and the longfin eel (*Anguilla bengalensis* and *Anguilla mossambica*). All flow-dependent species were present upstream of the dam, confirming the near perennial status of the river in this section. Downstream of the dam, benthic habitat conditions were degraded and all flow dependent species were absent.

View towards the Mokolo Dam outflow

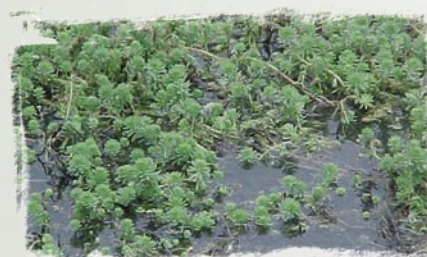
Small populations of the highly invasive alien weed parrots feather (*Myriophyllum aquaticum*), were noticed in pools below Mokolo Dam, as well as within the dam itself.

Parrots feather: (declared weed)

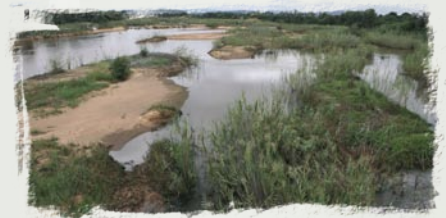
Reed encroachment is considered the main vegetation impact and again there are clear indications that the regulated flow regime is contributing to this problem. Alien vegetation was very sparse in this study unit, with only a few syringa (*Melia azedarach*) being recorded. Downstream from Lephale, disturbance to the riparian zone was limited to bridges, sand mining, and agricultural practices (mostly water abstraction pumps and the cutting of vegetation to the river's edge).

Mokolo River at Lephale

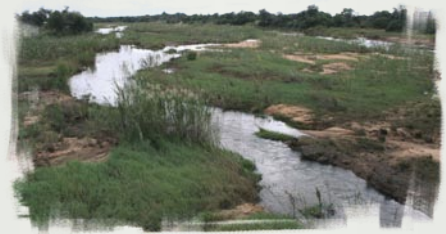
Mokolo River at Lephale

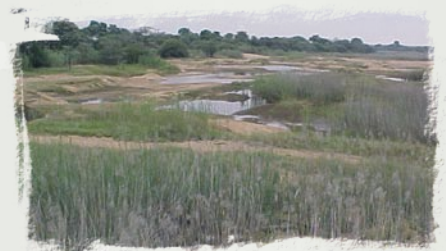
Lower Mokolo River, often used for sand mining

Sand mining is a listed activity in terms of the National Environmental Management Act and must undergo an Environmental Impact Assessment process. It seems unlikely that the sand mining activities in this catchment have been properly evaluated in an EIA, and all appear to be poorly managed. It should also be noted that regulations concerning sand mining have recently been reviewed and changed.

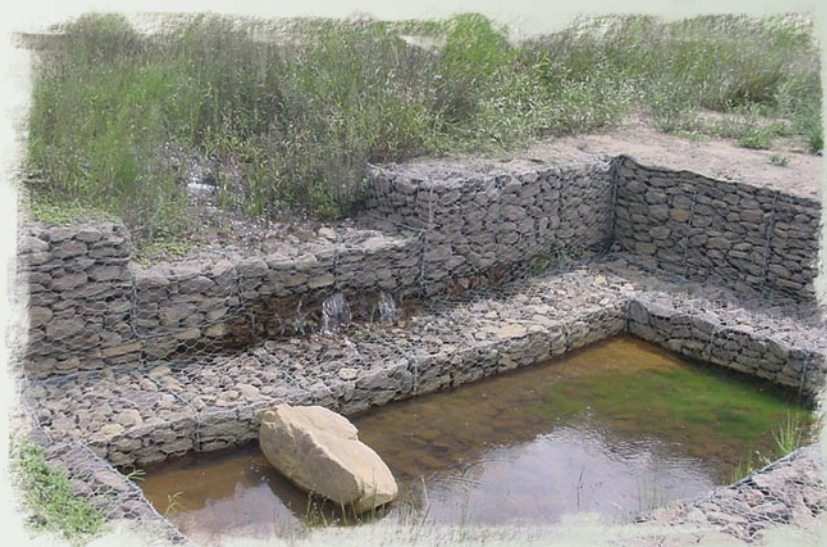
*A rock gabion, showing the structure and the water flow*

Rehabilitation has been done using rock gabion interventions and leveling drains across the wetlands. There are now more than 100 rock gabion structures in the Mokolo River around Alma, and most of the rock gabion structures are working well. However, some are failing due to problems such as overgrazing and cattle trampling on the gabions. Maintenance will be carried out on these structures. Other structures are silted and their spillway's need to be raised in order to trap more sediment behind them. Raising the spillway will be repeated until the whole donga is filled with sediments.

There is a need to make land-owners aware of the wetlands and their functions, their ecological value, and how to protect them from degradation by cattle trampling.

If possible, only controlled grazing should be allowed in wetlands, and then only in successfully rehabilitated wetlands to prevent further degradation.

When cattle and game drink water in partially rehabilitated areas, they trample over and around the gabions, loosening the soil at the edge of the structures. Erosion then re-occurs in times of heavy rains.

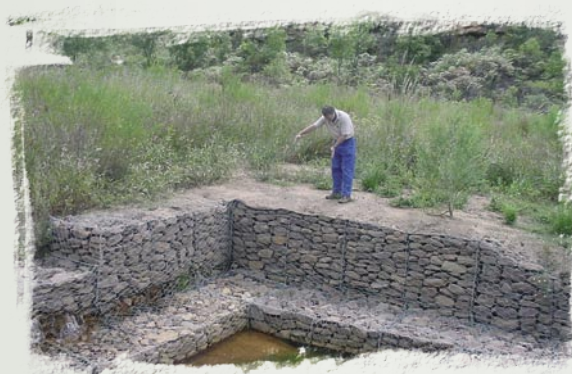
*Examining a rock gabion*
