HABITAT INTEGRITY

# Habitat Integrity of Selected Rivers of the North West Province

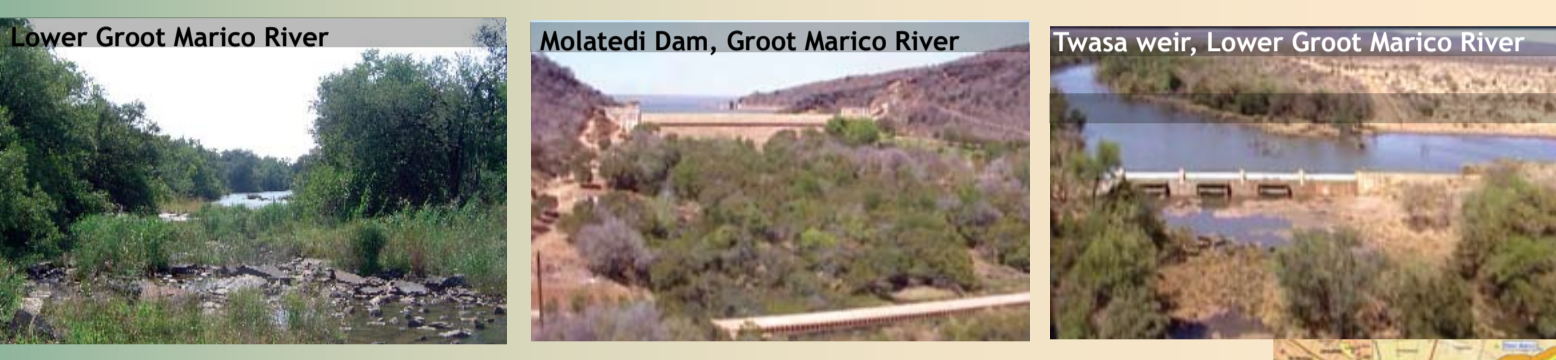
### Habitat Integrity Results: Groot Marico River

In general, the tributaries in the Upper Groot Marico catchment (Draaifontein, Kaaaloo se Loop, Rietspuit, Ribbokfontein se Loop, Van Straatenstvl, and Sterkstrook), consist of natural wetlands in the upper reaches, while the lower reaches flow over the plateau and are largely impacted by agricultural activities as well as invasive alien vegetation.

The Lower Groot Marico is dominated by large dams (Marico Bosveld and Molatedi Dam) that provide for domestic and agricultural water supply. This results in severe flow modifications that impact on both the instream and riparian zones.

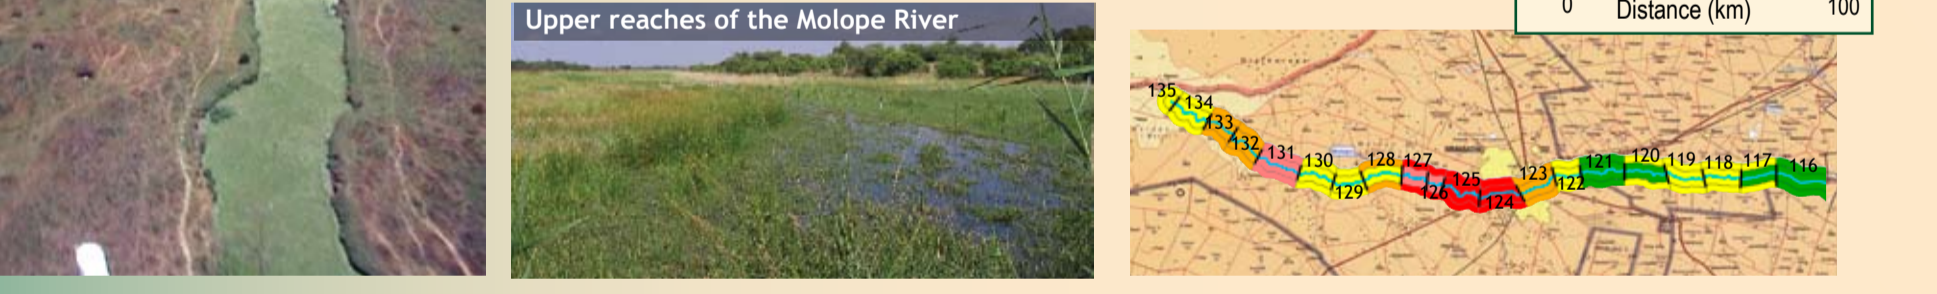
### Habitat Integrity Results: Molopo River

The integrity of the Molopo River varies from a largely natural (B category) upstream from Mafikeng to a low D and E category downstream of Mafikeng. The exception is the rehabilitated wetland areas in the upper river and in the Mafikeng Nature Reserve where wetland rehabilitation has taken place.

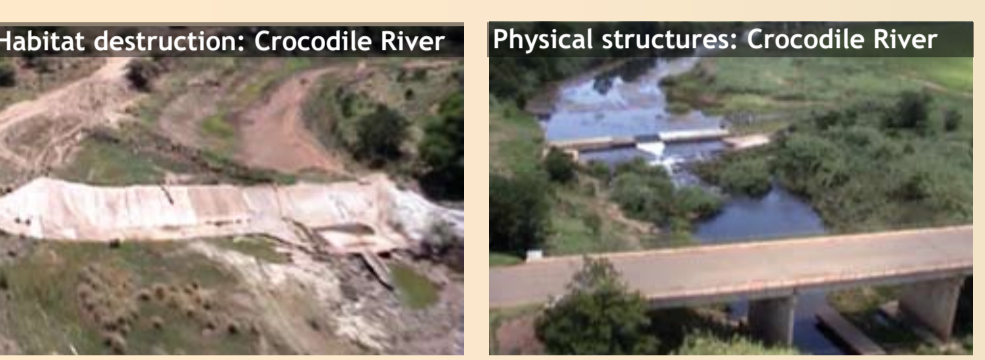
### Habitat Integrity Results: Crocodile River

The Crocodile River system is heavily utilised and the impacts are the result of the major impoundments of Hartbeespoort and Roodekopjes Dams, which alter the flow variability and volumes downstream resulting in bed and channel modification.

Heavy alien plant infestations in the riparian zone and vegetation removal in the intensive irrigated areas contributes to the deterioration of habitat integrity. The habitat integrity gradually improves in the downstream direction in the Crocodile system.

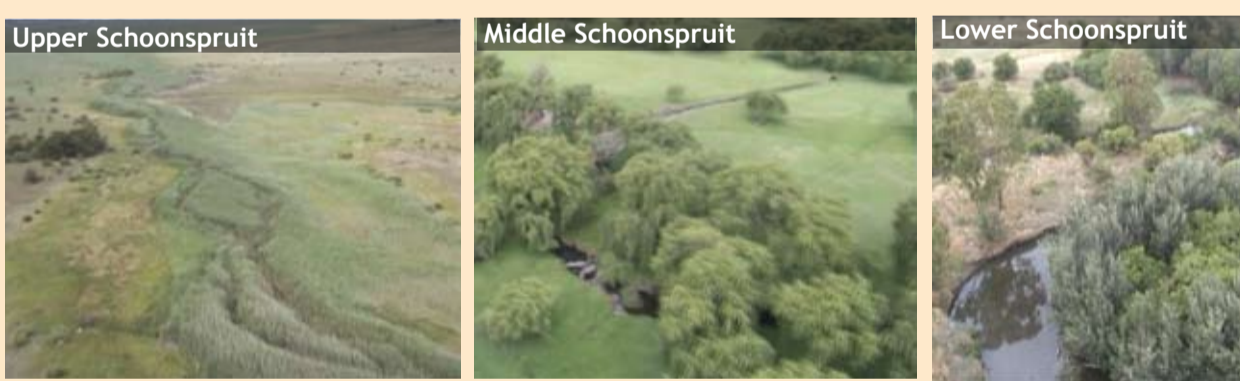
### Habitat Integrity Results: Schoonspruit River

The Schoonspruit can be divided into distinct reaches depending on the riparian zone vegetation and the type of ecosystem dominating the river. The upper reaches are characterised by wetland habitat.

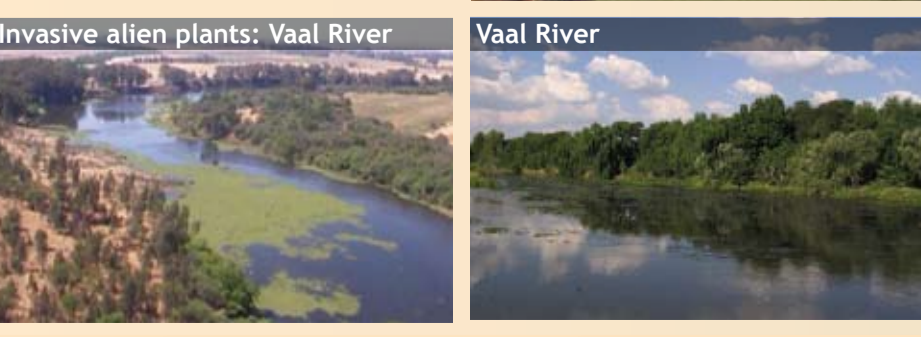
### Habitat Integrity Results: Vaal River

The habitat integrity for the sections of the Vaal River assessed is mostly in a moderately modified state (C category). The only aspects that reduce habitat integrity to a largely modified state are the degree of inundation and riparian zone impacts.

A substantial number of new housing developments are taking place in the vicinity of Parys with specific impacts in terms of vegetation. This resulted in the variation in the habitat integrity that can be attributed to the clearing of vegetation and the associated localised impacts caused by sediment deposition in the river.
