Post Feasibility Bridging Study for the Proposed Bulk Conveyance Infrastructure  
from the Raised Clanwilliam Dam (WP0485)

## **Existing Infrastructure and Current Agricultural Development Sub-Report**

**Date** : June 2018

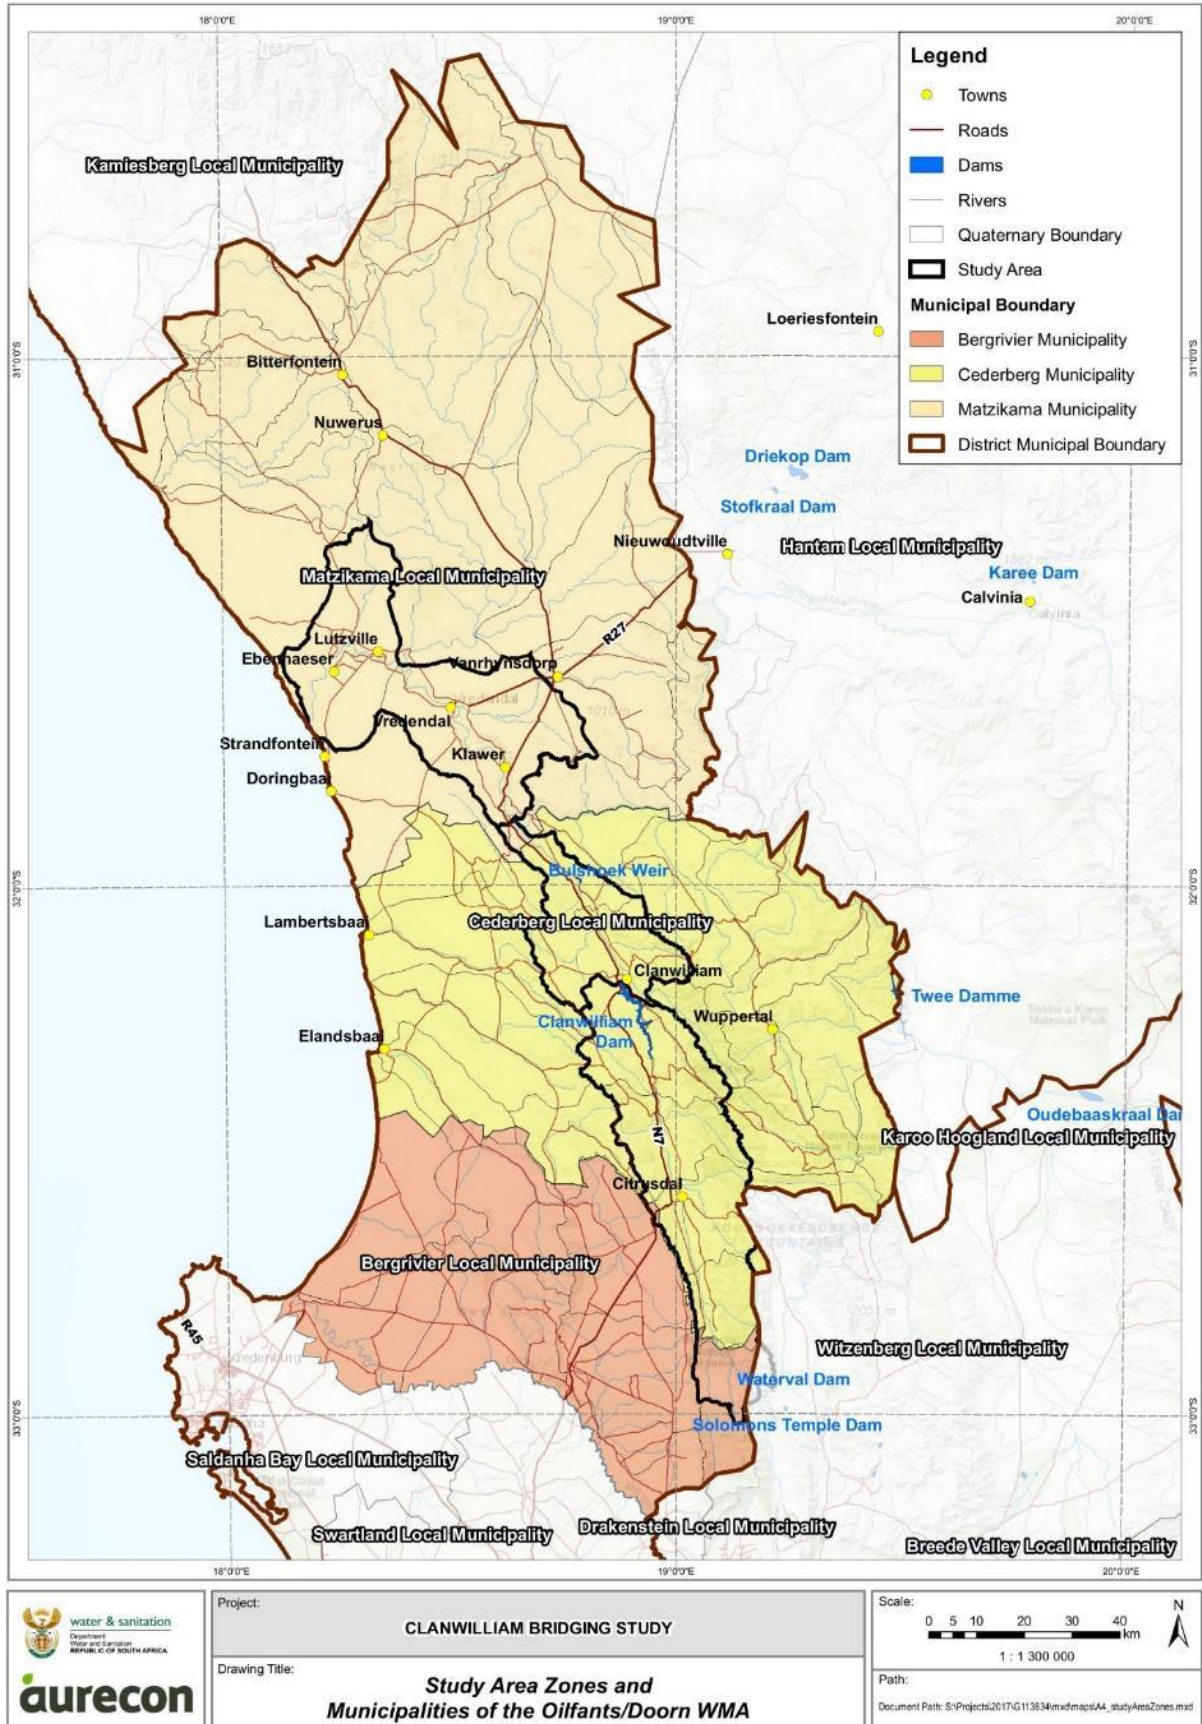
Figure 1.1 | The study area zones and municipalities

For the purposes of this study, the Olifants River catchment's study area, shown in **Figure 1.1** has been separated into three relatively homogeneous regions, namely:

- Region 1: Catchment area upstream of Clanwilliam Dam;
- Region 2: Catchment area downstream of Clanwilliam Dam and upstream of Bulshoek Weir;
- Region 3: Catchment area downstream of Bulshoek Weir to the estuary.

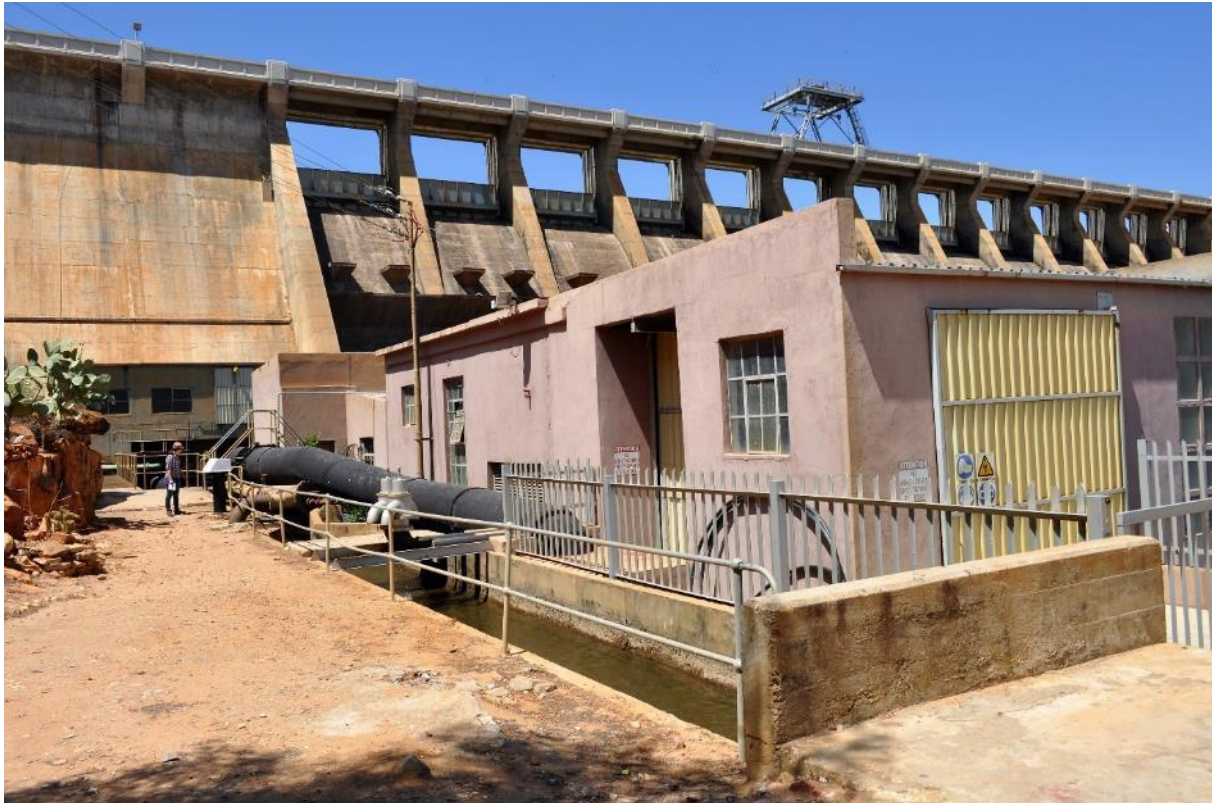
**Figure 3.3 | Existing turbine on the right bank of Clanwilliam Dam**

The only power station in the area is a small privately-owned hydro-electric installation (non-consumptive water user) on the right bank at Clanwilliam Dam which supplies electricity to the town of Clanwilliam (**Figure 3.3**). In 1998, Clackson Power (Pty) Ltd bought the hydropower station from the Cederberg Municipality. On 17 April 2001, the DWS and Clackson Power entered into an operations agreement that the power station will not consume any water, but that it will make use of water released from the Clanwilliam Dam, as and when water is released, for power generation. On 28 March 2008, Clackson Power registered with NERSA to generate 1.5 MW hydropower.

Provision has been made in the proposed new outlet works on the left bank to supply the hydropower plant. The plant has to move to the left bank. Although the construction of civil

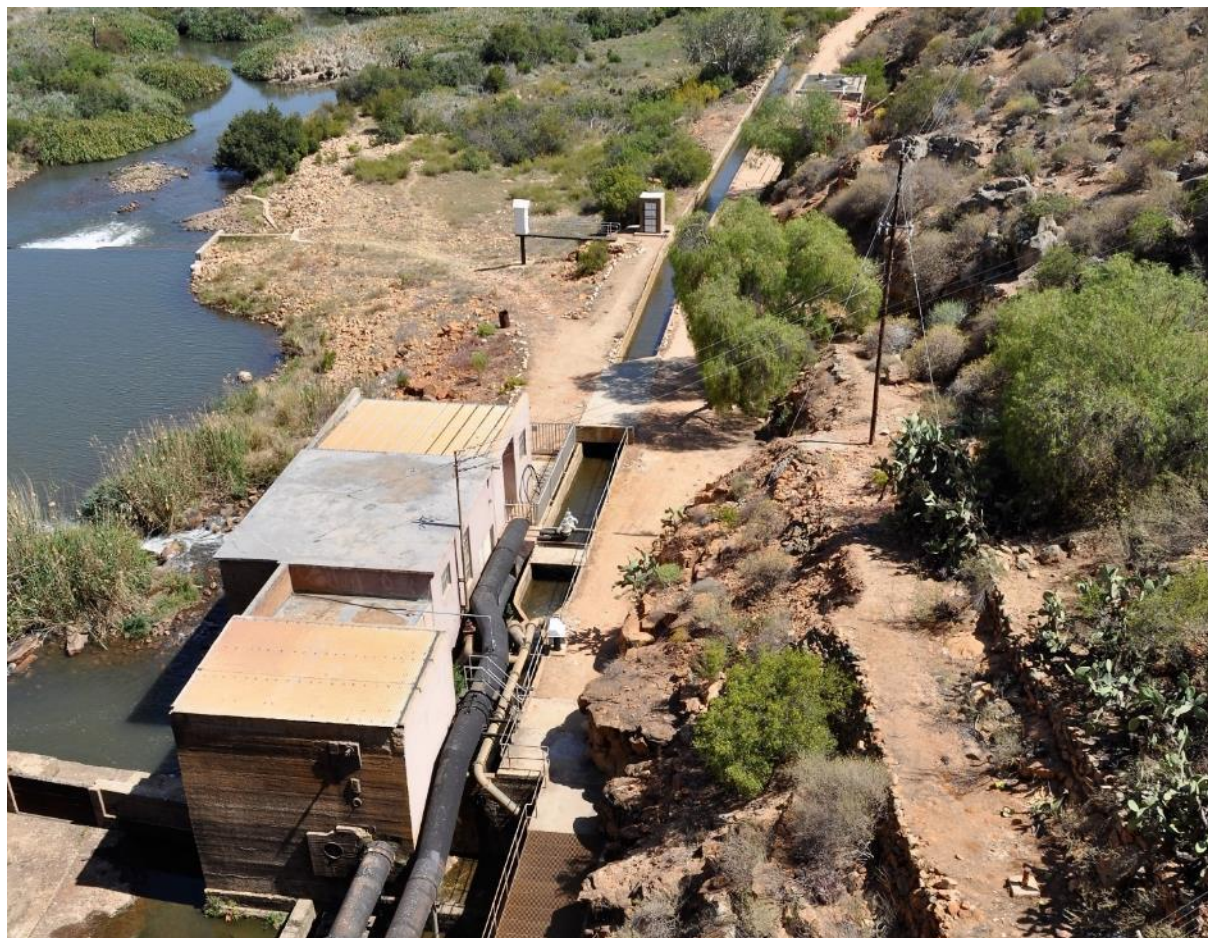
Figure 3.4 | Start of the Clanwilliam Canal

In the Clanwilliam scheme, there are 564 ha scheduled allocations from the Clanwilliam Canal and 665 ha allocated from the Olifants River. Water from the canal to water users is supplied at a rate of 0.83 l/s/ha, thus the maximum capacity required is 1685 m<sup>3</sup>/h. However, the maximum carrying capacity of the canal is accepted as 1700 m<sup>3</sup>/h (0.47 m<sup>3</sup>/s), which means that during peak periods the canal is close to full capacity. Although, according to discussions with the Clanwilliam WUA in November 2017, the canal currently has some spare capacity. Canal losses are estimated as 20%.

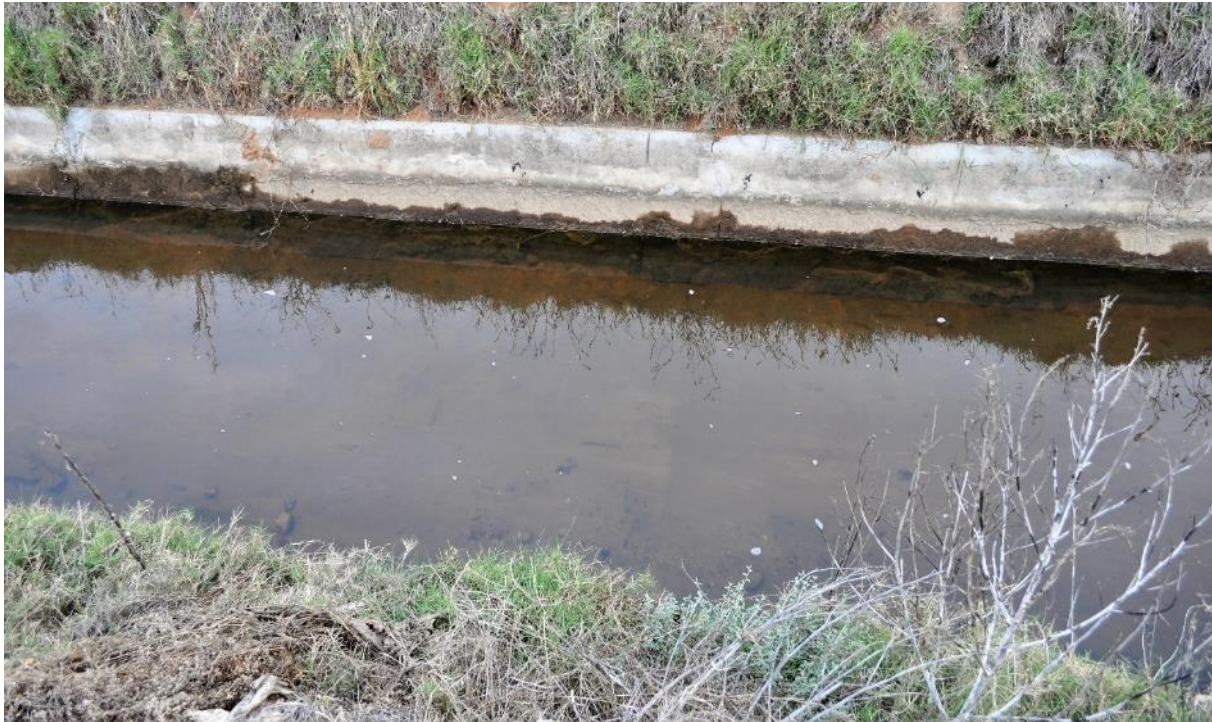
**Figure 3.5 | Typical condition of concrete lining along the Clanwilliam Canal**

The canal has a uniform profile. A recent site visit to the canal revealed that the Clanwilliam Canal has patch repairs along most of its length (**Figure 3.5**). In many canal sections, the stone aggregate in the concrete canal lining was exposed due to the aggressive water. The canal lining was on average less than 100 mm thick.

The study proposed short-term, medium-term and longer-term interventions. The short-term actions (1 to 3 years) include *inter-alia* resolving the maintenance backlog, replacement of broken canal lining panels and relining of very poor canal sections. The medium-term actions (4 to 6 years) include repairing berms and stormwater management structures, repairing service roads, reinstatement of safety measures, repairing siphons and water meter structures. The longer-term actions (7 to 9 years) include upgrades to the balancing dams, service points,

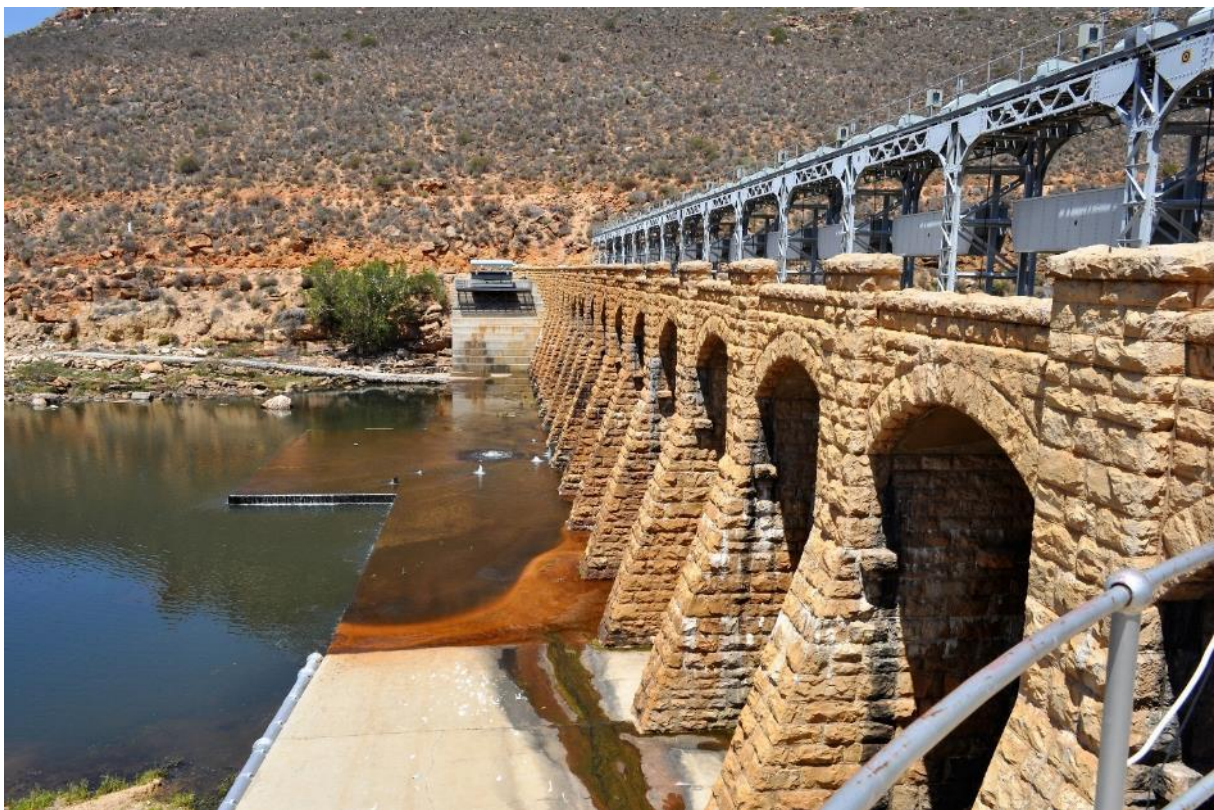
**Figure 3.6 | Bulshoek Weir**

The Bulshoek Weir, completed in 1920, is a stone-masonry gravity structure (**Figure 3.6**). A series of connected arches and buttresses supporting a bridge deck and a gantry for the spillway gate hoists make up the dam wall. Sixteen gates are positioned between the buttresses on top of the ogee-shaped crests.

Leakage through the foundation of the dam has been a problem since its completion, as indicated by grouting records from as early as the 1930s (Schall, cited by Oosthuizen and Brink 2015). A 1998 investigation documented large, deep cavities in the foundation where substantial flows were visible on the surface of the tail water. From 1999 to 2001, local operational and maintenance staff attempted to reduce the leak by using a geofabric upstream, sealing the downstream cavities with sand, and channelling the major leaks through pipes. The leak was estimated at 800 l/s as noted by Oosthuizen and Brink (2015); however, Mr R

The Bulshoek Weir is founded on the quartzitic sandstone and sandstone of the Table Mountain Group of the Cape Supergroup. Seepage water moving along the sandstone's sub-horizontal bedding planes is intercepted by a fault in the foundation that runs parallel to the dam wall. The leaking water also washed fine material from the bedding planes and created cavities in the foundation. Since the bedding planes are continuous over large areas, the shear strength loss could eventually spread along the entire base of the dam.

From November 2003 until February 2005, the DWS undertook remedial work on the Bulshoek Weir, with the main objective to protect the dam from structural failure. A concrete apron was provided downstream of the existing structure and doweled into the rock foundation to increase the sliding resistance of the structure. As part of the remedial work undertaken, mass concrete retaining walls were provided on each flank to reduce potential further erosion of the foundation rock downstream. Instrumentation comprising survey beacons, targets and bench marks was provided, as well as 3D Crack Tilt Gauges. The mechanical and electrical equipment for operating the spillway gates was refurbished at the same time.

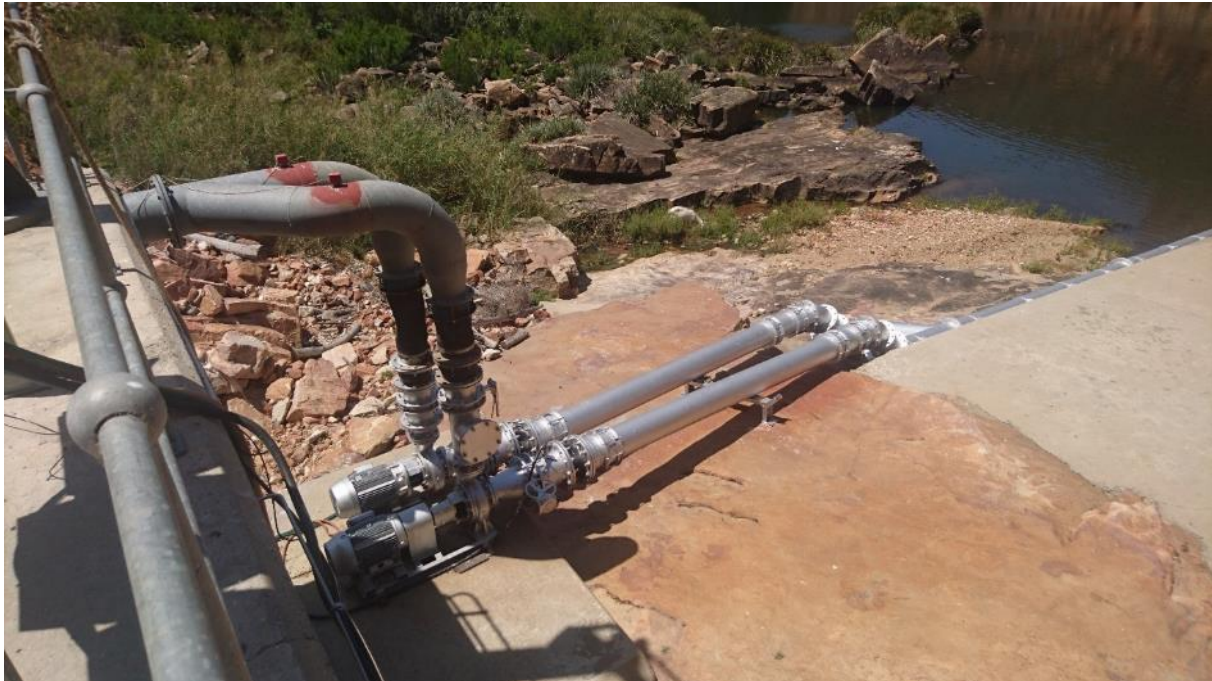
Figure 3.7 | Pumping system installed at Bulshoek Weir to recover leakage

The leakage amount differs depending on the water level in the dam. At full supply level in the dam (5.5 m), an estimated 2 400 m<sup>3</sup>/h is lost. It was also noted that there is a large leak (250 m<sup>3</sup>/h) on the southern flank of the dam.

During the 2004 drought period, a pumping system (two pumps, pipework and electrical works) was installed for R600 000, in order to recover some of the leaked water (**Figure 3.7**). Water is pumped straight into the canal while it is operational; otherwise water is pumped into the reservoir of the Bulshoek Weir. Operational costs for the pumping system are approximately R60 000 per month.

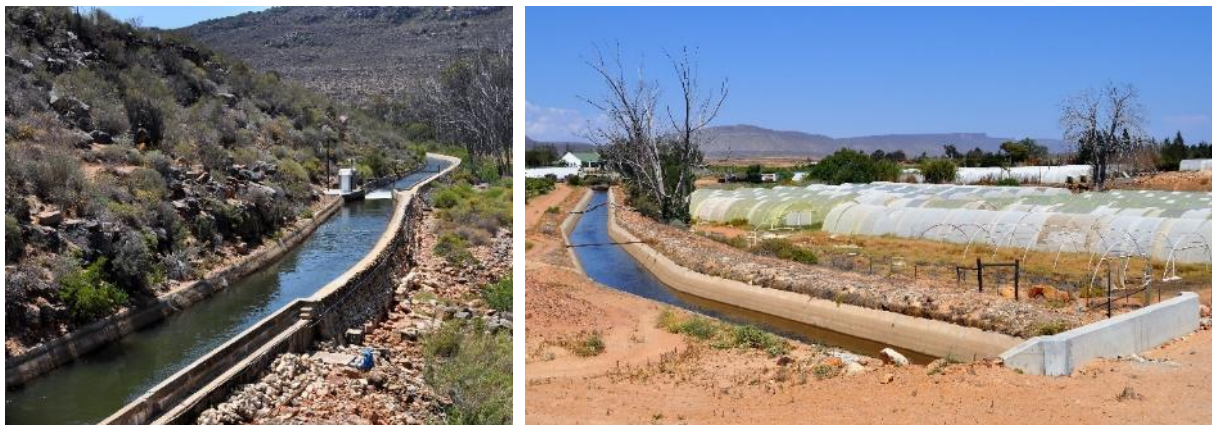
Figure 3.8 | The Lower Olifants Canal

Downstream of the Bulshoek Weir, water is diverted into the Lower Olifants Canal (**Figure 3.8**) which is the main conveyance system in the Olifants River (Van Rhynsdorp) Government Water Scheme (GWS). The canals and tunnels were mainly constructed during the 1930s.

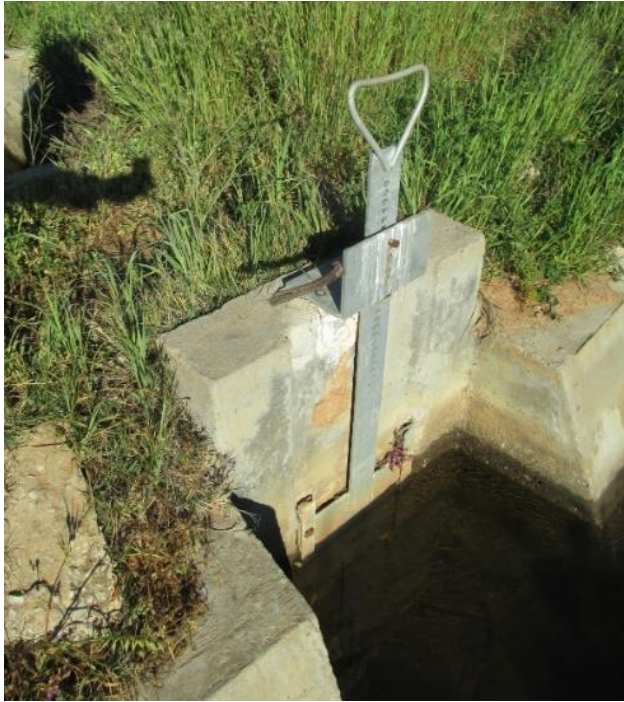
**Figure 3.10 | Typical canal off-take**

The existing system allows abstractions from the canal as requested by irrigators, i.e. a demand system. The 600 or so off-takes are set on a weekly basis (**Figure 3.10**) – irrigators must apply for a specific volume of water for the next week as well as the period in which the water must be supplied to his/her property. Flows are controlled by sluices and are measured with V-notches on all outlets where the stream exceeds 150 m<sup>3</sup>/h. A telemetry system is used where automatic control gates are installed on the main canals. There are five automatic sluices: one at Bulshoek Weir, and two at the left and right bank bi-furcation works respectively. There are additional telemetric controlled outlets at the municipality, Namakwa Sands and

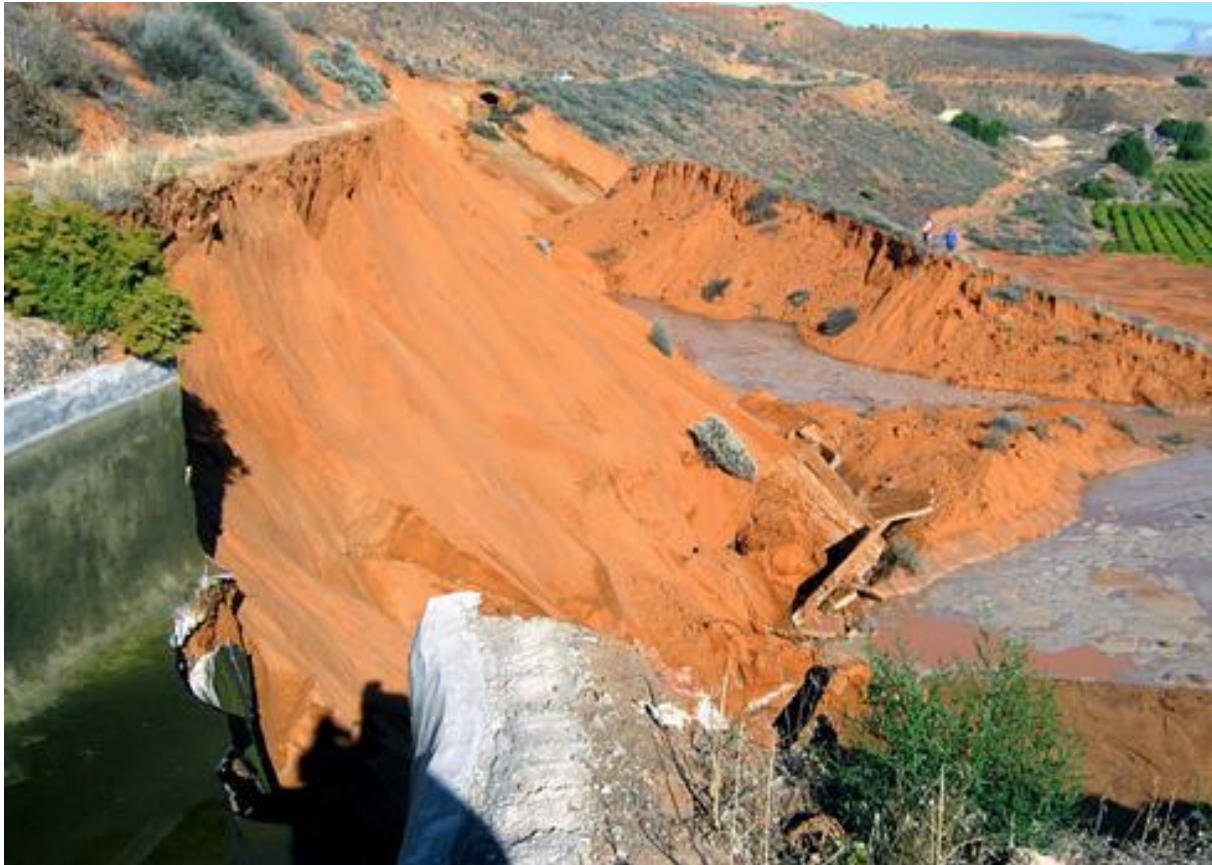
**Figure 3.11 | Lower Olifants Canal break in 2015 (IOL, 2015)**

The 2015 break was as a result of a 180 m long failure in the soil supporting the concrete lining near Klawer (**Figure 3.11**). The canal collapse cost the agriculture sector an estimated R100 million (Creamer Media, 2017). Following this break, the WCDoA committed to a R4 million

After more than 80 years of usage, the concrete lining has become frail and prone to damage, which results in canal breaks occurring frequently.

proactive maintenance programme for the canal, in which funds are released on an emergency basis, given the importance of infrastructure to the agriculture sector in the area. The plan involved the LORWUA assisting WCDoA in identifying the most critical areas for maintenance. In 2016, R1.2 million was spent to fix a 1200 m section near Verdeling, and in 2017, repair work on a 1400 m section near Vredendal was earmarked as a priority area.

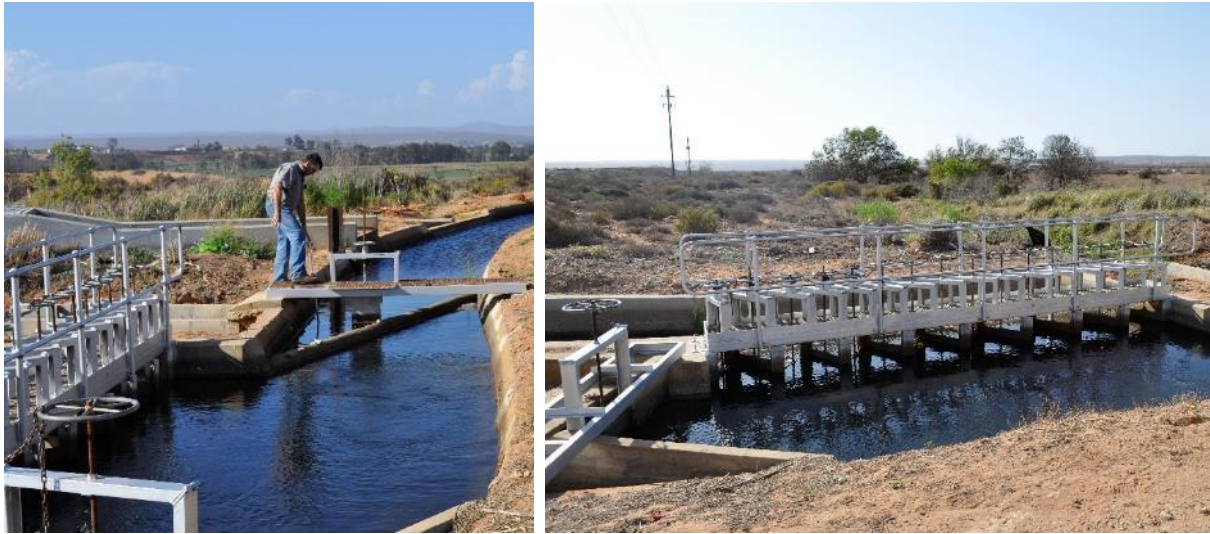
### **Figure 3.12 | Sluice gates installed near the Ebenhaezer balancing dam**

A long-weir and adjustable sluice gates (**Figure 3.12**) are used to control the water level in the canal according to allocated water demand, and the surplus water is diverted to the balancing

dam. When the water level in the canal is less than required, the canal water flow is stabilised by pumping water from the balancing dam to the canal.
