Post Feasibility Bridging Study for the Proposed Bulk Conveyance Infrastructure from the
Raised Clanwilliam Dam (WP0485)

Existing Conveyance Infrastructure and Irrigated Land Report

DWS Report Number : P WMA 09/E10/00/0417/6

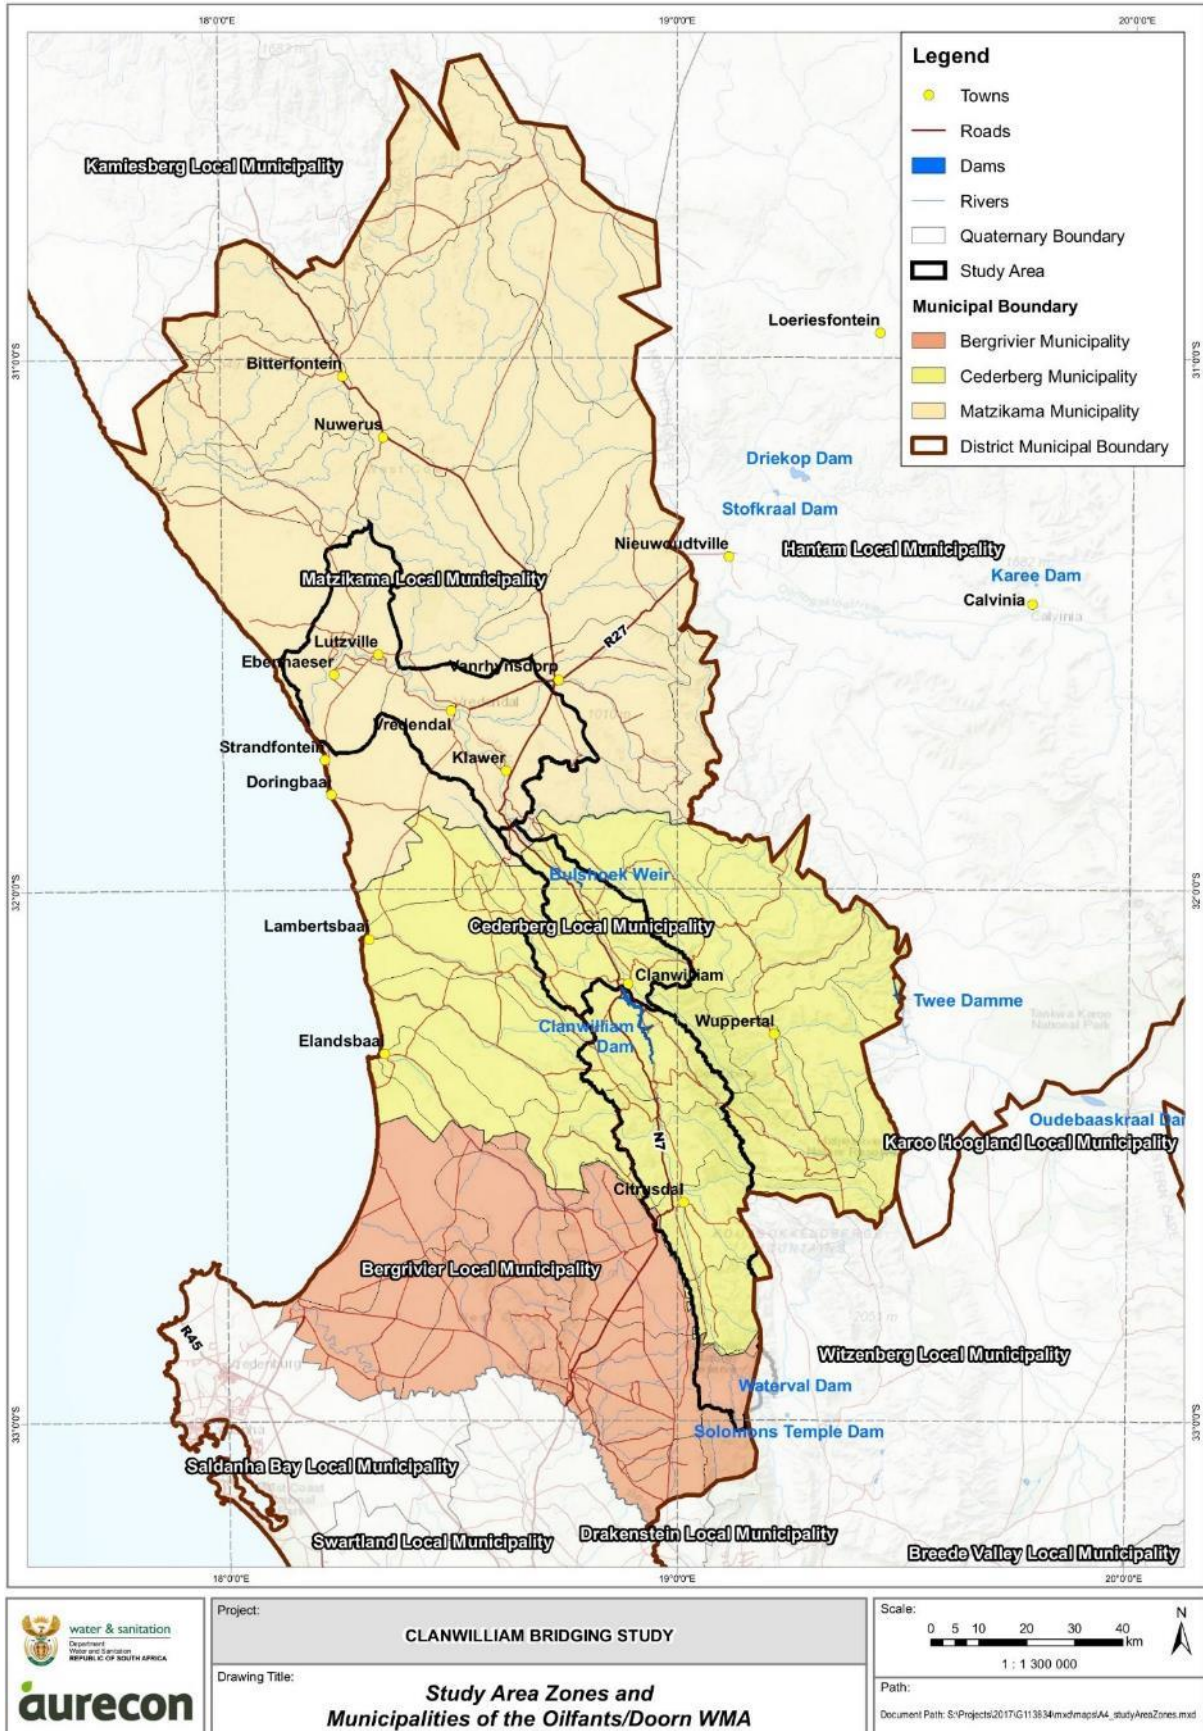
Figure 1.1 | The study area zones and municipalities

For the purposes of this study, the Olifants River catchment's study area, shown in **Figure 1.1** has been separated into three relatively homogeneous regions, namely:

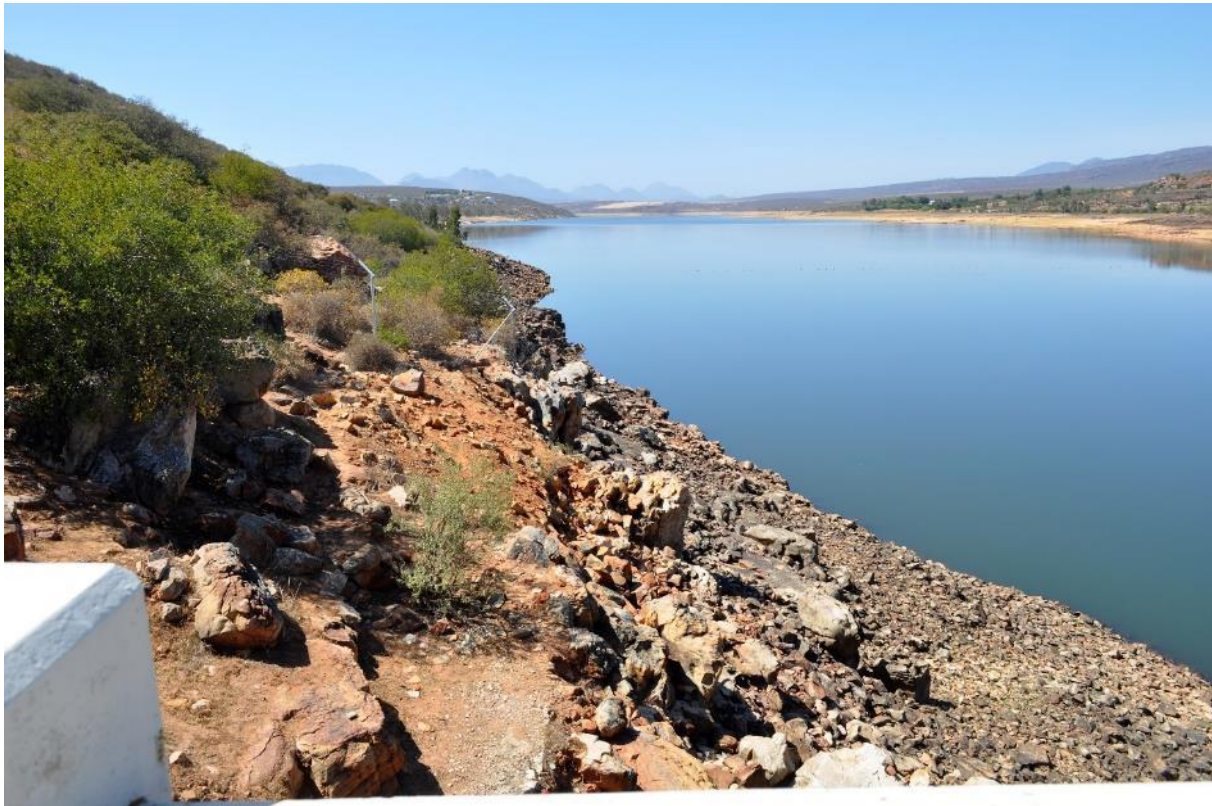
Figure 3.2 | Low water levels in the Clanwilliam Dam in November 2017

During a recent visit to the study area in November 2017, the Clanwilliam Dam was 39% full (**Figure 3.2**). The dam's water level may be allowed to drop to 6% before the next rain season.

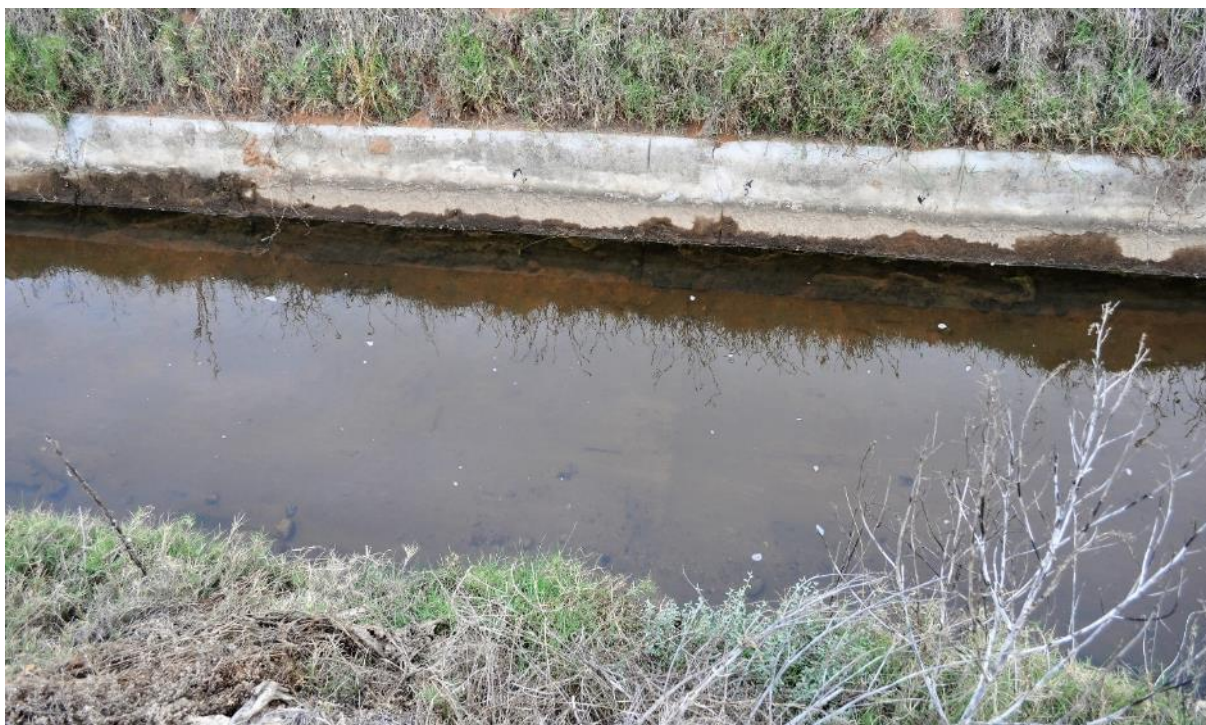
The canal has a uniform profile. A recent site visit to the canal revealed that the Clanwilliam Canal has patch repairs along most of its length (**Figure 3.5**). In many canal sections, the

stone aggregate in the concrete canal lining was exposed due to the aggressive water. The canal lining was on average less than 100 mm thick.

Figure 3.5 | Typical condition of concrete lining along the Clanwilliam Canal

The study proposed short-term, medium-term and longer-term interventions. The short-term actions (1 to 3 years) include *inter-alia* resolving the maintenance backlog, replacement of broken canal lining panels and relining of very poor canal sections. The medium-term actions

- Short-term actions for the canal lining comprise canal repairs such as earthwork repairs (including berm, shoulder level and gaps) and concrete repairs (including crack repairs, surface finishes, expansion joint and sealing repairs, and broken panel repairs).
- Medium-term actions for the canal lining comprise replacement/renewal of the lining.

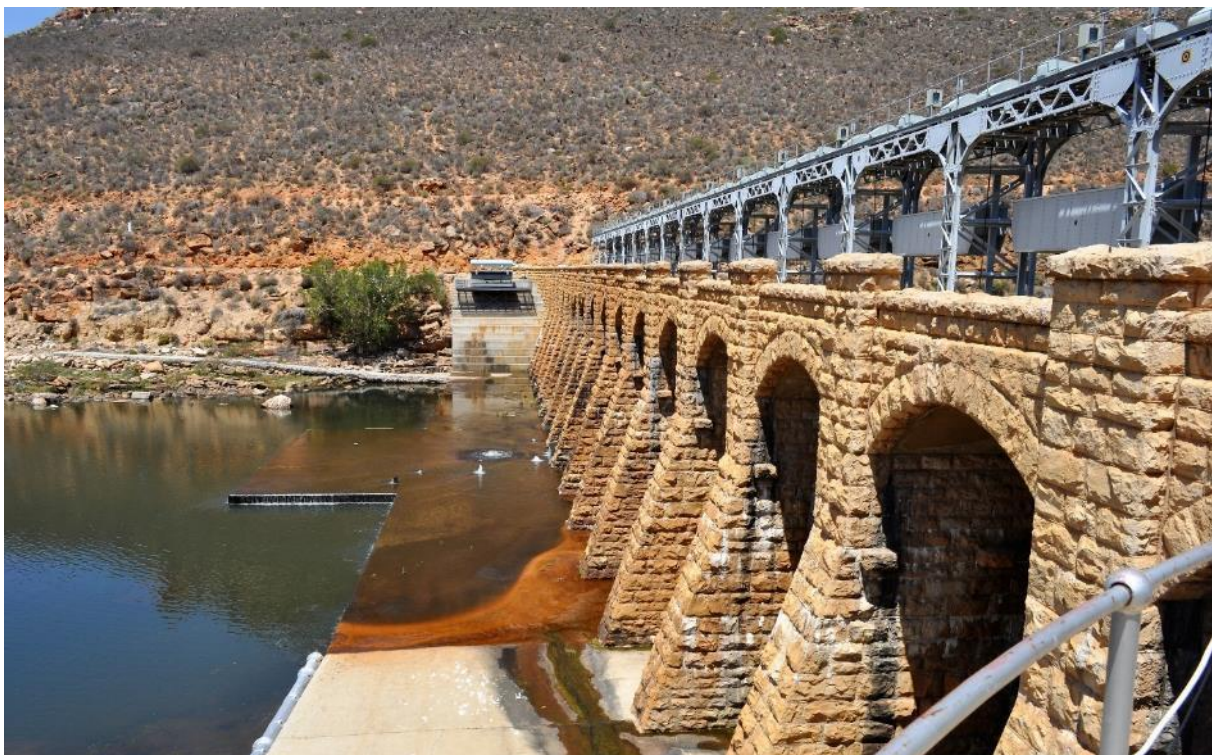
Figure 3.7 | Bulshoek Weir

The Bulshoek Weir, completed in 1920, is a stone-masonry gravity structure (**Figure 3.7**). A series of connected arches and buttresses supporting a bridge deck and a gantry for the spillway gate hoists make up the dam wall. Sixteen gates are positioned between the buttresses on top of the ogee-shaped crests.

Leakage through the foundation of the dam has been a problem since its completion, as indicated by grouting records from as early as the 1930s (Schall, cited by Oosthuizen and Brink 2015). A 1998 investigation documented large, deep cavities in the foundation where substantial flows were visible on the surface of the tail water. From 1999 to 2001, local operational and maintenance staff attempted to reduce the leak by using a geofabric upstream, sealing the downstream cavities with sand, and channelling the major leaks through pipes. The leak was estimated at 800 l/s, as noted by Oosthuizen and Brink (2015); however, Mr R Nieuwoudt's (DWS) assessment is that the leak was more in the order of 400-500 l/s. Although the flow was substantially decreased after each attempt, the leakage would gradually increase afterwards (Oosthuizen and Brink, 2015). The first two formal Dam Safety Inspections by the (then) Sub-Directorate: Dam Safety of DWAF, noted cracks in the masonry balustrade on the top of the dam, as well as at one of the spillway gates, which indicated problems with the foundations.

The leakage amount differs, depending on the water level in the dam. At full supply level in the dam (5.5 m), an estimated 2 400 m³/h is lost. It was also noted that there is a large leak (250 m³/h) on the southern flank of the dam.

Following a review of various documents provided by the DWS Dam Safety Office (DWAF (2002a); DWAF (2002b); DWAF (2008); and DWS (2016b)), several recommendations are made with respect to the Bulshoek Weir:

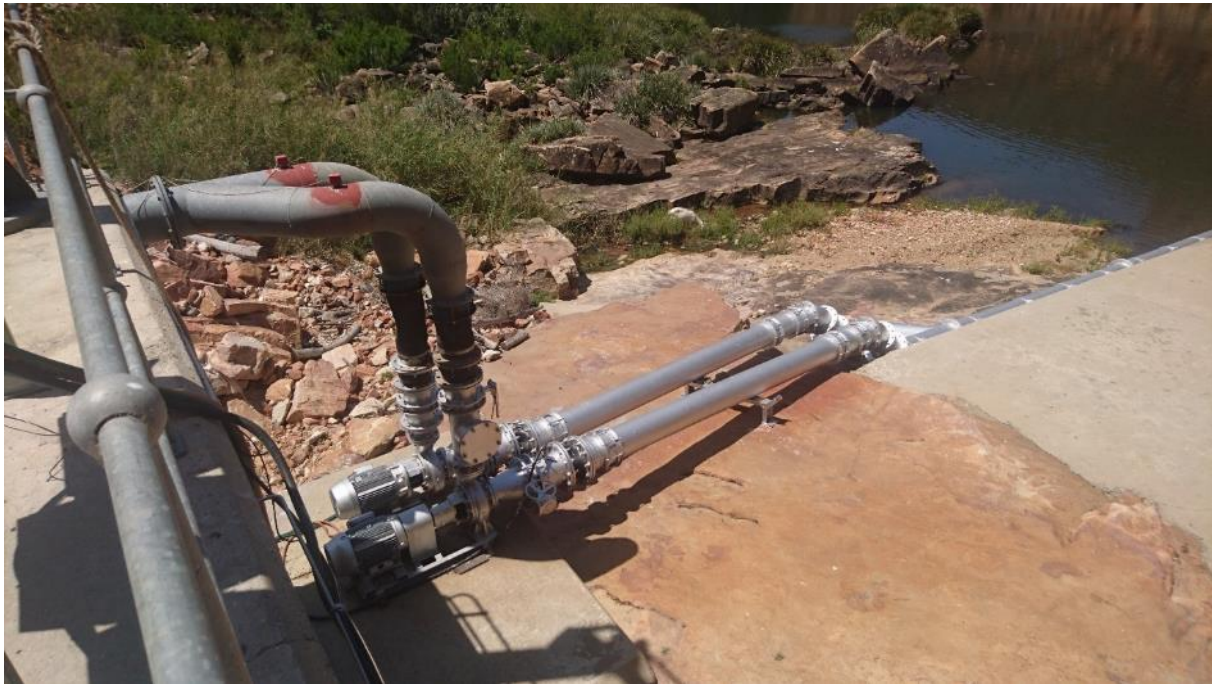
Figure 3.8 | Pumping system installed at Bulshoek Weir to recover leakage

During the 2004 drought period, a pumping system (two pumps, pipework and electrical works) was installed for R600 000, in order to recover some of the leaked water (**Figure 3.8**). Water is pumped straight into the canal while it is operational; otherwise water is pumped into the reservoir of the Bulshoek Weir. Operational costs for the pumping system are approximately R60 000 per month.

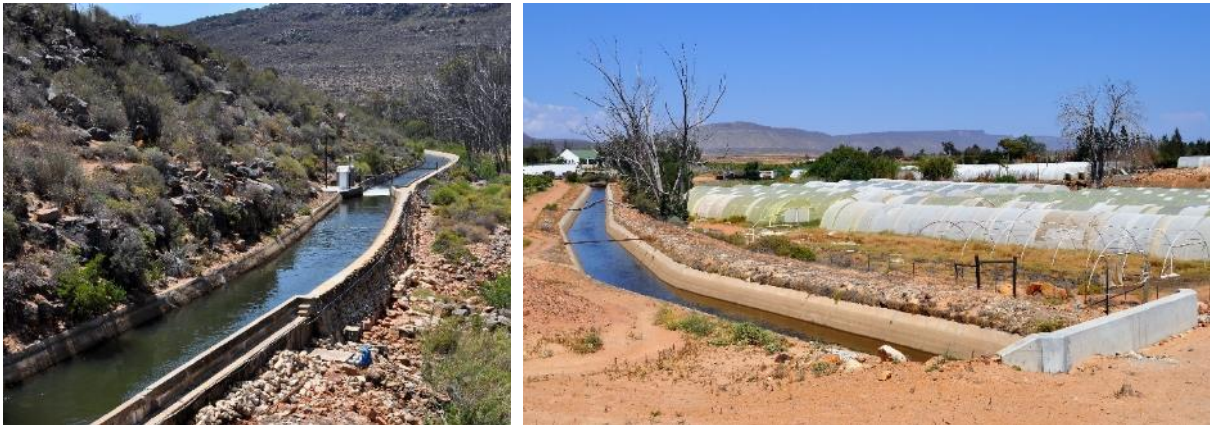
Figure 3.9 | The Lower Olifants Canal near Bulshoek Weir (left) and downstream

At of the Bulshoek Weir, water is diverted into the Lower Olifants Canal (**Figure 3.9**) which is the main conveyance system in the Olifants River (Van Rhynsdorp) Government Water Scheme (GWS). The canals and tunnels were mainly constructed during the 1930s.

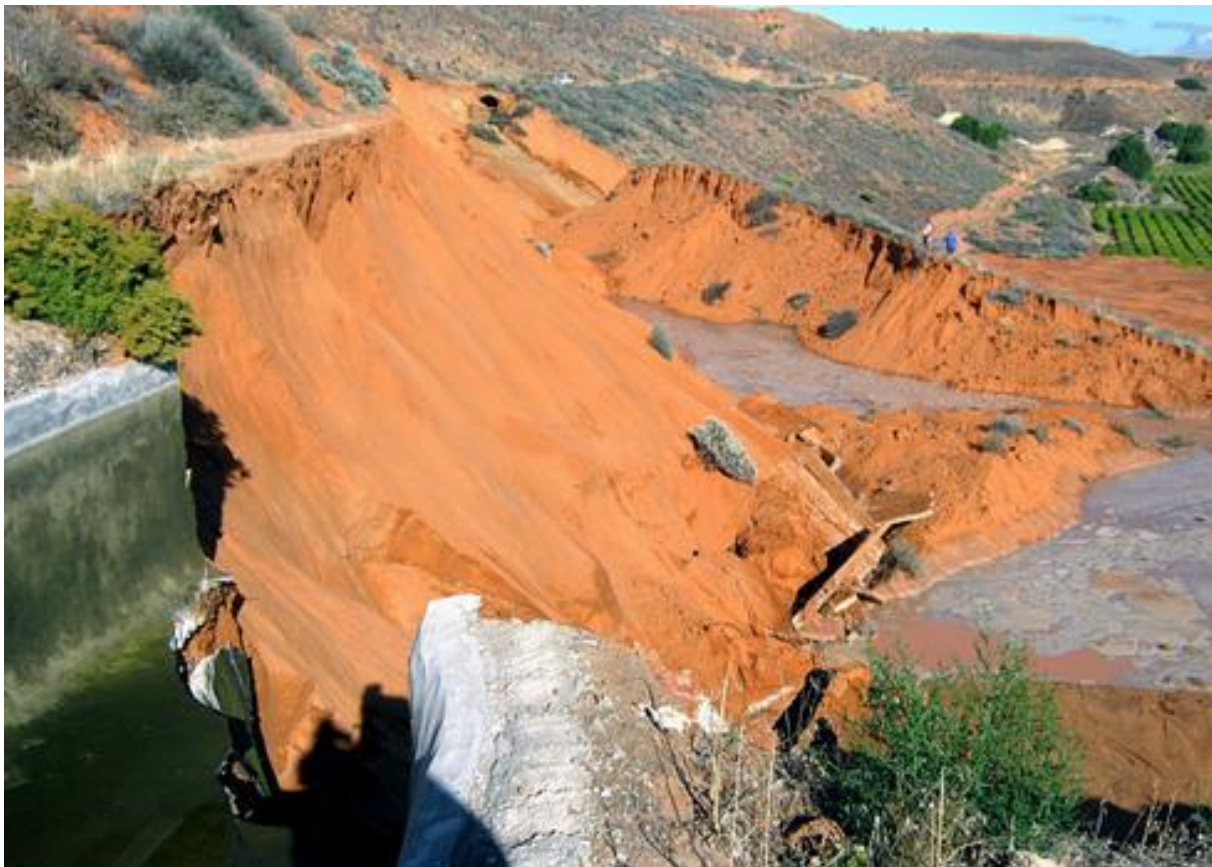
After more than 80 years of usage, the concrete lining has become frail and prone to damage, which results in canal breaks occurring frequently.

Figure 3.12 | Lower Olifants Canal break in 2015 (IOL, 2015)

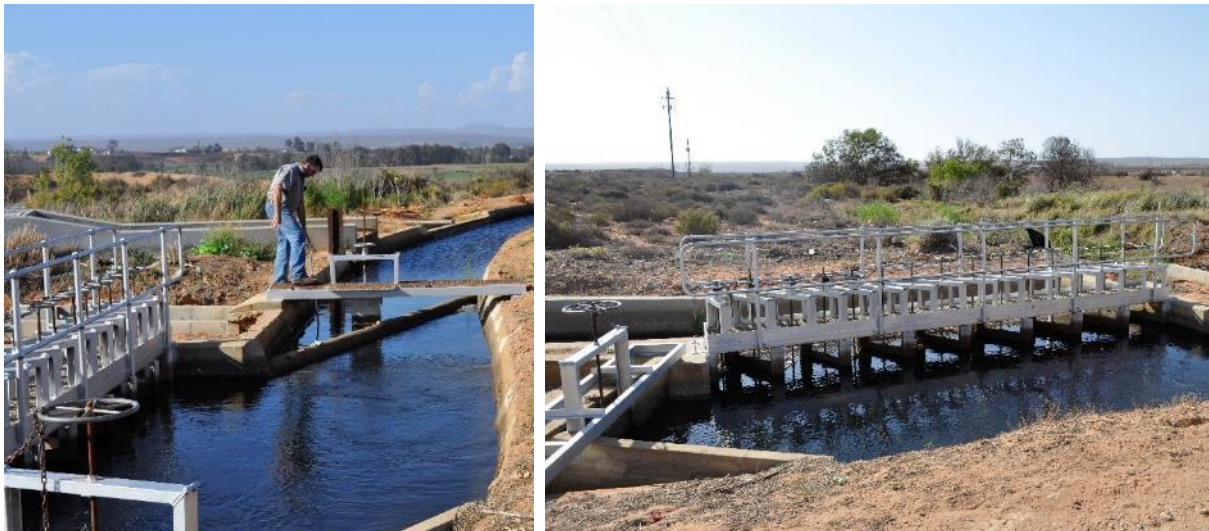
A long-weir and adjustable sluice gates (**Figure 3.18**) are used to control the water level in the canal according to allocated water demand, and the surplus water is diverted to the balancing dam. When the water level in the canal is less than required, the canal water flow is stabilised by pumping water from the balancing dam to the canal.

Figure 3.18 | Sluice gates installed near the Ebenhaeser balancing dam

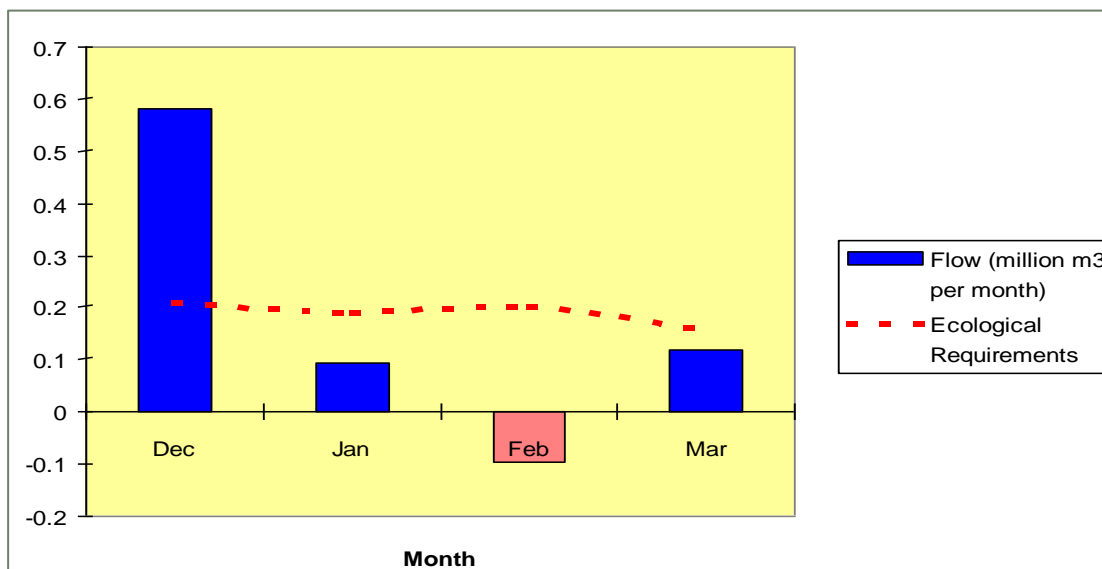
This ecological requirement is not met for at least three months of the year, as illustrated in **Figure 4.2**, which suggests that more than 400 000 m³ needs to be freed up during these months to meet the requirements of the ecological Reserve.

Figure 4.2 | Current average dry season flow profile in lower Jan Dissels section
