## **Geotechnical Report: Lower Coerney Dam Site**

Support of the Water Reconciliation Strategy for the Algoa Water Supply System

7 March 2019  
Revision: 1  
Reference: 112546

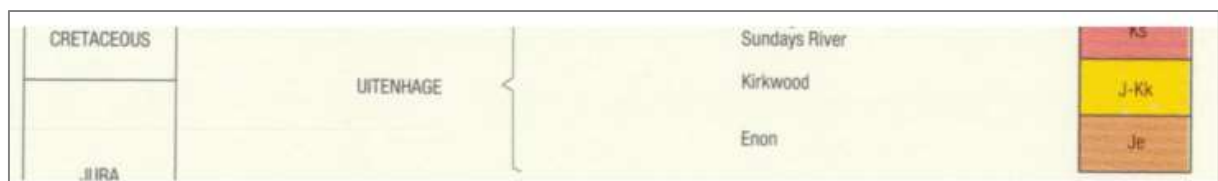
**Figure 4.2: Geological explanation, excerpt from geological map**

According to the 1:250 000 geological map (Port Elizabeth Sheet 3324, Council for Geoscience), the dam sites are both underlain by the strata of the Sunday River Formation, although in both instances the upper reaches of the respective basins are underlain by strata of the Kirkwood Formation. All are part of Uitenhage Group (Figure 4.1, Figure 4.2).

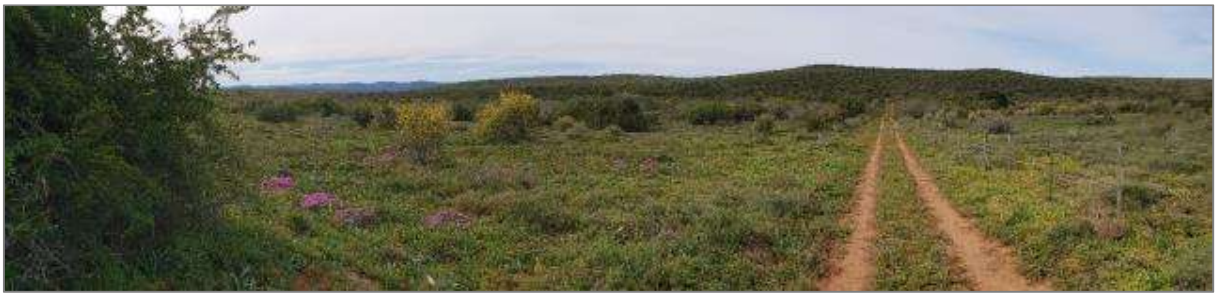
**Plate 5.1** General panorama of Lower Coerney site, from the access track a short distance downstream of the centre-line (which is to the left)

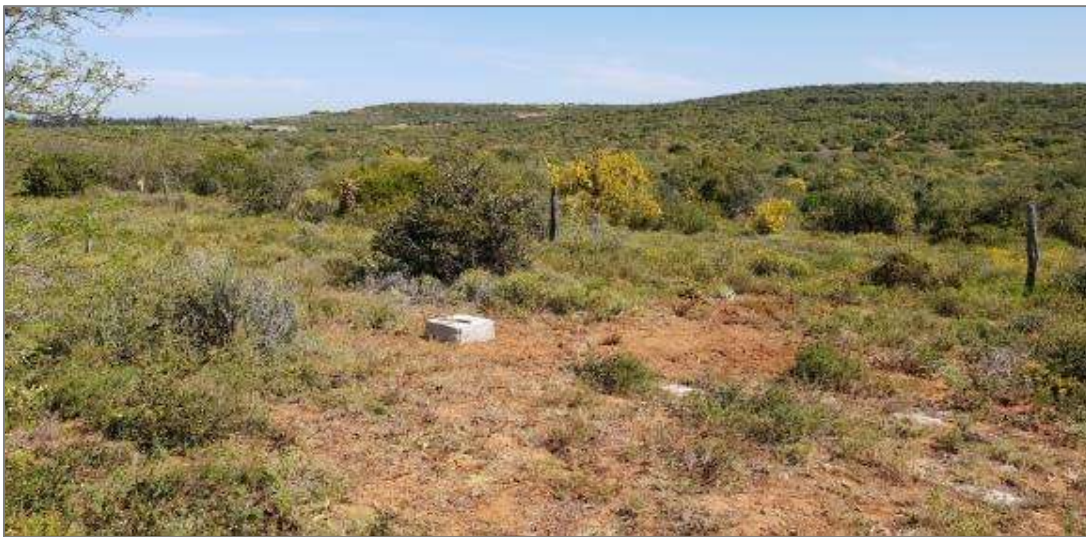
**Plate 5.2: General view of left flank conditions, looking here along the spillway alignment in a downstream direction**

Subsurface conditions on the left flank, inclusive of the spillway (**Plate 5.2**), have been investigated by geophysical traverses, test pits as well as boreholes, as shown on Drawing 112546-GEO-DRG-CC-001-A. The summarised findings are presented below in **Table 5.1** in the case of the test pits and **Table 5.2** for the boreholes. A longitudinal geological section has been compiled (drawings 112546-GEO-DRG-CC-002A-A and 112546-GEO-DRG-CC-002B-A).

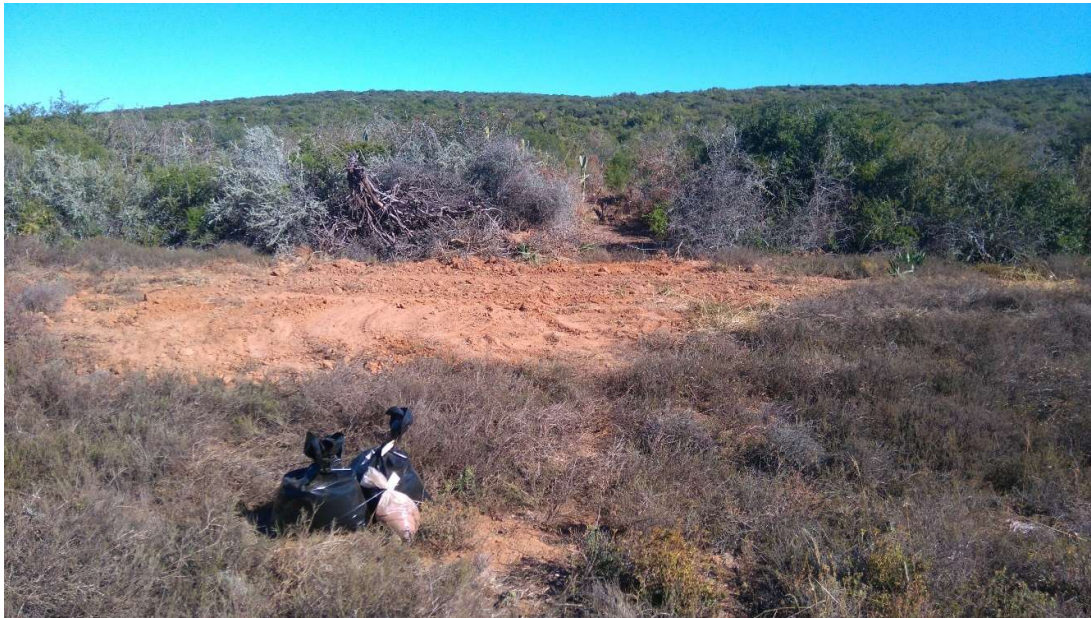
**Plate 5.3: River section view, looking towards right flank (test pit LC03 in foreground)**

The upper **topsoil** horizon covers the entire central section. This horizon is typically a fairly consistent 0.3 m thick. The topsoil comprises silty sand and at the time of the test pitting was typically described as dry, with consistency varying between very loose and medium dense. Occasionally the material is dense. Roots are generally present.

The underlying horizon of **colluvium** was intersected in test pits LC02 and LC03. The colluvial material comprises silty sand, or slightly clayey silty sand. The moisture content at the time was described as slightly moist, and the consistency as medium dense or dense. Pinholes were recognised in the structure. Roots are present. This colluvium is not present across the entire footprint in the river section and is likely patchy. Where present, the thickness varies between 0.7 m and 0.85 m.

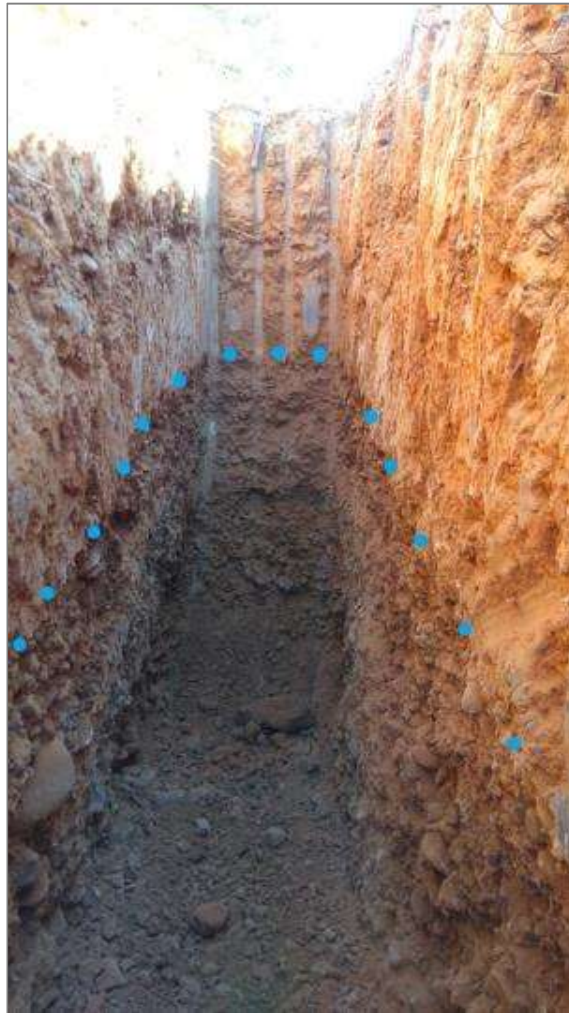
**Plate 6.1: The gravelly layer as exposed within a test pit (this view test pit LC22); the boundary indicated by the dotted line**

The significance of this stratum for the dam design is that these materials are potentially highly pervious, and in such cases would represent potential preferred seepage paths. This aspect, including the implications for excavation depths, as well as foundation treatment is discussed in more detail below.
