MOKOLO & CROCODILE (WEST) WATER AUGMENTATION PROJECT (MCWAP): PHASE 1.

WETLANDS & WATERCOURSE CROSSINGS SURVEY

Report author: Mathew Ross (*Pr Sci Nat*); Tahla Ross.
Report Ref: Nem_MCWAP PHASE 1_6/10
Date: June 2010

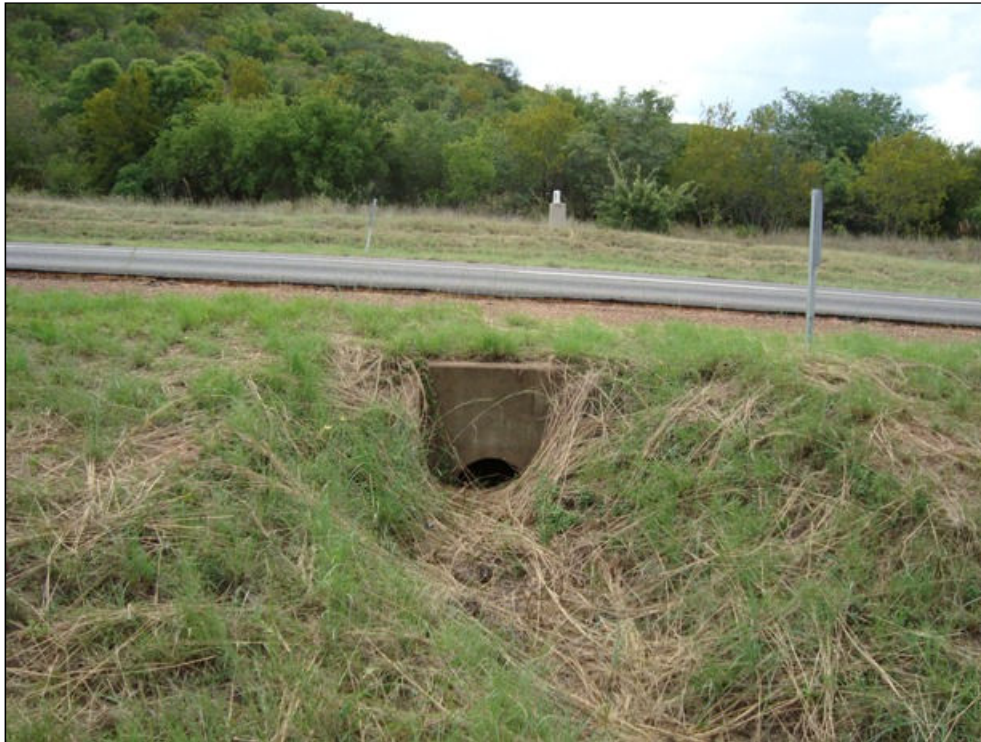
proposed pipeline alignment follows alongside a roadway, the majority of these drainage channels occur as culvert drains that merely allow for free drainage within the road reserve and do not represent ecologically sensitive habitats (Figure 5).

Figure 5: Drainage channels where the proposed pipeline alignment occurs alongside a roadway, which incorporated culvert drains that allowed for free drainage of water within the road reserves.

Impacts emanating from the proposed pipeline crossings at these points will be limited to the potential creation and aggravation of existing soil erosion. Many of these drainage lines fall within areas of steep topography and therefore surface water runoff occurs at a relatively high velocity during rainfall events. Disturbances of the rock and soil layers, together with vegetation stripping will lead to the occurrence of soil erosion and aggravate existing soil erosion potential within the area. If left unabated, this will eventually lead to gully formation that will require costly follow-up procedures to mitigate if allowed to occur. This was observed within certain areas along the existing pipeline (Figure 6) and illustrates the importance of managing for soil erosion both during and directly after the construction phase. Follow-up monitoring is then also important to identify any emerging problematic areas.

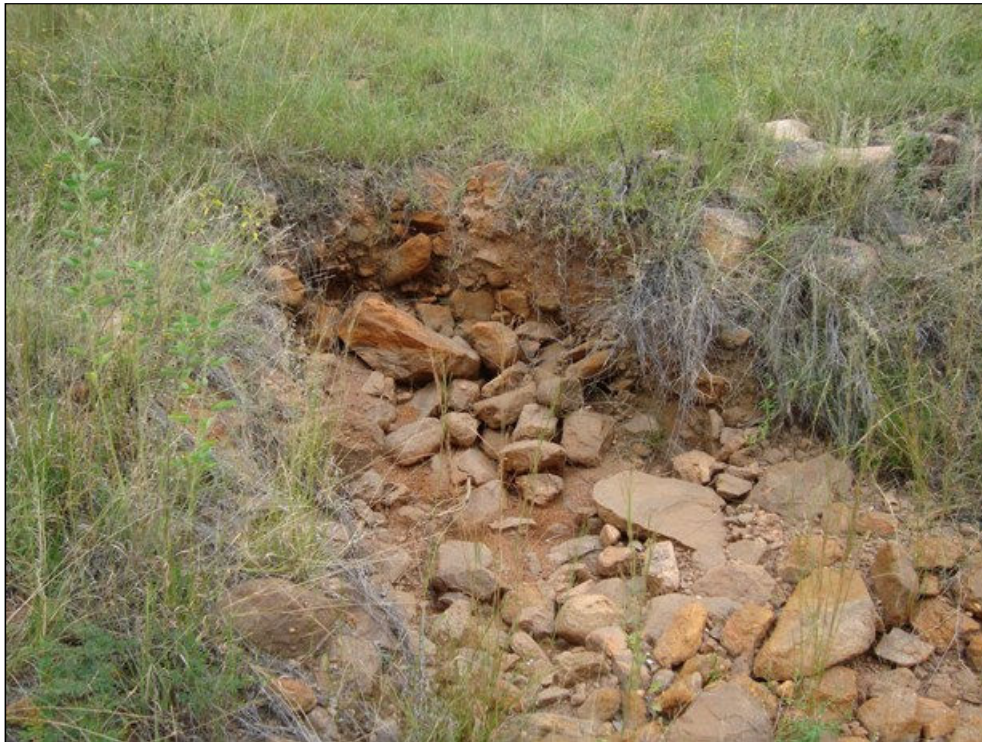
Figure 6: Soil erosion that is enhancing gully formation at a drainage line that was observed along the existing pipeline (taken at point 1.05 – Goedehoop 552LQ). Areas such as these will require the implementation of follow-up mitigation measures to stabilise and manage the emerging problem. This can readily be avoided with correct site reinstatement following the construction phase.

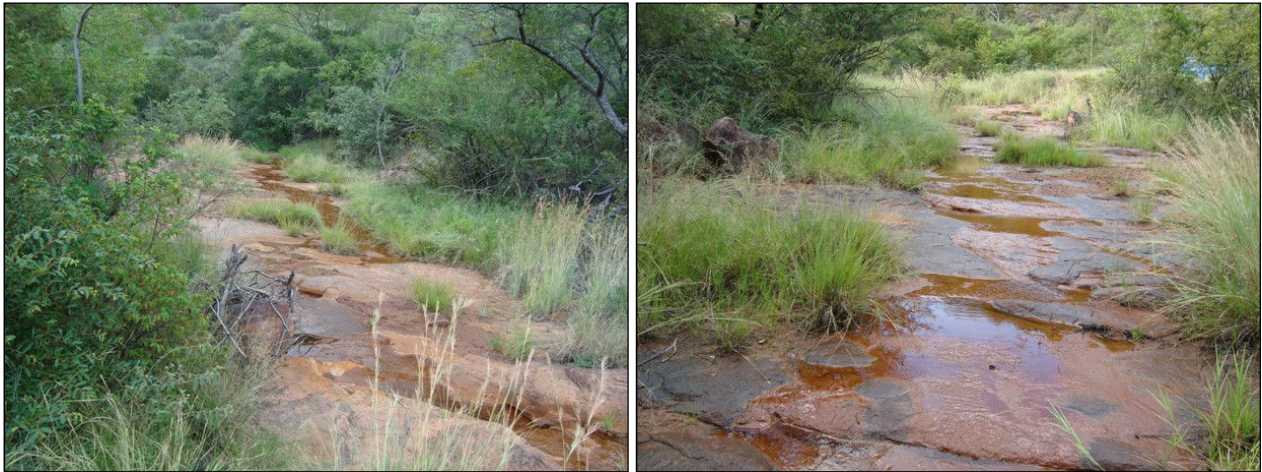
There was a mountain stream that was identified on the *Farm Witbank 647LQ* that flows for the majority of the year, only drying up for short periods during the dry season (Figure 7). This is therefore a semi-permanent system and cannot be regarded as a strictly perennial stream. The stream does, however, support an ecologically significant kloof habitat unit downstream that has been reported to incorporate plant species of conservational significance. The preservation of the ecological integrity and functionality of this stream is therefore imperative to conserving the habitat downstream of the proposed crossing site. The stream bed is predominantly bedrock and the disturbance of these bedrock layers will affect the hydrology and water quality of the system downstream. It is therefore recommended that this stream be crossed at a point where it has not developed into a kloof habitat and where the stream is the narrowest. The proposed crossing point coincides with an existing powerline servitude and is considered as the ideal crossing point (Figure 8). It is recommended that a bridge structure to support the crossing above the stream bed be

Figure 7: The mountain stream on the farm *Witbank 647LQ*.

implemented, which would not disturb the stream bed, rather than entrenching the pipeline through it. This should be done in a manner that will not impede the natural flow of water and take into consideration the potential force of floodwaters carried by the stream in order to retain structural integrity during flooding events. Further recommendations if this proposal is regarded as being non-feasible from a technical perspective are presented under section 7: *General Conclusions & Recommendations*.

A bridge structure is recommended for the stream crossing on the farm *Witbank 647LQ*. This stream is considered an ecologically sensitive stream system and therefore it is recommended that streambed disturbances be limited as far as possible. If this recommendations are not technically feasible at this point, however, the following recommendations should be taken into consideration:

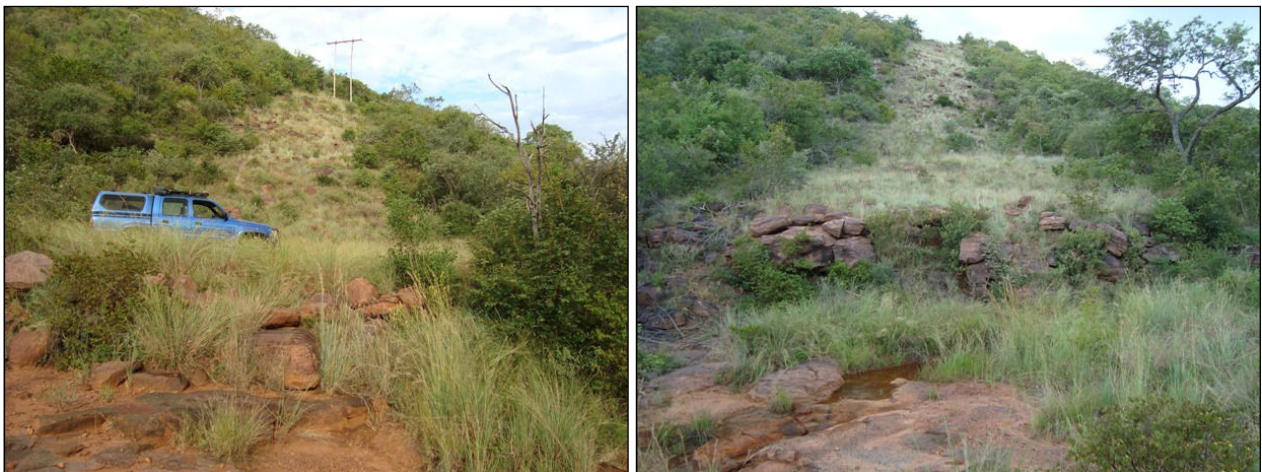
Figure 8: The proposed pipeline alignment route that follows the existing powerline servitude.

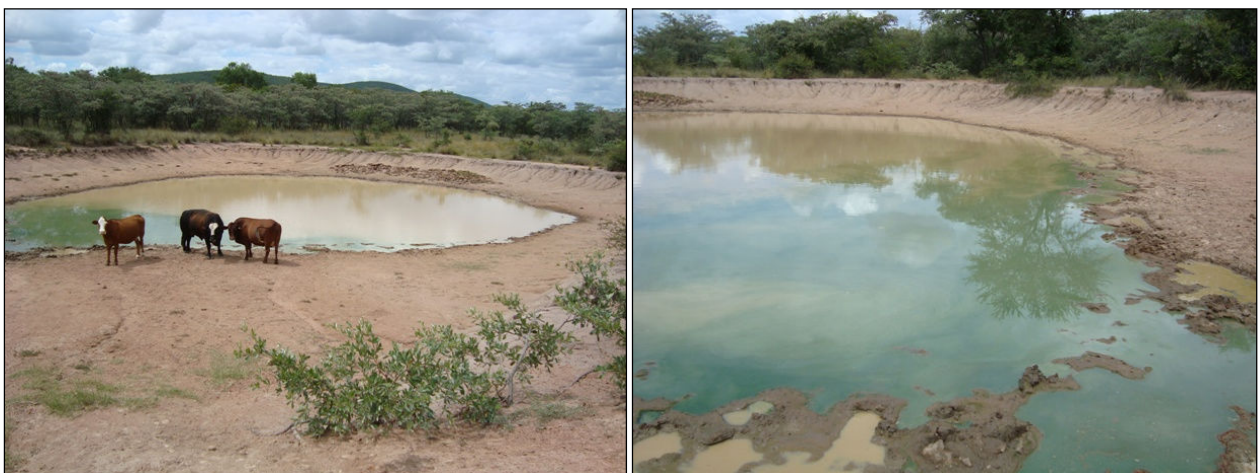
This occurred on the *Farm Fancy 556LQ* (Label 1.07). This wetland was part of an unchannelled valley-bottomed wetland that formed part of the feeder headwaters of the nearby Kutangspruit, which flowed into the Rietspruit located further to the northeast. This was a temporary wetland area that was fed through lateral seepage zones as well as surface water drainage during times of high rainfall and the water table has risen. The very sandy and deep soils meant that surface water rarely persisted throughout the season and therefore, in order to allow for permanent water for livestock, the landowner had excavated a depression within the wetland (Figure 9).

Figure 9: Excavation of the wetland crossing point (point 1.07) on the farm *Fancy 556LQ* that was excavated to enhance the persistence of surface water.

The removal of the majority of the porous coarse upper sand layers, thereby exposing the soil layers with higher clay content, meant that surface waters were inhibited from percolating into the soils. This did, however, subsequently mean that lateral movement of water within the soils was enhanced and the wetland drained prematurely towards and into the depression. This had the effect of drying up the wetlands downstream of the excavation that was reiterated by the encroachment of terrestrial floral species within the wetland habitat. Cattle drinking, trampling and contamination by livestock excrement had impacted the water quality within the depression. The outer edges of this wetland were delineated and a 50m conservation buffer designated to it. It was not regarded as an ecologically sensitive wetland and therefore an alignment shift of the pipeline to accommodate the wetland is not thought to be necessary. This is reiterated by the fact that another bulk water pipeline exists in association within this alignment route and the habitat unit has therefore already undergone a degree of transformation.

The designation of the buffer zones is therefore done so that ecologically sensitive construction procedures can be implemented to preserve the hydrological functionality of the wetland. Some recommendations include that no dumping of soils or excess building rubble take place within the buffer zones and that indiscriminate destruction of vegetation be discouraged within this area. The reinstatement of the correct soil layers to preserve the hydrological functionality of this wetland once again become pertinent to the conservation of this habitat unit and that cognisance of correct site reinstatement be taken to abate the formation of potential future soil erosion.

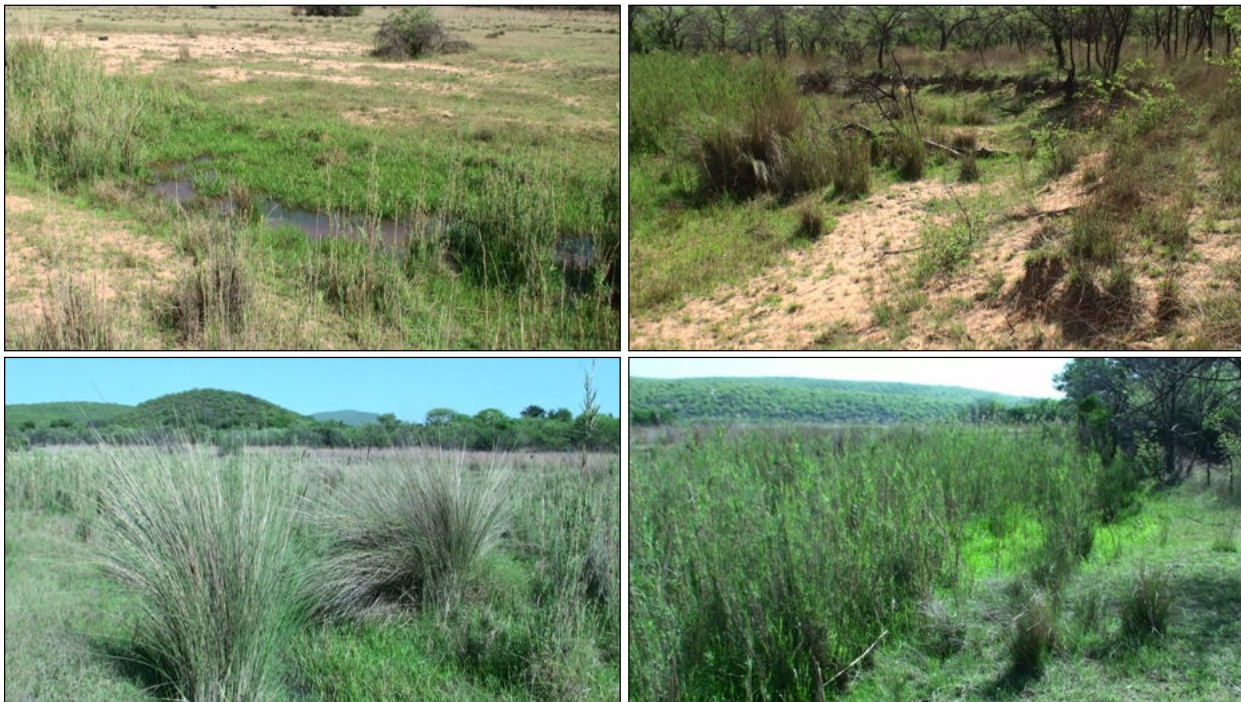
The two converging perennial streams (known as Riet 1 and Riet 2, respectively) that flow from the west form part of the Rietspruit and join this river within close proximity to the R510. The farm where Survey point 1.14 is located is a small-scale sheep farm. Some bush has been cleared in order to improve the grazing potential of the farm, however, naturally grassland-dominated areas were found to generally incorporate wetlands. The site is located high up in the catchment, and, together with the topography of the area, hillside seepage wetlands were expected to be relatively common. The streams were found to be supplemented by an extensive seepage zone that would indeed be impacted upon by the pipeline construction activities. There was a high degree of iron

oxide precipitate observed within the water, indicating that the channels are heavily supplemented by seepage zones. The position in the catchment also meant that these streams and wetlands had retained good water quality. The streams and associated flood zones were generally dominated by reeds (*Phragmites mauritianus*), sedge and grass species. The channels were generally inundated with vegetation due to the small volume of water within the channel as well as the general lack of floodwaters. The slow-flowing water and high degree of vegetation cover has allowed for a system that supports an exceptionally high diversity and density of various frog species. This also is attributed to the good water of the system.

Figure 14: Riverine and wetland habitat associated with survey area 1.14.

Some cattle activity within the riparian zones meant that a small degree of erosion was evident, but not thought to be significant. The general inundation of the channels with vegetation also meant that the potential for soil erosion is low. Besides having been slightly impacted by cattle and sheep grazing, the streams and wetlands within this area had retained a good PES, with wetland functionality having been retained.

- Upon completion of the laying of the pipeline, the soil should be replaced in the trench in the layer order in which they were removed. It is important to realize that wetland functionality relies substantially on movement of soil water. The movement of this water is largely dependent on the soil types and characteristics. By altering the soil layers and other characteristics means that soil water would be inhibited from moving laterally, thereby cutting off the water supply to the wetland;

- Earthmoving equipment and vehicles should be serviced and inspected regularly to allow for the timeous identification of any fluid leaks. Hydrocarbon contamination of wetland habitat is rated as a high impact;

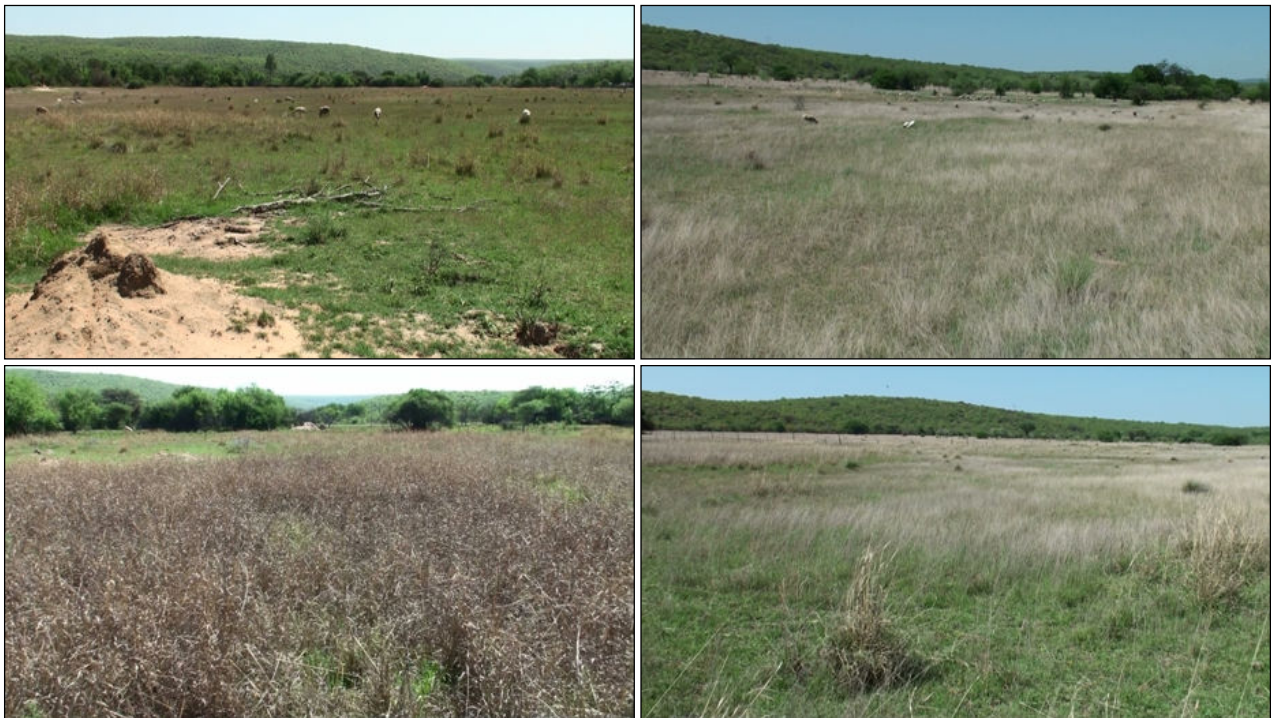
Another section of the same wetland system located further to the south-east was also identified during the field survey. This wetland is fed through a ground and hillside seepage, but can be categorised as temporary. The source of this wetland area is located to the nearby south. The presence of wetland features necessitated the allocation of conservation buffers. It was found that the pipeline did impinge on this wetland and associated buffer zone. Ecologically sensitive

Figure 15: Various views of the temporary wetland area located to the southeast of the main wetland complex.

construction methods and appropriate mitigation measures (see section 7) could see this impact being negated and rendered insignificant.

It was found that wetlands associated with this area and their associated buffer zones would be impacted by the proposed pipeline alignment. The wetlands that would be affected were observed to be temporary in nature and only of moderate slope. There is also not a high volume of water passing through these wetlands. This means that soil erosion potential is low. Impacts within this wetland area can therefore be readily mitigated to lessen any ecological impacts.

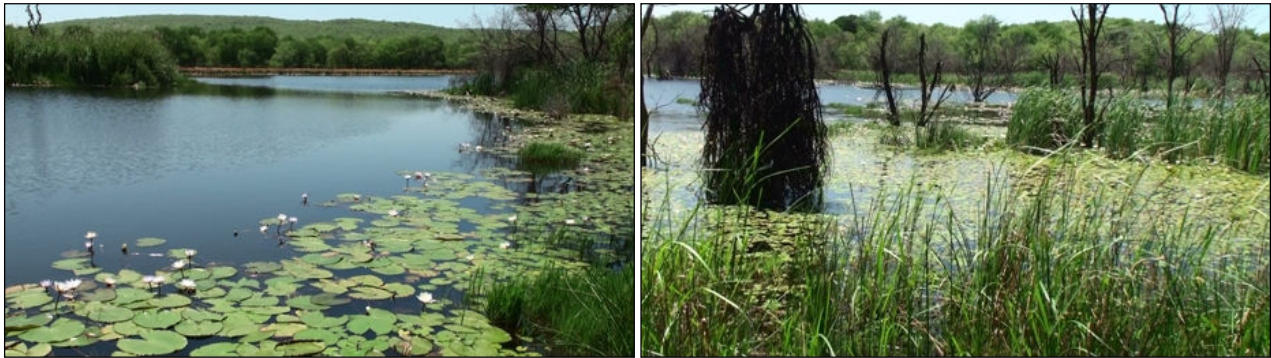
Survey site 1.15 was located on the Rietspruit itself, with the proposed pipeline alignment going through a dam that had been constructed within the watercourse. This dam was observed to have been constructed in the recent past. It is a shallow dam, being indicated by the emergent vegetation that had established within it. There was a high degree of water lilies (*Nymphaea mexicana*) – an exotic species, which could become problematic if allowed to escape into natural watercourses.

Figure 16: Various views of the impoundment at Survey site 1.15.

The water quality within the dam was observed to be good and a healthy population of fish, dominated by *Oreochromis mossambicus* (Mozambique tilapia) was also observed. The construction of the dam has led to a decline in overall ecological integrity of the system due to the dam wall posing an impassable migratory barrier to aquatic organisms. Below the dam, the watercourse is largely inundated with reeds and grasses. The relatively small volume of water passing through the channel and the obvious lack of frequent flooding events allows for vegetation to inundate the channels. This is a natural feature of these streams and allows for good habitat quality for sensitive and other amphibian species. Further downstream of the dam, the landowner has removed soil from the watercourse to allow for pools to form. This was sporadically done.

The same mitigation points as for Survey point 1.14 can be applied to this survey area to mitigate the impacts associated with the pipeline construction.

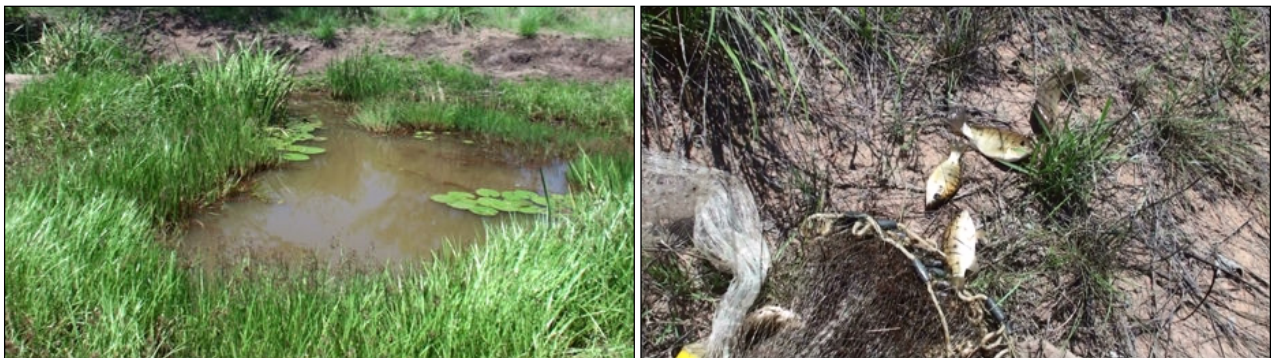
Figure 17: Sporadic excavations of the watercourse that have led to establishment of deeper pools and fish that were sampled from these pools.

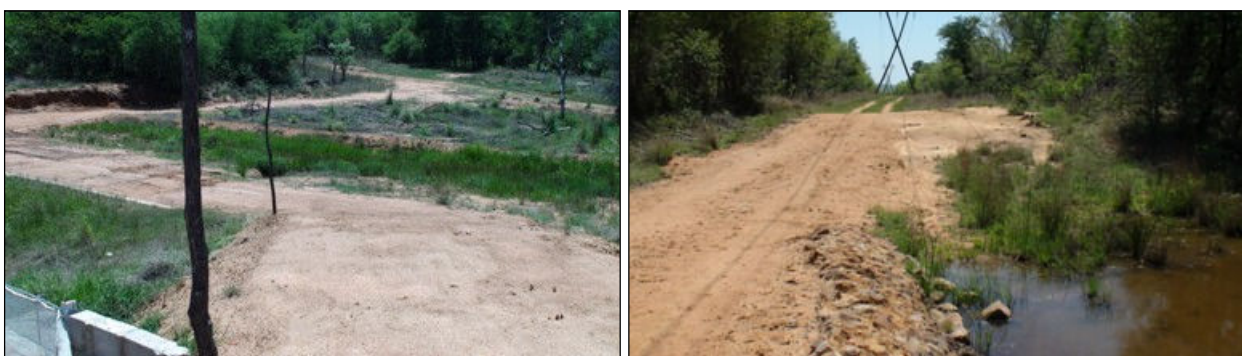
Figure 18: The existing pipeline servitude at Survey site 1.15.

The Rietspruit can therefore be said to have retained a good PES and therefore it is recommended that the pipeline crossing point be undertaken at a point of the least ecological impact. There is an existing pipeline crossing the Rietspruit downstream of the dam wall. There is then a vehicular bridge associated with this existing pipeline. It is recommended that the pipeline cross at this point as the bridge is a semi-permanent feature that could be lifted with minimal site disturbances, and reinstated to accommodate a new pipeline.

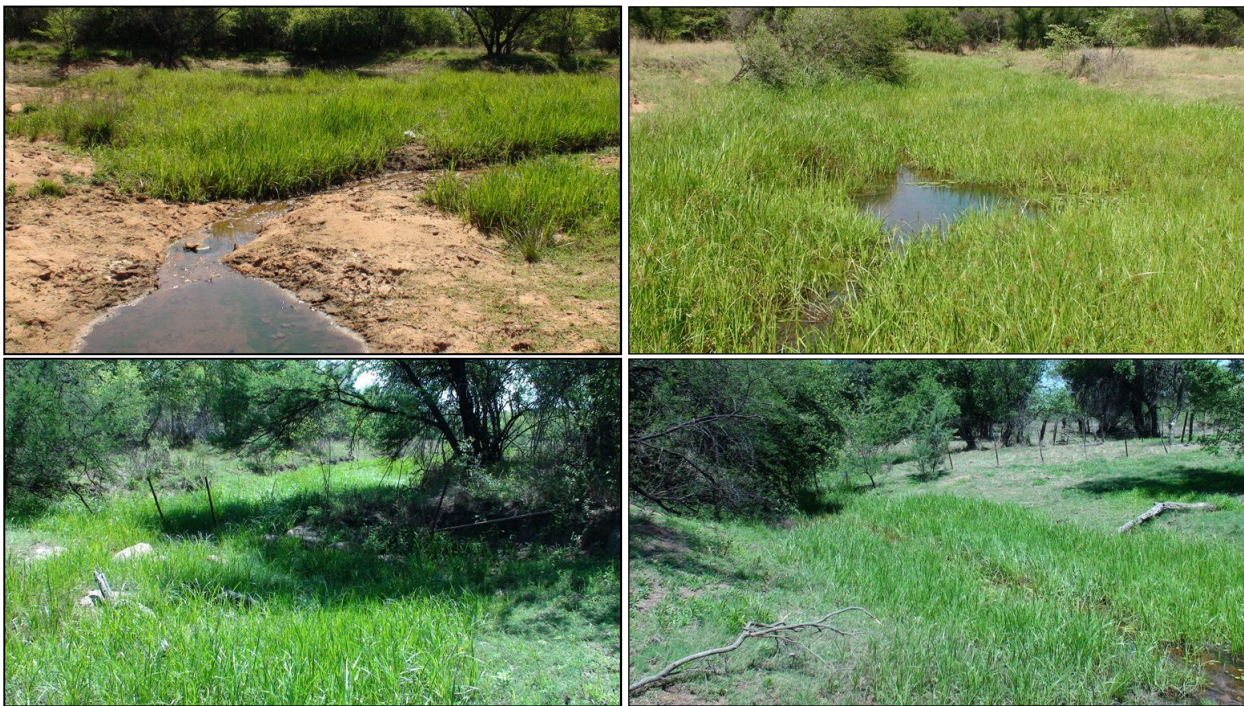
therefore do not readily flood during rainfall events. Therefore vegetation is allowed to inundate the watercourse, providing important habitat for (especially) numerous frog species. This section of the proposed pipeline route is a cattle farm and the cattle have had a moderate impact on the ecological integrity of the streams.

Historical activities within the watercourse slightly downstream have included excavations within the watercourse to allow for an impoundment of water. A dam wall had also been constructed within the watercourse which had failed, leading to the incision of the riverbanks within the river segment and siltation of the habitat downstream.

Figure 19: Various views of the wetlands associated with Survey point 1.16.

In order to minimise the impact of the pipeline construction on these wetland areas, it is recommended that the proposed pipeline run parallel to the existing pipeline within the area.

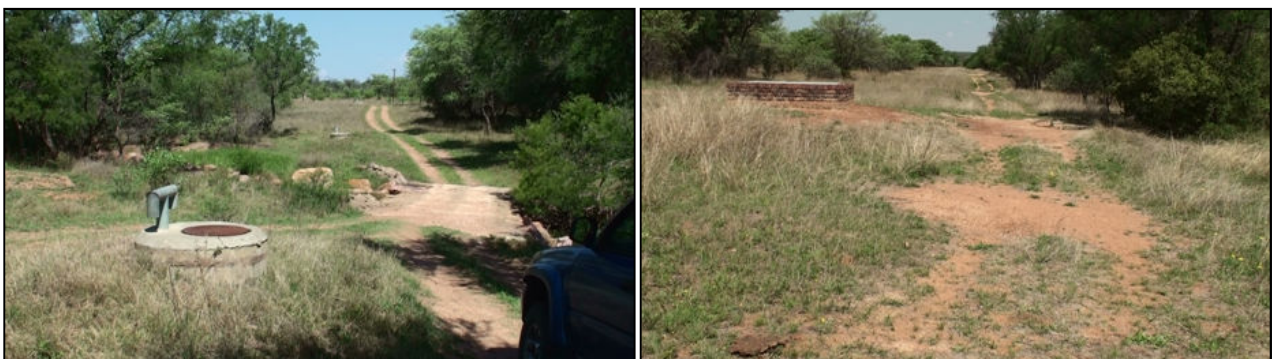
Figure 20: Views of the existing pipeline servitude at Survey point 1.16.

There were sensitive wetlands located within this survey area that fed perennial streams. There is an existing pipeline that is located on slightly higher ground. There is also an existing servitude roadway associated with this pipeline which means that natural vegetation has already been removed to accommodate it. It is highly recommended that this proposed alignment remain as closely associated to the existing pipeline as possible to reduce the impact on the wetlands within the area. The same mitigation points as for Survey site 1.14 can be applied to this survey area to mitigate the impacts associated with the pipeline construction.
