BASELINE AQUATIC AND IMPACT STUDY

**Baseline Aquatic and Impact Study for the
Proposed Mokolo and Crocodile River (West)
Water Augmentation Project (Phase 2A)
(MCWAP-2A): Water Transfer Infrastructure &
Borrow Pits**

Limpopo, South Africa

June 2018

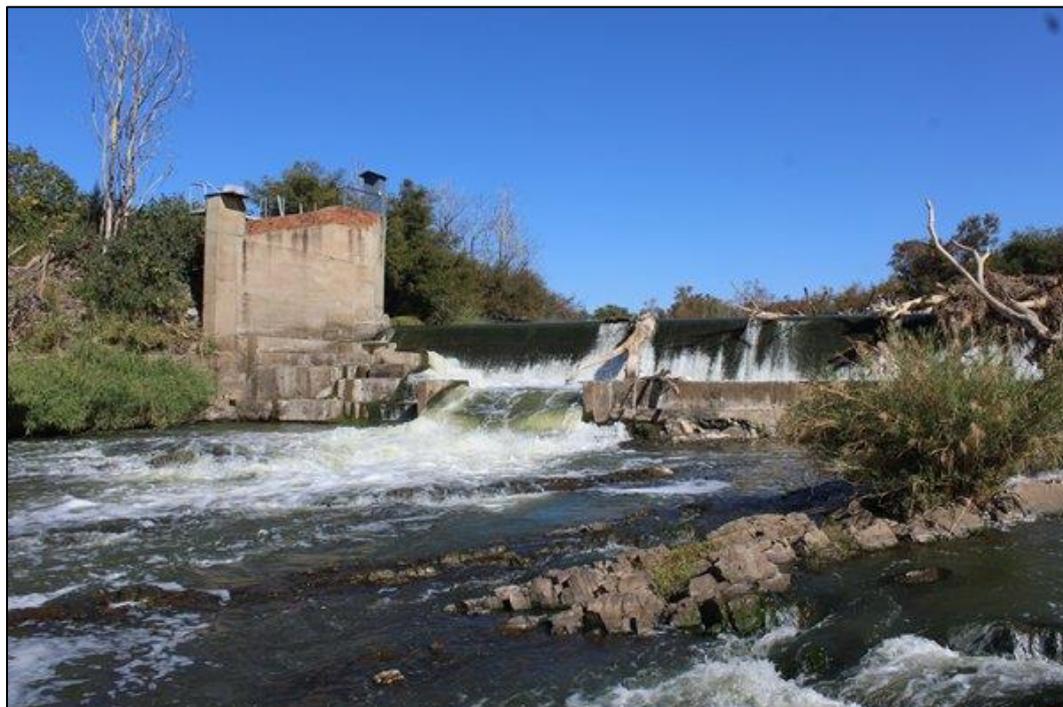
Figure 5-1: Illustration of instream weirs (Site CROC2, taken June 2018)

The results of the IHIA assessment indicate that the instream and riparian habitat integrity of the Crocodile River are largely modified (class D), indicating a large loss of natural habitat, biota and basic ecosystem functions has occurred. Modifications to instream habitat are a result of flow modifications due to numerous instream weirs (Figure 5-1), extensive water abstraction throughout the reach, water quality modifications (eutrophication), and erosion which has resulted in sedimentation of instream habitat. Modifications to riparian habitat are a result of bank and channel modifications (Figure 5-2), flow modifications and water abstraction. The riparian zone vegetation was largely indigenous with few alien invasive species observed.

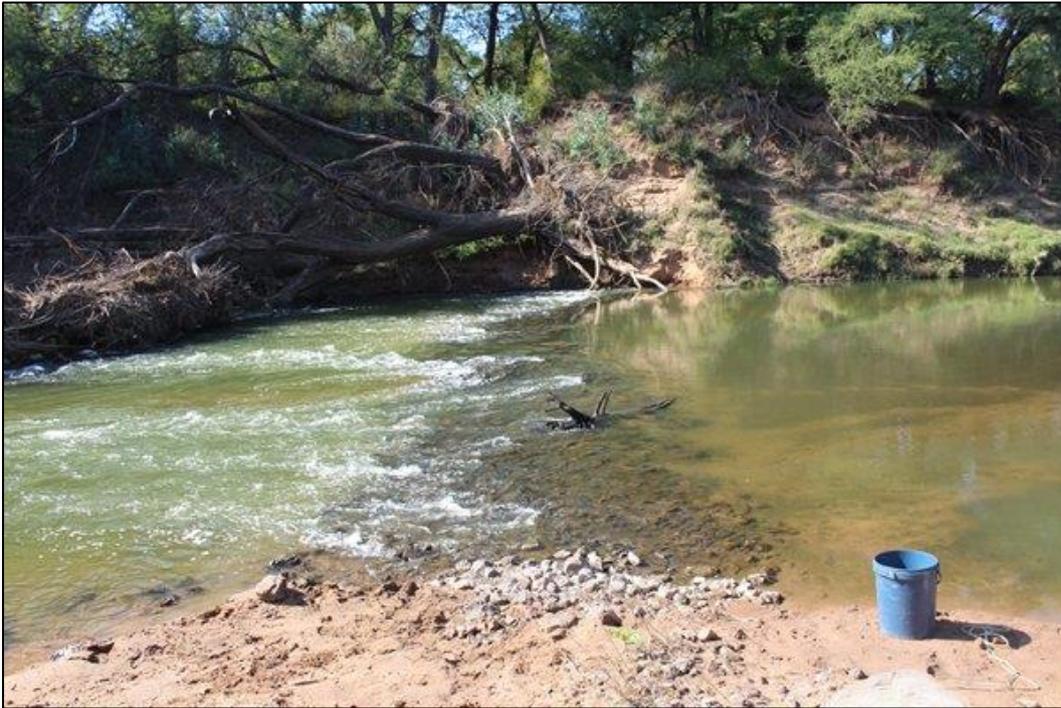
Figure 5-2: Illustration of bank erosion and low water crossing (Site CROC4, taken June 2018)

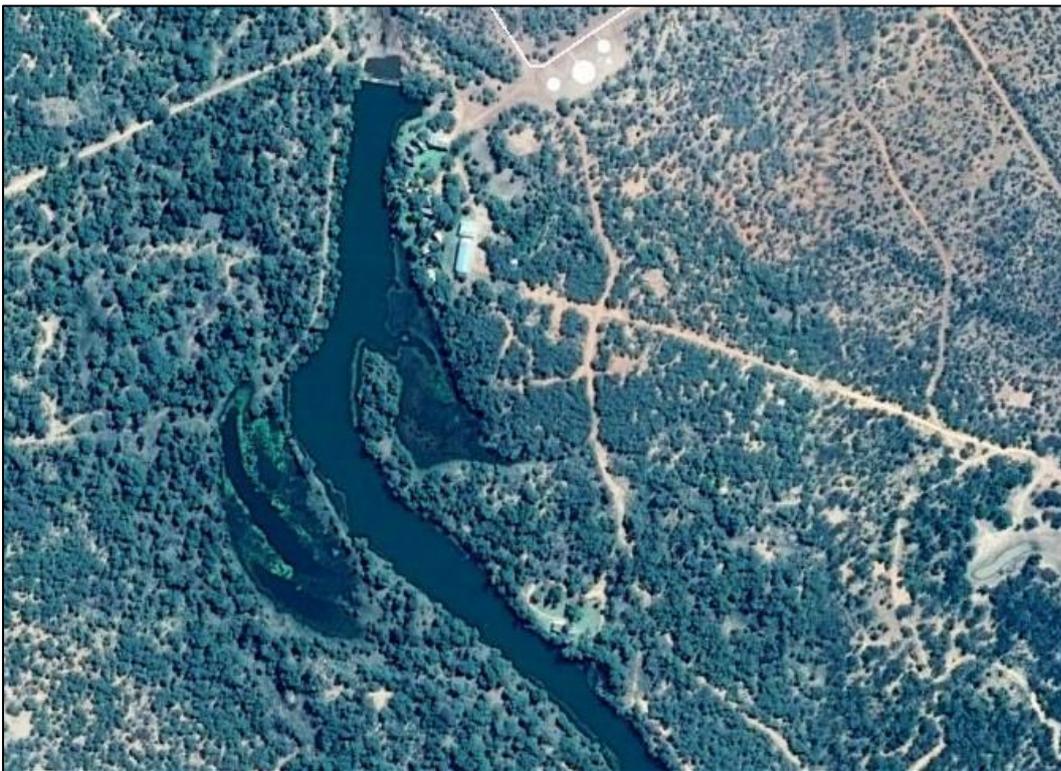
Figure 5-3: Illustration of inundation due to instream weir on the Matlabas River (Google Earth imagery, 2016)

The results of the IHIA assessment indicate that the instream and riparian habitat integrity of the Matlabas River are moderately modified (class C), indicating a loss and change of natural habitat and biota have occurred but the basic ecosystem functions are still predominantly unchanged. Modifications to instream habitat include instream weirs, which have resulted in inundation, modifying bed, channel and banks within the reach (Figure 5-3). Agriculture activities and associated abstraction were observed along the reach (Figure 5-4).

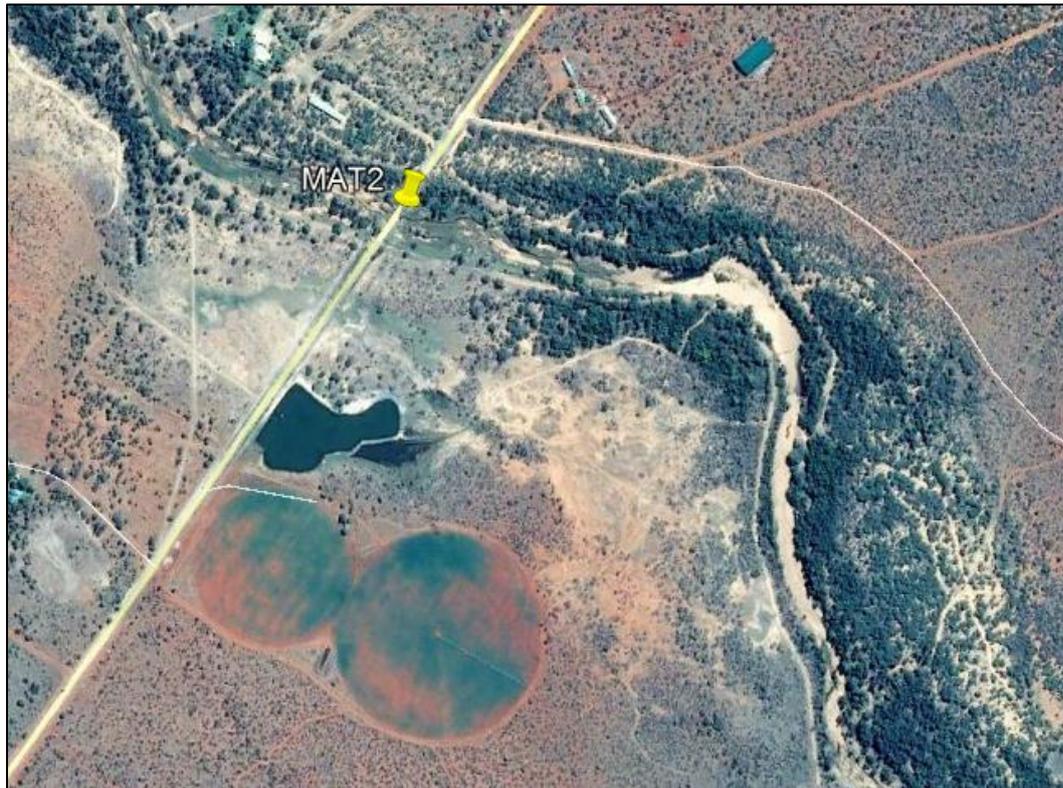
Figure 5-4: Illustration of agricultural activities along the Matlabas River (Google Earth imagery, 2016)

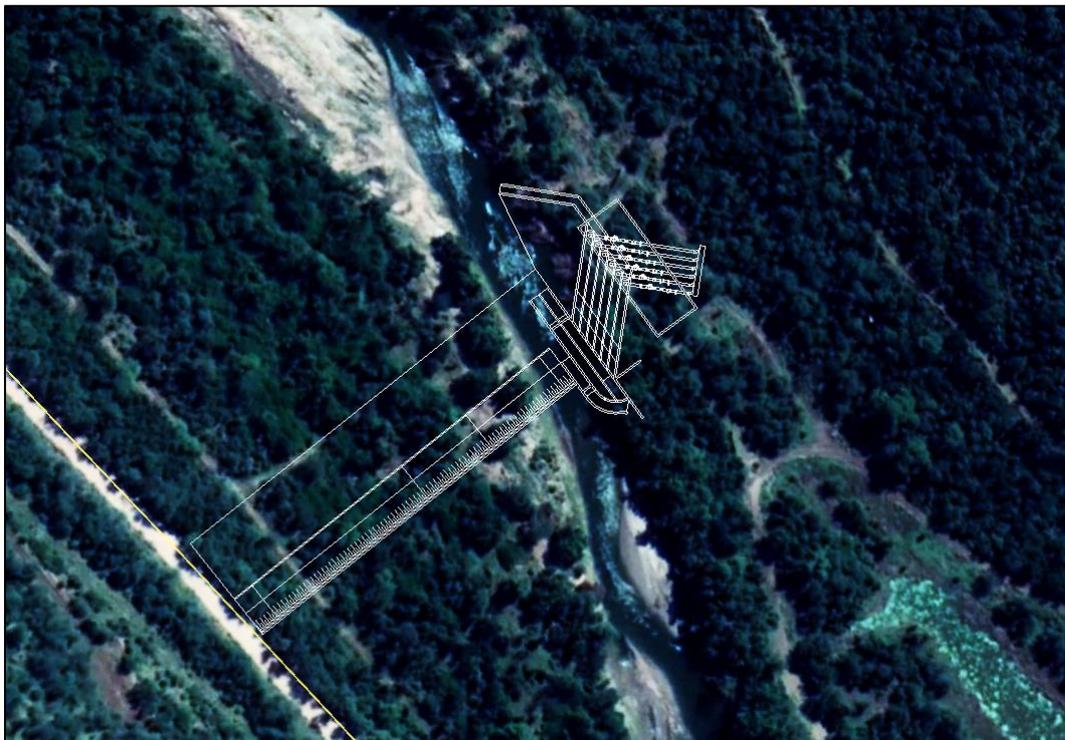
Figure 7-1: Overlay of proposed weir structure ($\pm 4 - 6$ m high) over Crocodile River at site CROC4

- Abstraction works
 - Abstraction weir (Vlieëpoort Weir) (Figure 7-1);
 - River abstraction pump station;
 - Desilting works; and
 - Sediment return pipeline (into Crocodile River).
- Pipeline
 - Central pipeline; and
 - Alternatives.
- Gauging Weirs
 - Bierspruit;
 - Sandspruit; and
 - New Paul Hugo Weir.
- Borrow pits (23) (Section 7.2)
