Report Number: P WMA 04/B50/00/8310/7

DEVELOPMENT OF A RECONCILIATION STRATEGY FOR THE OLIFANTS RIVER WATER SUPPLY SYSTEM

Water Quality Report

FINAL REPORT
December 2011

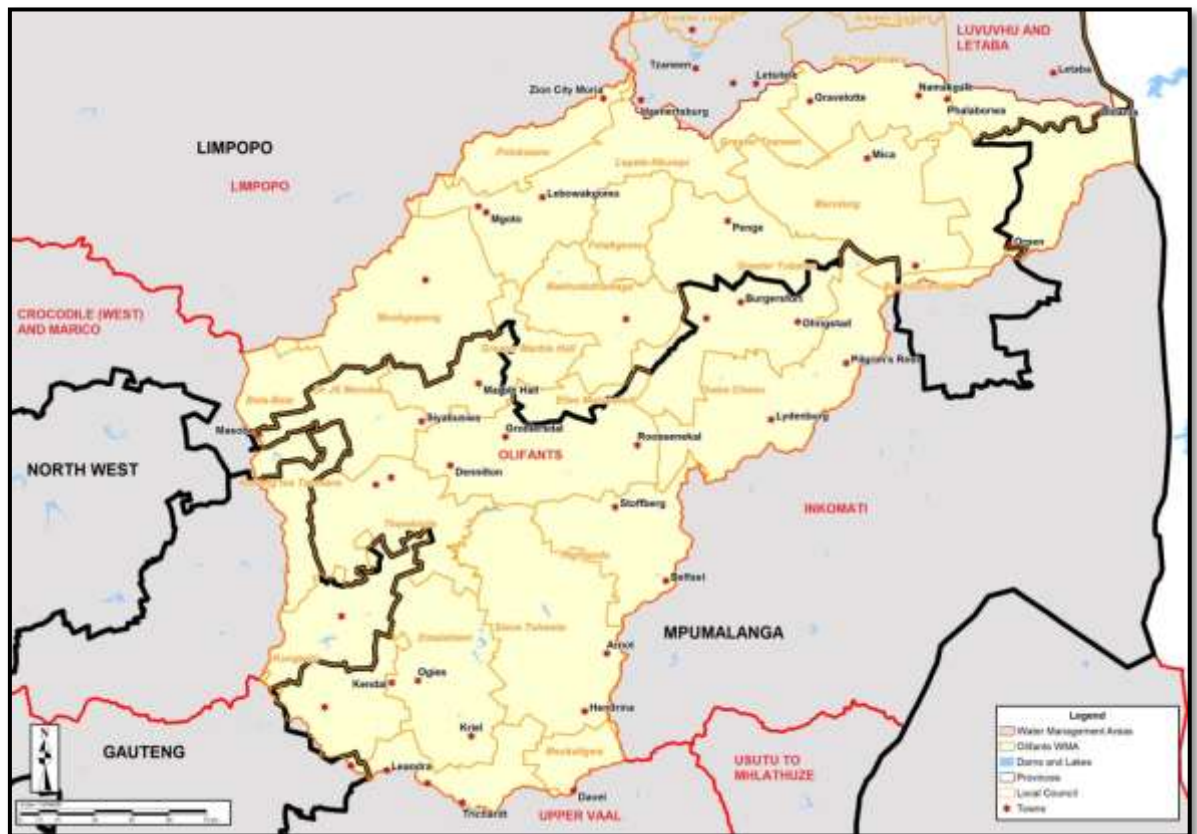
Figure 4.6: Municipalities in the Olifants WMA

The Olifants WMA falls within three provinces viz Gauteng, Mpumalanga, and the Limpopo Province (**Figure 4.6**).

The major urban areas include Emalahleni and Steve Tshwete in the Upper Olifants Sub-area and Phalaborwa in the Lower Olifants Sub-area. The Middle Olifants and Steelpoort Sub-area are largely undeveloped with scattered rural settlements (DWA, 2004).
