**Riparian Habitat and Wetland Delineation Impact
Assessment for the proposed Surface Water
Developments for Augmentation of the Western Cape
Water Supply System**

November 2016

REFERENCE

10598

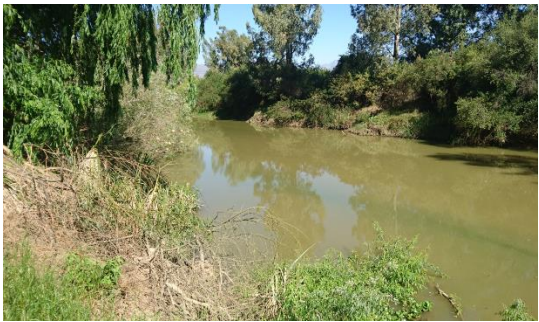
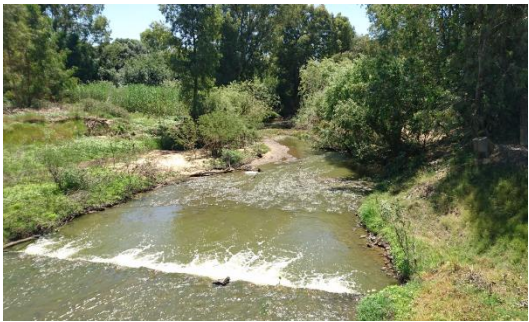
| | Upstream | Downstream |
|---|---|--|
| Berg River (River Reach) | | |

| | Upstream | Downstream |
|---|---|--|
| GPS coordinates | Between 33°19'43.30"S; 18°58'50.16"E and 33°20'31.24"S; 18°58'44.66"E | |

| <p>Site description</p> | <p>Located on the Berg River. The river reach was characterised by slow flowing waters over stones, sand, gravel and mud. Adequate marginal vegetation was present. The river reach consisted of mostly deep pools with a small section of riffles and runs. Impacts observed included eutrophic waters, erosion and a weir.</p> |

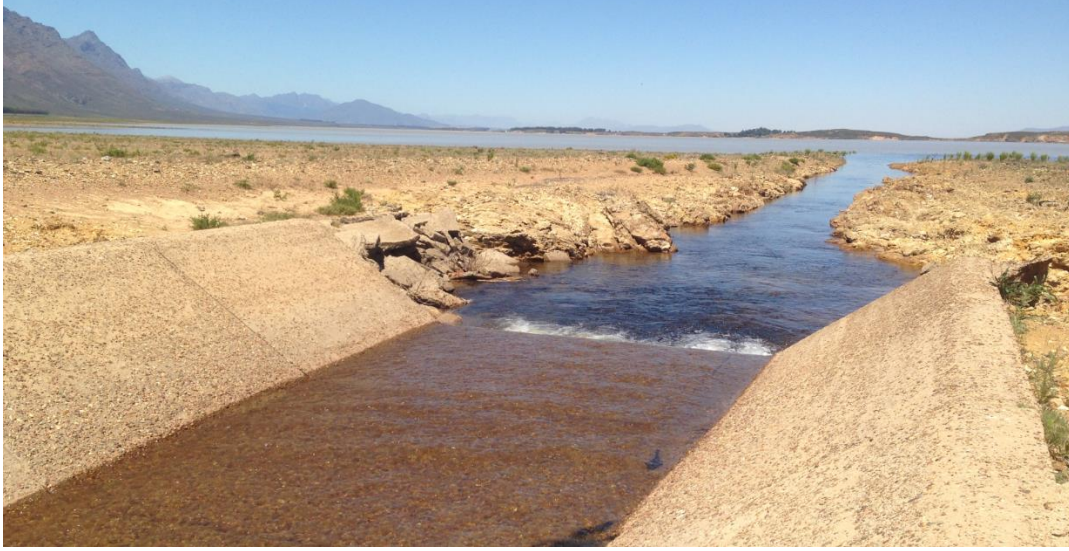
| <p>Northern Discharge Point ATL1</p> | |

| <p>GPS coordinates</p> | <p>33°20'6.84"S 19° 2'41.24"E</p> |
| <p>Site description</p> | <p>Located on the Voëlvlei Dam in the North-eastern corner of the dam. The site is located at the release point of an existing canal characterised by rock, stones, sand and gravel.</p> |

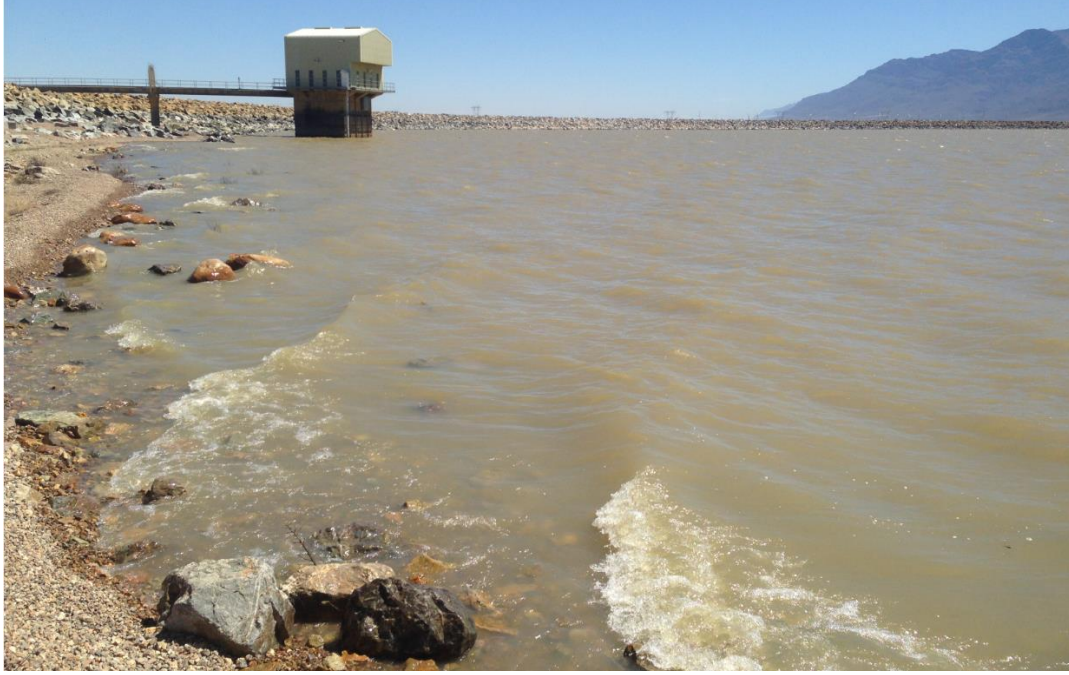
| <p>Central Discharge Point ALT2</p> | |

| <p>GPS coordinates</p> | <p>33°20'53.37"S 19° 1'31.10"E</p> |

| <p>Site description</p> | <p>Located on the Voëlvlei Dam in the North-western corner of the dam. The site is located approximately 120 meters south of the pump station. The proposed release point consists of scattered rock, stones, sand and gravel.</p> |

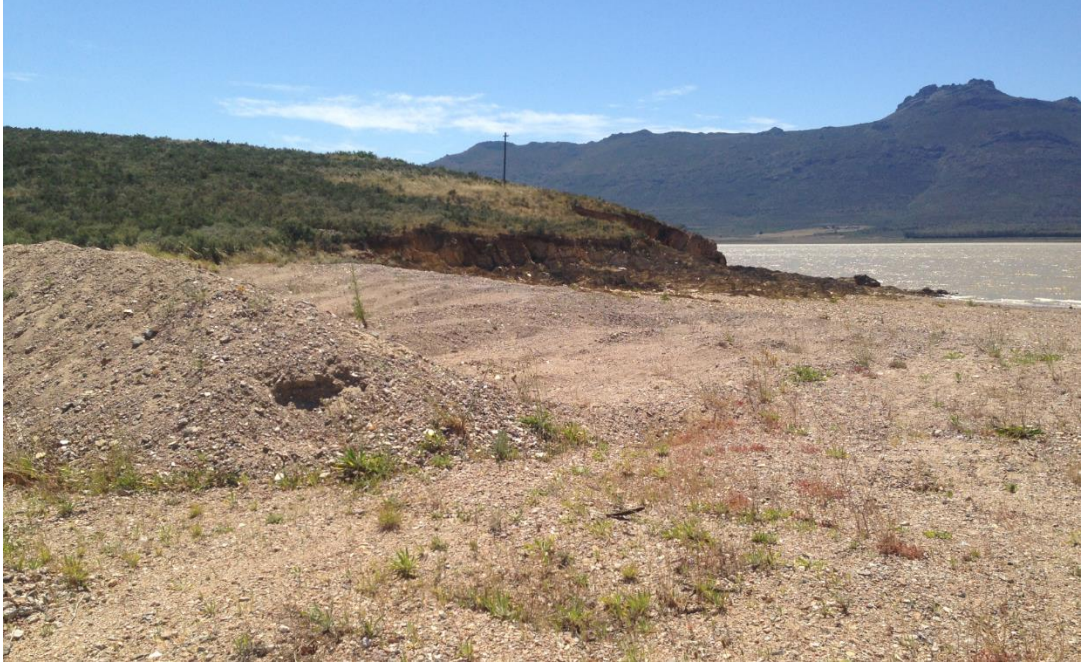
| <p>Southern Discharge Point</p> <p>ALT3</p> | |

| <p>GPS coordinates</p> | <p>33°21'35.84"S 19° 1'39.20"E</p> |
| <p>Site description</p> | <p>Located on the Voëlvlei Dam on the Eastern bank of the dam. The site is located at an excavated bay characterised by sand and gravel over a gentle slope.</p> |

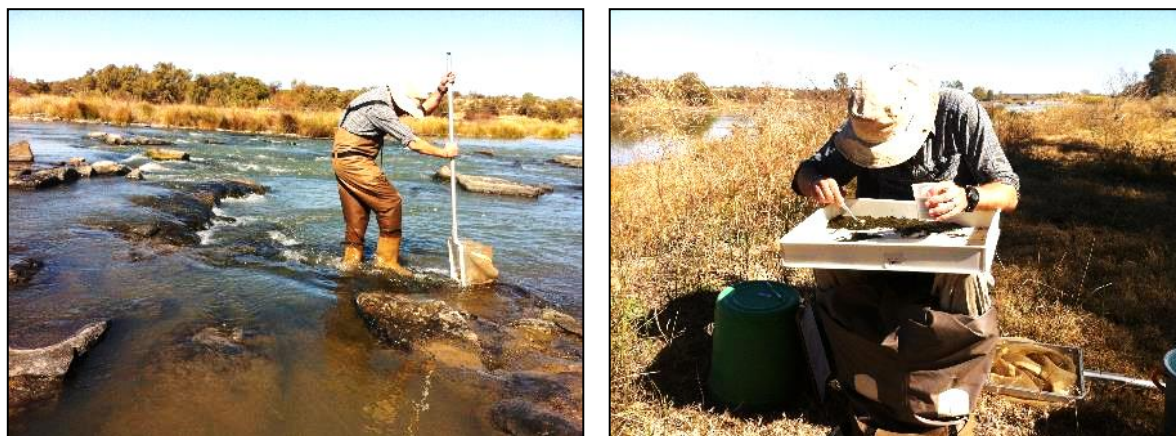
Figure 4: Kick and sweep sampling method, SASS5 (South African Scoring System Version 5)

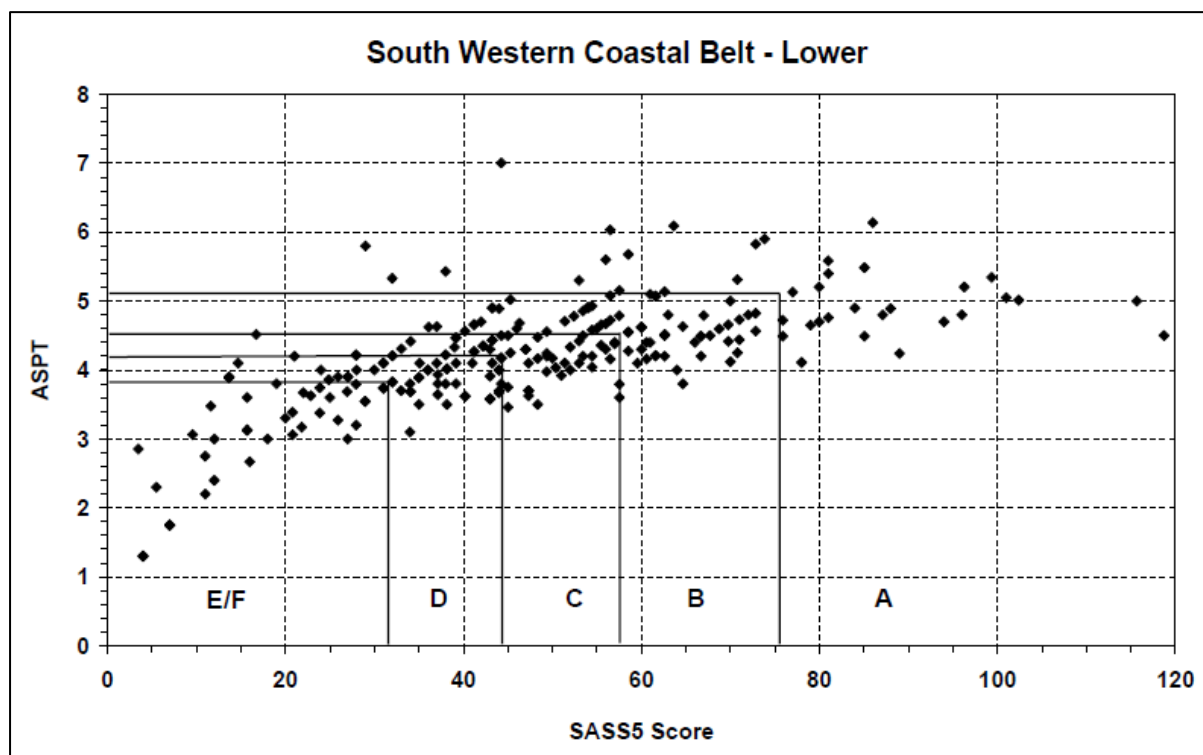
Figure 5: Biological Bands for the South Western Coastal Belt – Lower zone, calculated using percentiles

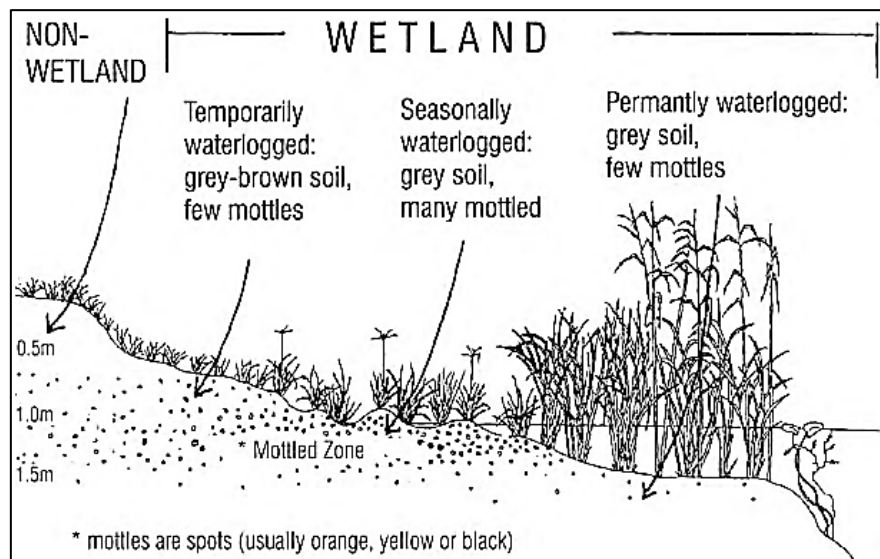
Figure 6: Cross section through a wetland, indicating how the soil wetness and vegetation indicators change (DWAF, 2005)

Vegetation is used as the primary wetland indicator, which must be present under normal circumstances. However, in practise, the soil wetness indicator tends to be the most important, and the other three indicators are used in a confirmatory role.

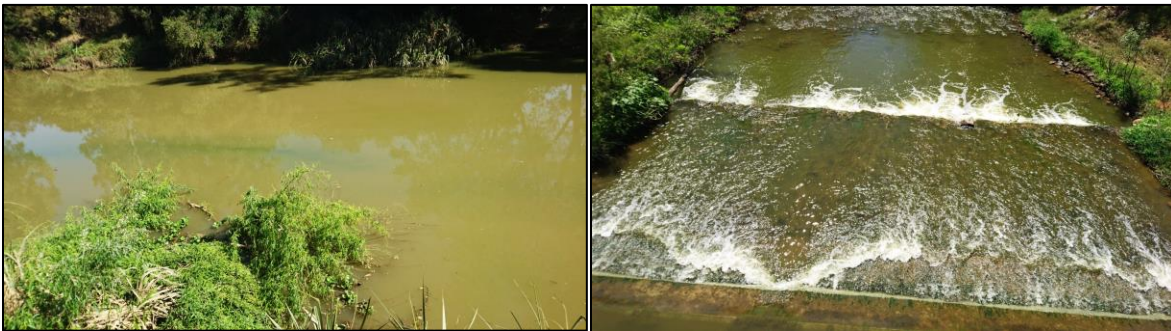
Figure 7: Eutrophic conditions experienced in the Berg River

During the survey DO levels in the Berg River were above the maximum prescribed limits with a measurement of 178% recorded. This high reading is in excess of saturation (super-saturation of oxygen) which usually indicates eutrophication in a water body (DWAF, 1996). The conditions in the Berg River at the time of sampling were in agreement that the river was eutrophic (green in colour) which may stem from nutrient input from both WTW discharges and agricultural input in the catchment (Figure 7). Elevated oxygen concentrations (super saturation) may cause gas bubble disease in fish. Supersaturated conditions also tend to inhibit photosynthesis in green algae, favouring instead bluegreen algae, which are more tolerant of supersaturation, but which may become a nuisance to other water users (DWAF, 1996). Therefore, DO would have been a limiting factor of aquatic biota at the time of the survey if these high DO levels persist for extended periods (Table 14).

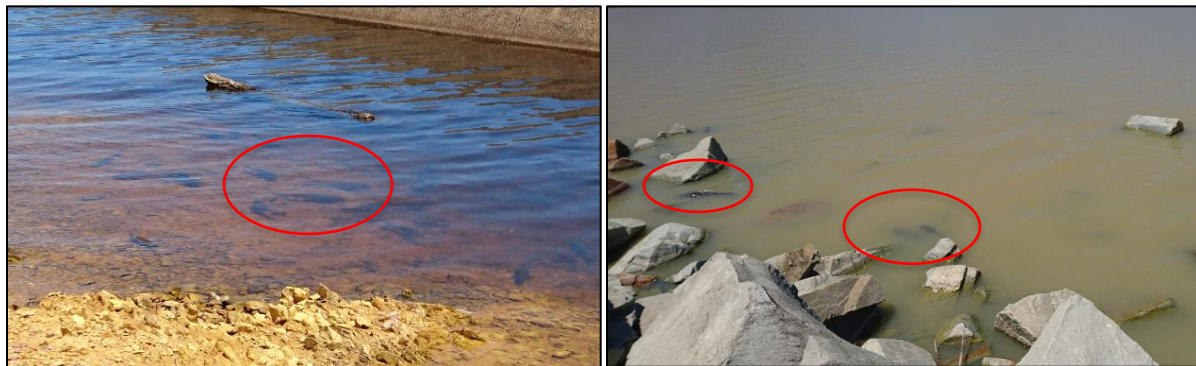
Figure 8: Fish seen feeding and spawning in the Voëlvlei Dam

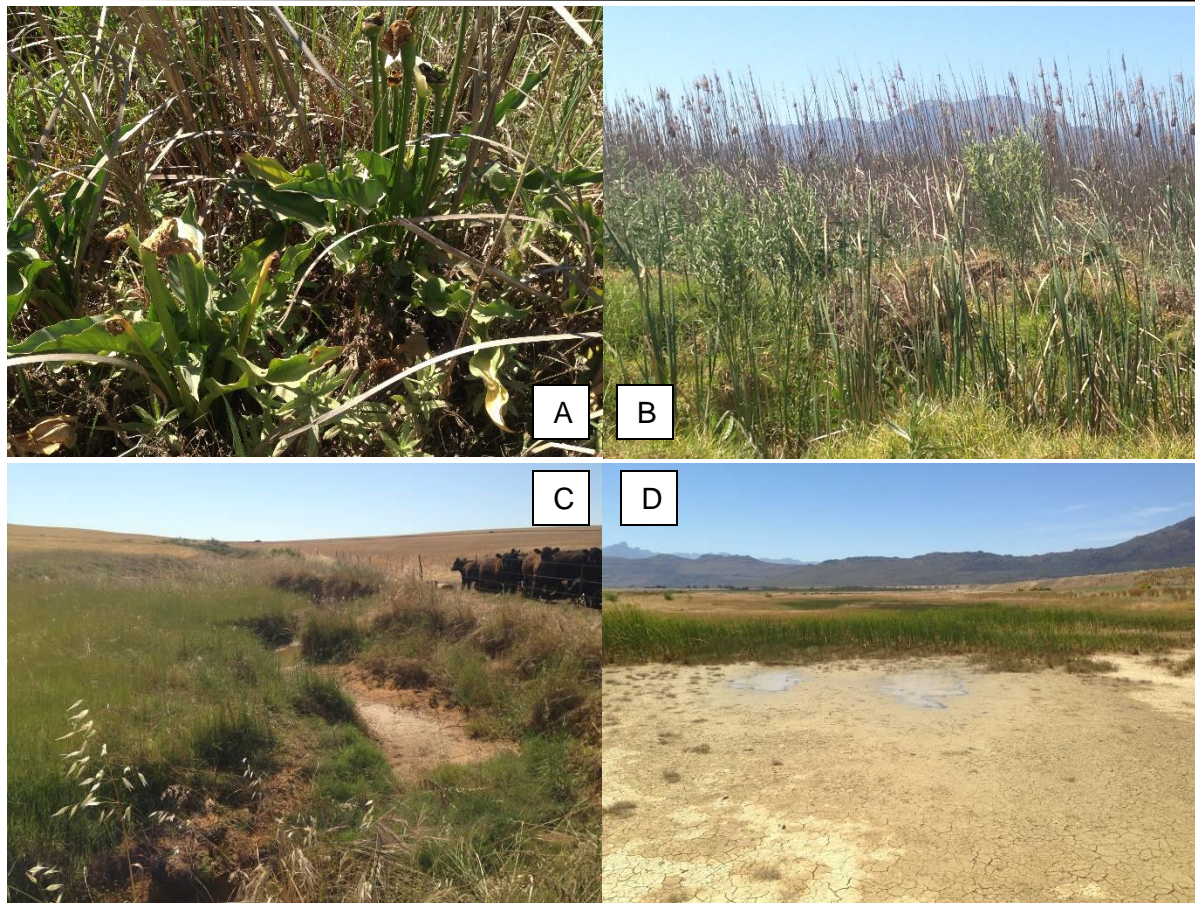
Figure 13: Photographs of some wetland indicators considered for the study. A: Vegetation, *Zantedeschia aethiopica*. B: Vegetation: *Phragmites sp* & *Typha capensis*. C: Topography, channel. D: Topography, depressions

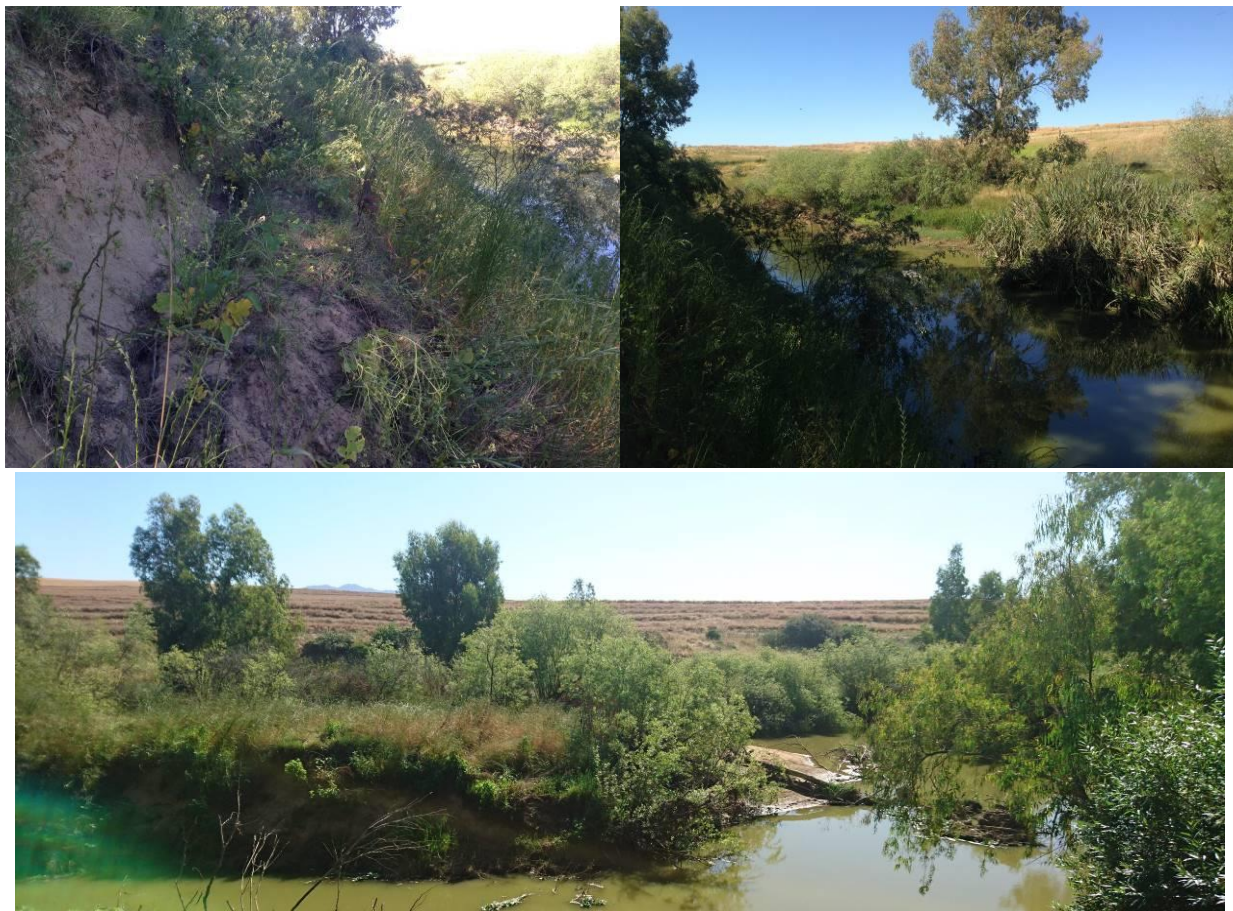
Figure 15: Photographs of the riparian areas assessed for the study

According to Ollis et al. (2013) riparian areas that are not too well drained and saturated or flooded for prolonged periods should be classified as wetlands, for example 'floodplain wetland' or 'channelled valley-bottom wetland'. In this instance, the Berg River has been classified as a floodplain system.

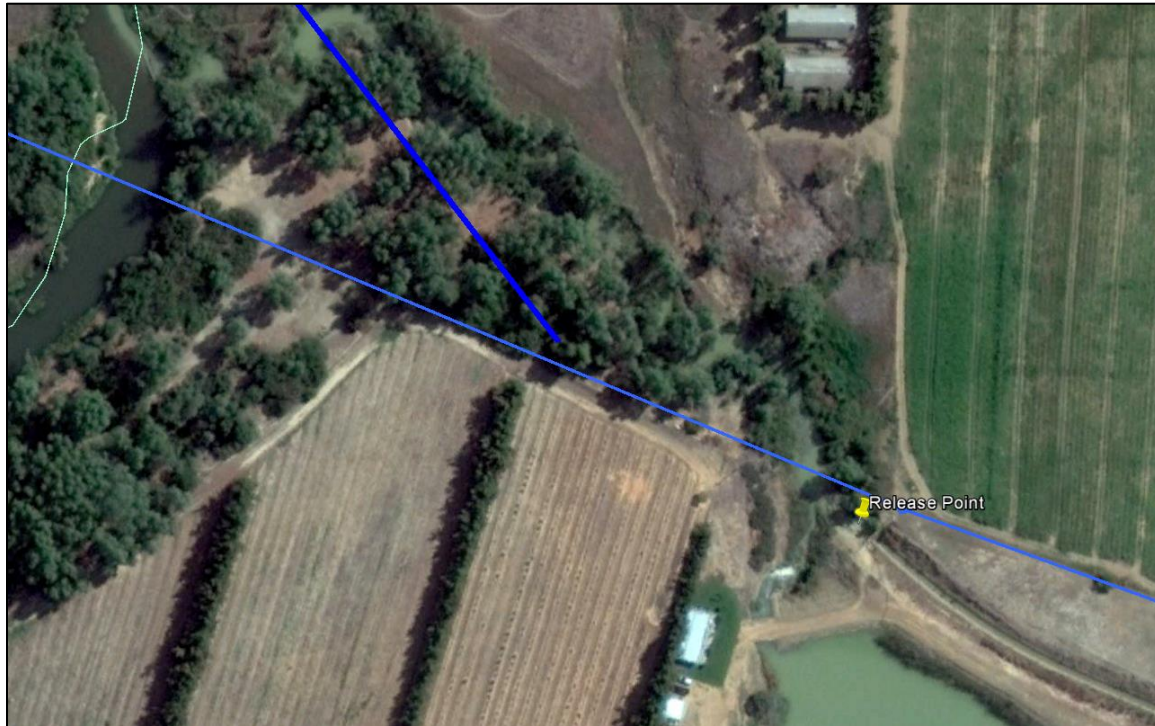
Figure 19: Summer release discharge point into the Berg River with proposed pipeline (Blue)

A Y-connection may be better suited as the discharged flow velocity will be deflected and dissipated as it hits and flows against the Y-shape. A T-shape connection may result in the flows being redirected into the channel banks, further eroding them.

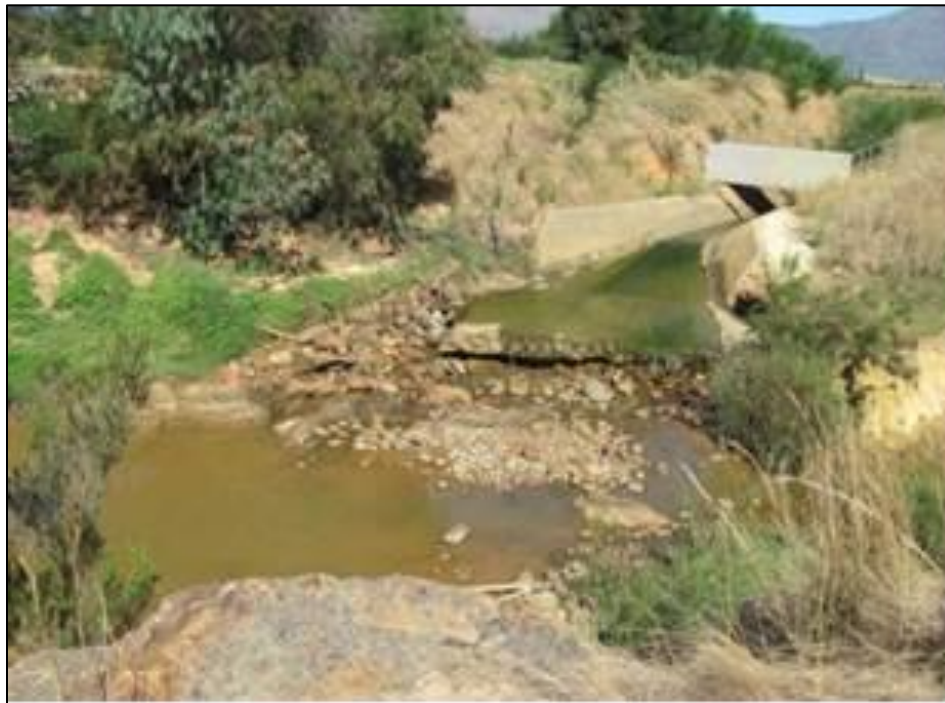
Figure 20: Highly eroded discharge point (photo courtesy Nemai Consulting)
