REPORT NO. : P WMA 12/T30/00/5314/15

MZIMVUBU WATER PROJECT

AQUATIC ECOLOGY ASSESSMENT

SEPTEMBER 2014

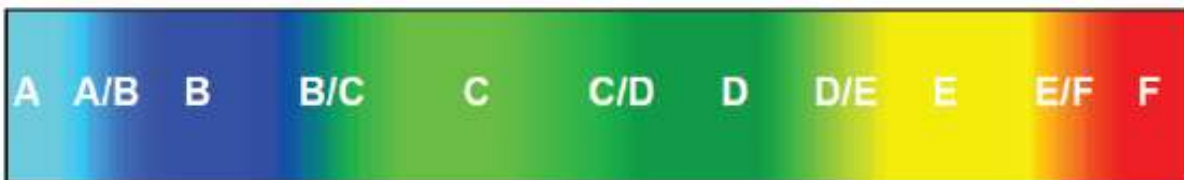
Figure 3: Ecological categories (EC) eco-status A to F continuum approach employed (Kleynhans and Louw, 2007)

In addition the ecological category (EC) classification will be employed using the eco-status A to F continuum approach (Kleynhans and Louw, 2007). This approach allows for boundary categories denoted as B/C, C/D etc., as illustrated in **Figure 3**.

The index employs preferences and intolerances of the reference fish assemblage, as well as the response of the actual (present) fish assemblage to particular drivers to indicate a change from reference conditions. Intolerances and preferences are divided into metric groups relating to preferences and requirements of individual species. This allows cause-effect relationships to be understood, i.e. between drivers and responses of the fish assemblage to changes in drivers. These metric groups are subsequently ranked, rated and finally integrated as a fish Ecological Category (EC) shown previously in **Figure 3**. Fish expected to occur in the system is summarised in **Table 5**.

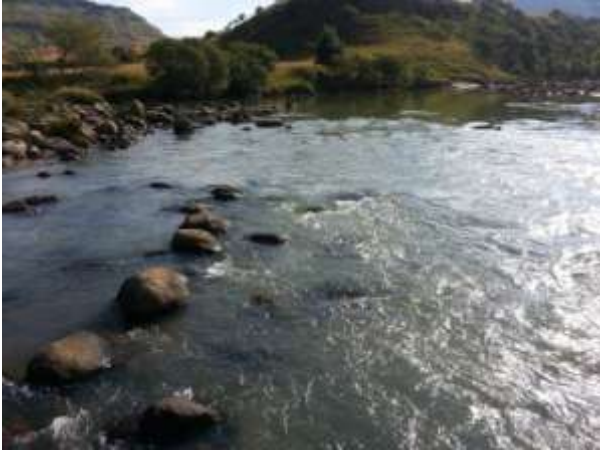
Figure 9: Upstream view of the TS1 site on the Tsitsa River showing the rocky substrate at this point, as assessed April 2014.

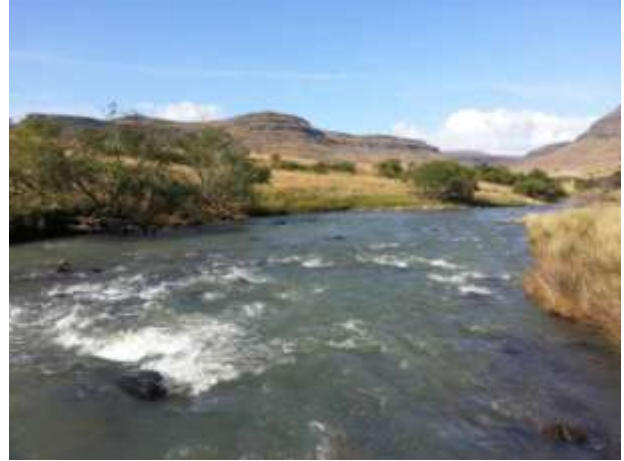
Figure 10: Downstream view of the TS1 site showing the diversity of flow types present, as assessed April 2014.

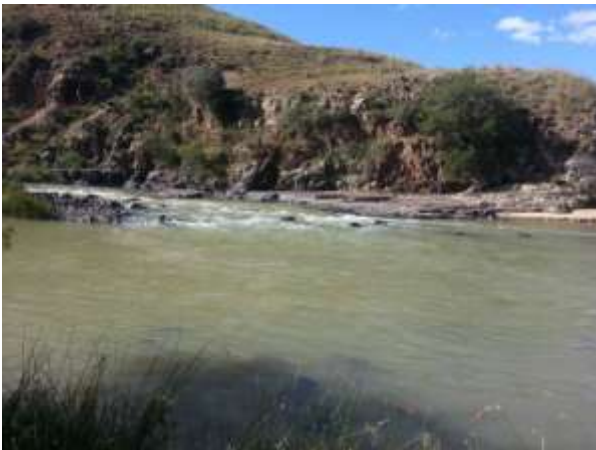
Figure 11: Upstream view of the Tsitsa River (TS4) showing the diversity of depth and flow profiles at this point, as assessed April 2014.

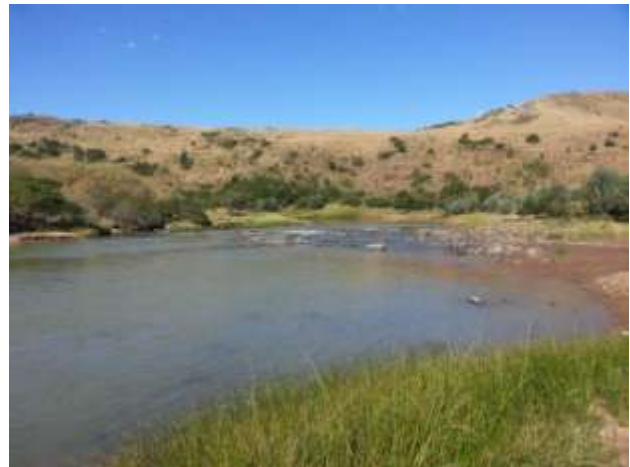
Figure 12: A downstream view of the TS4 site in the vicinity of the proposed Ntabelanga Dam wall, as assessed April 2014.

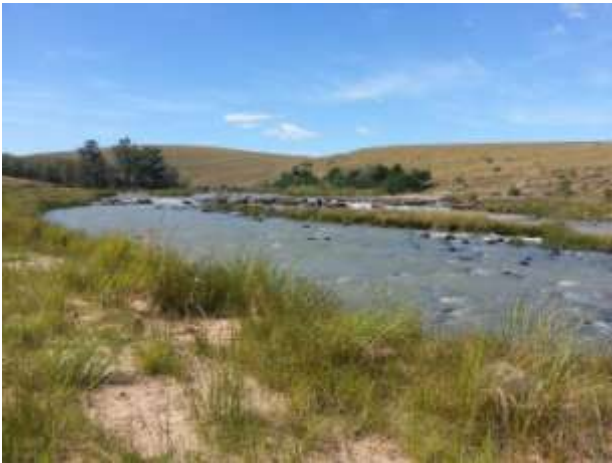
Figure 13: Upstream view of the TS7 site on the Tsitsa River showing the excellent rocky substrate at this point, as assessed April 2014.

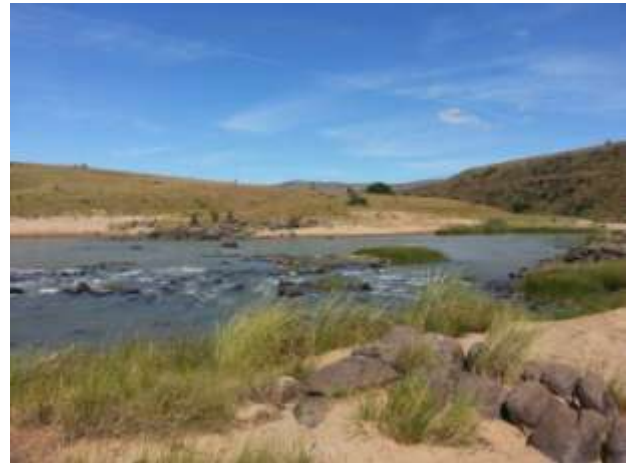
Figure 14: Downstream view of the TS7 site showing the diversity of flows at this point, as assessed April 2014.

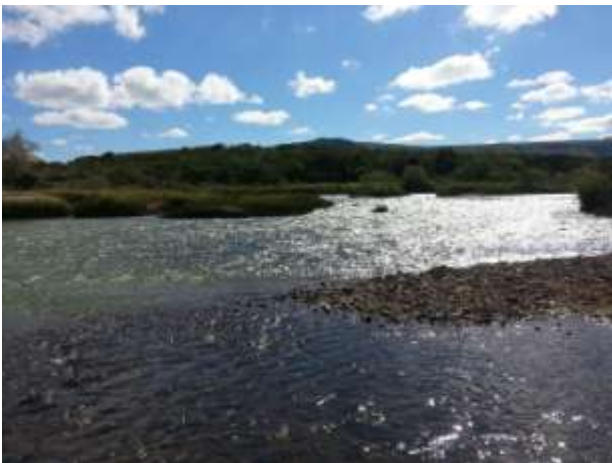
Figure 15: Upstream view of the TS8 site on the excellent rocky riffles and rapids at this point, as assessed April 2014.

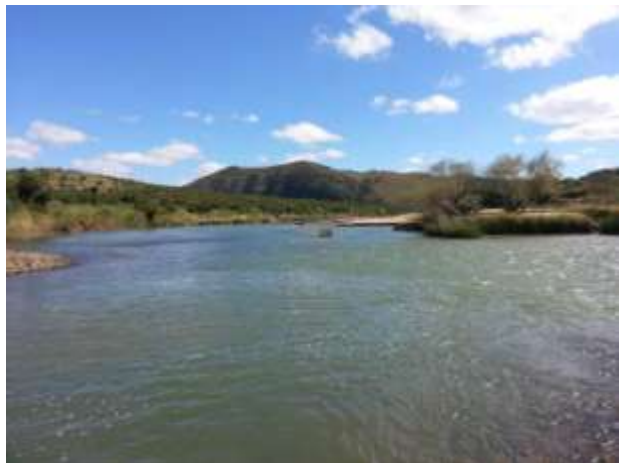
Figure 16: Downstream view of the TS8 site showing the deeper pools, providing cover for fish, as assessed April 2014.

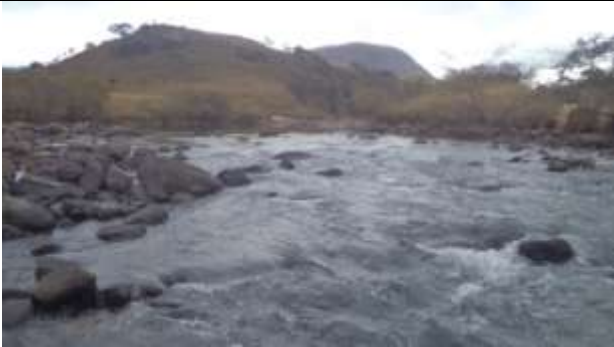
Figure 17: Upstream view of the TS1 site on the Tsitsa River as assessed June 2014, showing the rocky substrate at this point and slightly lower flow compared to April 2014.

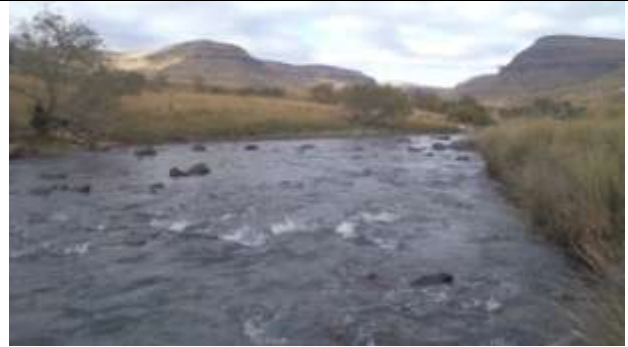
Figure 18: Downstream view of the TS1 site at the time of assessment in June 2014.

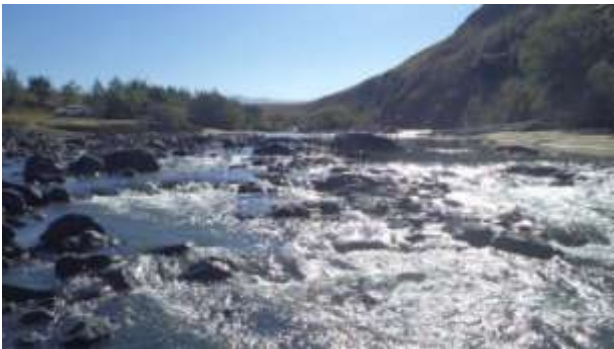
Figure 19: Upstream view of the Tsitsa River (TS4) as assessed in June 2014, showing the decrease in diversity of depth and flow profiles at this point, when compared to the April 2014 assessment.

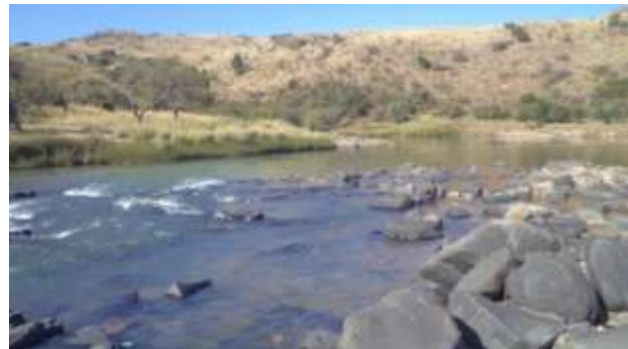
Figure 20: A downstream view of the TS4 site in the vicinity of the proposed Ntabelanga dam wall, as assessed in June 2014.

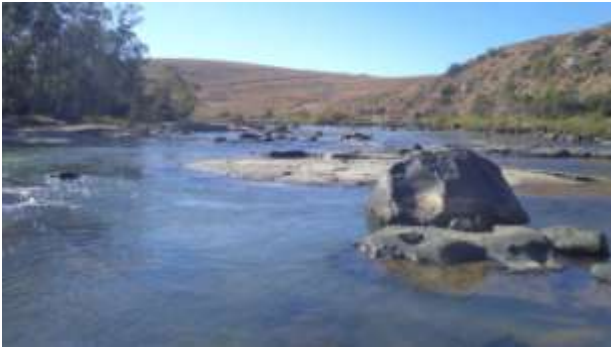
Figure 21: Upstream view of the TS7 site on the Tsitsa River showing the excellent rocky substrate at this point, as assessed in June 2014.

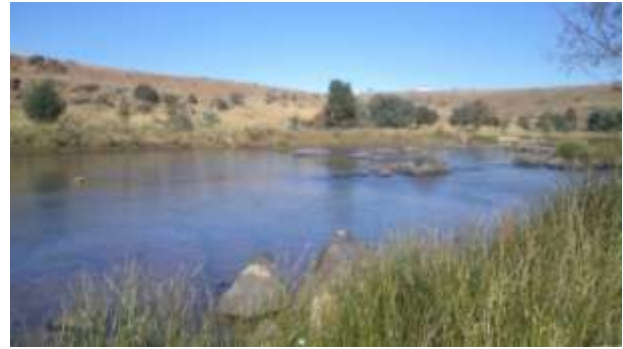
Figure 22: Downstream view of the TS7 site as assessed in June 2014, showing the decrease in diversity of flows at this point when compared to the April 2014 assessment.

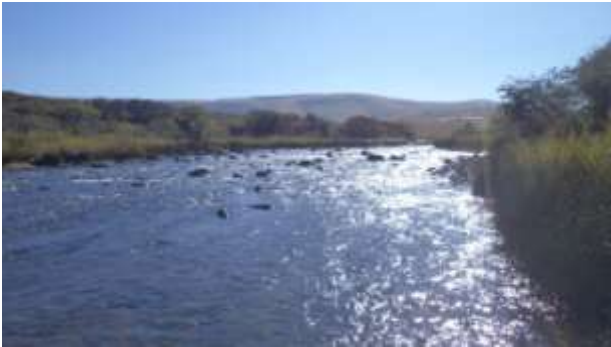
Figure 23: Upstream view of the TS8 site on the excellent rocky riffles at this point, as assessed in June 2014.

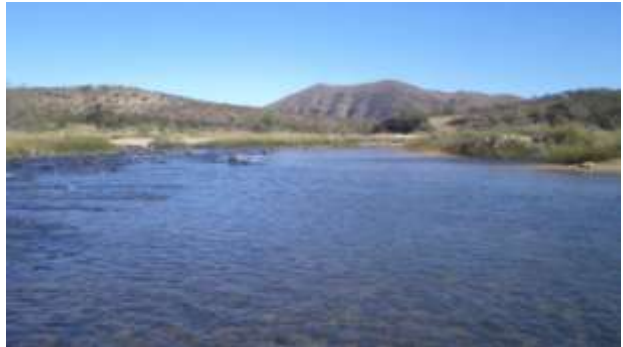
Figure 24: Downstream view of the TS8 site showing slightly deeper habitat providing cover for fish, as assessed in June 2014.

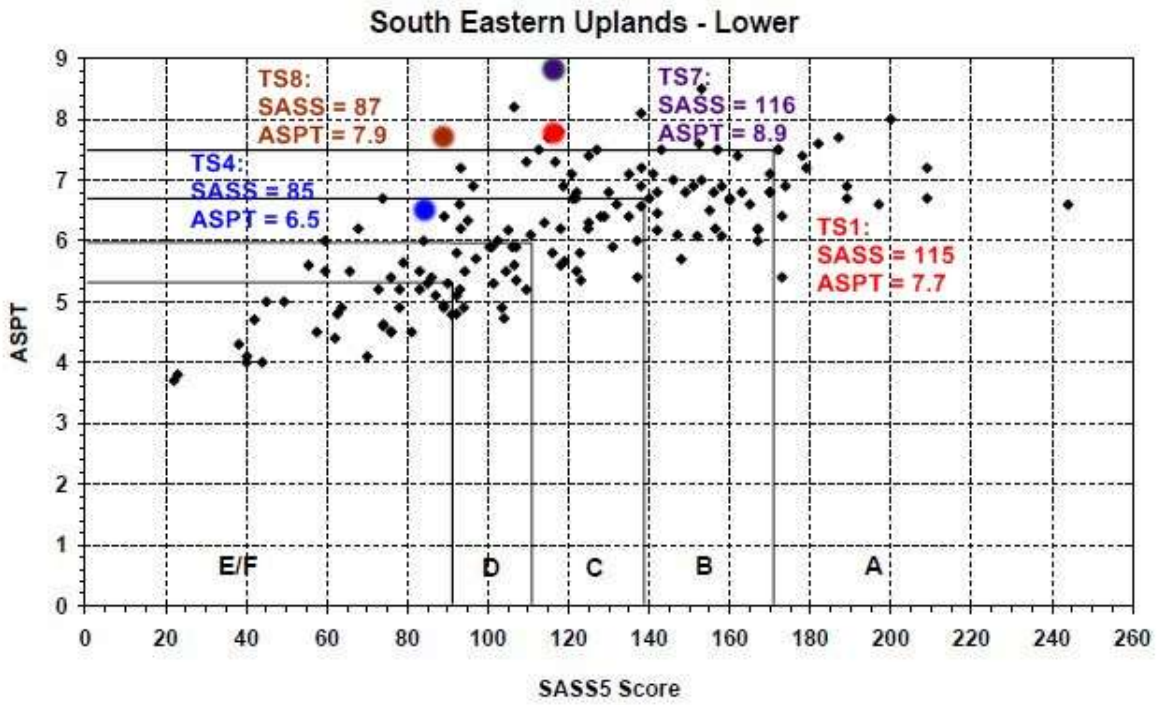
Figure 27: Visual depiction of SASS5 and ASPT scores for sites on the Tsitsa River based on the Dallas (2007) classification as recorded during April 2014.

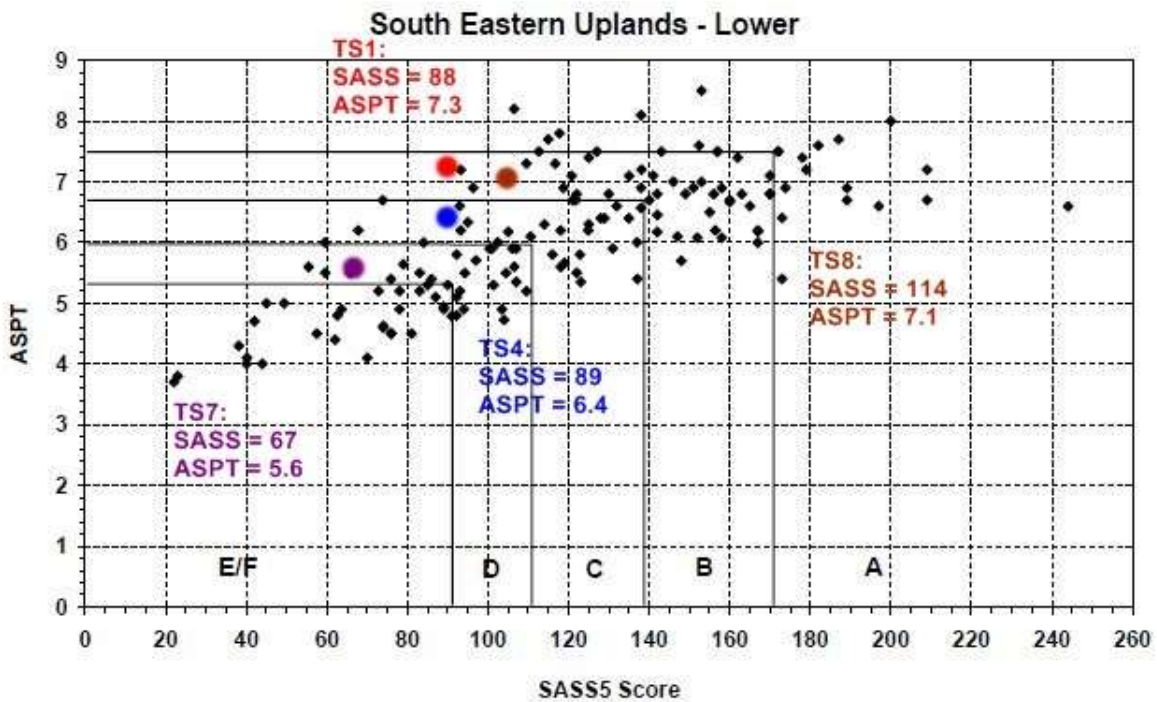
Figure 28: Visual depiction of SASS5 and ASPT scores for sites on the Tsitsa River based on the Dallas (2007) classification as recorded during June 2014.

- Because of the very similar habitat, flow and water quality conditions at the sites, there is little variation in SASS5 results from a spatial perspective. During April 2014 sites T1 and T7 presented with similar SASS5 scores whilst sites TS4 and TS8 had similar SASS5 scores (**Figure 27**).
- Because of the lower flow conditions in June 2014, there were more variation between sites compared to April 2014 results. During June 2014 sites T1 and T4 presented with similar SASS5 scores. TS8 had the highest SASS5 score whilst sites TS7 had the lowest SASS5 score (**Figure 28**).

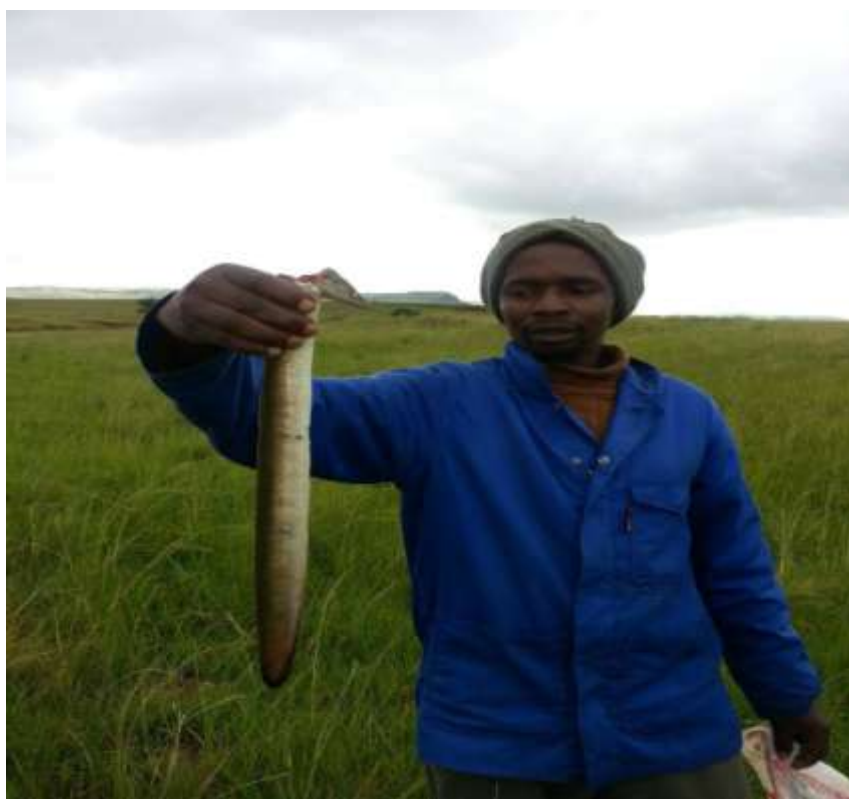
Figure 32: Local fisherman with an *Anguilla mossambica* specimen caught in the proposed Ntabelanga Dam development area.

SPECIES NAME	Number of fish collected at sites TS1, TS4, TS7 and TS8	Frequency of occurrence score (FROC)
<i>Cyprinus carpio</i>	Observed only	1
<i>Anguilla mossambica</i>	Known to occur in system, observed at the Ntabelanga dam area (Figure 32) and sites conducive to them being present	1

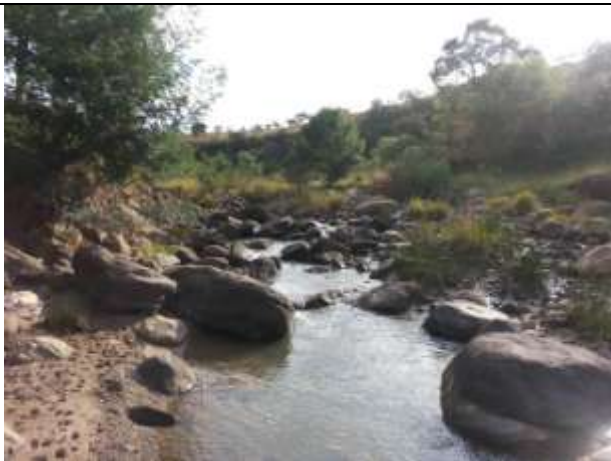
Figure 33: Upstream view of the TS2 site on an unnamed tributary of the Tsitsa River showing the good habitat available of the site during April 2014.

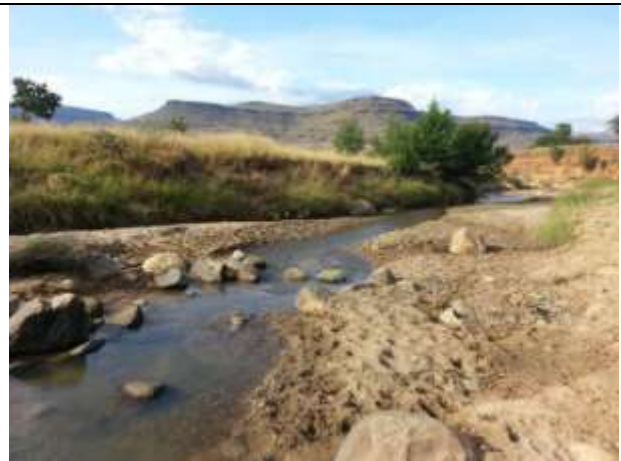
Figure 34: Downstream view of the TS2 site showing the sandy substrate present at the site as assessed April 2014.

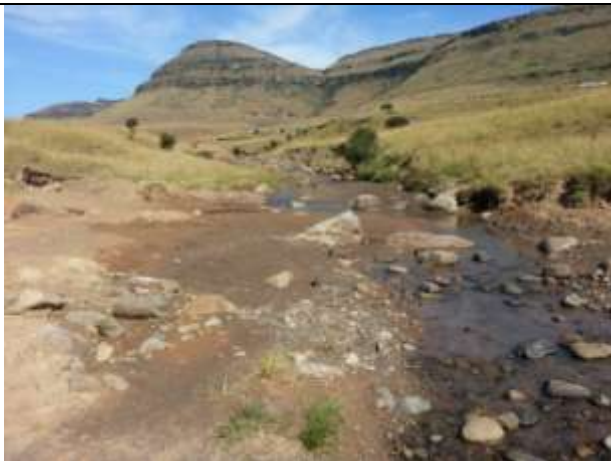
Figure 35: Upstream view of the TS3 site on an unnamed tributary of the Tsitsa River, showing the limited habitat and cover in the system at this point as assessed in April 2014.

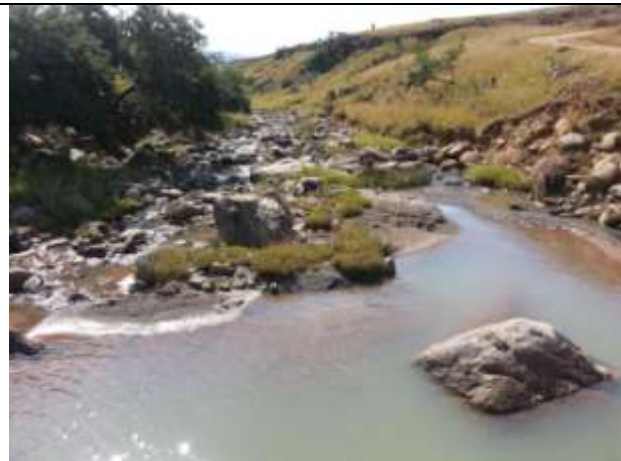
Figure 36: Downstream view of the TS3 site on an unnamed tributary of the Tsitsa River assessed April 2014

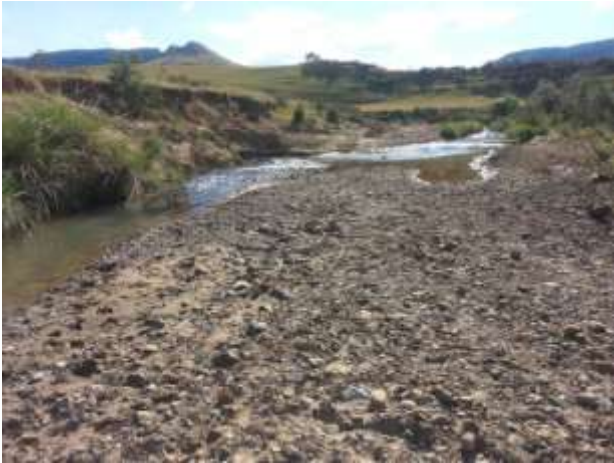
Figure 37: Upstream view of the TS5 site on an unnamed tributary of the Tsitsa River showing the diversity of habitat and cover at the point.

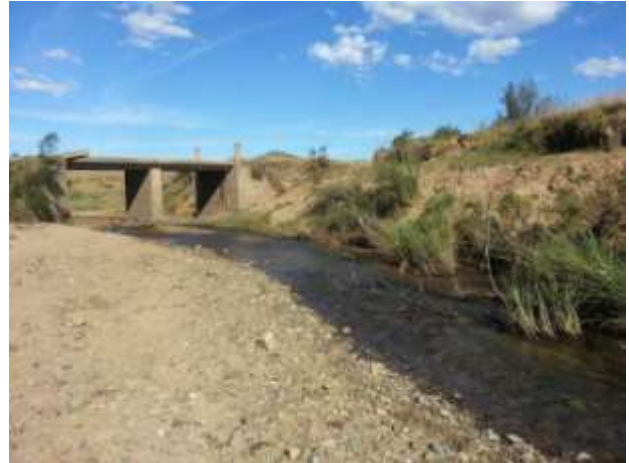
Figure 38: Downstream view of the TS5 site on an unnamed tributary of the Tsitsa River showing the good flow in the system at the time of assessment.

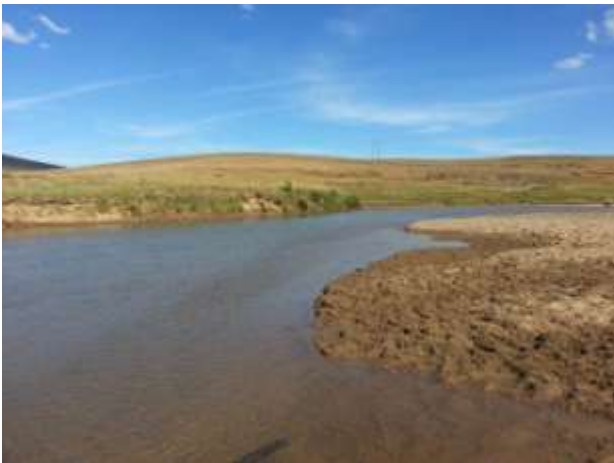
Figure 39: Upstream view of the TS6 site on the Inxu River showing the dominance of sandy substrate at the point.

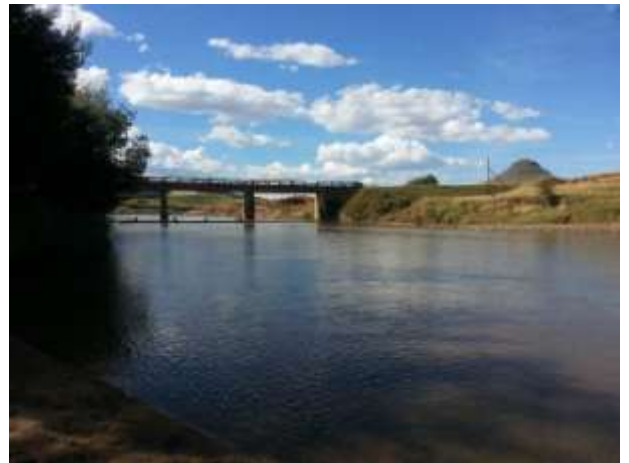
Figure 40: Downstream view of the TS6 site on the Inxu River showing the slow laminar flow at the point.

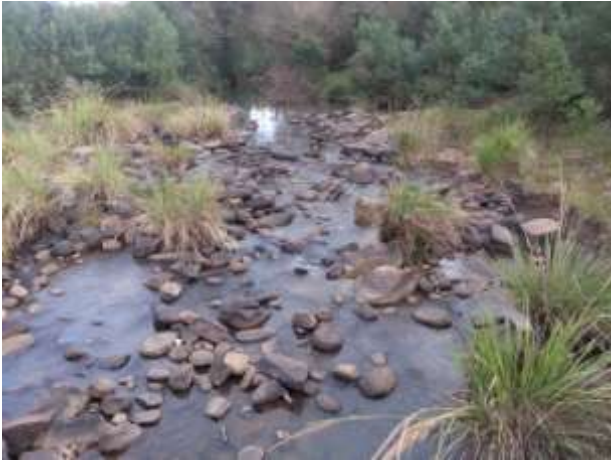
Figure 41: Upstream view of the TS9 site on an unnamed tributary of the Tsitsa River showing the good rocky substrate at this point.

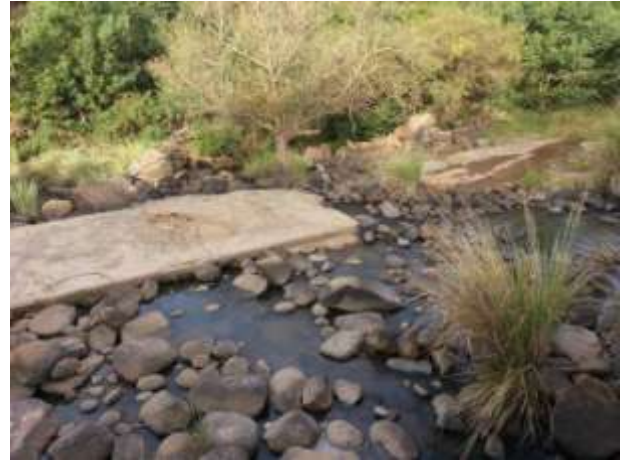
Figure 42: Downstream view of the TS9 site on an unnamed tributary of the Tsitsa River showing the limited flow at the point.

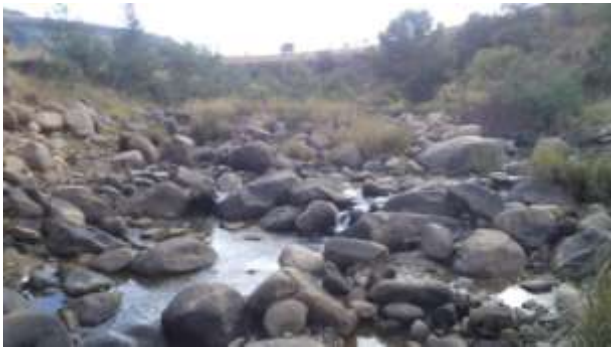
Figure 43: Upstream view of the TS2 site on an unnamed tributary of the Tsitsa River showing the good habitat available despite slightly lower flow conditions during June 2014.

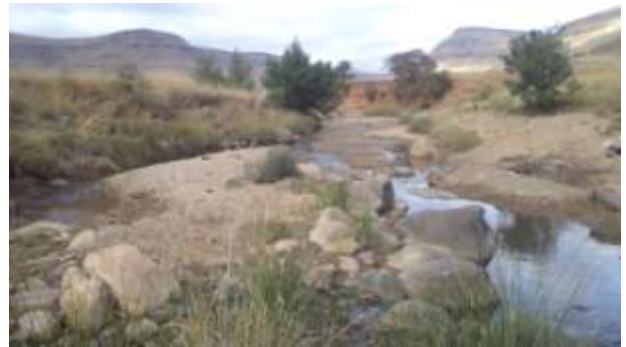
Figure 44: Downstream view of the TS2 site showing the sandy substrate present at the site as assessed June 2014.

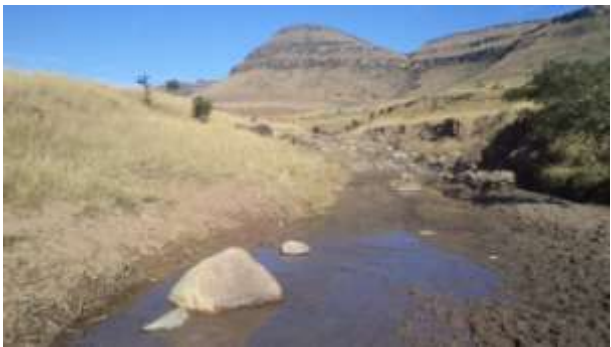
Figure 45: Upstream view of the TS3 site on an unnamed tributary of the Tsitsa River showing the rocky substrate at this point. With lower flow conditions more sand and gravel substrate were also available for sampling in June 2014.

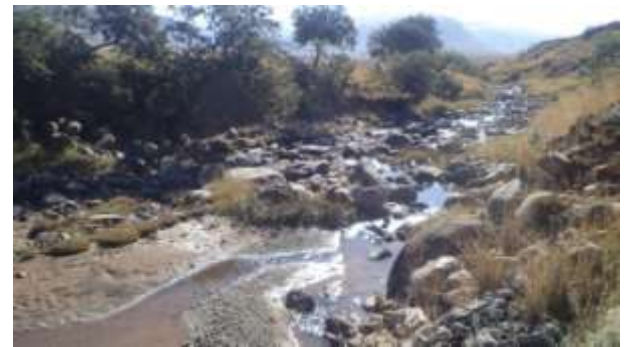
Figure 46: Downstream view of the TS3 site on an unnamed tributary of the Tsitsa River, showing lower water levels as assessed in June 2014.

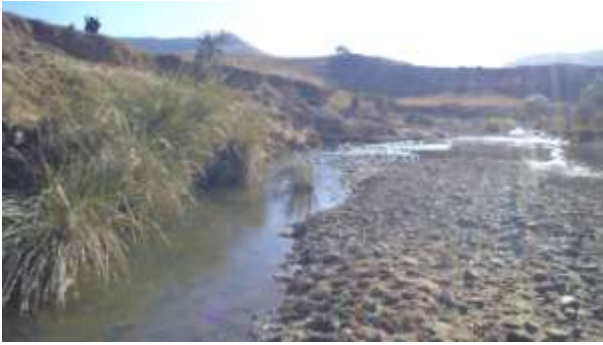
Figure 47: Upstream view of the TS5 site on an unnamed tributary of the Tsitsa River showing the largely unchanged conditions (compared to April 2013) as assessed during June 2014.

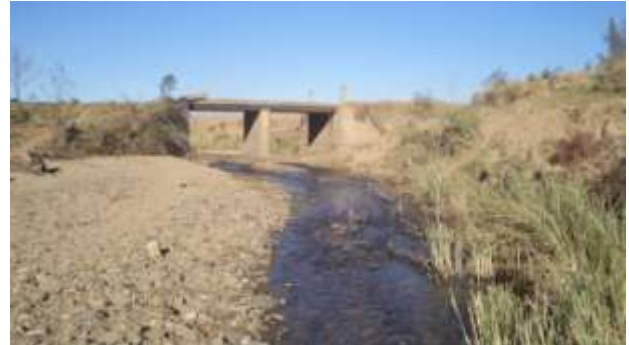
Figure 48: Downstream view of the TS5 site on an unnamed tributary of the Tsitsa River showing slightly slower (compared to April 2014 assessment) flow in the system at the time of the June 2014 assessment.

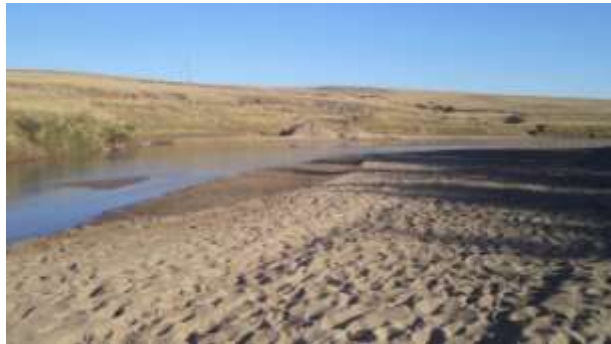
Figure 49: Upstream view of the TS6 site on the Inxu River showing the dominance of sandy substrate at the point, even more pronounced during the June 2014 assessment (pictured above) when compared to April 2014, due to the lower flow conditions in winter.

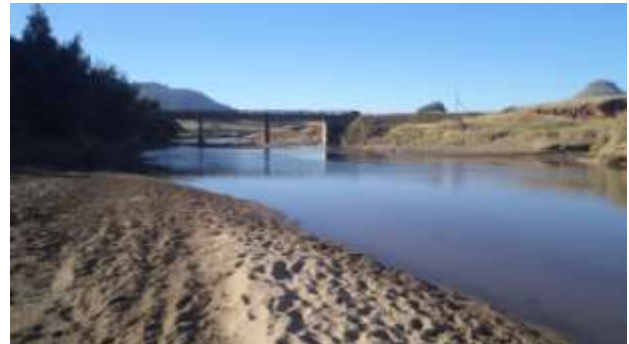
Figure 50: Downstream view of the TS6 site on the Inxu River showing the lower water level and slightly slower laminar flow at the point when compared to April 2014, as assessed during June 2014.

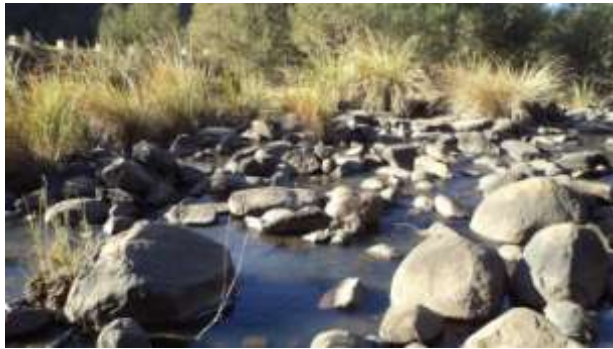
Figure 51: Upstream view of the TS9 site on an unnamed tributary of the Tsitsa River showing the good rocky substrate but limited flow at this point, as assessed in June 2014.

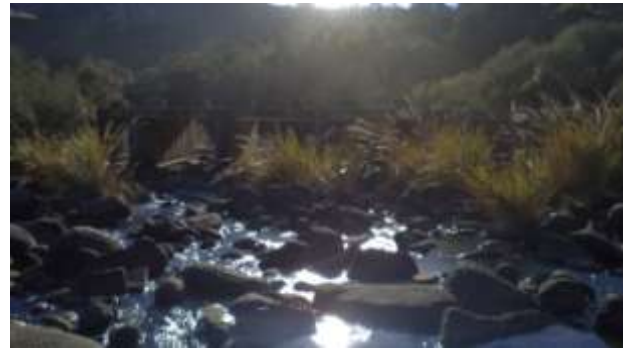
Figure 52: Downstream view of the TS9 site on an unnamed tributary of the Tsitsa.

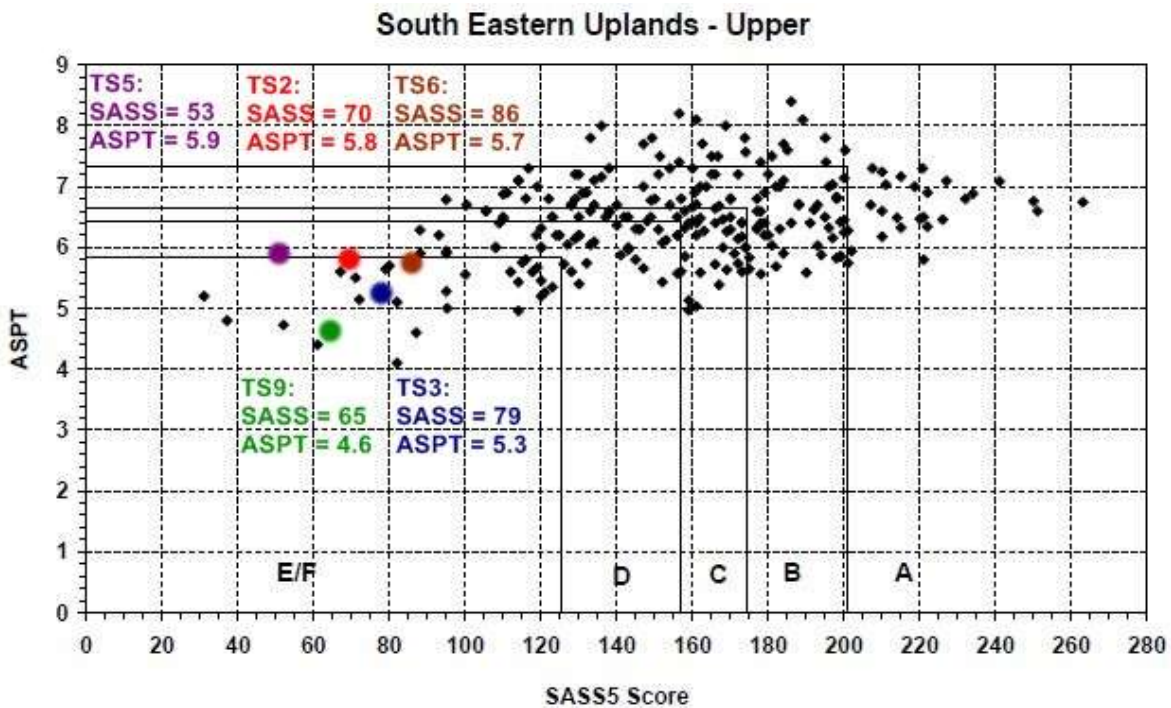
Figure 57: Visual depiction of SASS5 and ASPT scores for sites on the Tsitsa River tributaries based on the Dallas (2007) classification, as assessed during April 2014.
