REPORT NO. : P WMA 12/T30/00/5314/10

Environmental Impact Assessment

MZIMVUBU WATER PROJECT

FLORAL IMPACT ASSESSMENT

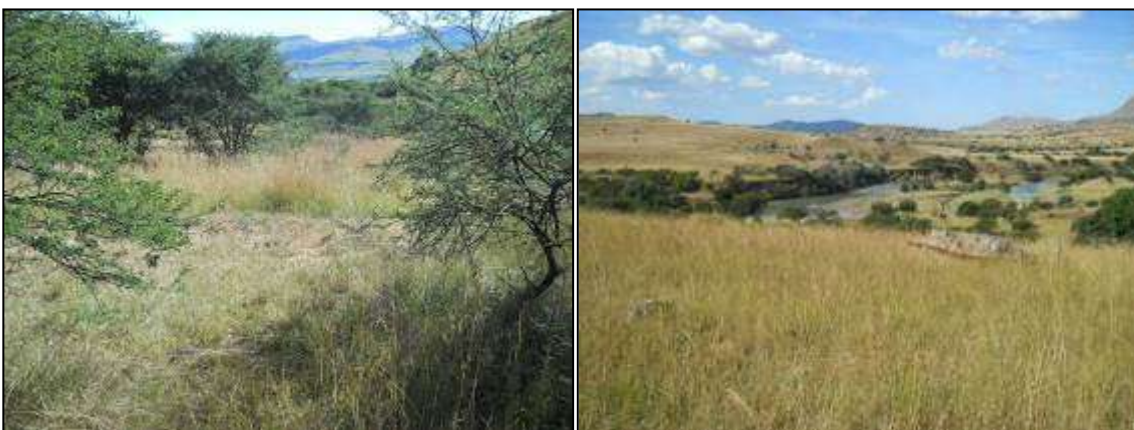
Figure 18: *Acacia karroo* dominating within the grassland / *Acacia* Thornveld habitat unit.

Dominant floral species within the Grassland / *Acacia* Thornveld habitat unit include the woody species *Acacia karroo*, *A. mearnsii*, *A. dealbata*, and *A. baileyana*. Most of these *Acacia*'s species are associated with disturbance and declared alien and/or invader floral species. A number of herbaceous species are present in this habitat unit and includes *Aloe marlothii*, *Helichrysum oreophilim*, *Hermannia transvaalensis* and *Taraxacum officinale*.

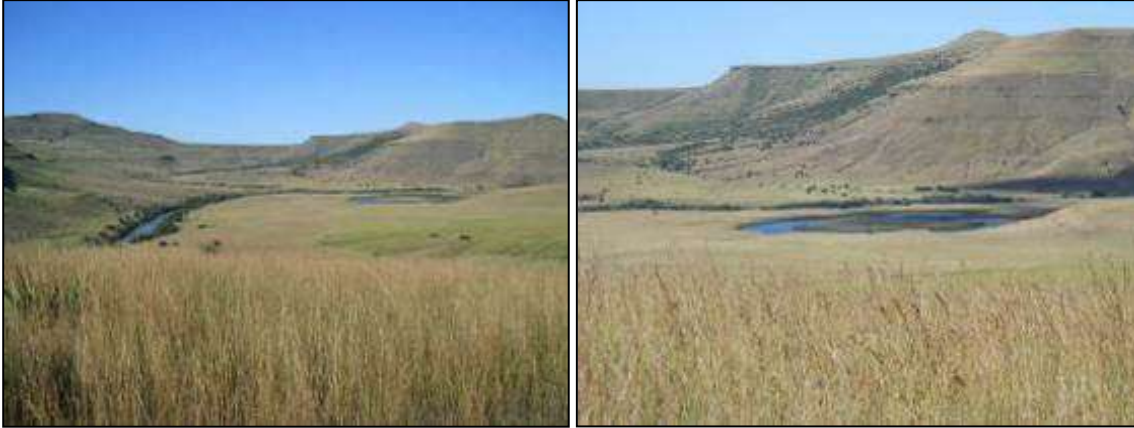
Figure 19: Veld dominated by *Hyparrhenia hirta* where the construction site will be located. A floodplain wetland feature located further downwards of the proposed site.

The section selected for the placement of infrastructure is located behind the Ntabelanga Dam wall within a grassland area. This area has undergone transformation due to historic agricultural activities. Currently the veld is dominated by *Hyparrhenia hirta*. This area is therefore low in floral diversity. It should also be noted that a floodplain wetland system is located further downwards downstream of the proposed dam wall construction site.

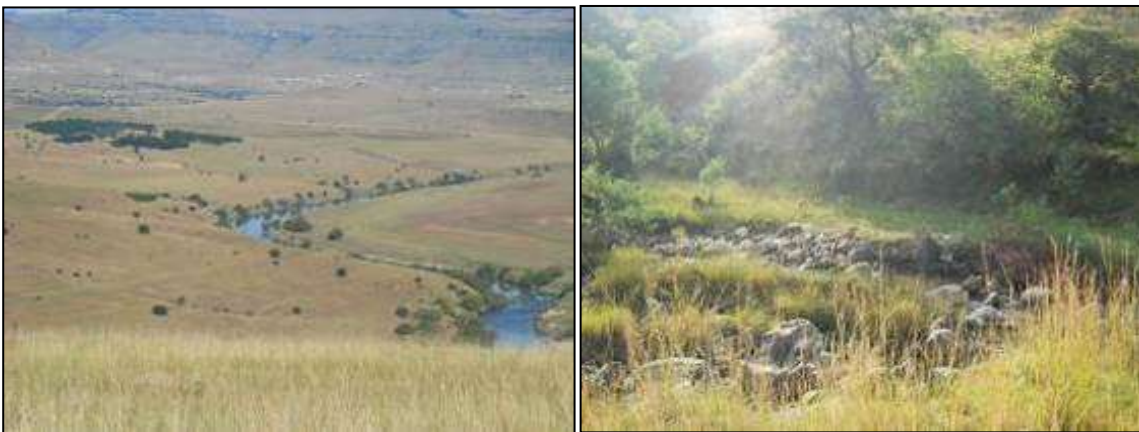
Figure 20: Riparian and wetland vegetation along the Tsitsa River and smaller tributaries.

The vegetation present within the Riparian / Wetland habitat unit contains many species observed within the Grassland / *Acacia* Thornveld habitat unit, but also includes a number of obligate wetlands species such as *Bulbostylis hispidula*, *Schoenoplectus corymbosus*, *Typha capensis* and *Cyperus* species. Vegetation within the Riparian / Wetland habitat unit varies from being woody along the larger rivers with associated riparian systems with more open grasslands due to vegetation clearance and erosion along the drainage lines and smaller tributaries.

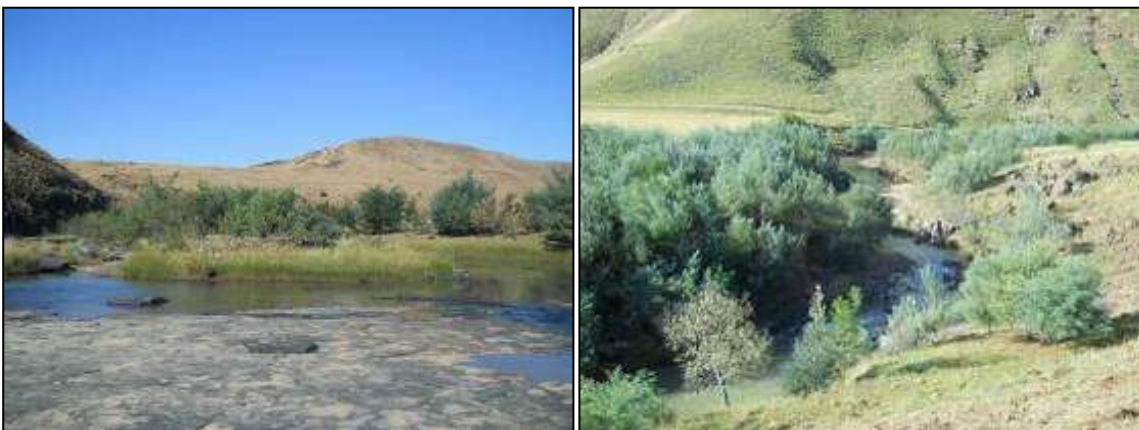
Figure 21: Alien invader species such as *Acacia dealbata* dominating the vegetation in the riparian zones of the main riparian systems.

Large areas along the riparian features contain alien tree species such as *Acacia mearnsii*, *A. dealbata*, *A. baileyana*, *Eucalyptus grandis* and *E. camaldulensis*. These declared alien invader species compete with and replace indigenous grasslands and riverine species.

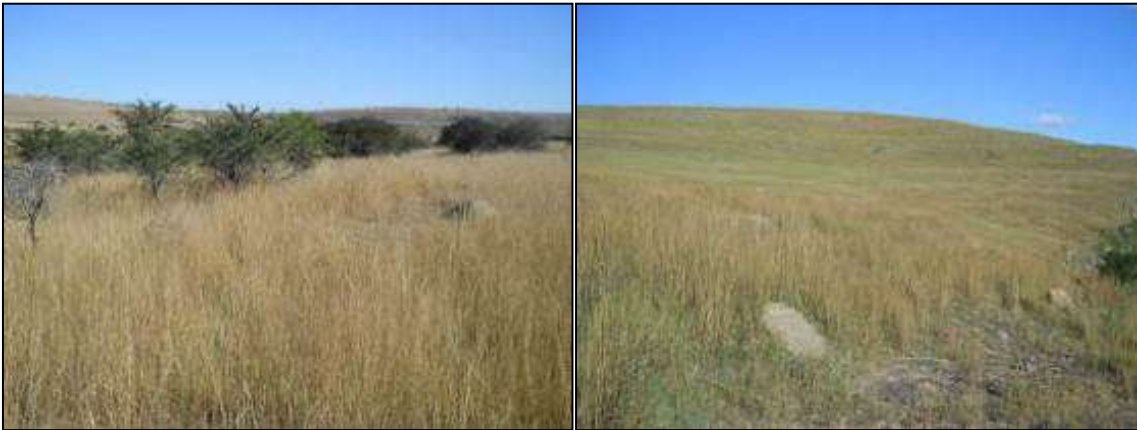
Figure 24: Open grassland areas along the Tsitsa River on the western section of the Lalini dam study area.

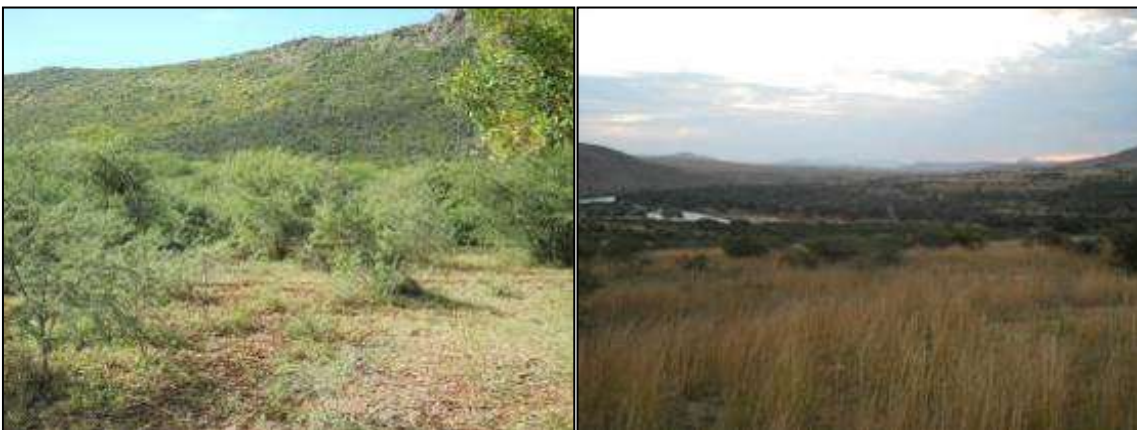
Figure 25: *Acacia karroo* dominating within the grassland / *Acacia* Thornveld habitat unit.

Dominant floral species within the Grassland / *Acacia* Thornveld habitat unit include the woody species *Acacia karroo*. A number of herbaceous species are present in this habitat unit and includes *Aloe marlothii*, *Berkheya bipinnatifida*, *Hermannia transvaalensis*, *Kalanchoe*

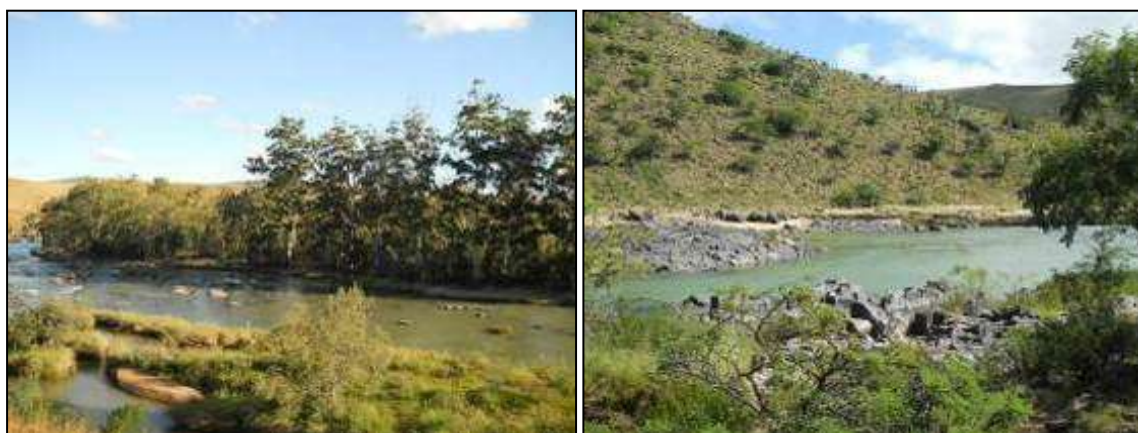
Figure 26: Riparian and wetland vegetation along the Tsitsa River.

Various drainage lines, small tributaries traverse the study area, including the larger Tsitsa River. The vegetation present within the Riparian / Wetland habitat unit contains woody species, exotic and indigenous as observed within the Grassland / *Acacia* Thornveld habitat unit. Large areas along the riparian features contain alien tree species such as *Acacia mearnsii*, *Eucalyptus grandis* and *E. camaldulensis*. These declared alien invader species compete with and replace indigenous grasslands and riverine species. The remainder of the vegetation found within the drainage lines includes a number of obligate wetlands species such as *Bulbostylis hispidula*, *Schoenoplectus corymbosus*, and various *Cyperus* species.

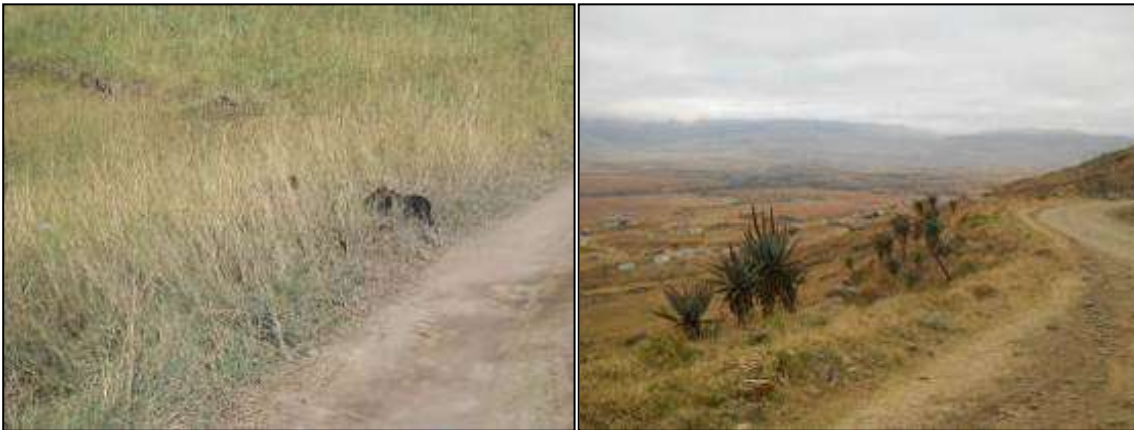
Figure 27: Transformed grassland areas alongside the road upgrade area. Indigenous species such as *Aloe ferox* and *Aloe aborescence* located alongside the road to be upgraded entering the Ntabelanga site.

upgraded by resurfacing and improving river crossings. The road upgrades are mostly in the Ntabelanga Dam study area. In terms of vegetation diversity, the edge effects of the existing roads has transformed the vegetation to the extent that only grass species such as *Eragrostis curvula*, *E. chloromelas*, *Hyparrhenia hirta*, *Sporobolus africanus* and *Cynodon dactylon*, which are associated with more disturbed areas, occur alongside the current access roads. Other areas of the road upgrade are located within the higher altitude areas. Indigenous species such as *Aloe marlothii*, *Aloe ferox* and *Aloe aborescence* occurred alongside the current road. These and other indigenous species could be relocated should they occur within the road upgrade footprint area.

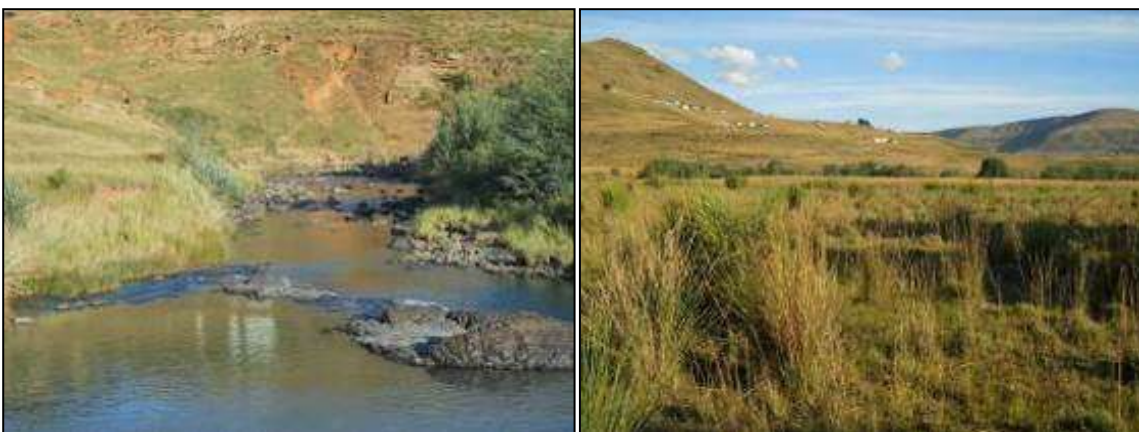
Figure 28: Riparian and wetland crossing along the road to be upgraded in the Ntabelanga Dam study area.

Numerous drainage lines, seeps, riparian systems and valley bottom wetland features traverse the road to be upgraded. The wetland features need to be considered when construction of the road upgrades commences to ensure that e.g. sedimentation of wetland features does not take place, wetlands that have undergone severe erosion close to the road, be reinforced to prevent further degradation and stream flow is established.

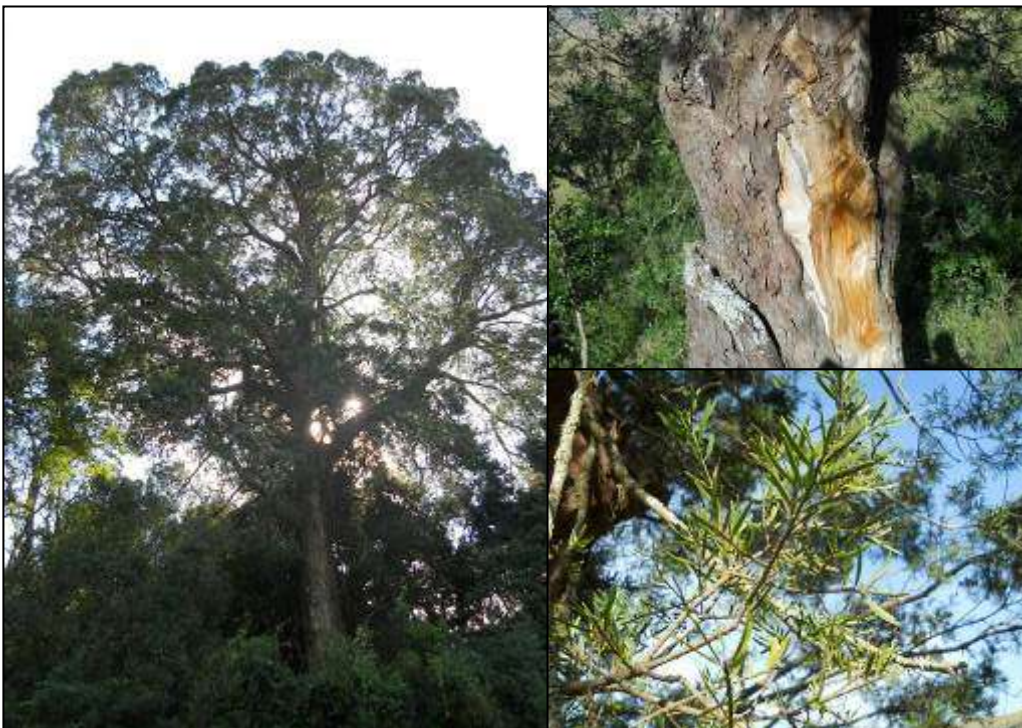
Figure 29: *Podocarpus falcatus* located on the northern section of the dam, along the road upgrade section.

Podocarpus falcatus and *P. latifolius* were identified in low abundance alongside the road upgrade (roads to be resurfaced) areas within the Ntabelanga Dam, on the northern section of

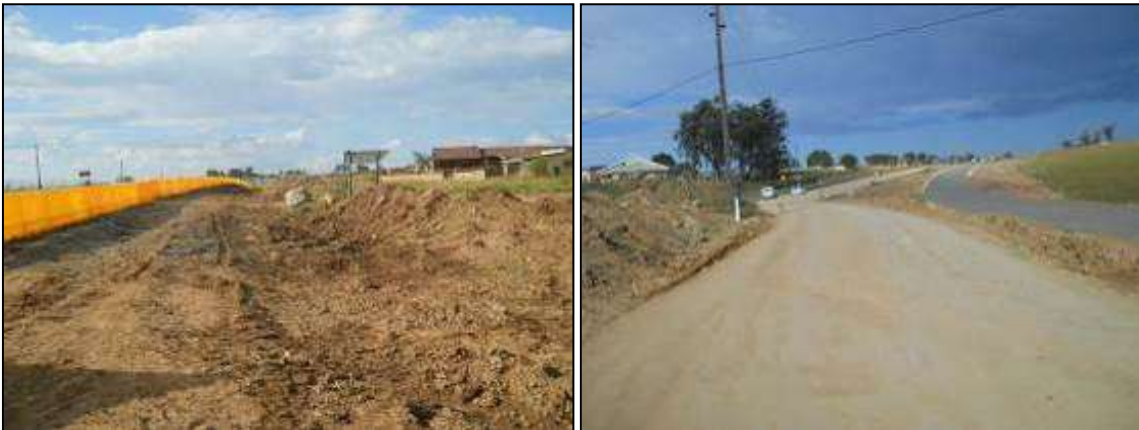
Figure 30: Current construction activities to upgrade roads outside the Qumbu area.

Primary and secondary pipelines conveying water to selected areas are located within the Tsolo and Qumbu local areas. Most of the areas where the construction of these pipelines is proposed are located adjacent to main roads. This, due to the edge effects from the road, vegetation has been transformed. Very little indigenous vegetation occurred along the route. Species mostly associated with disturbance such as *Eragrostis curvula*, *Hyparrhenia hirta* and *Cynodon dactylon* were present. In some areas outside Qumbu current construction activities to upgrade the roads have already taken place.

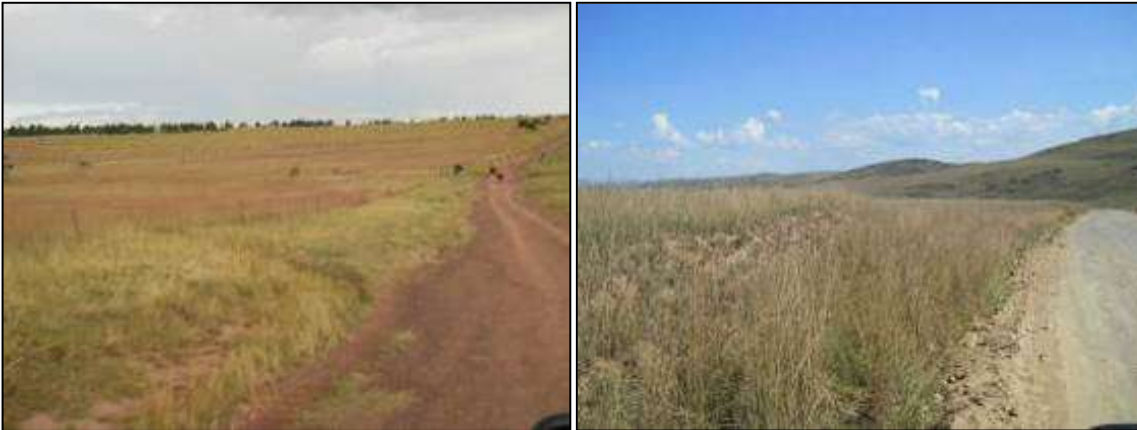
Figure 32: Transformed grassland vegetation along the proposed pipeline.

Figure 32 indicates the locations of the wetland features traversing the pipeline. The remainder of the pipeline contains transformed grasslands, which were not indicated on the maps due to the scale of the pipeline locations.

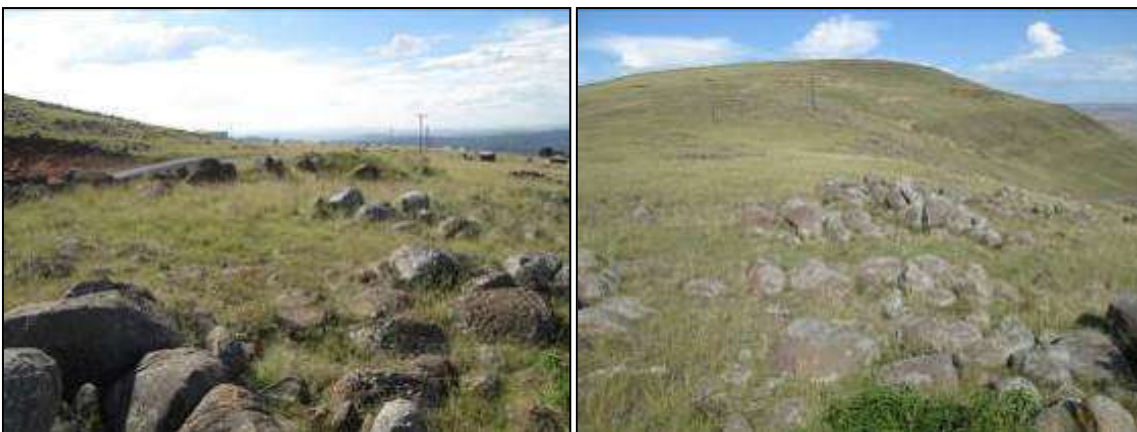
Figure 33: Rocky outcrops located adjacent to the secondary pipeline routes.

Pockets of rocky outcrops or where the pipeline traverses mountain areas were located. These areas were mapped on a desktop level to indicate where vegetation has changed. Although not all areas of the rocky outcrops contained indigenous floral vegetation, these areas are still considered different to the remainder of the habitat units. Mitigation measures when construction of the pipeline takes place should consider these rocky areas and mountain passes and minimise the impacts within these areas.
