5. DESCRIPTION OF THE AFFECTED ENVIRONMENT

5.2 AQUATIC ECOLOGICAL ASSESSMENT RESULTS FOR THE TSITSA RIVER

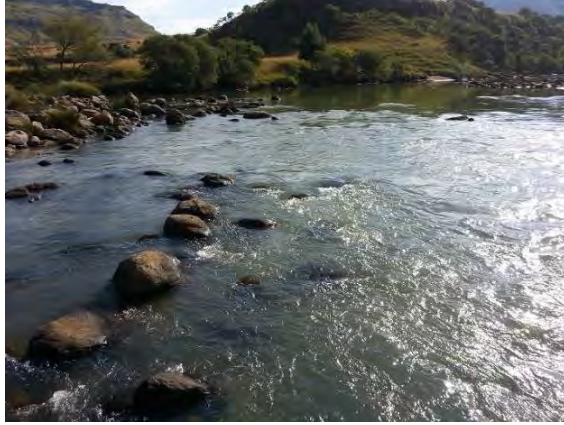
Figure 9: Upstream view of the TS1 site on the Tsitsa River showing the rocky substrate at this point, as assessed April 2014.

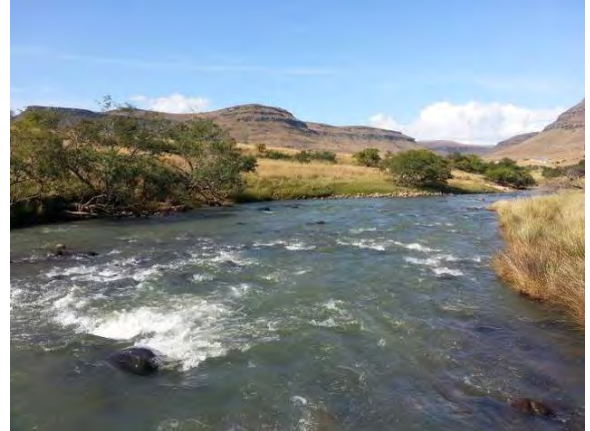
Figure 10: Downstream view of the TS1 site showing the diversity of flow types present, as assessed April 2014.

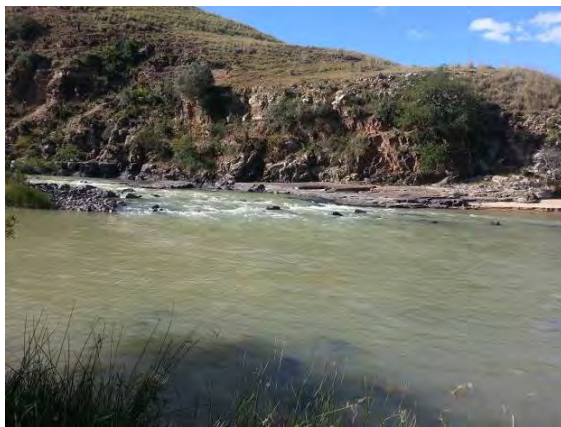
Figure 11: Upstream view of the Tsitsa River (TS4) showing the diversity of depth and flow profiles at this point, as assessed April 2014.

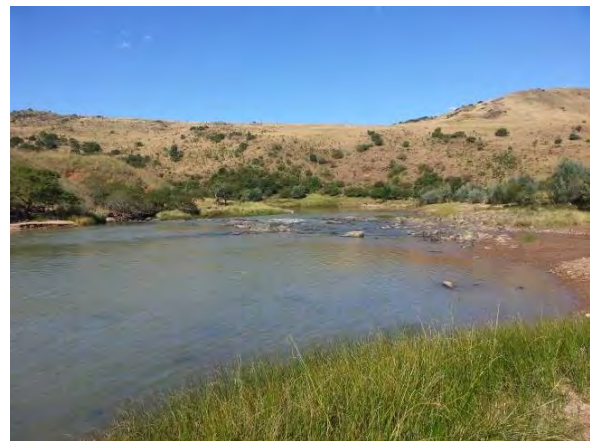
Figure 12: A downstream view of the TS4 site in the vicinity of the proposed Ntabelanga Dam wall, as assessed April 2014.

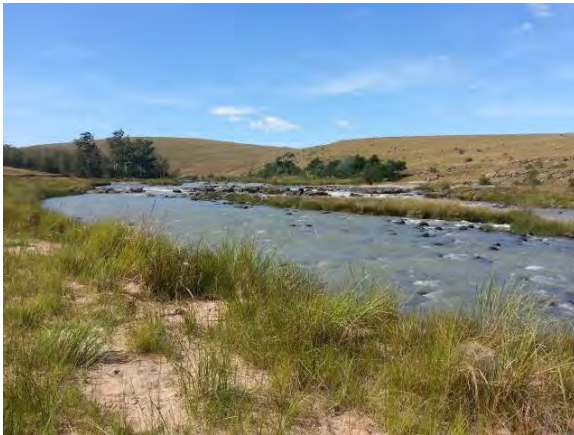
Figure 13: Upstream view of the TS7 site on the Tsitsa River showing the excellent rocky substrate at this point, as assessed April 2014.

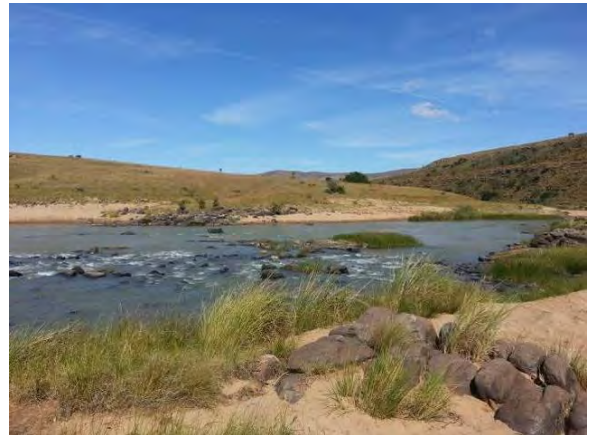
Figure 14: Downstream view of the TS7 site showing the diversity of flows at this point, as assessed April 2014.

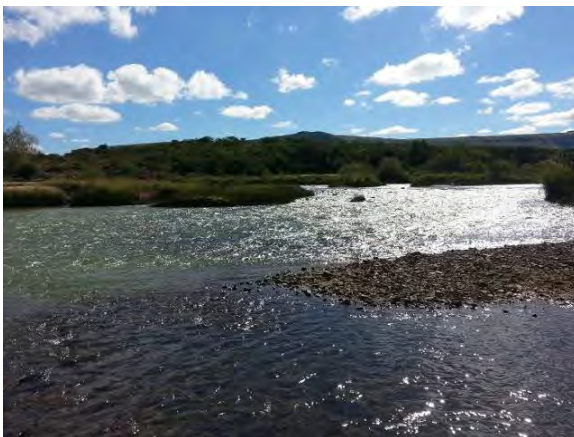
Figure 15: Upstream view of the TS8 site on the excellent rocky riffles and rapids at this point, as assessed April 2014.

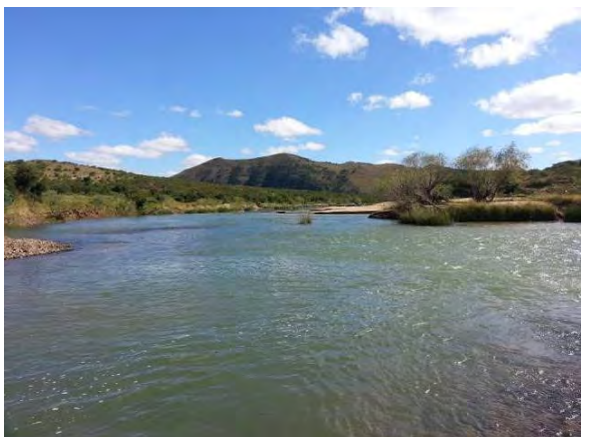
Figure 16: Downstream view of the TS8 site showing the deeper pools, providing cover for fish, as assessed April 2014.

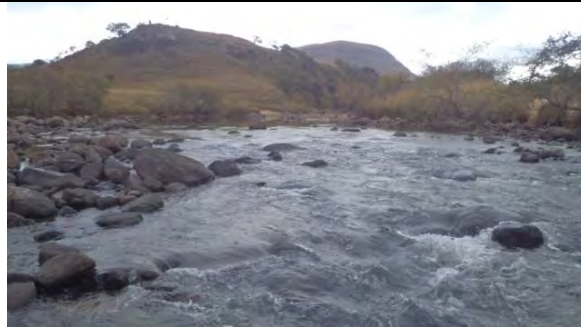
Figure 17: Upstream view of the TS1 site on the Tsitsa River as assessed June 2014, showing the rocky substrate at this point and slightly lower flow compared to April 2014.

At site TS1 lower flow conditions resulted in sand and gravel substrate becoming available for sampling in June 2014. Furthermore a lower percentage leafy material and less bank cover was observed in June 2014 compared to April 2014. This can be expected under the dry winter conditions. Lower percentage leaf cover was recorded at the majority of the other sites sampled for the same reason. Apart from the latter the IHAS variables recorded remained similar between assessments at sites TS4, TS7 and TS8.

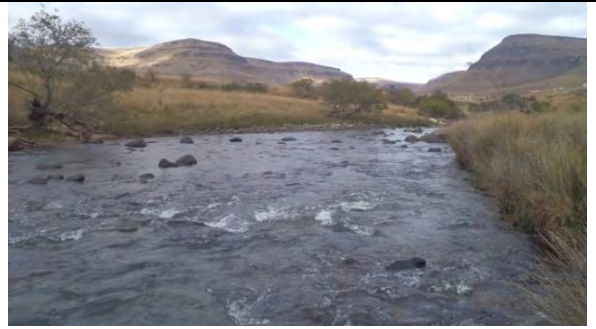
Figure 18: Downstream view of the TS1 site at the time of assessment in June 2014.

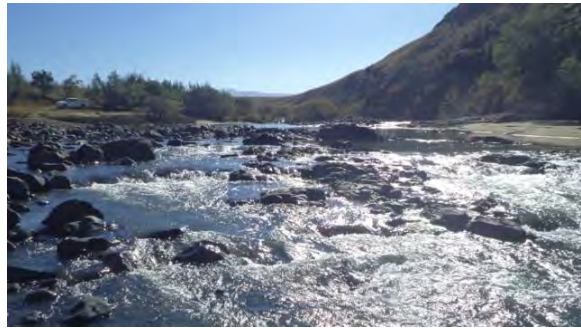
Figure 19: Upstream view of the Tsitsa River (TS4) as assessed in June 2014, showing the decrease in diversity of depth and flow profiles at this point, when compared to the April 2014 assessment.

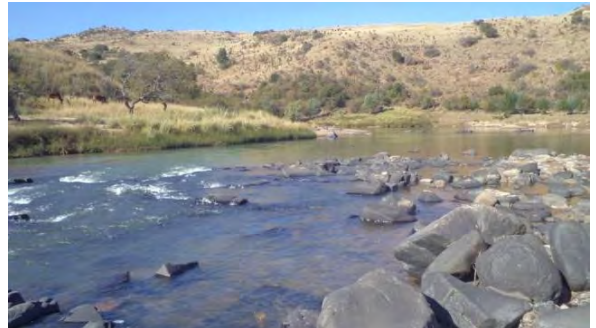
Figure 20: A downstream view of the TS4 site in the vicinity of the proposed Ntabelanga dam wall, as assessed in June 2014.

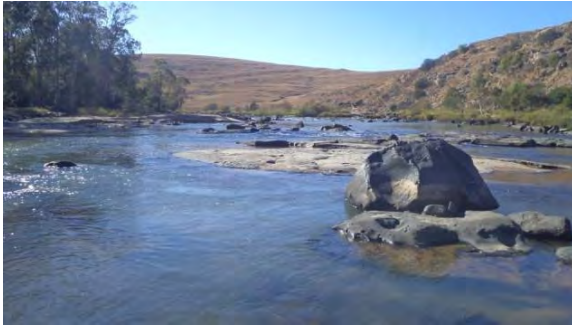
Figure 21: Upstream view of the TS7 site on the Tsitsa River showing the excellent rocky substrate at this point, as assessed in June 2014.

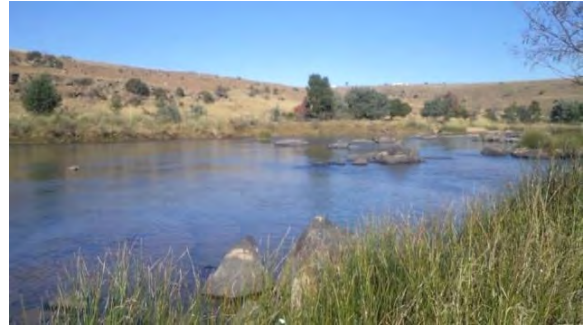
Figure 22: Downstream view of the TS7 site as assessed in June 2014, showing the decrease in diversity of flows at this point when compared to the April 2014 assessment.

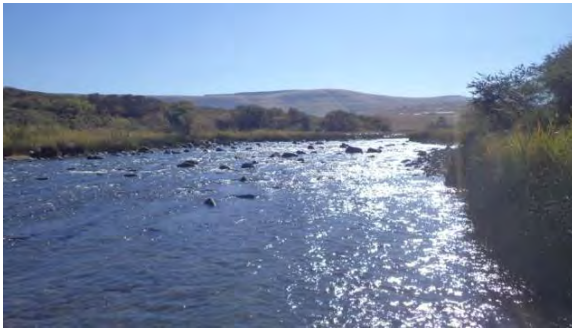
Figure 23: Upstream view of the TS8 site on the excellent rocky riffles at this point, as assessed in June 2014.

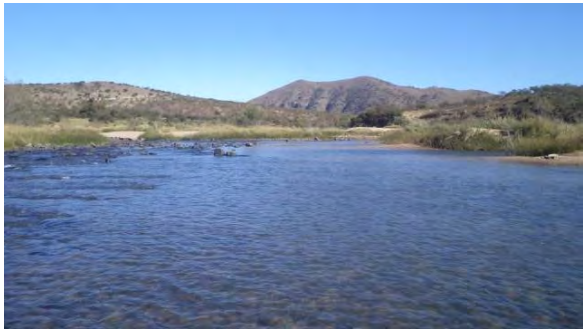
Figure 24: Downstream view of the TS8 site showing slightly deeper habitat providing cover for fish, as assessed in June 2014.

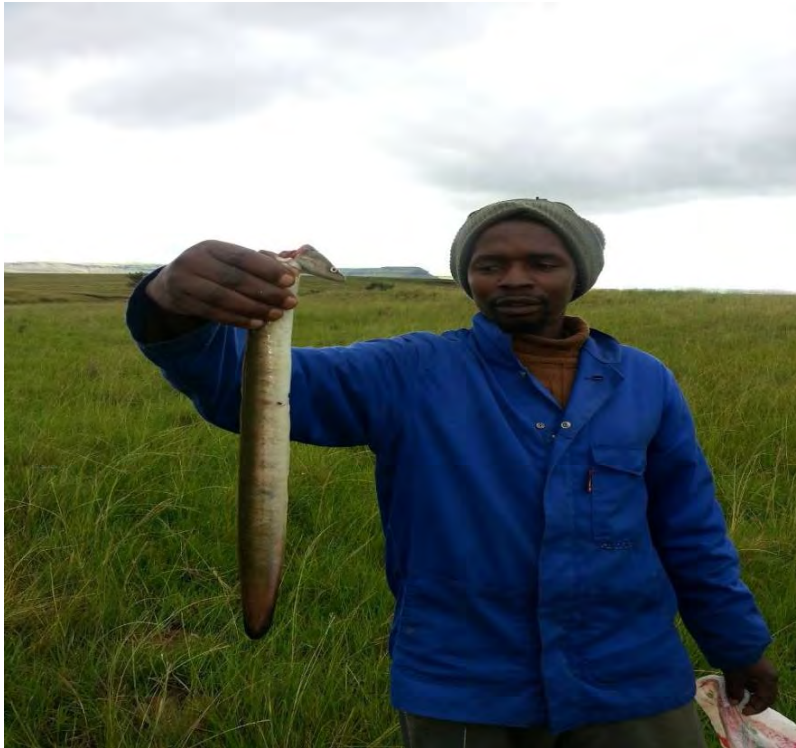
SPECIES NAME	Number of fish collected at sites TS1, TS4, TS7 and TS8	Frequency of occurrence score (FROC)
<i>Cyprinus carpio</i>	Observed only	1
<i>Anguilla mossambica</i>	Known to occur in system, observed at the Ntabelanga dam area (Figure 32) and sites conducive to them being present	1

Figure 32: Local fisherman with an *Anguilla mossambica* specimen caught in the proposed Ntabelanga Dam development area.

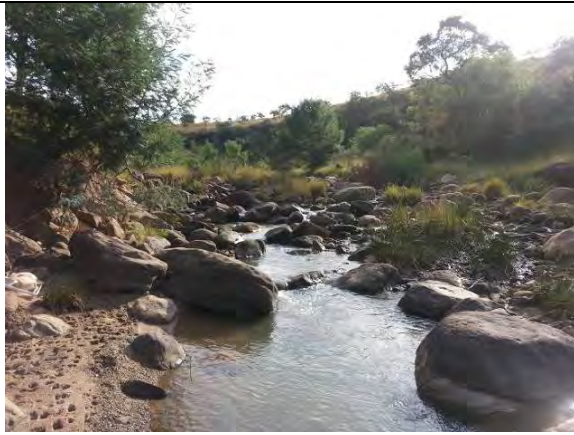
Figure 33: Upstream view of the TS2 site on an unnamed tributary of the Tsitsa River showing the good habitat available of the site during April 2014.

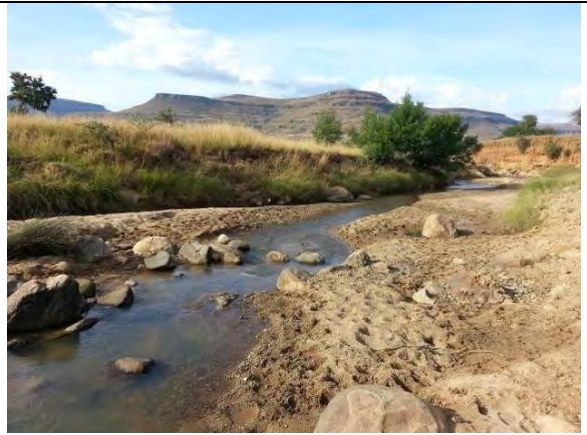
Figure 34: Downstream view of the TS2 site showing the sandy substrate present at the site as assessed April 2014.

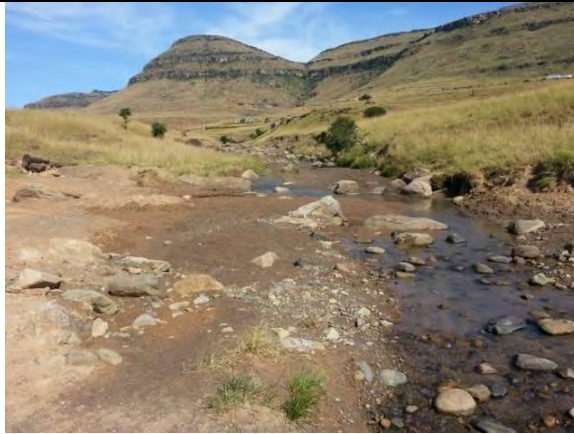
Figure 35: Upstream view of the TS3 site on an unnamed tributary of the Tsitsa River, showing the limited habitat and cover in the system at this point as assessed in April 2014.

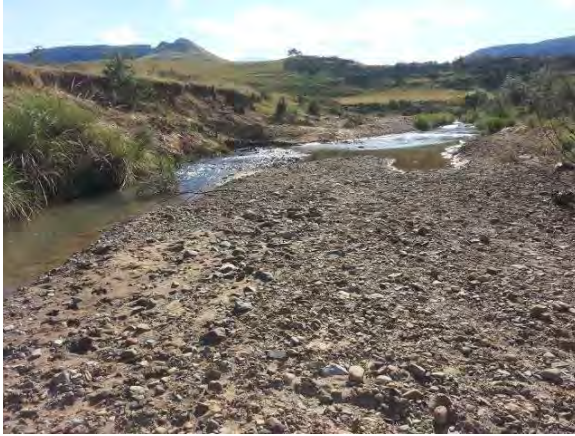
Figure 37: Upstream view of the TS5 site on an unnamed tributary of the Tsitsa River showing the diversity of habitat and cover at the point.

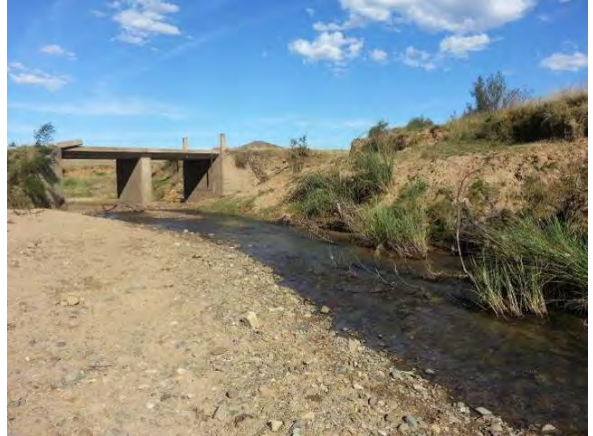
Figure 38: Downstream view of the TS5 site on an unnamed tributary of the Tsitsa River showing the good flow in the system at the time of assessment.

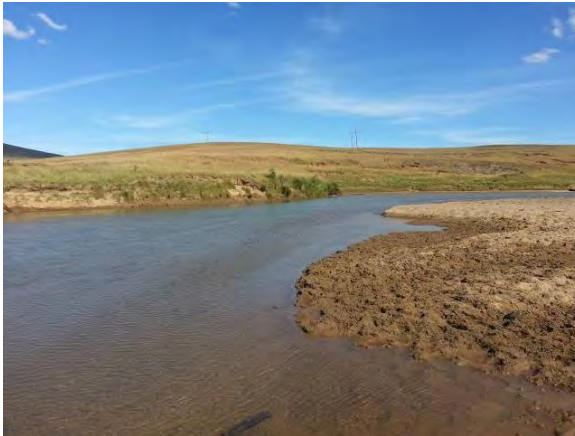
Figure 39: Upstream view of the TS6 site on the Inxu River showing the dominance of sandy substrate at the point.

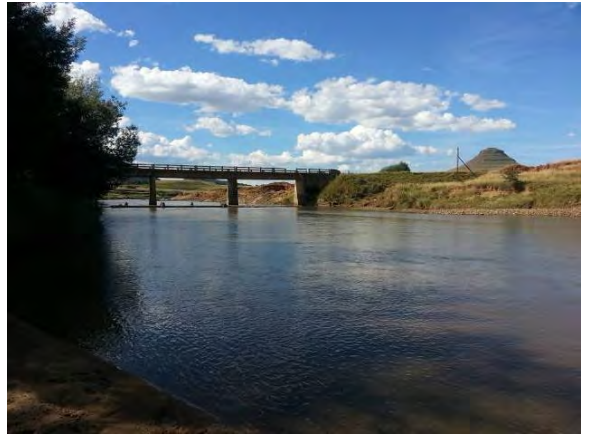
Figure 40: Downstream view of the TS6 site on the Inxu River showing the slow laminar flow at the point.

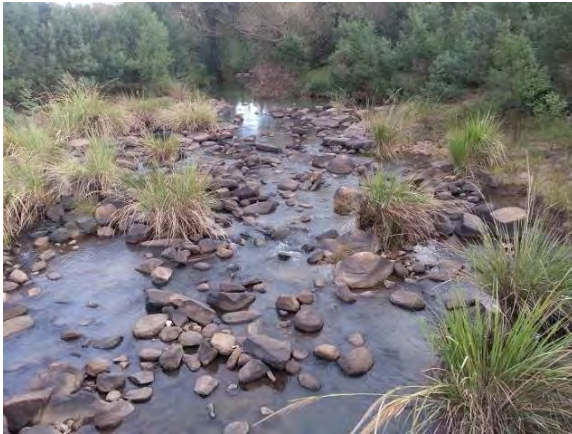
Figure 41: Upstream view of the TS9 site on an unnamed tributary of the Tsitsa River showing the good rocky substrate at this point.

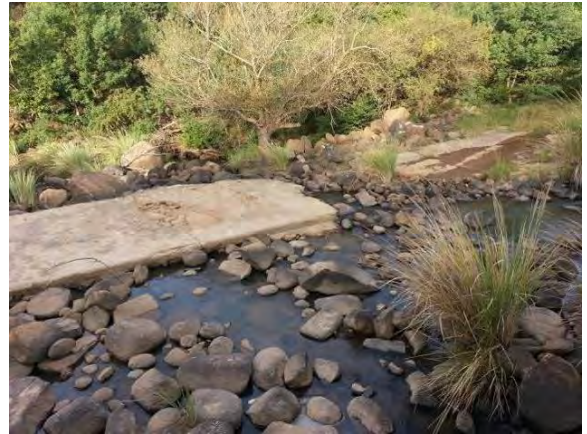
Figure 42: Downstream view of the TS9 site on an unnamed tributary of the Tsitsa River showing the limited flow at the point.

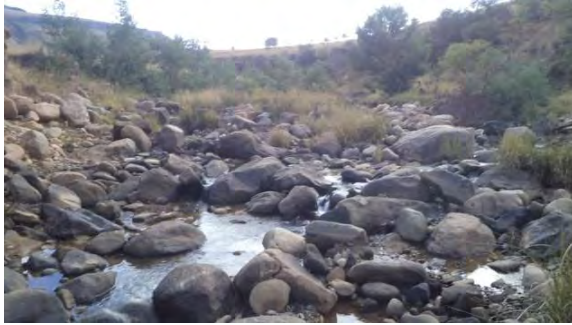
Figure 43: Upstream view of the TS2 site on an unnamed tributary of the Tsitsa River showing the good habitat available despite slightly lower flow conditions during June 2014.

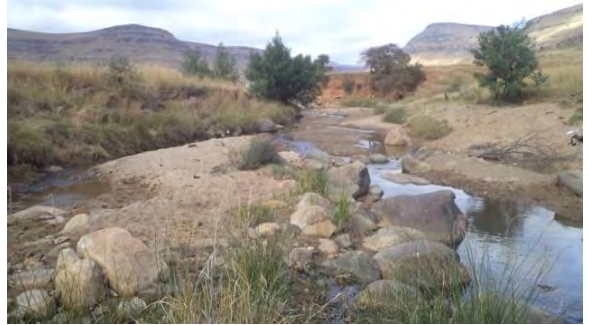
Figure 44: Downstream view of the TS2 site showing the sandy substrate present at the site as assessed June 2014.

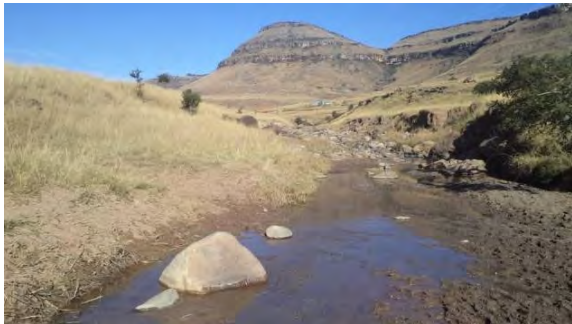
Figure 45: Upstream view of the TS3 site on an unnamed tributary of the Tsitsa River showing the rocky substrate at this point. With lower flow conditions more sand and gravel substrate were also available for sampling in June 2014.

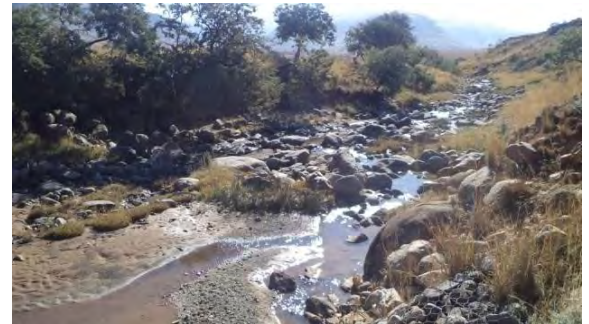
Figure 46: Downstream view of the TS3 site on an unnamed tributary of the Tsitsa River, showing lower water levels as assessed in June 2014.

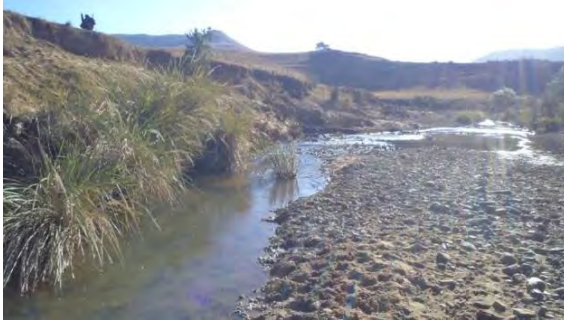
Figure 47: Upstream view of the TS5 site on an unnamed tributary of the Tsitsa River showing the largely unchanged conditions (compared to April 2013) as assessed during June 2014.

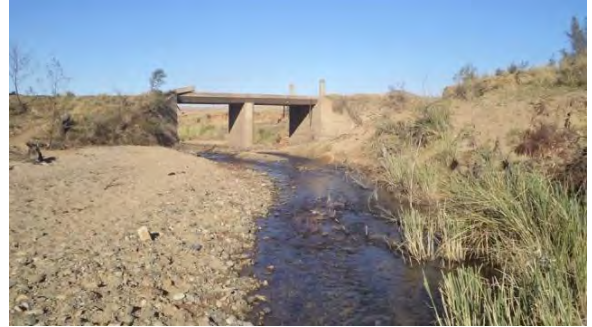
Figure 48: Downstream view of the TS5 site on an unnamed tributary of the Tsitsa River showing slightly slower (compared to April 2014 assessment) flow in the system at the time of the June 2014 assessment.

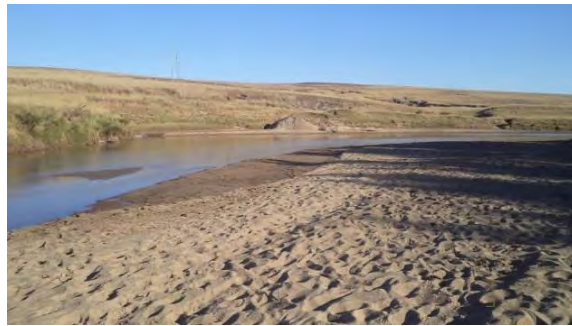
Figure 49: Upstream view of the TS6 site on the Inxu River showing the dominance of sandy substrate at the point, even more pronounced during the June 2014 assessment (pictured above) when compared to April 2014, due to the lower flow conditions in winter.

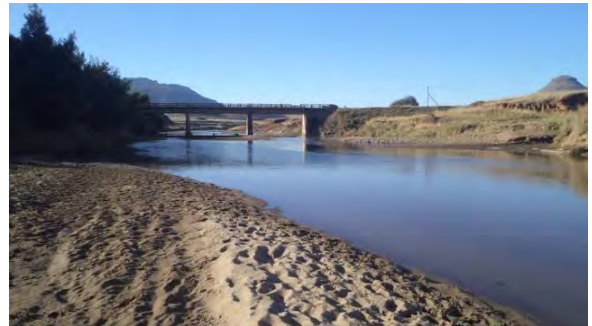
Figure 50: Downstream view of the TS6 site on the Inxu River showing the lower water level and slightly slower laminar flow at the point when compared to April 2014, as assessed during June 2014.

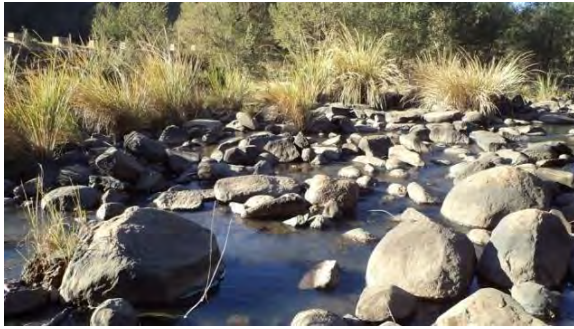
Figure 51: Upstream view of the TS9 site on an unnamed tributary of the Tsitsa River showing the good rocky substrate but limited flow at this point, as assessed in June 2014.

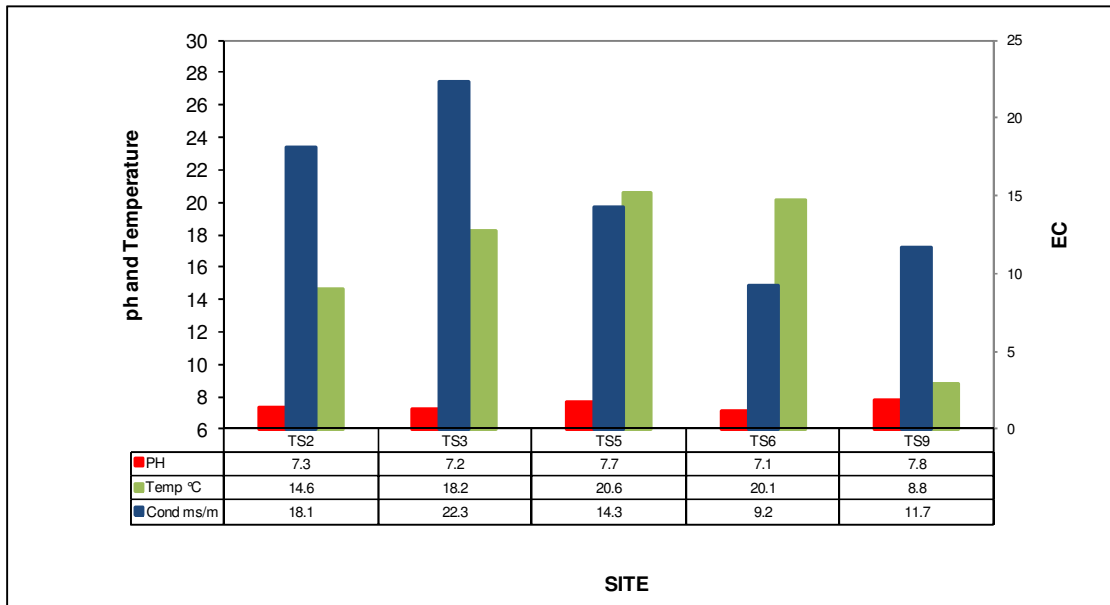
Figure 54: Physico-chemical water quality variables as measured at the respective Inxu River and smaller Tsitsa River tributary sites during June 2014.

- Temporally there was a decrease in pH at all sites between April 2014 and June 2014, ranging between 11.2% (site TS9) and 20.7%, exceeding the guideline recommendation in all instances indicating that there is significant seasonal variation in pH;

A graphic presentation of results is depicted in **Figures 53 and 54**.

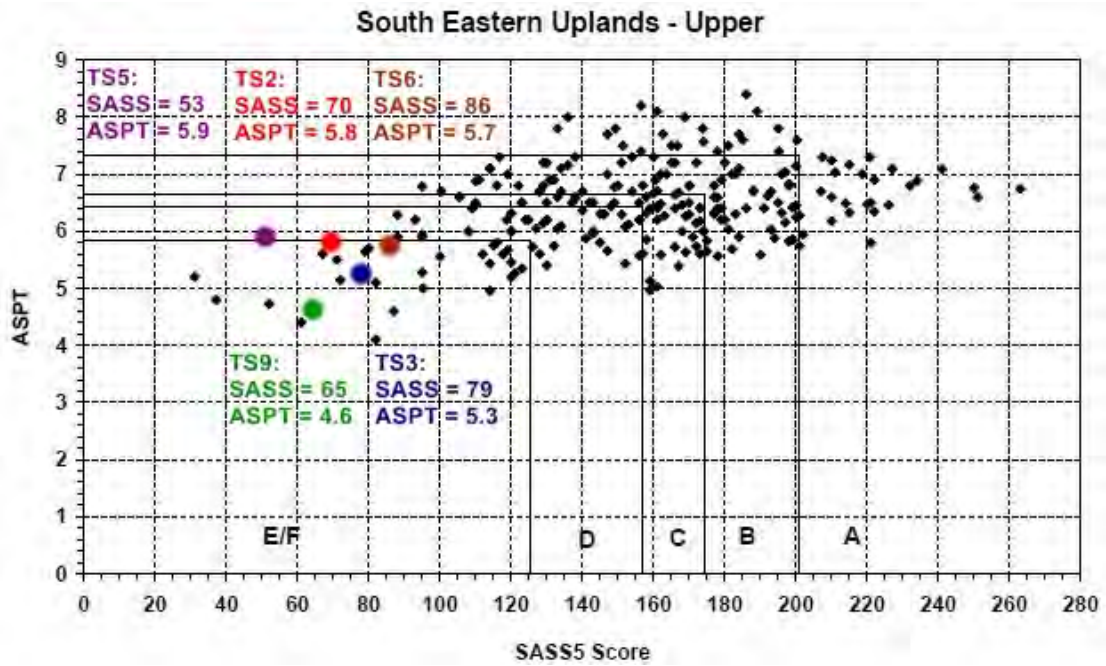
Figure 57: Visual depiction of SASS5 and ASPT scores for sites on the Tsitsa River tributaries based on the Dallas (2007) classification, as assessed during April 2014.

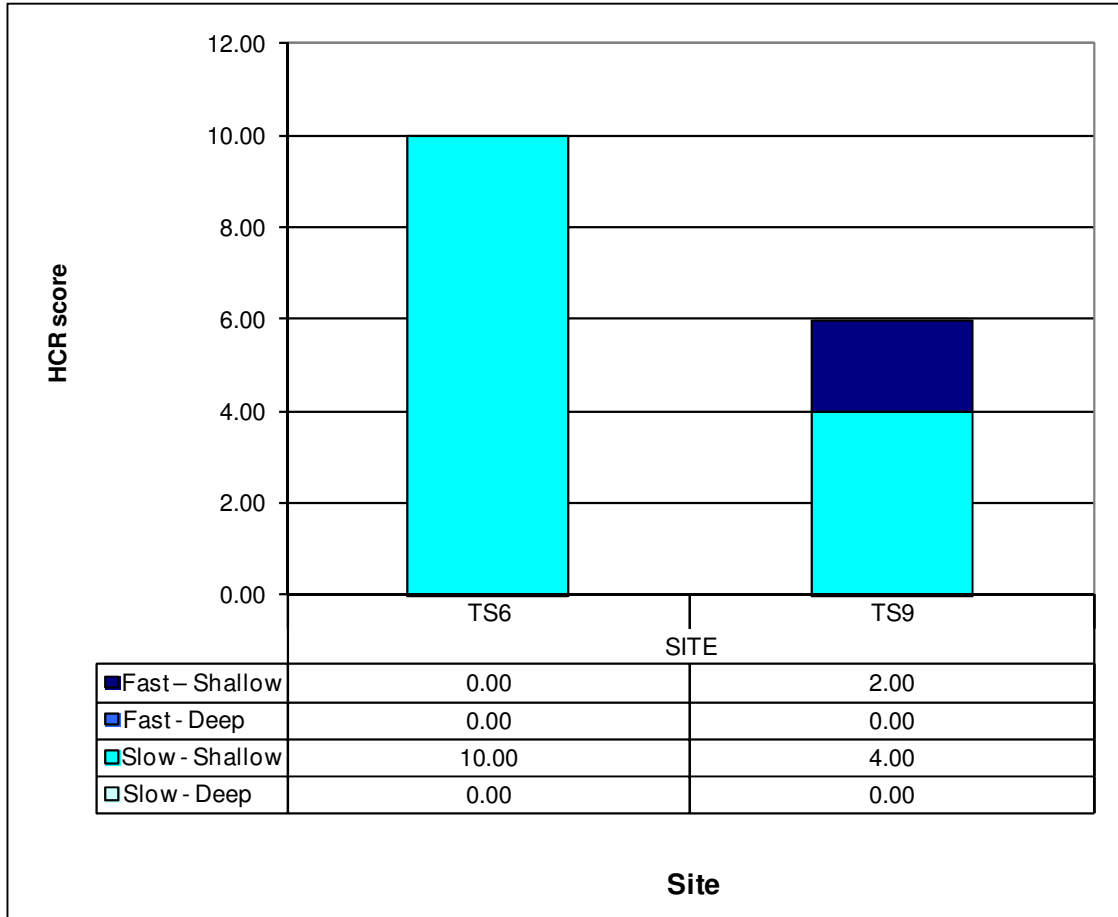
Figure 59: HCR scores for Tsitsa River tributary sites TS6 and TS9.

Assessment and sampling resulted in no fish being collected at any of the tributary sites. Because of the depauperate fish species diversity in the area, fish are not expected to occur in the small and shallow sites TS2, TS3 and TS5. However, as fish are expected to occur at sites TS6 and TS9 only HCR ratings for these two sites were provided in **Table 35**. Site TS6 presented with slow flow conditions only, whilst the latter was combined with some fast flow in riffle areas at site TS9.
