8. DESCRIPTION OF THE AFFECTED ENVIRONMENT

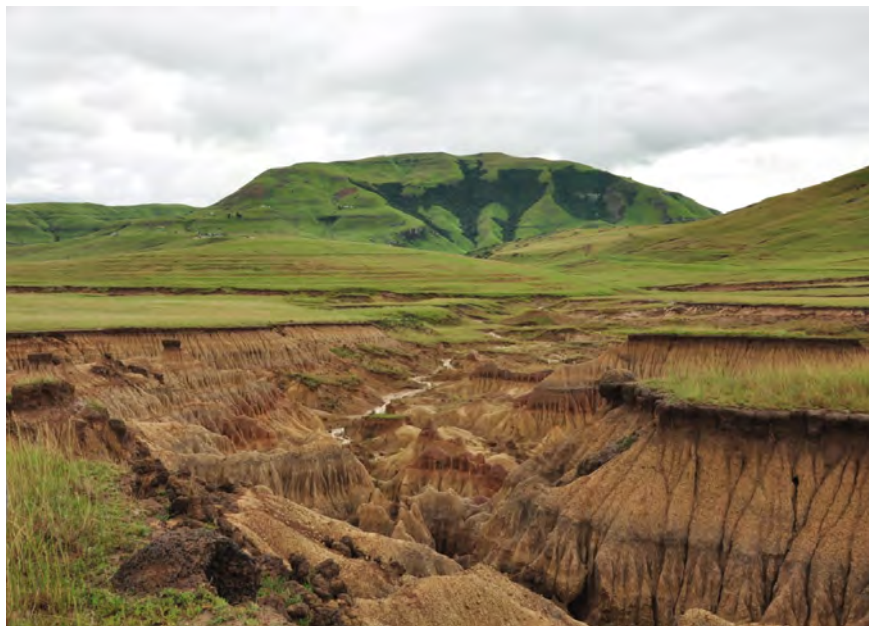
Figure 29: Donga in the Ntabelanga Dam area

There are extensive areas of severe gully erosion on the inter-fluvial areas adjacent to stream channels (**Figure 29**). The erosional and piping characteristics are suggestive of the presence of dispersive soils (DWA, 2013b).
