## 5.5 ROAD UPGRADES AND PIPELINES

### 5.5.1 Road upgrades at Ntabelanga and Lalini Dams

### 5.5.2 Primary and secondary pipelines

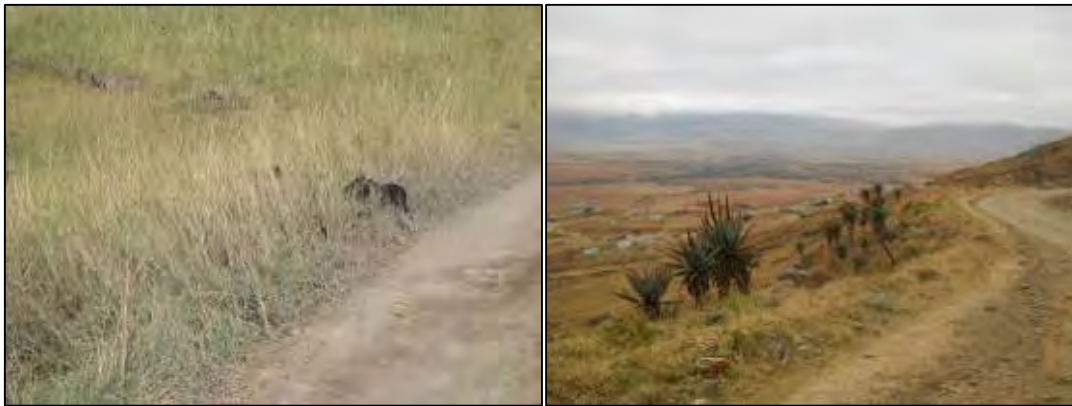
**Figure 27: Transformed grassland areas alongside the road upgrade area. Indigenous species such as *Aloe ferox* and *Aloe aborescence* located alongside the road to be upgraded entering the Ntabelanga site.**

Some new sections of road will be constructed either to provide access to the construction sites or to replace existing roads that will be inundated. In addition to this, some existing roads will be upgraded by resurfacing and improving river crossings. The road upgrades are mostly in the Ntabelanga Dam study area. In terms of vegetation diversity, the edge effects of the existing roads has transformed the vegetation to the extent that only grass species such as *Eragrostis curvula*, *E. chloromelas*, *Hyparrhenia hirta*, *Sporobolus africanus* and *Cynodon dactylon*, which are associated with more disturbed areas, occur alongside the current access roads. Other areas of the road upgrade are located within the higher altitude areas. Indigenous species such as *Aloe marlothii*, *Aloe ferox* and *Aloe aborescence* occurred alongside the current road. These and other indigenous species could be relocated should they occur within the road upgrade footprint area.

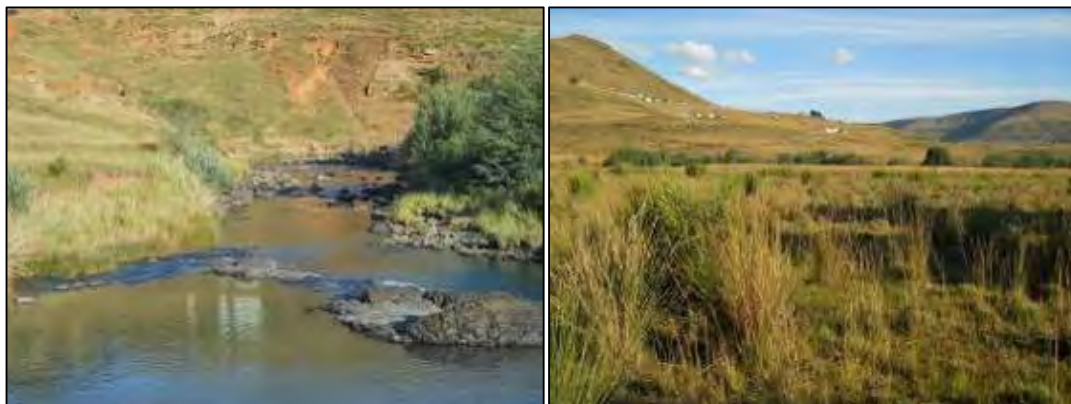
**Figure 28: Riparian and wetland crossing along the road to be upgraded in the Ntabelanga Dam study area.**

Numerous drainage lines, seeps, riparian systems and valley bottom wetland features traverse the road to be upgraded. The wetland features need to be considered when construction of the road upgrades commences to ensure that e.g. sedimentation of wetland features does not take place, wetlands that have undergone severe erosion close to the road, be reinforced to prevent further degradation and stream flow is established.

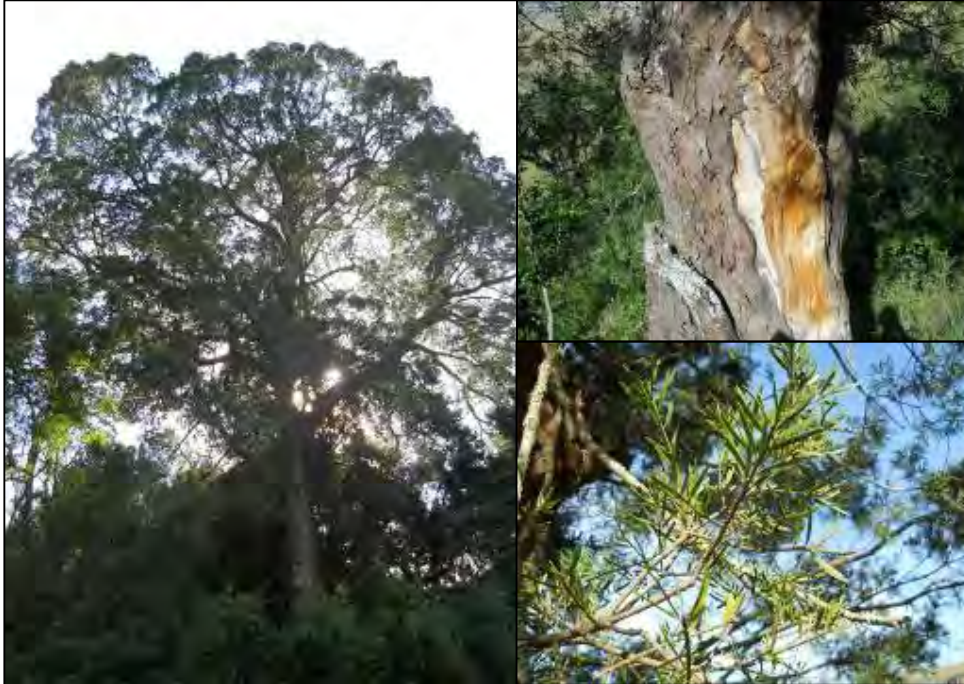
**Figure 29: *Podocarpus falcatus* located on the northern section of the dam, along the road upgrade section.**

*Podocarpus falcatus* and *P. latifolius* were identified in low abundance alongside the road upgrade (roads to be resurfaced) areas within the Ntabelanga Dam, on the northern section of the dam. More *Podocarpus* species were located on the secondary pipeline route south of the town Tsolo. These species are considered protected according to the notice of the list of protected tree species under the National Forests Act, 1998 (Act No. 84 of 1998). Possible mitigation measure would be to re-align the roads to avoid the trees from being removed or permits for the removal of these protected tree species (should it occur within the construction footprint area) need to be obtained at the relevant authorities before any construction activities occur within this area.

<i>Podocarpus falcatus</i> and <i>P. latifolius</i> along the road upgrade route within Ntabelanga Dam	Coordinates
GPS1	31° 4'43.25"S 28°33'30.09"E
GPS2	31° 4'42.57"S 28°33'30.27"E
GPS3	31° 4'43.96"S 28°33'20.62"E
GPS4	31° 4'45.51"S 28°33'4.57"E
<i>Podocarpus falcatus</i> and <i>P. latifolius</i> along the secondary pipeline route south of the town of Tsolo.	
GPS5	31°24'18.62"S 28°46'28.97"E
GPS6	31°24'21.15"S 28°45'1.87"E

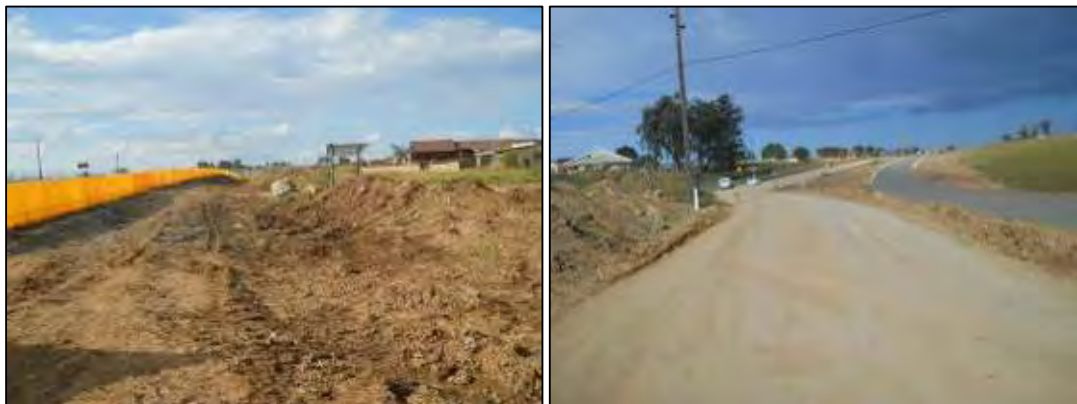
**Figure 30: Current construction activities to upgrade roads outside the Qumbu area.**

Primary and secondary pipelines conveying water to selected areas are located within the Tsolo and Qumbu local areas. Most of the areas where the construction of these pipelines is proposed are located adjacent to main roads. This, due to the edge effects from the road, vegetation has been transformed. Very little indigenous vegetation occurred along the route. Species mostly associated with disturbance such as *Eragrostis curvula*, *Hyparrhenia hirta* and *Cynodon dactylon* were present. In some areas outside Qumbu current construction activities to upgrade the roads have already taken place.

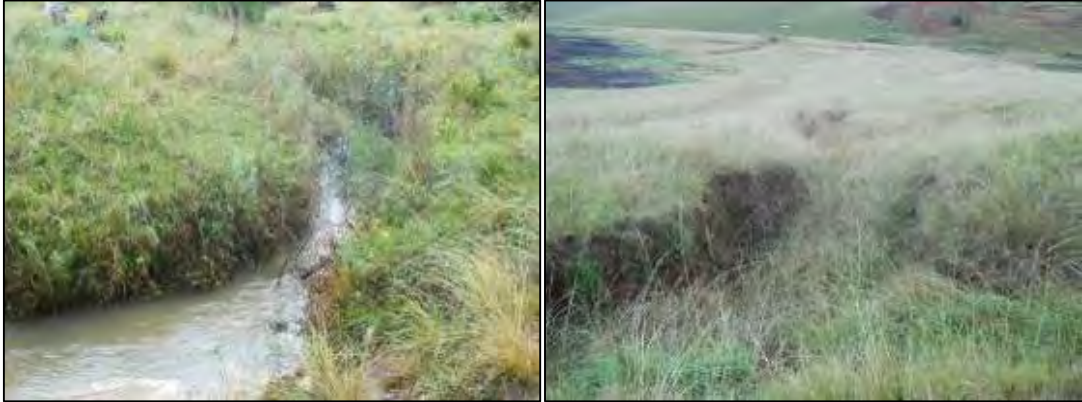
**Figure 31: Riparian crossings and drainage lines crossing the proposed pipeline infrastructure.**

Areas where the proposed primary and secondary pipeline will be located is crossing several riparian and wetland features, containing mostly alien invader floral species such

as *Acacia mearnsii*, *A. dealbata*, *Eucalyptus grandis*, *E. camaldulensis*, *Melia azedarach* and *Solanum mauritianum*. Several wetland and riparian system traverse the primary and secondary pipeline routes supporting a different graminoid assemblage of increased diversity.

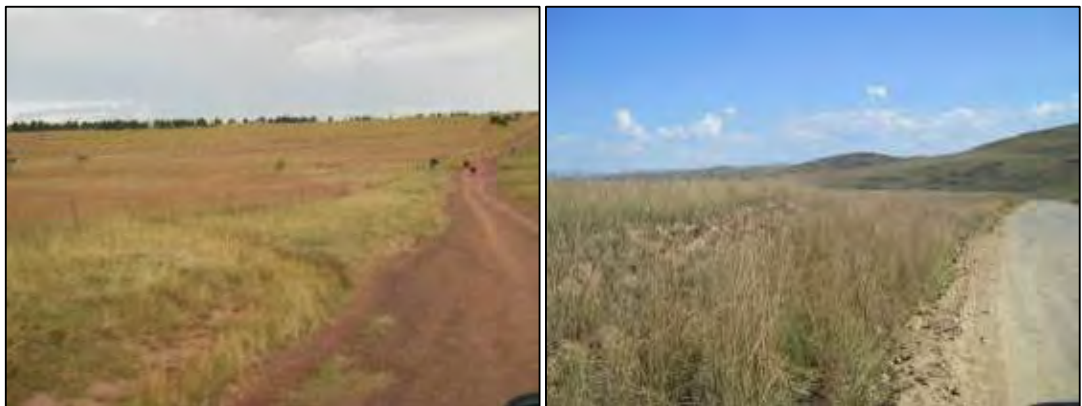
**Figure 32: Transformed grassland vegetation along the proposed pipeline.**

Figure 32 indicates the locations of the wetland features traversing the pipeline. The remainder of the pipeline contains transformed grasslands, which were not indicated on the maps due to the scale of the pipeline locations.

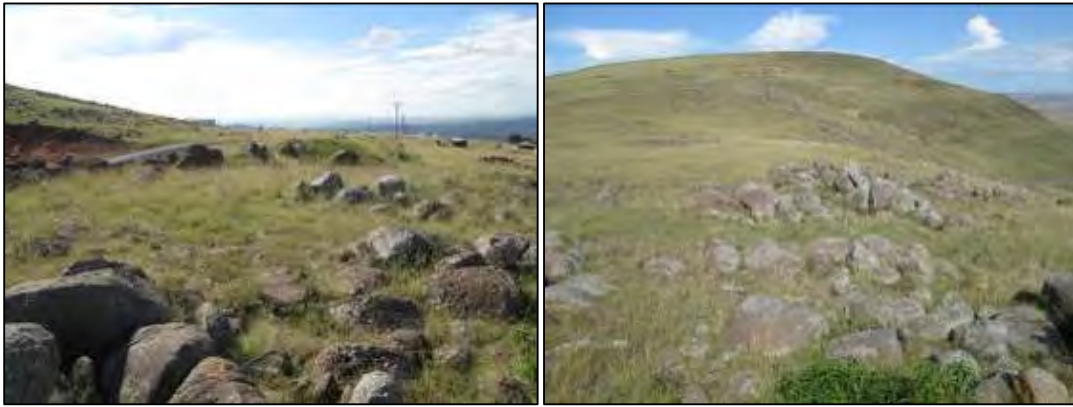
**Figure 33: Rocky outcrops located adjacent to the secondary pipeline routes.**

Pockets of rocky outcrops or where the pipeline traverses mountain areas were located. These areas were mapped on a desktop level to indicate where vegetation has changed. Although not all areas of the rocky outcrops contained indigenous floral vegetation, these

areas are still considered different to the remainder of the habitat units. Mitigation measures when construction of the pipeline takes places should considered these rocky areas and mountain passes and minimise the impacts within these areas.
