5 DESCRIPTION OF THE AFFECTED ENVIRONMENT

5.1 ECOLOGICAL DESKTOP DESCRIPTION

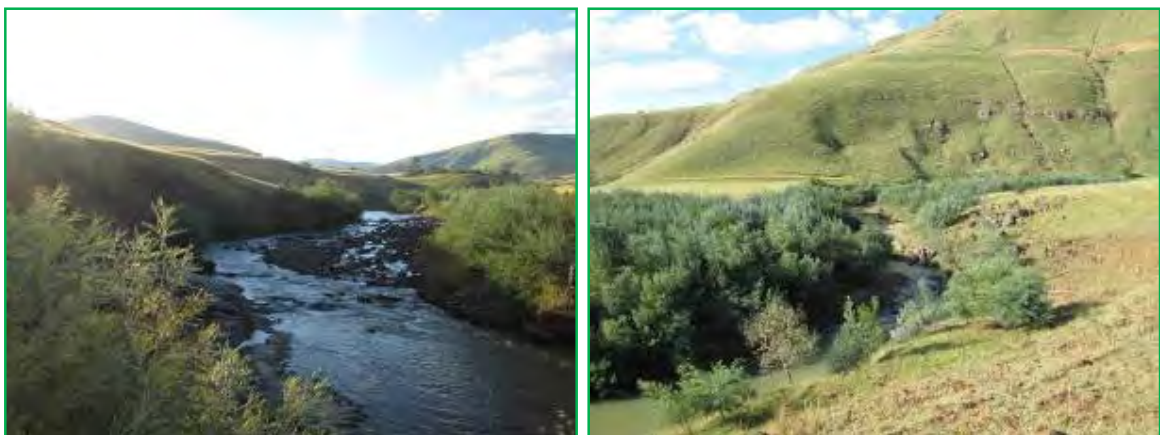
Figure 9: Representative photographs of portions of the Tsitsa River, showing the proliferation of *Acacia mearnsii* within the riparian zone.

The floral species composition of the riparian zone has undergone varying degrees of modification, principally as a result of anthropogenic activities such as grazing of cattle, harvesting of thatching grass and firewood, and sand winning. Incision and erosion of the river banks in some areas has resulted in a loss of vegetation cover; in some areas the loss is considered severe. Disturbances to the natural vegetation composition has resulted in the proliferation of alien species such as *Acacia mearnsii* and *Eucalyptus cameldulensis* in many sites although some indigenous woody species such as *Salix mucronata* remain in the less disturbed areas. The non-woody component consisted of largely indigenous species such as *Arundinella nepalensis*, *Miscanthus junceus* and *Cyperus spp.* **Figures 9 to 11** show representative photographs of the riparian vegetation along the Tsitsa River.

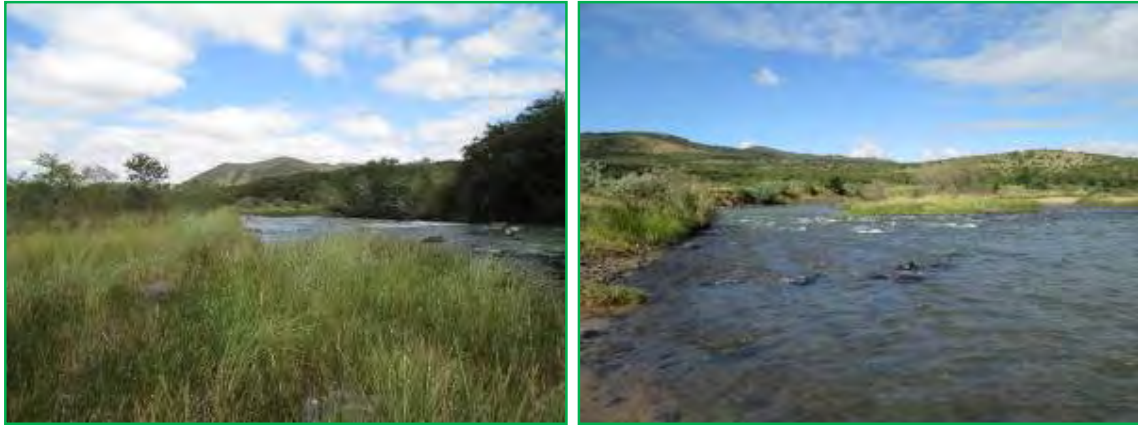
Figure 10: Representative photographs of portions of the Tsitsa River, showing largely natural vegetation cover.

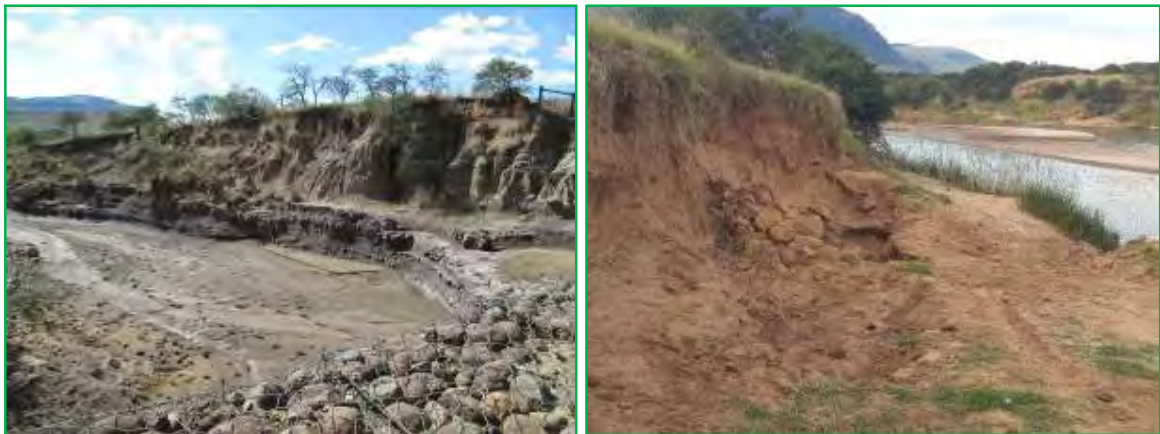
Figure 11: Representative photographs showing severe incision and erosion of river banks (left) and sediment winning (right).

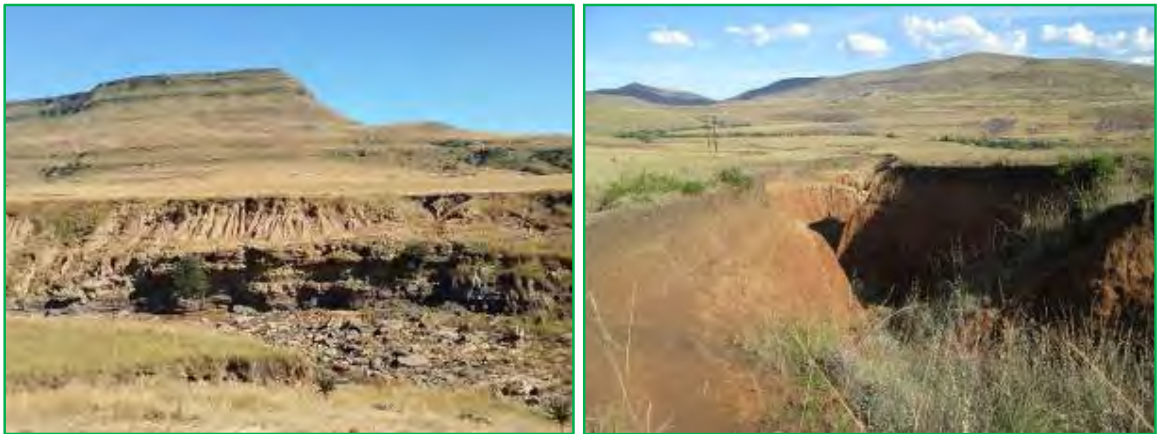
Figure 12: Representative photographs showing examples of the typical erosion patterns within the catchment.

Geomorphology is considered to have undergone greater levels of transformation than hydrology, water quality and vegetation. This is attributed to the severity of river bank incision observed in sections of the river courses both during the site assessments and on digital satellite imagery, and the increased sediment inputs as a result of this erosion. Furthermore, it is deemed highly likely that due to the extensive erosion within the catchment, particularly within the drainage lines feeding into the rivers, that the sediment regime is significantly altered (**Figure 12**).

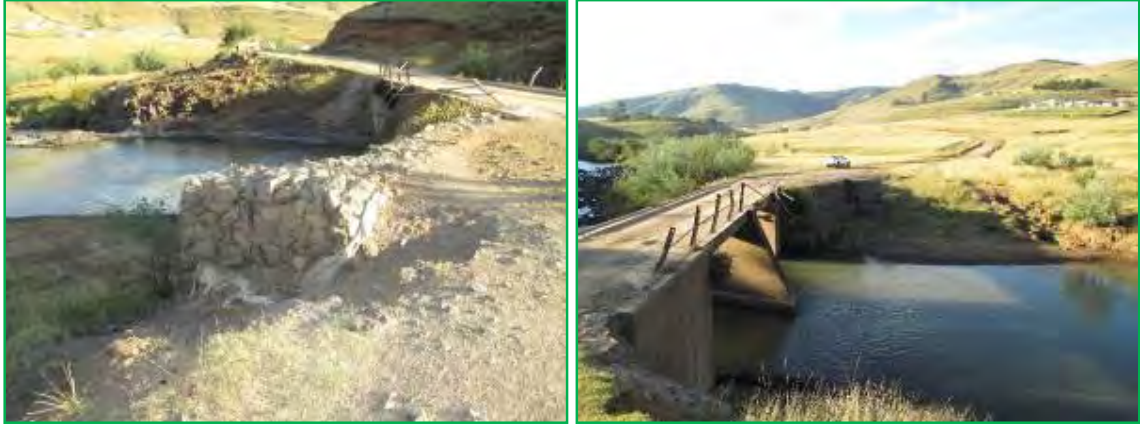
Figure 13: Representative photographs of the Tsitsa River showing flow modifying infrastructure such as gabions (left) and bridges (right).

The hydrology of the systems are deemed to be in a relatively natural state, having obtained scores in all assessments which placed it in a PES Category B/C. Primary impacts on the rivers include altered channel size and competency as a result of erosion of the banks, and stands of alien invasive species such as *Acacia mearnsii* and *Eucalyptus cameldulensis* resulting in localised reduction of water inputs to the river due to on site water usage by these species. Small scale abstraction for domestic use in neighbouring rural homesteads and for subsistence farming is also responsible for a slight reduction of water although the levels of abstraction are not considered significant within the context of the catchment. Additional modifications to the hydrology include flow-modifying infrastructure within the river, such as weirs, support structures for bridges and gabions (**Figure 13**).

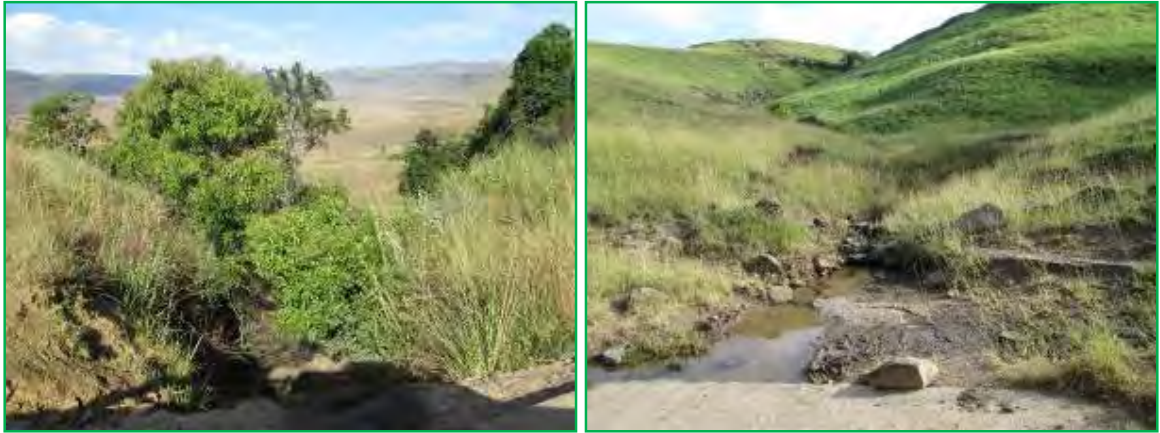
Figure 17: Representative photographs of drainage line features within the study area.

Numerous drainage line features were identified throughout the study area, and were considered to be wetland features due to the prolonged presence of water throughout the year, which has resulted in the formation of wetland characteristics as defined by the NWA (1998). This includes the presence of obligate and facultative vegetation, the presence of gleyed soils, and the degree of soil saturation noted within the soil samples. Representative photographs of the drainage lines are presented in **Figure 17** below.

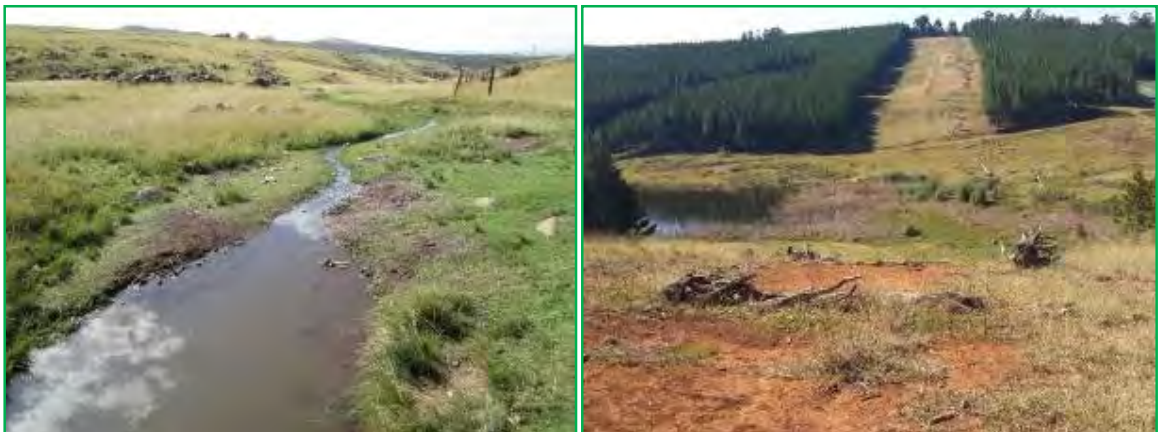
Figure 18: Representative photographs of channelled valley bottom wetland features within a communal area (left) and in the commercial forestry south of Tsolo (right).

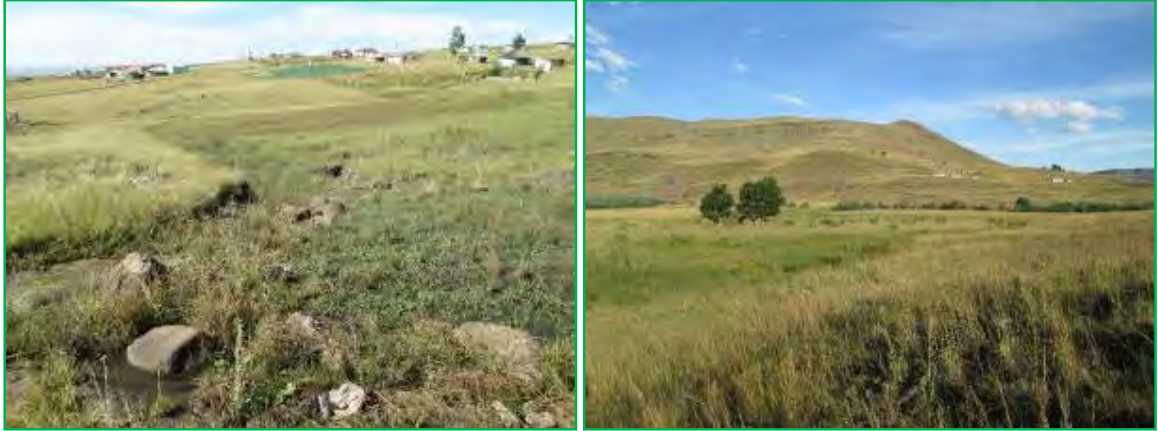
Figure 19: Representative photographs of hillslope seep wetland features within the study area.

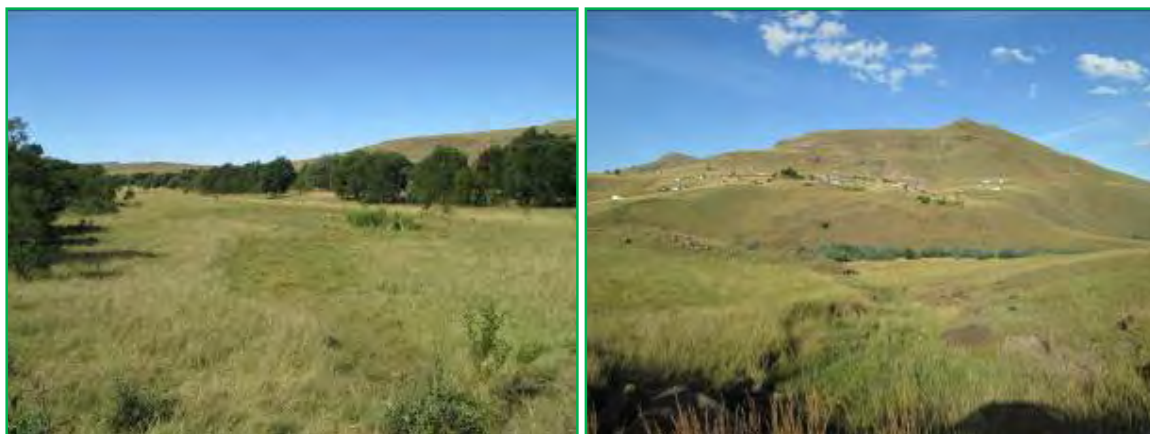
Figure 24: Representative photographs of slope (left) and valley bottom (right) terrain units found within the study area.

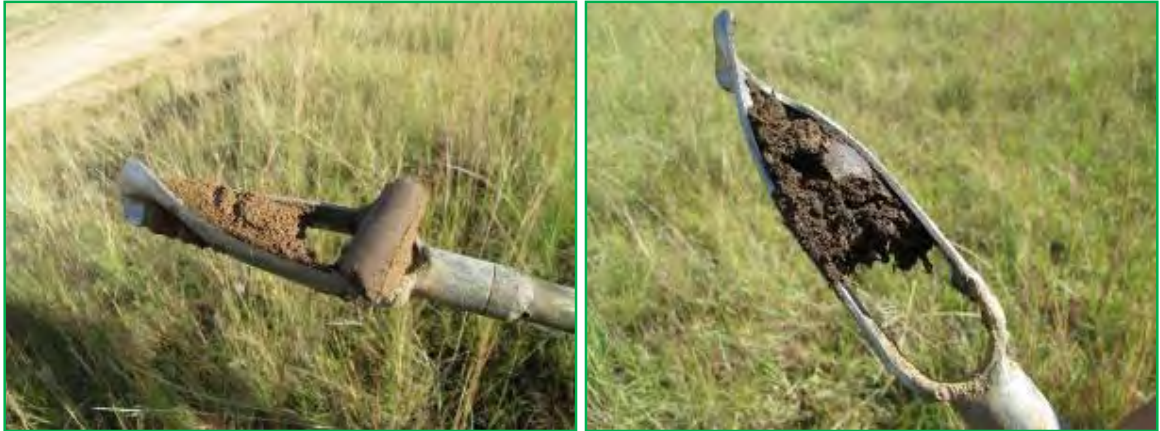
Figure 25: Representative photographs of soil samples taken within two different seep wetland features.

- The soil form indicator (**Figure 25**) was used to determine the presence of soils that are associated with prolonged and frequent saturation, as well as variation in the depth of the saturated soil zone within 50cm of the soil surface. This indicator was used to identify gleyed soils where the soil is a greyish/greenish/bluish colour due to the leaching out of iron. Whilst mottling was not extensive, it was present in the temporary zone. These factors were utilised to aid in determining the location of the wetland zones and their boundaries.

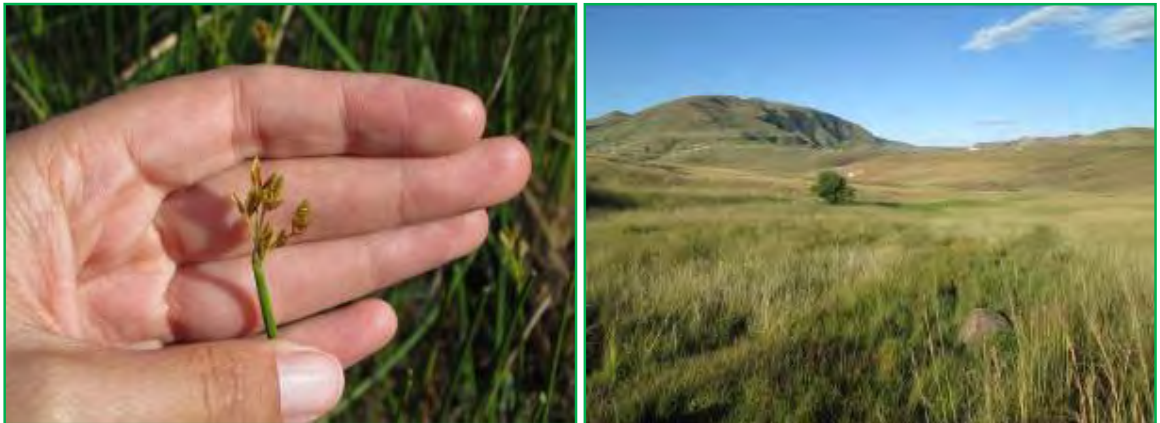
Figure 26: The presence and distribution of hydrophytic wetland vegetation such as *Schoenoplectus brachycerus* (left) aids in determining the boundaries of the wetland (right).

- The vegetation indicator (**Figure 26**) was used where possible in the identification of the wetland boundary through the identification of the distribution of both facultative and obligate wetland vegetation associated with soils that are frequently saturated. Key species utilised, particularly in the seep wetlands, included *Schoenoplectus brachycerus*, *Eragrostis chloromelas*, *Sporobolus africanus* and *Arundinella nepalensis*. Changes in vegetation density and levels of greening were also considered during the delineation process, particularly in instances such as in the seep wetlands where terrestrial species are more abundant.
