## 6. DESCRIPTION OF THE ENVIRONMENT

## 6.3 GEOLOGY AND SOILS

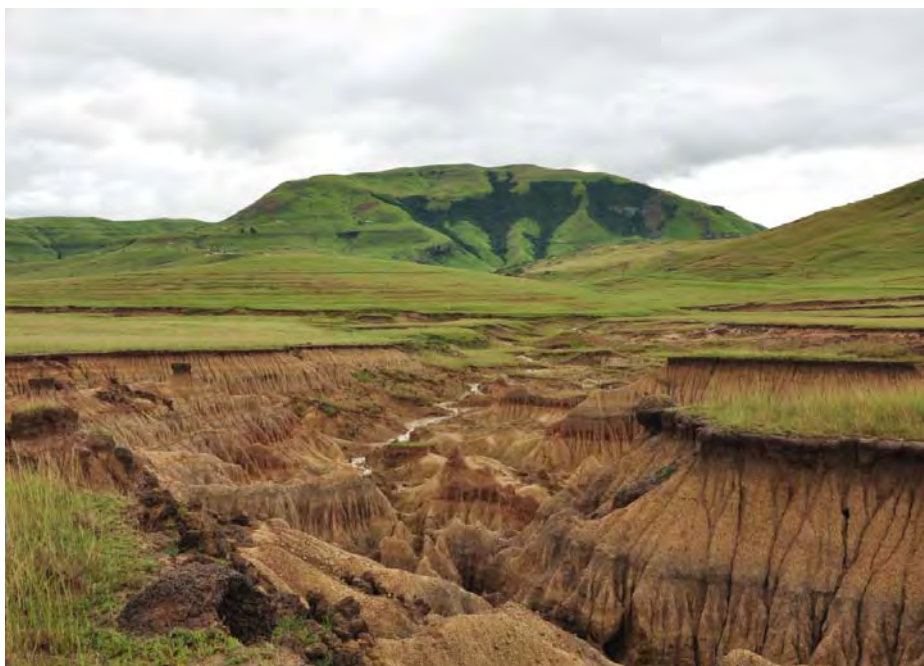
**Figure 34: Donga in the Ntabelanga Dam area**

There are extensive areas of severe gulley erosion on the inter-fluvial areas adjacent to stream channels (**Figure 34**). The erosion and piping characteristics are suggestive of the presence of dispersive soils (DWA, 2013b).
