7. DESCRIPTION OF THE AFFECTED ENVIRONMENT

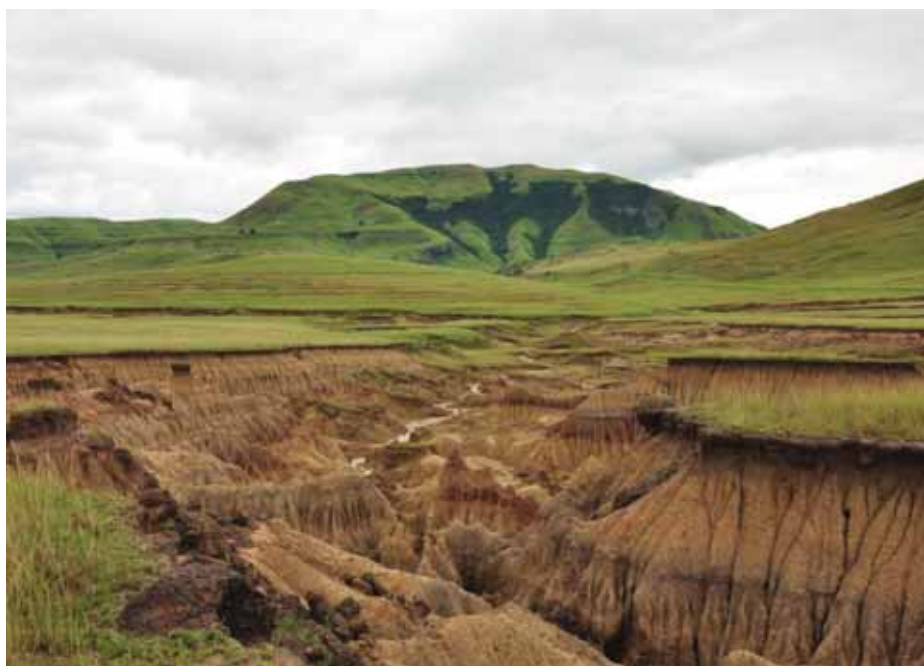
Figure 25: Donga in the Ntabelanga Dam area

There are extensive areas of severe gulley erosion on the inter-fluvial areas adjacent to stream channels (**Figure 25**). The erosional and piping characteristics are suggestive of the presence of dispersive soils (DWA, 2013b).

In the Mzimvubu and Tsitsa River catchments, soil erosion is an outcome of high rainfall intensities, steep slopes, erodible soils and land use practices that are conducive to erosion. The latter include overgrazing and cultivation on unsuitable thin soils with sloping terrain, which causes grass to not recover, a loss of root structure and sheet erosion.
