UMKHOMAZI WATER PROJECT
MODULE 3 – POTABLE WATER MODULE

Detailed Feasibility Study
Geotechnical Investigation Report - Volume 1
(Raw Water Pipeline)

**Detailed Feasibility Study - Geotechnical Investigation
Report – Volume 1 (Raw Water Pipeline)**

Report No. 108/114/12/R8-1

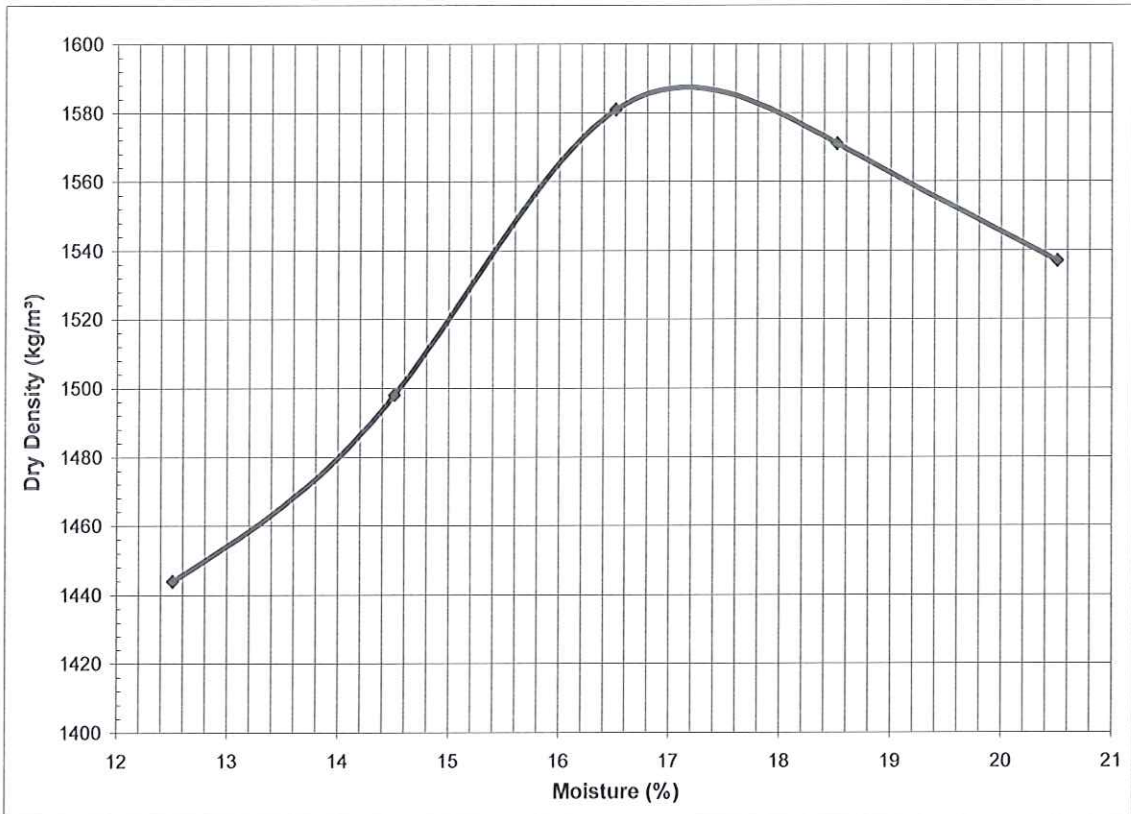
Sample No. : 28069	Field No. : RW 02/1
Natural/Stabilised : Natural	Depth (m) :
Material Description : Colluvium	Origin :
	Compaction Effort : Mod AASHTO
Maximum Dry Density (kg/m³) 1587	Optimum Moisture Content (%) 17.1

Moisture (%)	12.5	14.5	16.5	18.5	20.5
Dry Density (kg/m³)	1444	1498	1581	1571	1537

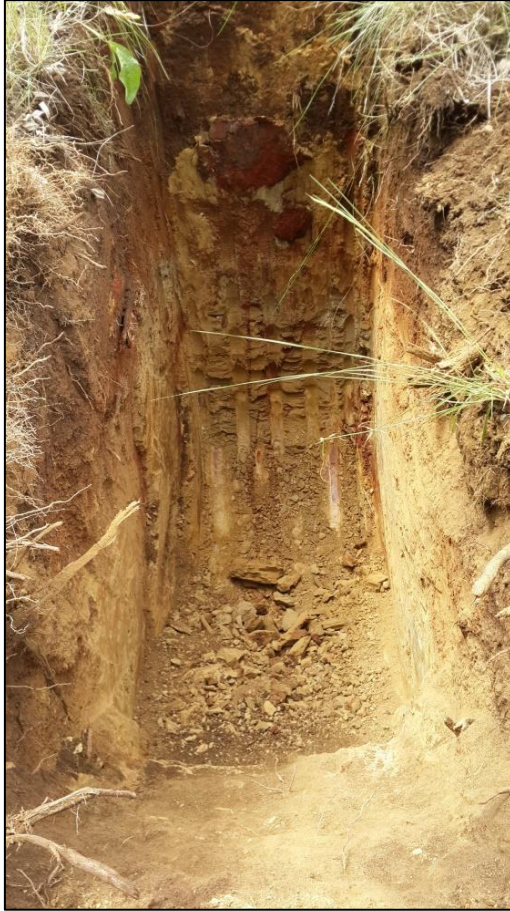
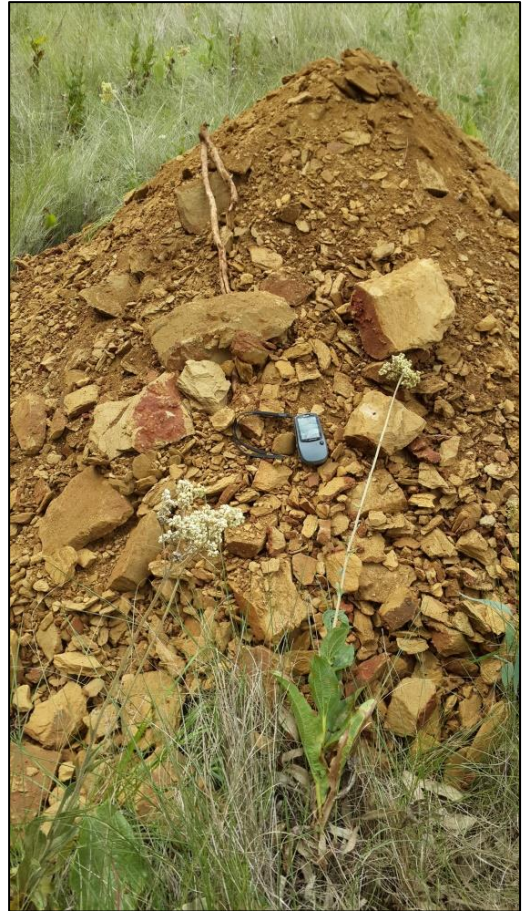
Plate 1: Typical soil profile encountered throughout the site (RW09) with clayey sand colluvium overlying clayey silt residual shale. (13 March 2014).

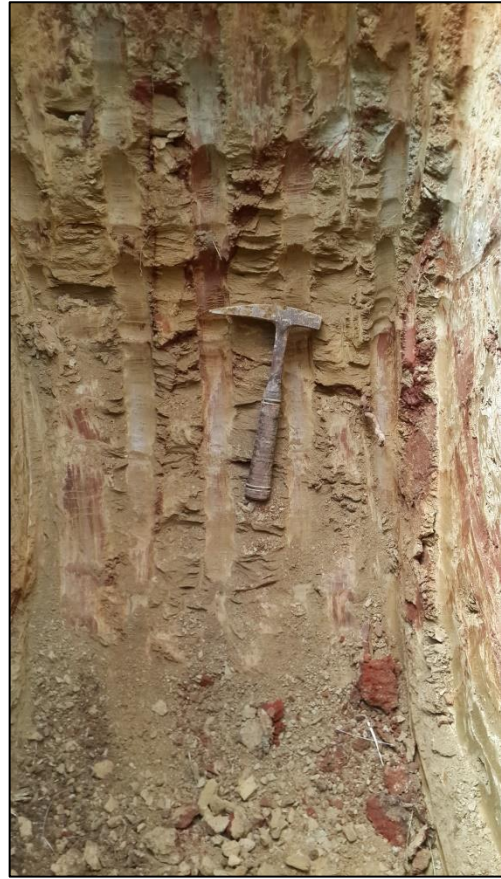
Plate 2: Shallow refusal of TLB on completely weathered very soft rock shale. (13 March 2014).

Hard rock excavation conditions may be experienced in Zone A where tillite, shale and dolerite bedrock were encountered from depths of between 0,3m and 2,1m below surface. It could be possible for a large (30 ton) excavator with a rock bucket to excavate into closely jointed very soft rock tillite, shale and dolerite, but this will be considered to as “hard rock excavation”. Rock breaking equipment will be required to break localised zones of harder rock. Rock breaking equipment or blasting will be required for excavations in medium hard to hard rock.

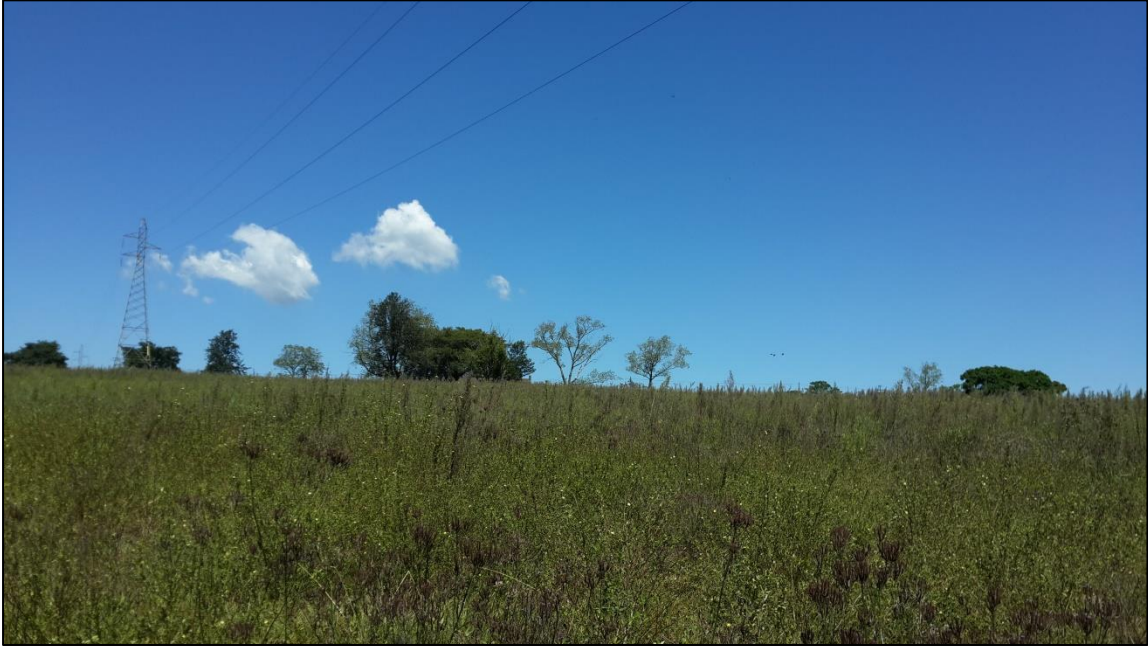
Plate 3: Over head powerlines intersect the site in a east to west direction.
(13 March 2014, western view)

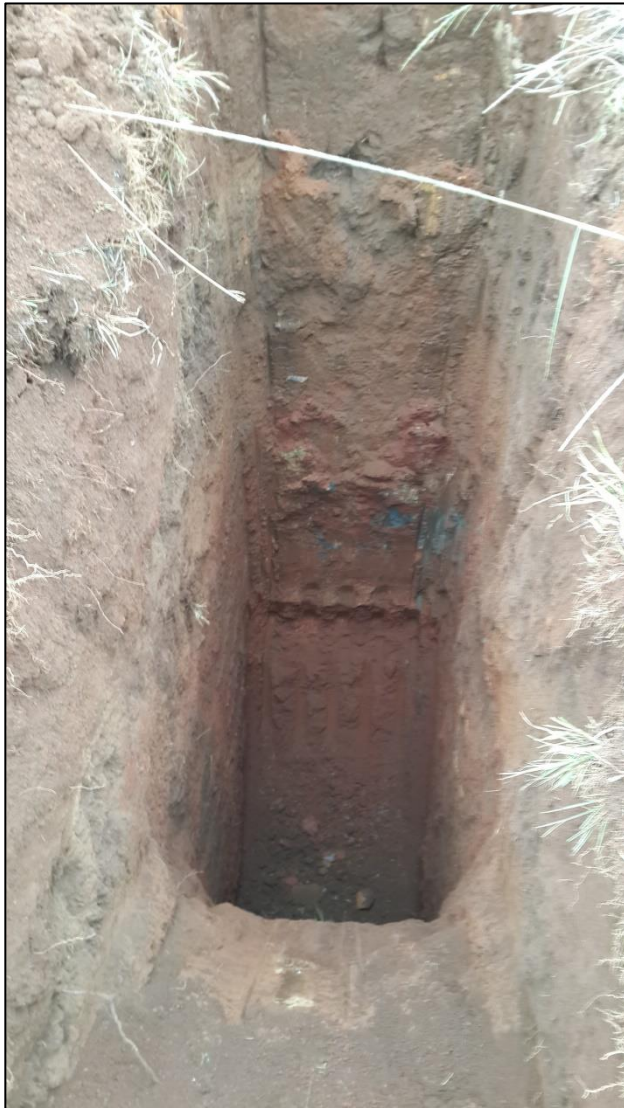
Plate 4:

Deep soil profiles were encountered in Zone B, with clayey transported material overlying residual shale.
(13 March 2014)

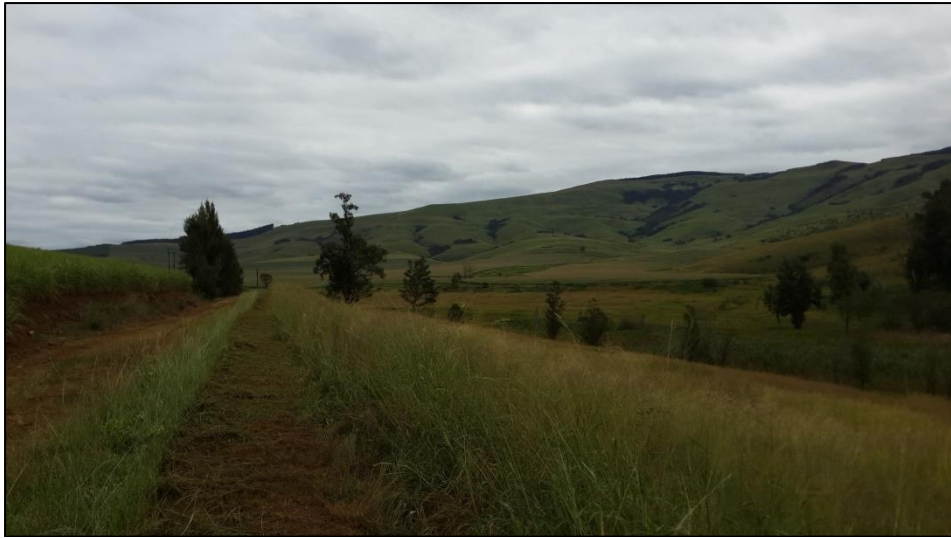
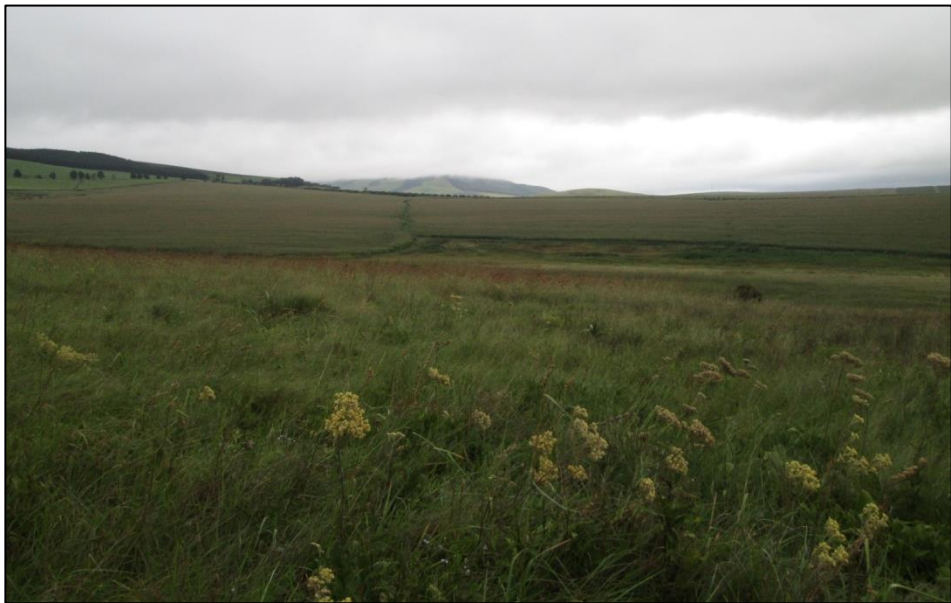
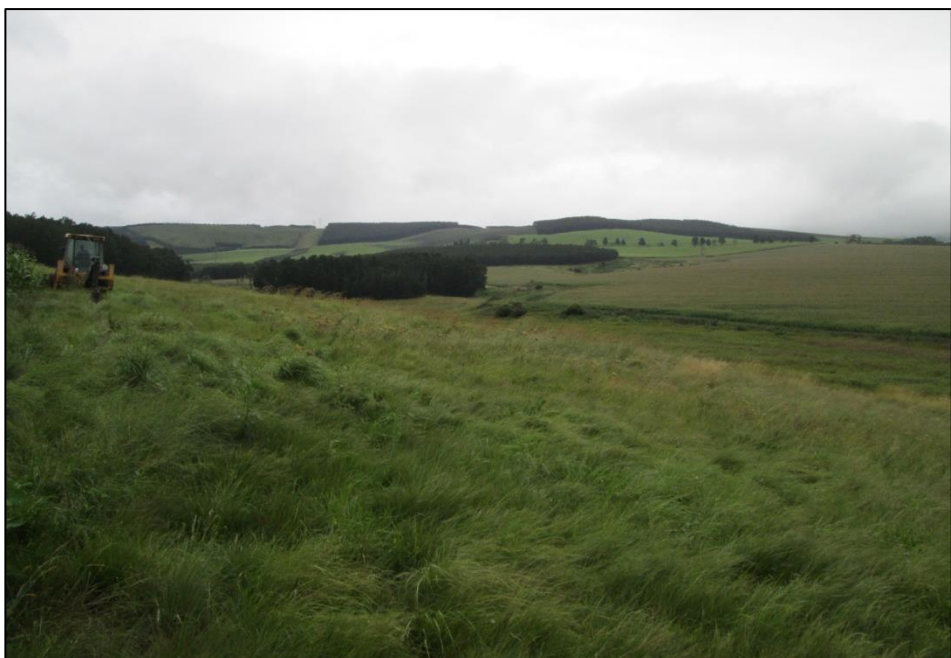
Plate 5: Grass cover many areas of the Raw Water Pipeline site. A black wattle

forest also occurs near Baynesfield Estate dam site.

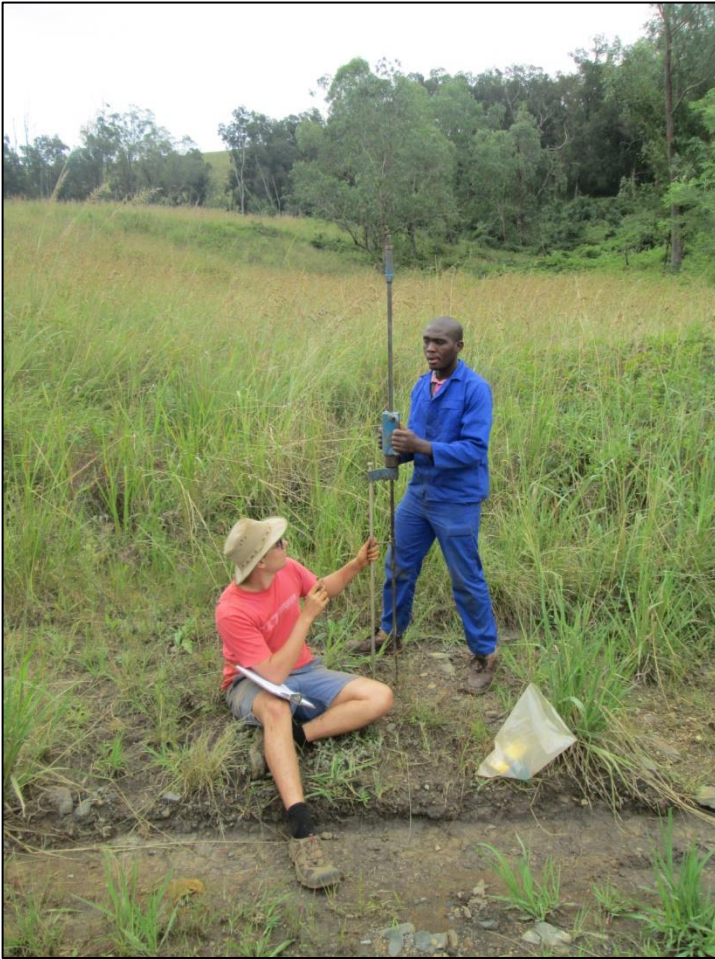
Plate 6:

Dynamic Probe Light (DPL) penetration tests were conducted on a proposed raw water pipeline to determine the consistency of the in situ material. (13 March 2014, northwestern view)
