The uMkhomazi Water Project Phase 1: Module 1: Technical Feasibility Study: Raw Water

ENGINEERING FEASIBILITY DESIGN REPORT

**WRITE UP 3:
SITE INVESTIGATION FOR THE
POSITIONING OF GAUGING WEIRS**

OCTOBER 2014

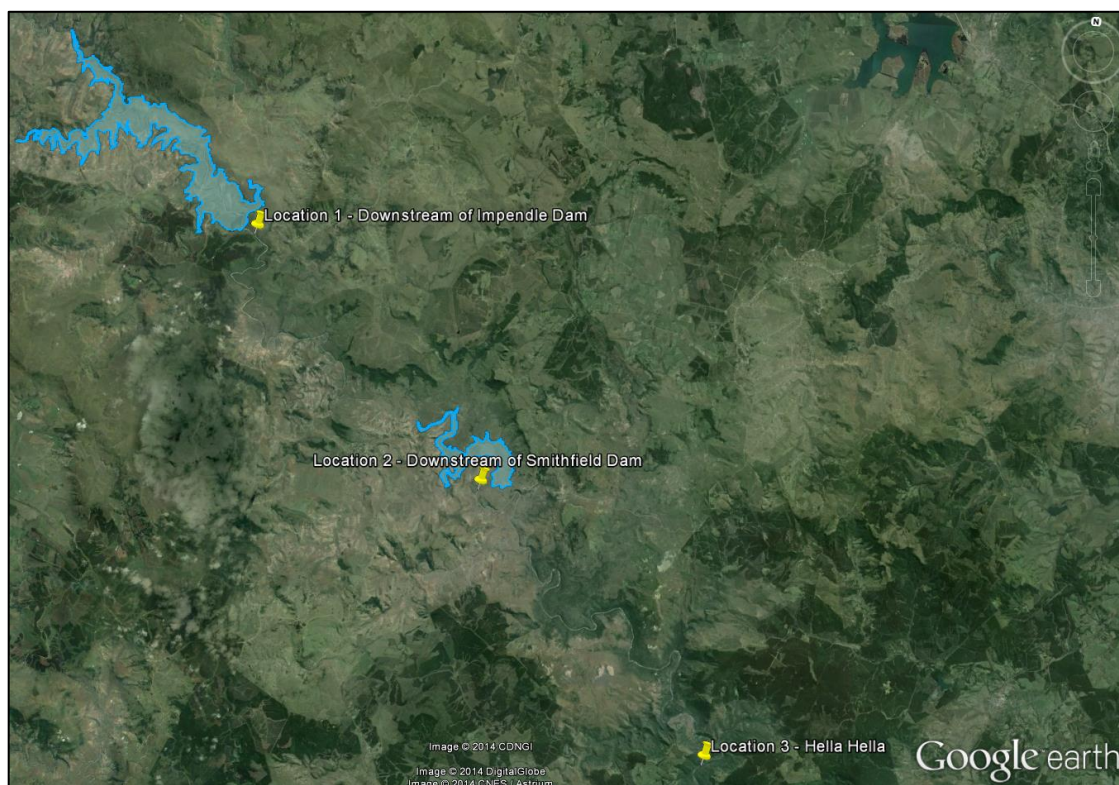
Three gauging weir positions were identified from the site investigation. These were, as indicated in **Figure 1.2**, (1) downstream of Impendle Dam, (2) downstream of Smithfield Dam and (3) near Hella Hella.

Figure 1.2 Proposed locations of gauging weirs

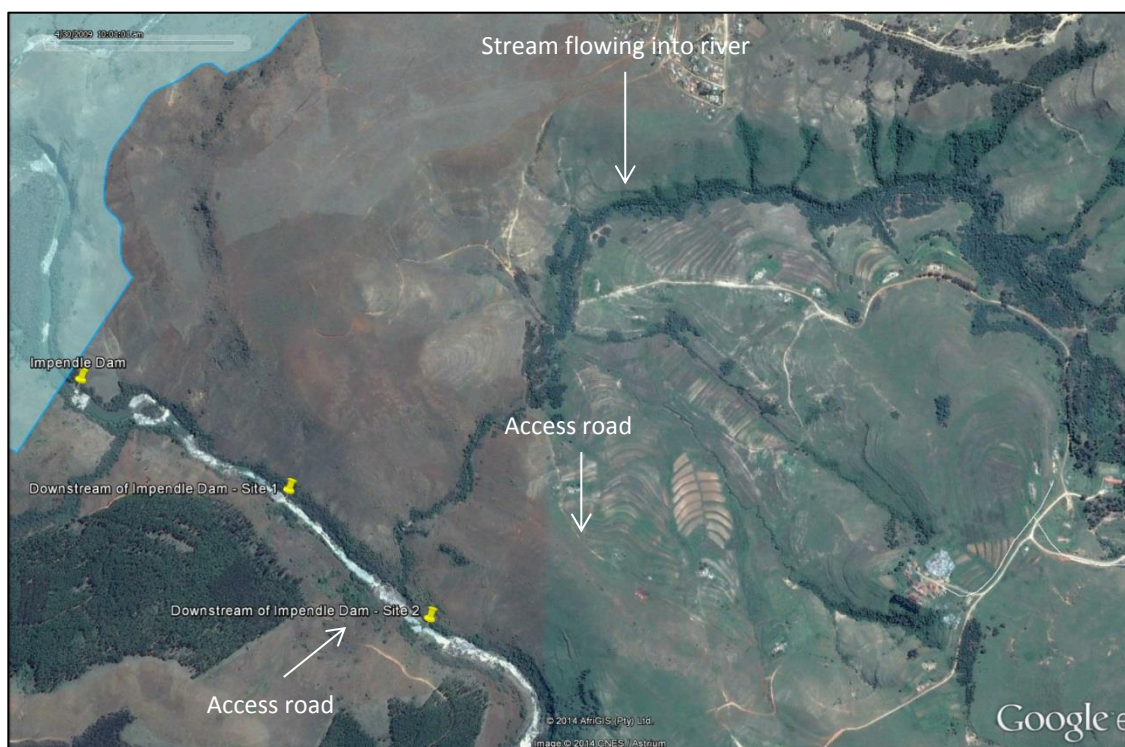
Three potential sites within the first 1.5 km immediately downstream of the proposed Impendle Dam were investigated. However, one of these was discarded as there was a stream flowing directly onto the site (indicated in **Figure 2.1**) which would have made construction at this site very difficult as well as impacting on the natural environment surrounding the stream. Thus, the other two sites with coordinates 29°39'8.92"S; 29°46'29.65"E and 29°39'23.79"S; 29°46'48.66"E, respectively, are discussed in detail and the preferred site identified in this section. **Figure 2.1**, included below, shows the location of the two sites to be discussed in the following text as well as showing the full supply level (FSL) of Impendle Dam, in blue.

Figure 2.1 Potential sites downstream of Impendle Dam showing stream flowing into river from the left bank

Access to the left bank would be more difficult as the existing roads, which service a small number of dwellings (**Figure 2.1**), are approximately 650 m from the river at coordinates 29°39'07.64"S 29°47'06.04"E and the conditions of these roads are unknown. Either extensions to the existing road would be required or a temporary bridge should be constructed from the right hand side so as to provide access across the uMkhomazi River. Construction would need to be completed during the low-rainfall winter months.

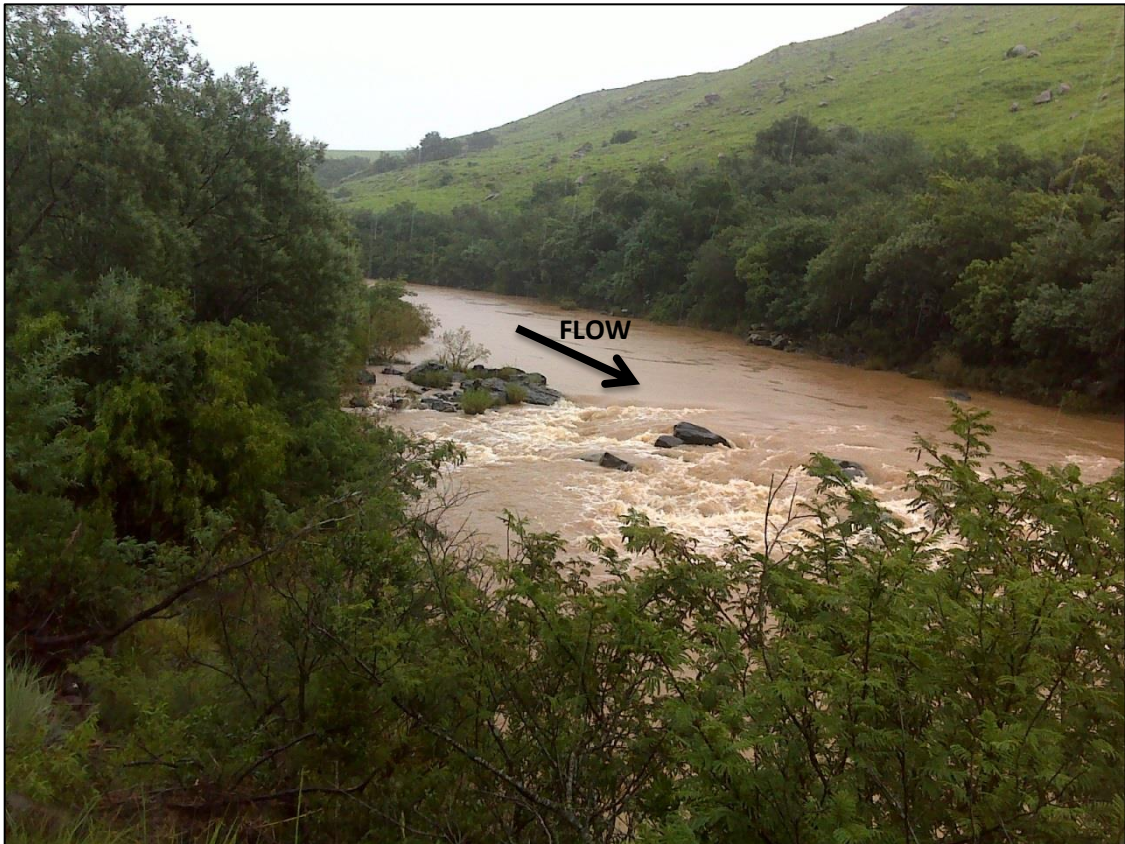
There is, however, a bend in the river, as seen at the top of **Figure 2.2**, prior to the 140 m straight section and this could possibly impact on the streamlines and

velocity distribution across the channel. The guideline given by *Van Heerden, et al. (1986)* states that the approach channel should be 4 to 5 times the channel width at design capacity, thus, the 140 m straight pool should be sufficient.

Figure 2.2 Downstream of Impendle – Site 1 control section taken from the right bank

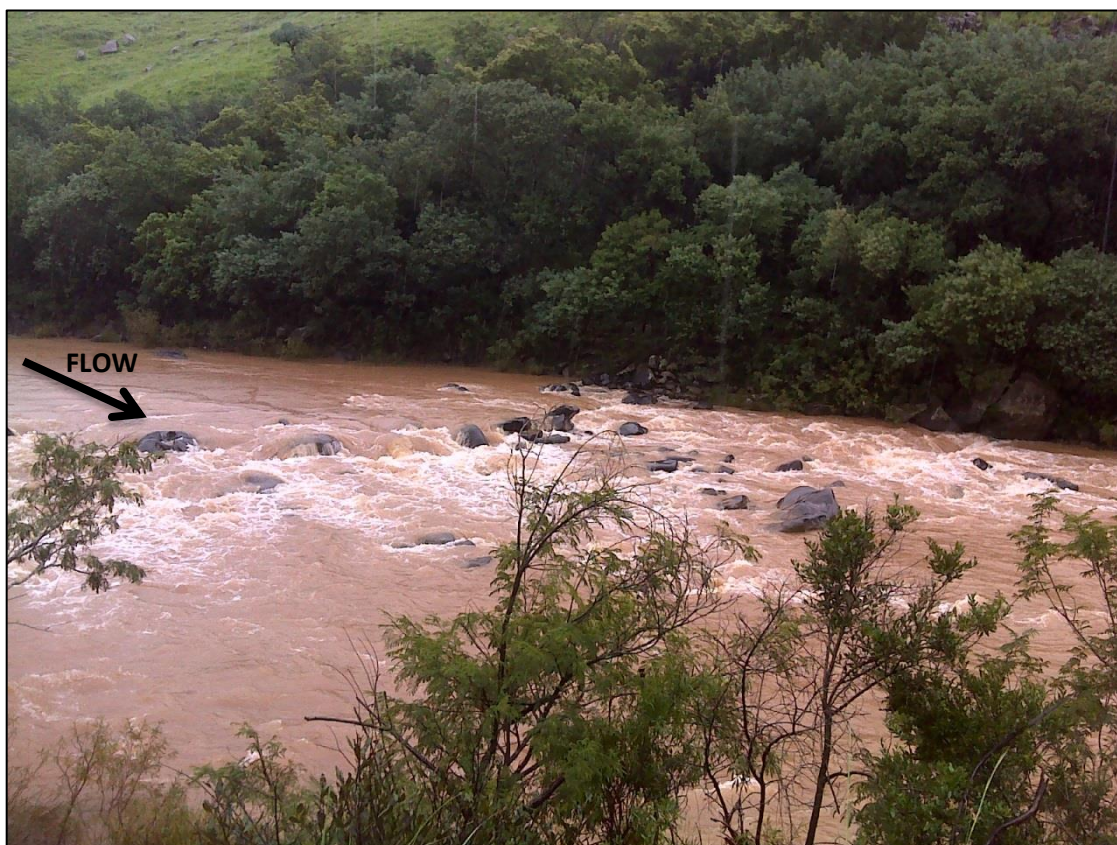
Figure 2.3 indicates a substantial amount of exposed rock at the start of the rapids and on the side banks of the river. Thus, it is assumed that there would be good foundation material available at this point in the river.

Figure 2.3 Downstream of Impendle – Site 1 showing exposed rock, rapids and an increase in the slope of the river bed from the right bank

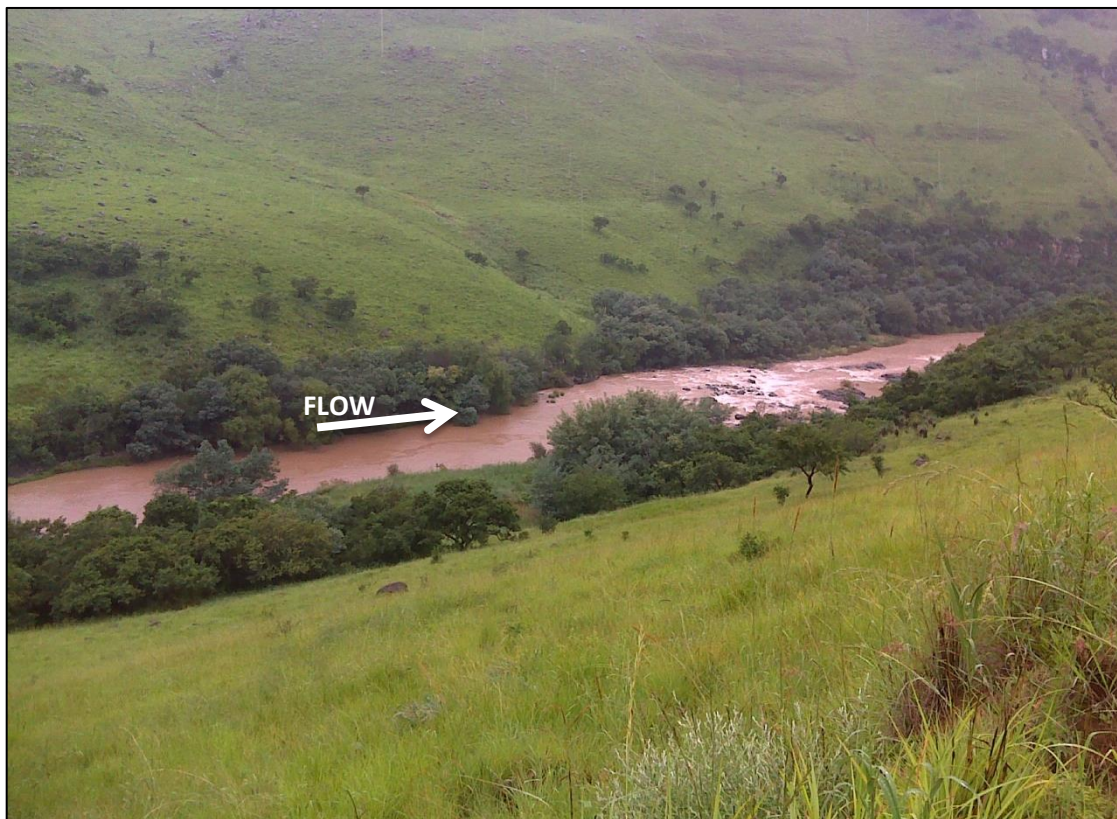
Figure 2.4 shows the site as viewed from the right river bank, the site was found to be approximately 30 m wide. There is a straight section of river from a control section, which would be inundated, approximately 130 m long leading up to the proposed site. The river is also straight for approximately 350 m prior to that control point. After the proposed position of the weir the river does increase in slope which would assist with avoiding submergence of the weir.

Figure 2.4 Downstream of Impendle Dam – Site 2 located at the control point on the right, as viewed from the right bank

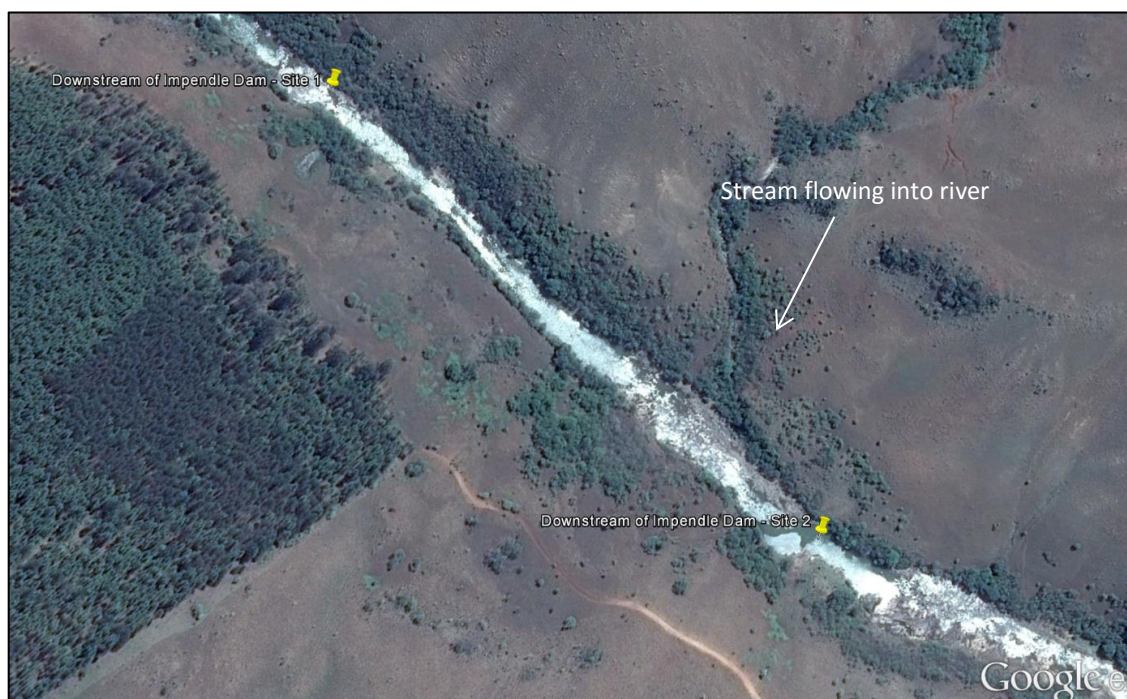
A negative aspect about the site is that there is a stream joining the main river channel upstream of where the weir would be constructed as can be seen in **Figure 2.6** and **Figure 2.1**. In **Figure 2.1** the catchment area, of approximately 6.3 km², of this stream is visible. The problem with the stream is that it would impact on the ability of the weir to accurately determine the discharge leaving the future Impendle Dam as there would be additional flows entering the river system downstream of the dam. **Figure 2.4** indicates that there may be another, albeit small, stream entering the river at this site, but this should be downstream of where the weir would be constructed.

Figure 2.6 Downstream of Impendle Dam- Sites 1 and 2

The biggest difference between the sites is the presence of the stream which would distort the reading at site 2. Thus, site 1 is the preferred site for this location.

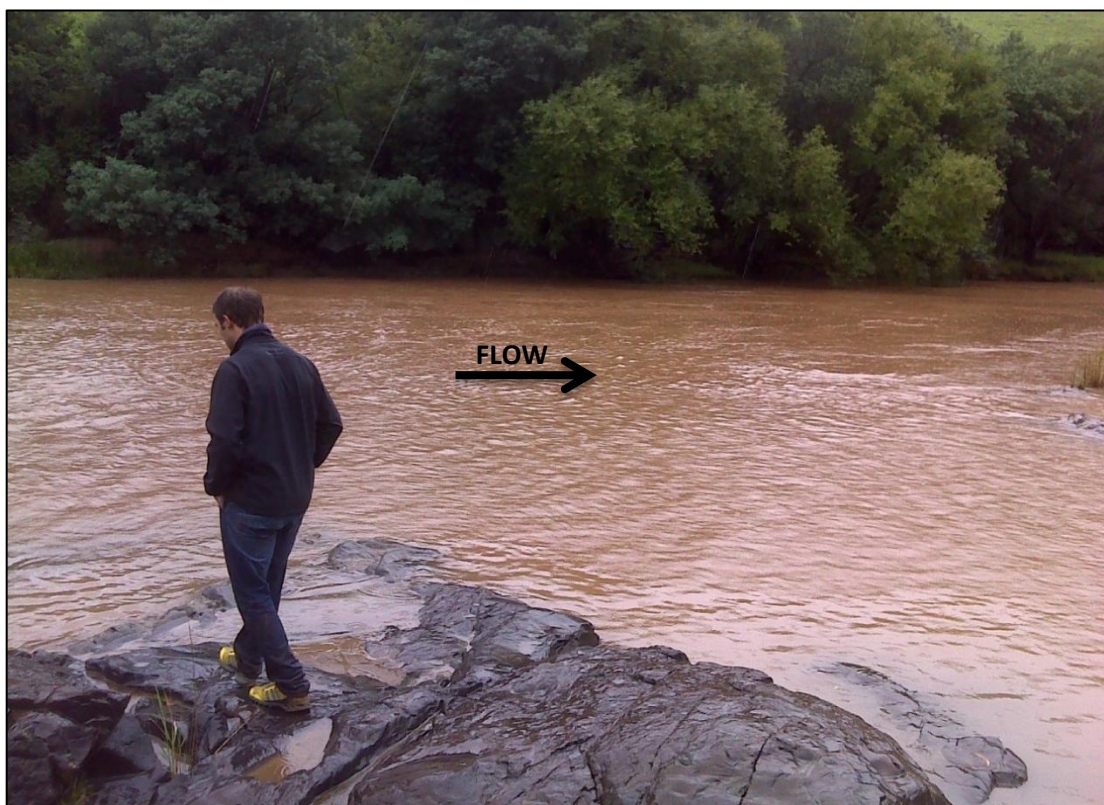
Figure 2.7 and **Figure 2.8** show the presence of rock material on both sides of the river. This is a good indication that there would be good founding material for the construction of a weir.

Figure 2.7 Downstream of Impendle Dam - Site 2 exposed rock in river channel

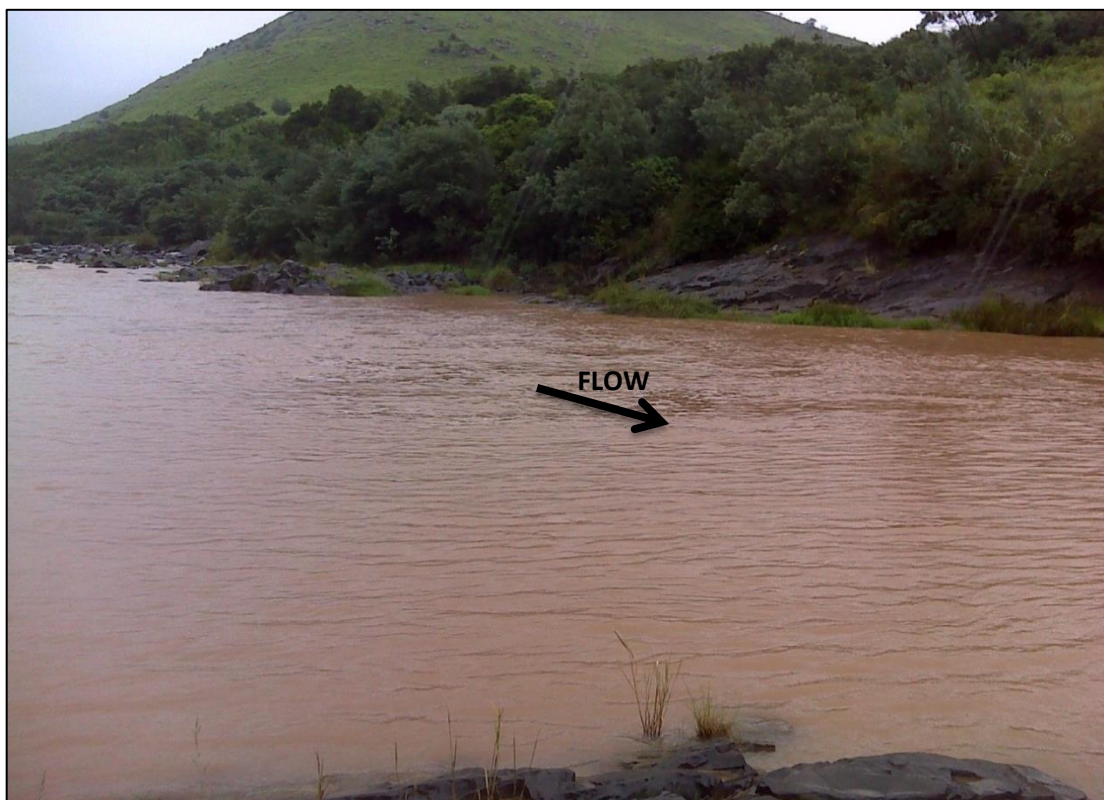
Figure 2.8 Downstream of Impendle Dam - Site 2 exposed rock in river channel and on river bank

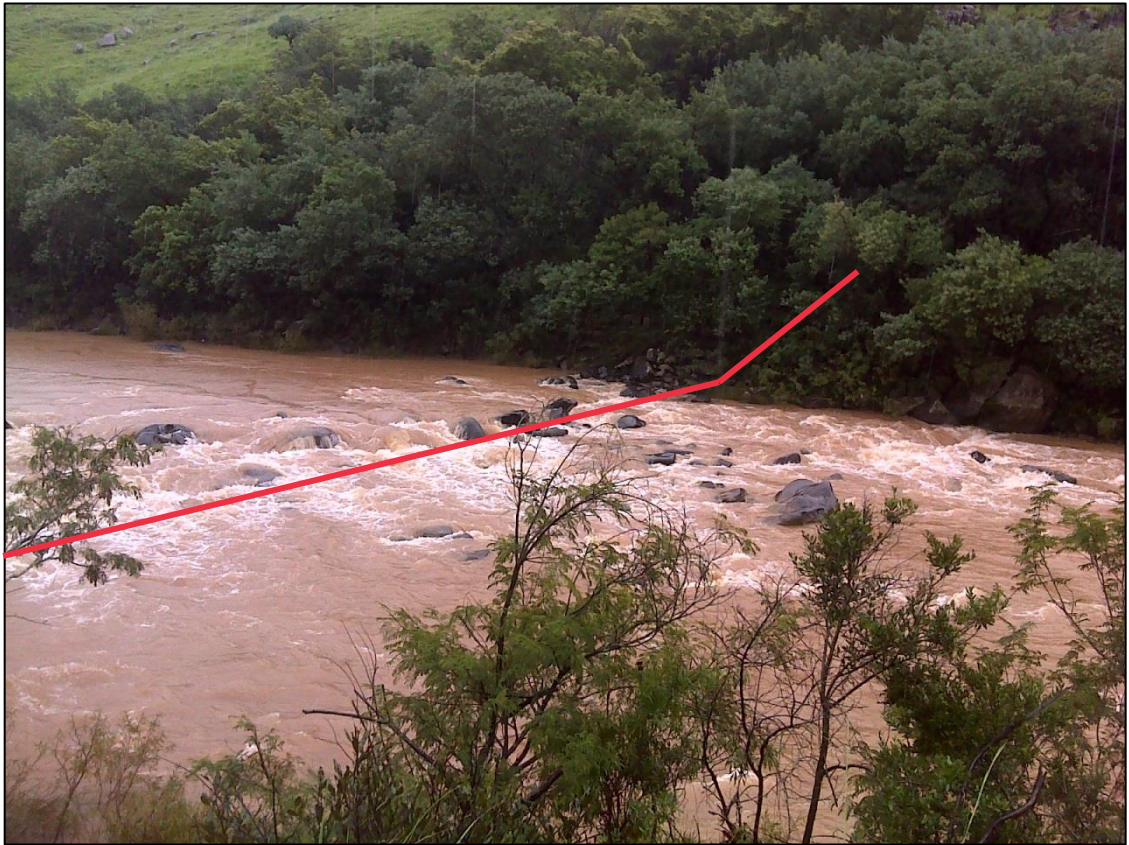
The centreline of the site selected for survey has been included below as **Figure 2.9**.

Figure 2.9 Downstream of Impendle Dam – Site 1 showing centreline to be surveyed

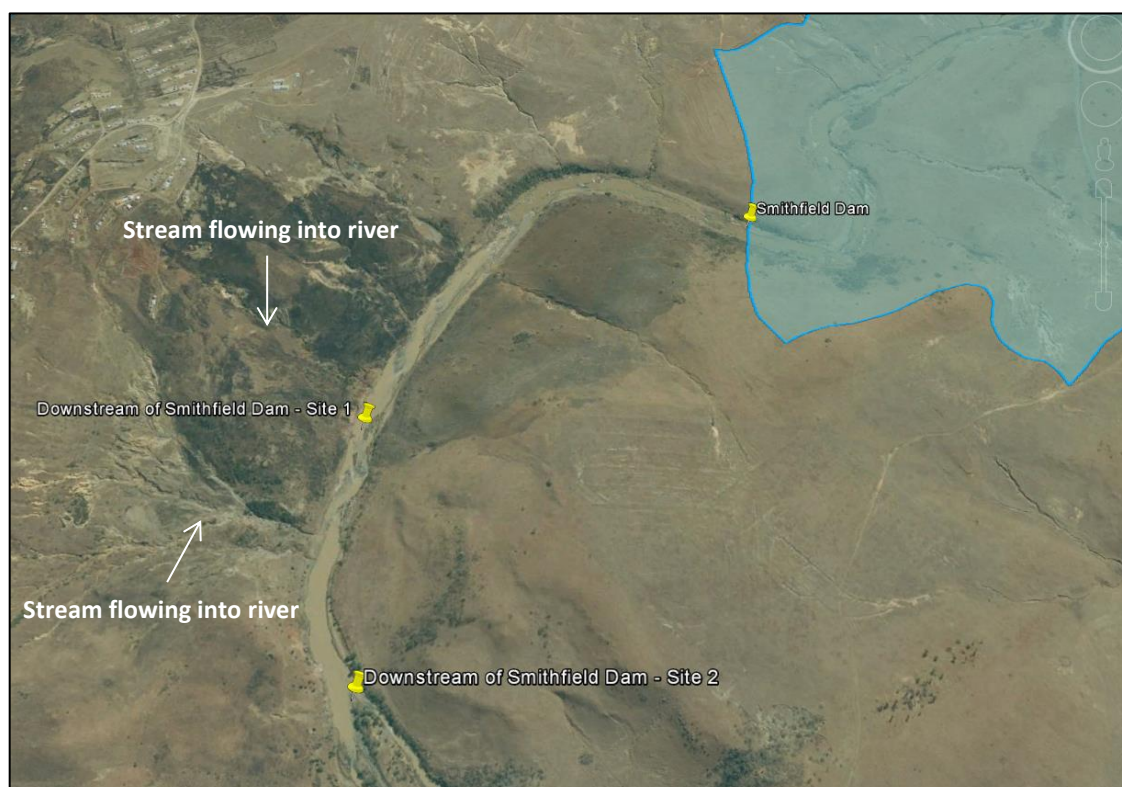
Two sites were examined within the first 2 km downstream of Smithfield Dam and these can be seen in **Figure 3.1**, below, as can the FSL (930 masl) of Smithfield Dam which is drawn in blue. The sites are at coordinates 29°46'53.09"S 29°55'52.70"E and 29°47'11.91"S 29°55'53.11"E, respectively. It was desirable to be as close to the dam as possible, this meant that the first straight section after the wall was also examined. This position, however, will become the plunge pool for the chute from the dam and thus, could not be considered further.

Figure 3.1 Possible locations of proposed gauging weir downstream of Smithfield Dam

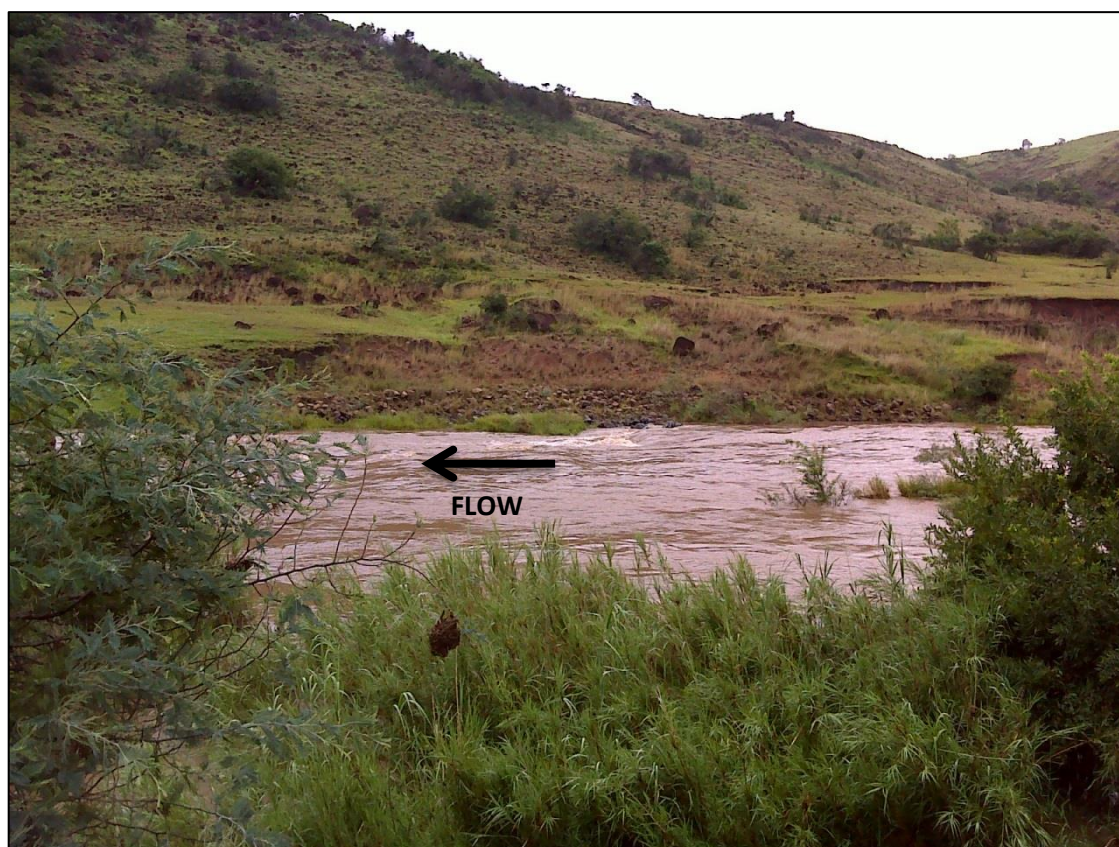
Figure 3.3 indicates that immediately downstream of the chosen site the bed slope of the river increases slightly, accelerating the water. This would help to reduce the chances of inundation.

Figure 3.3 Downstream of Smithfield Dam – Site 1 viewed from river level on the left side showing some exposed rock and an increase in the bed slope

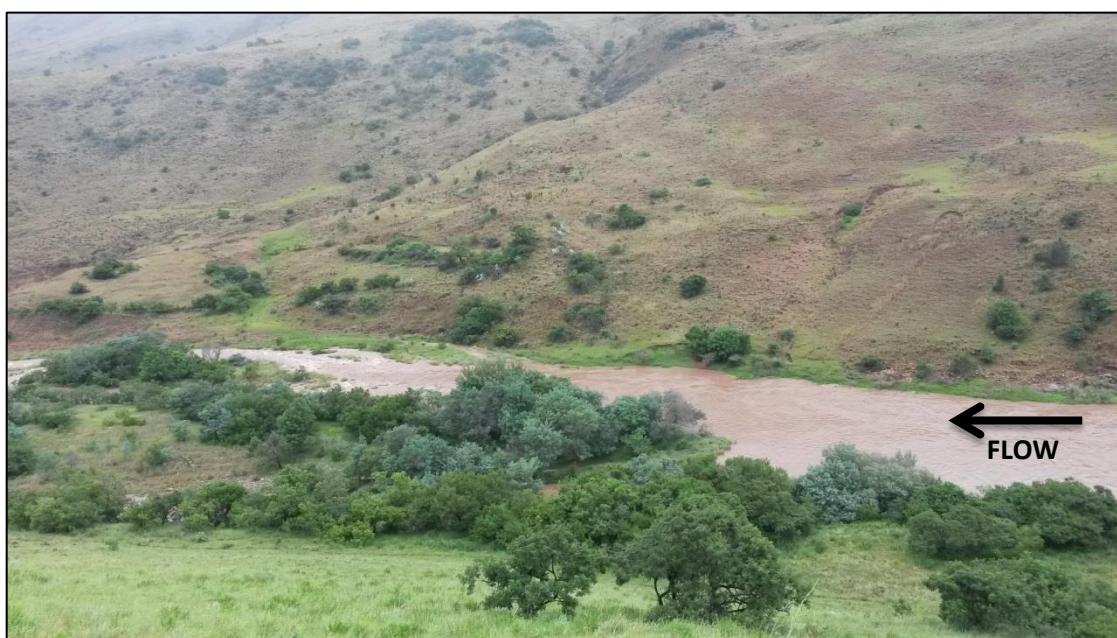
As can be seen in **Figure 3.5** there is a straight approach channel, approximately 150 m long, leading up to the proposed site 2. There is a bend, however, just before this which is visible in **Figure 3.6**.

Figure 3.5 Downstream of Smithfield Dam – Site 2 viewed from top of left bank

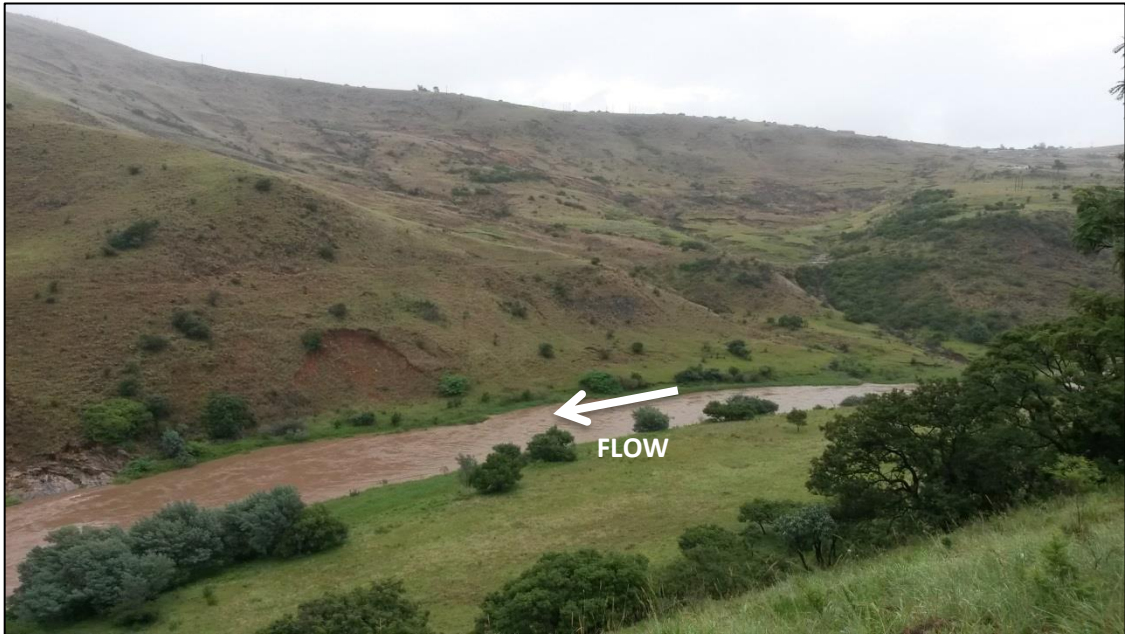
Figure 3.6 Downstream of Smithfield Dam – Site 2 viewed from top of left bank

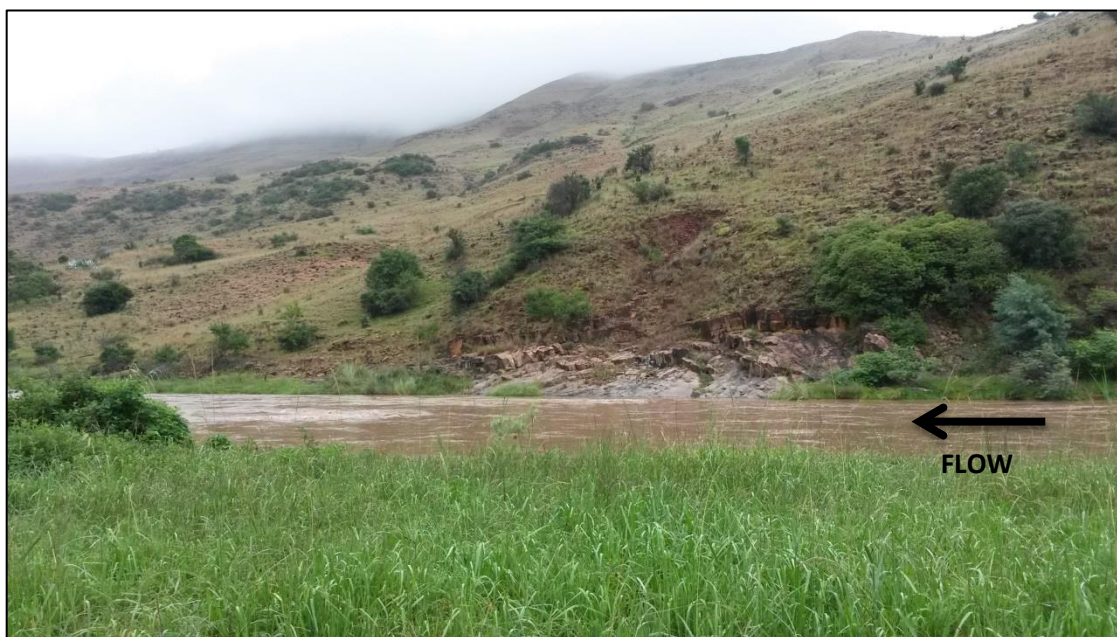
At site 2 the river is slightly wider (± 60 m) than site 1, although the steeper banks would suggest that there may be less excavation required in order to find good founding rock on which to construct. The width of the site suggests that the straight length of pool leading up to it may be slightly too short to meet the guidelines as set out by *Van Heerden, et al. (1986)*. **Figure 3.7** shows exposed rock face seen on the right bank of the river approximately 60 m upstream of the proposed site 2 indicating again that excavation may be easier at site 2.

Figure 3.7 Downstream of Smithfield Dam – Site 2 showing exposed rock face on the right bank upstream of the proposed site

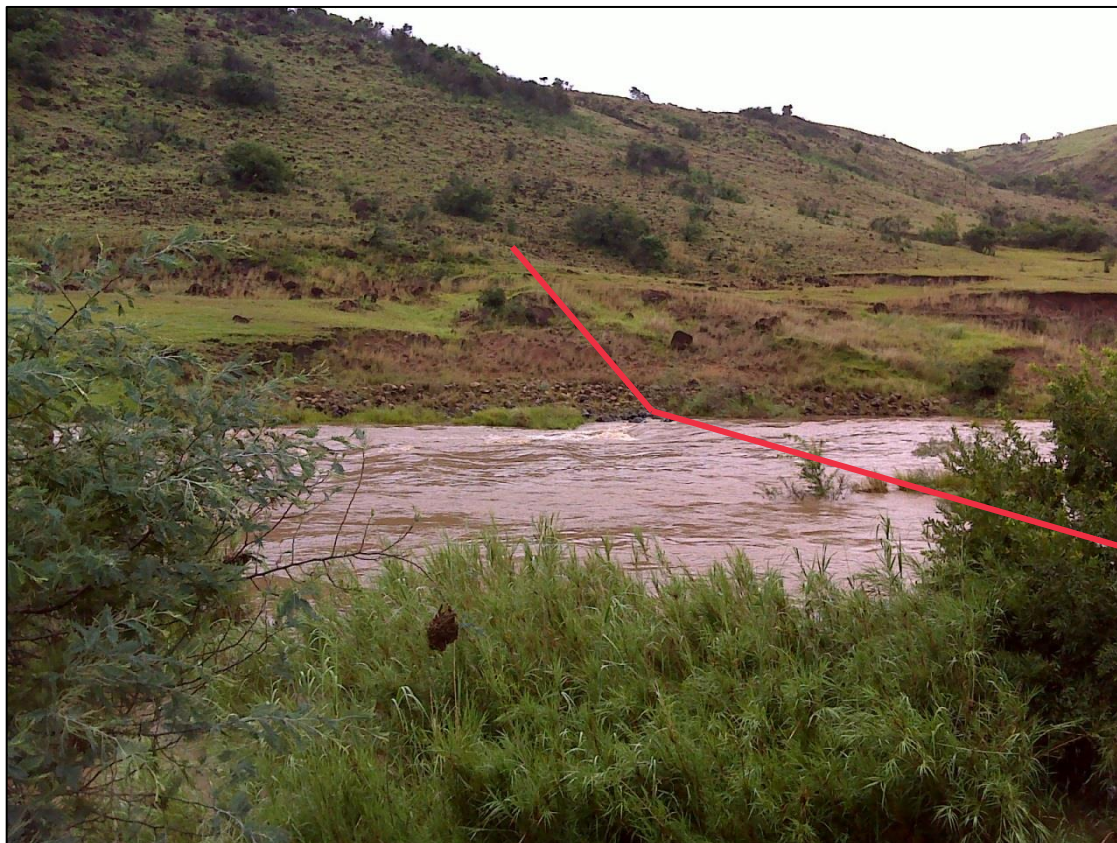
The centreline of the site selected for survey has been included below as **Figure 3.8**.

Figure 3.8 Downstream of Smithfield Dam – Site 1 showing centreline to be surveyed

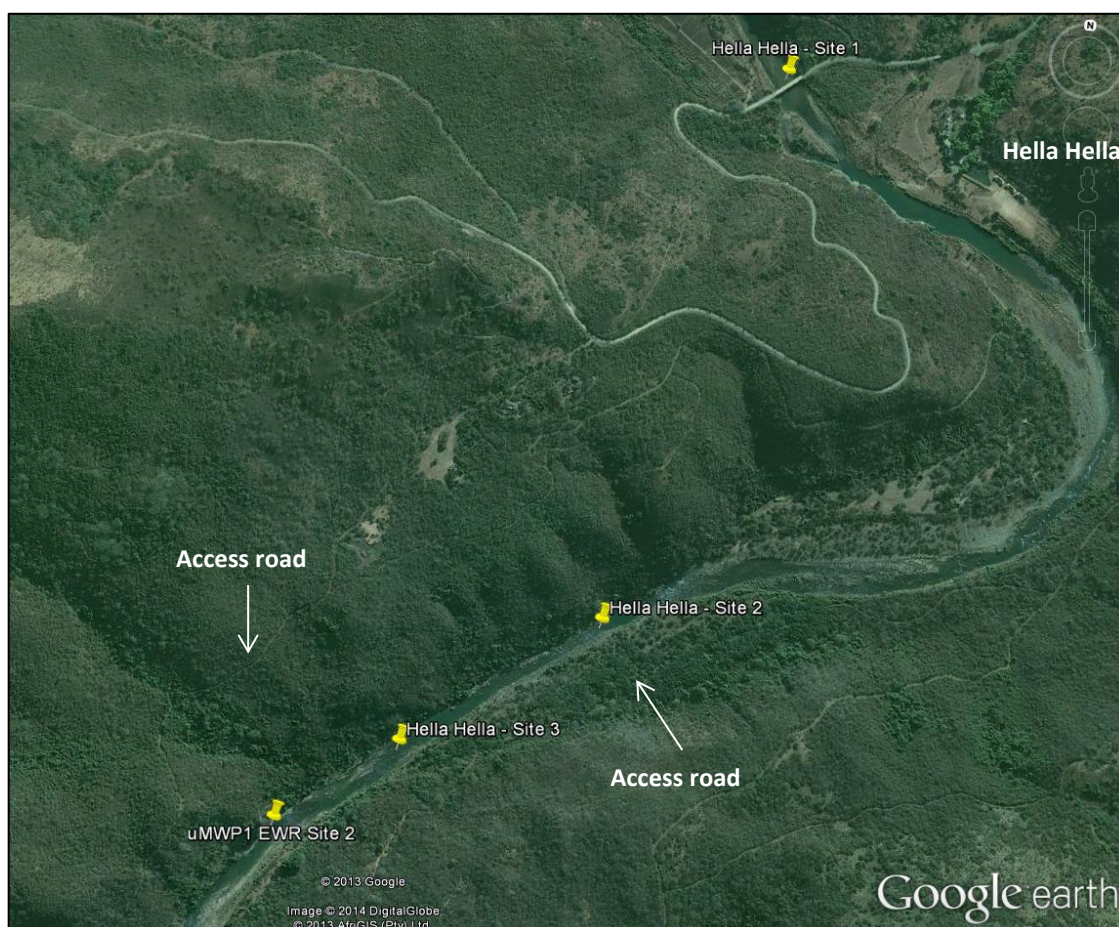
The third gauging weir was required to determine the runoff from the incremental catchment downstream of Smithfield Dam, to account for this in determining the magnitude of EWR releases from the dam. Three sites were examined at this location near Hella Hella, along the uMkhomazi River. The furthest downstream (site 3) being ± 2.5 km downstream of the bridge next to site 1 as shown in **Figure 4.1** and **Figure 4.2**. The coordinates of the sites are $29^{\circ}54'26.72''\text{S}$ $30^{\circ}5'39.28''\text{E}$ (site 1), $29^{\circ}55'2.93''\text{S}$ $30^{\circ}5'28.76''\text{E}$ (site 2) and $29^{\circ}55'12.31''\text{S}$ $30^{\circ}5'14.26''\text{E}$ (site 3). Also indicated on **Figure 4.1** are the access roads and the uMkhomazi River IFR/EWR site 2 that has been selected as part of the *Mkomazi IFR Study (IWR Environmental, 1998)*.

Figure 4.1 Possible locations of Hella Hella gauging weir

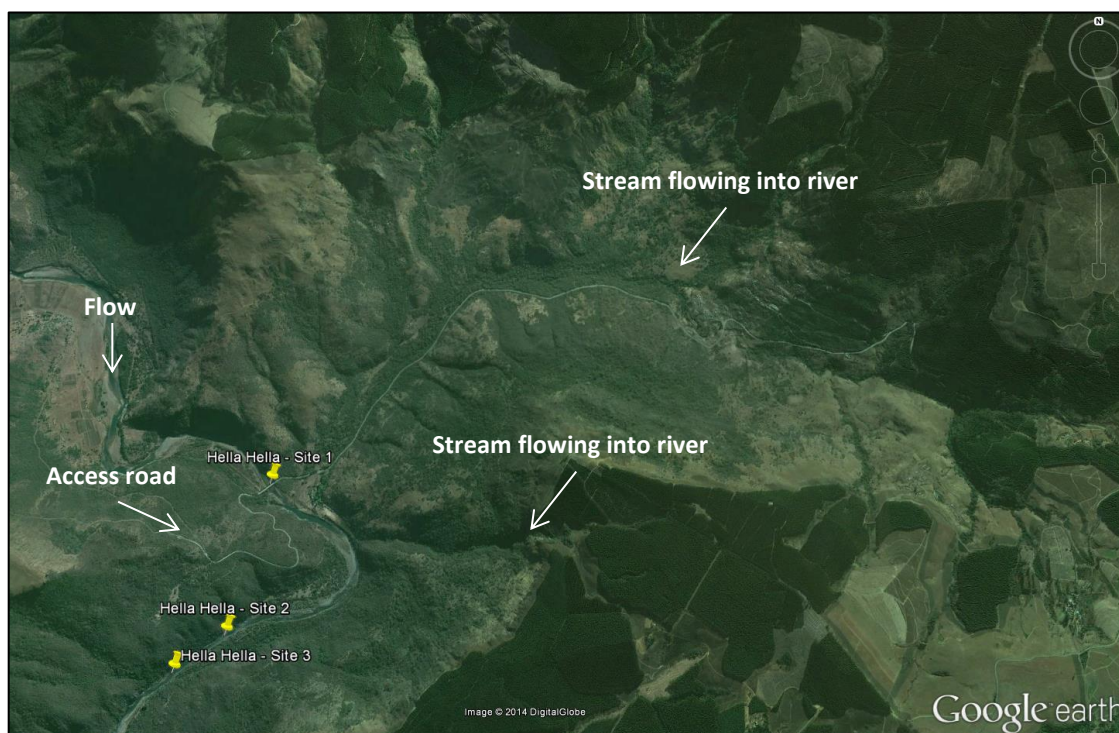
Figure 4.2 Possible locations for Hella Hella gauging weir and streams flowing into the river below site 1

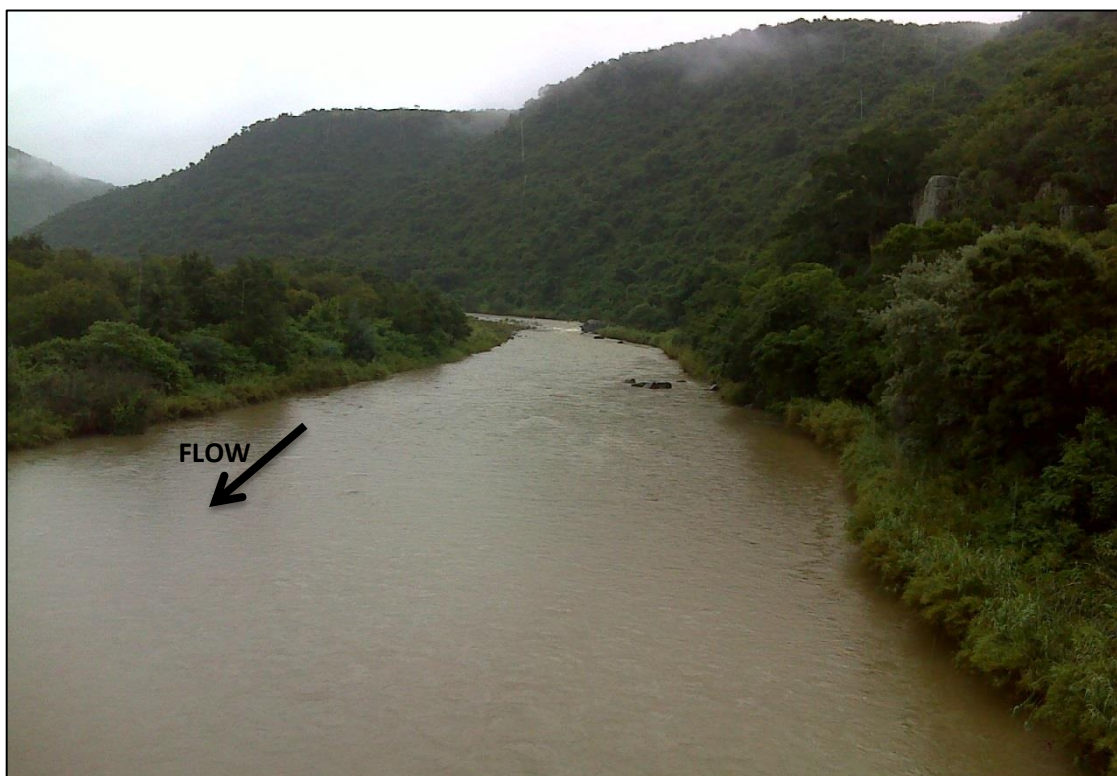
At the proposed location of the weir the uMkhomazi River is about 50 m wide and there is a long straight section of about 230 m leading up to the site (as seen in **Figure 4.3**) and, thus, the flow profile should be steady and fully developed.

Figure 4.3 Hella Hella – Site 1 viewed from the bridge looking upstream

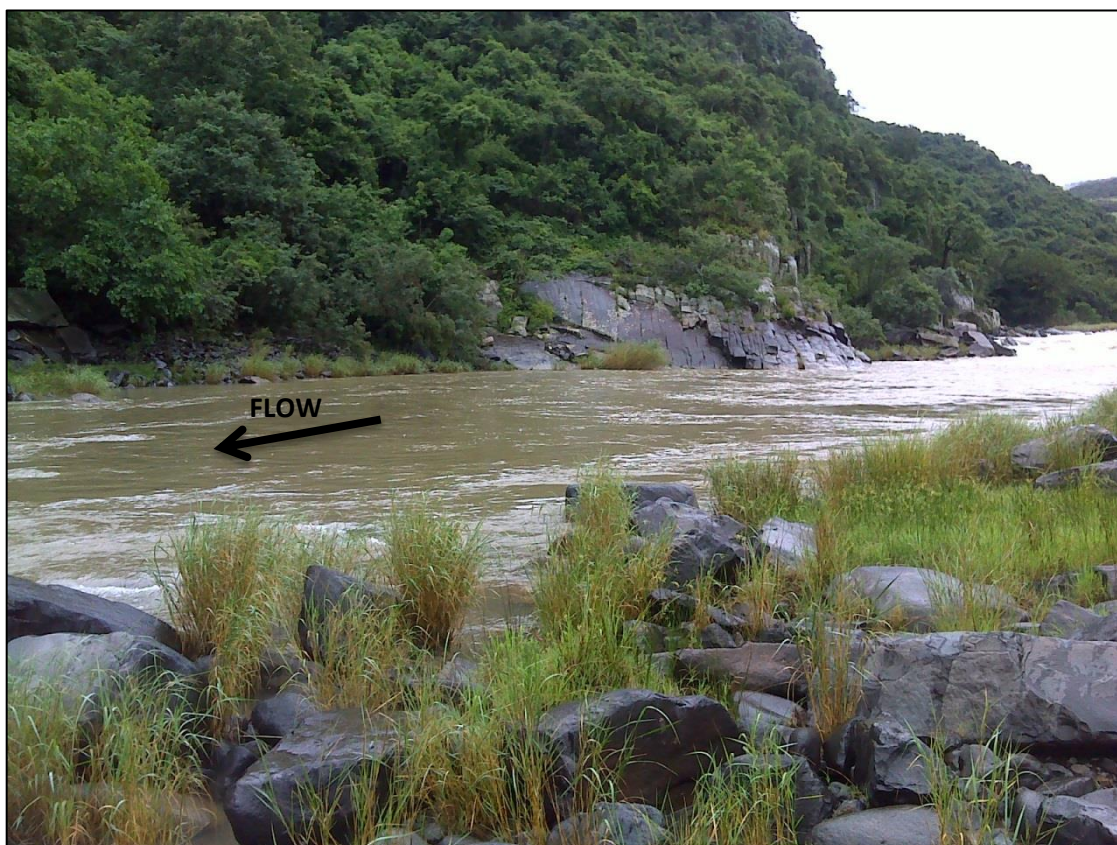
The river at the position of this site is approximately 20 m wide and has a straight section leading up to the site of more than 200 m, however, there is a section of aerated water approximately 100 m upstream of site 2 as seen in **Figure 4.5**. At the site there is also a small section of aerated water (**Figure 4.6**) and the bed slope increases; this would assist with avoiding inundation of the weir.

Figure 4.5 Hella Hella – Site 2 looking upstream from site

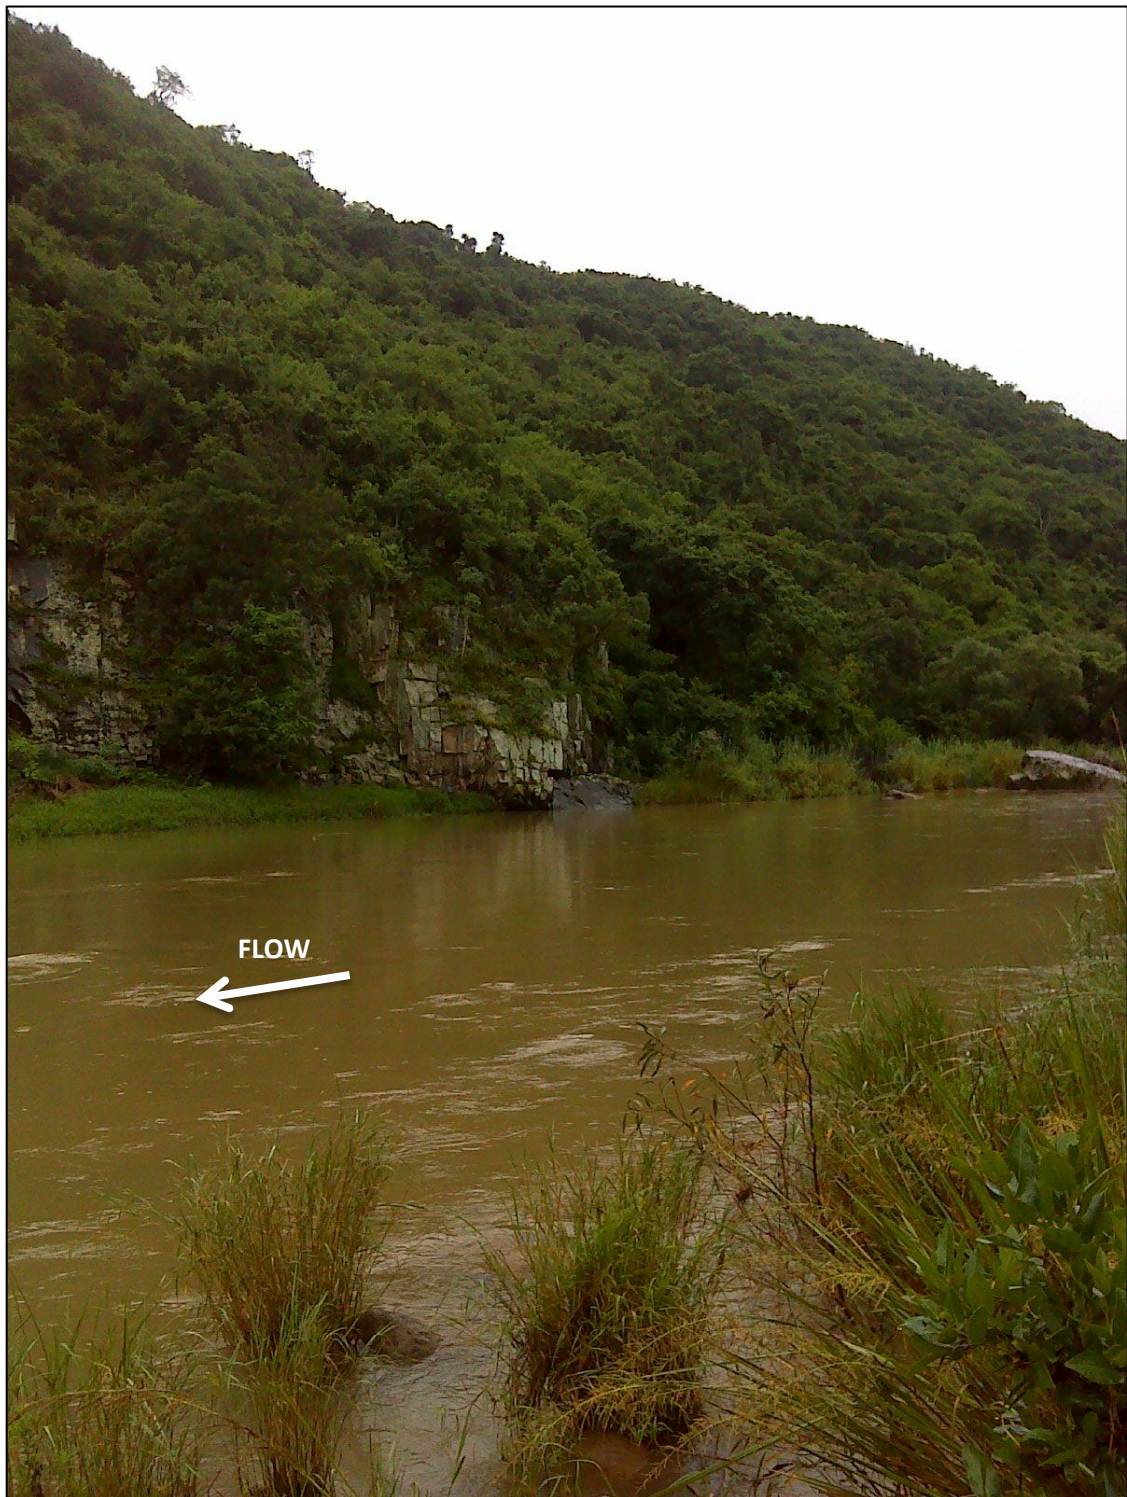
The site is on a long straight section of the river (± 550 m) and is at a point where the river width is approximately 30 m wide. The water leading up to the site is calm and developed as seen in **Figure 4.7** and appears to increase in velocity as it travels through the site (**Figure 4.8**) indicating that there may be an increase in the river bed slope.

Figure 4.7 Hella Hella – Site 3 looking upstream from the left bank

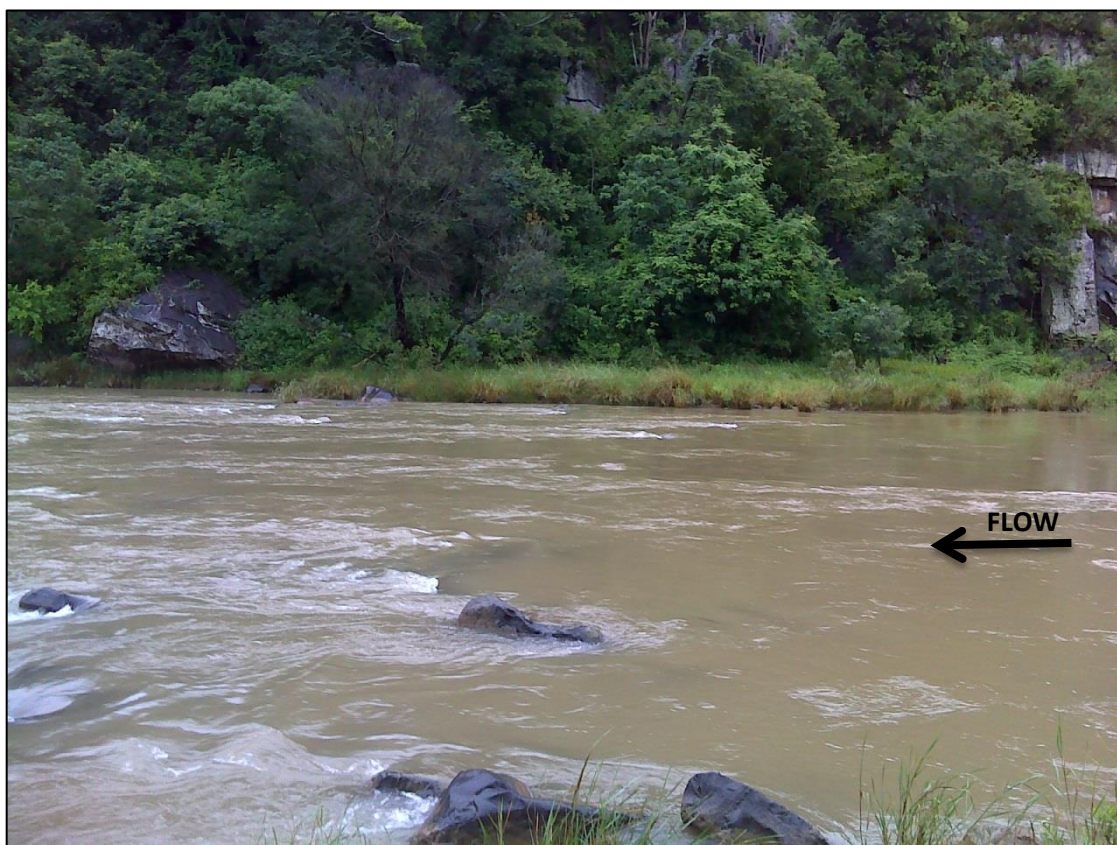
Figure 4.8 Downstream – Site 3 looking across river towards the right bank showing accelerating water and exposed rock

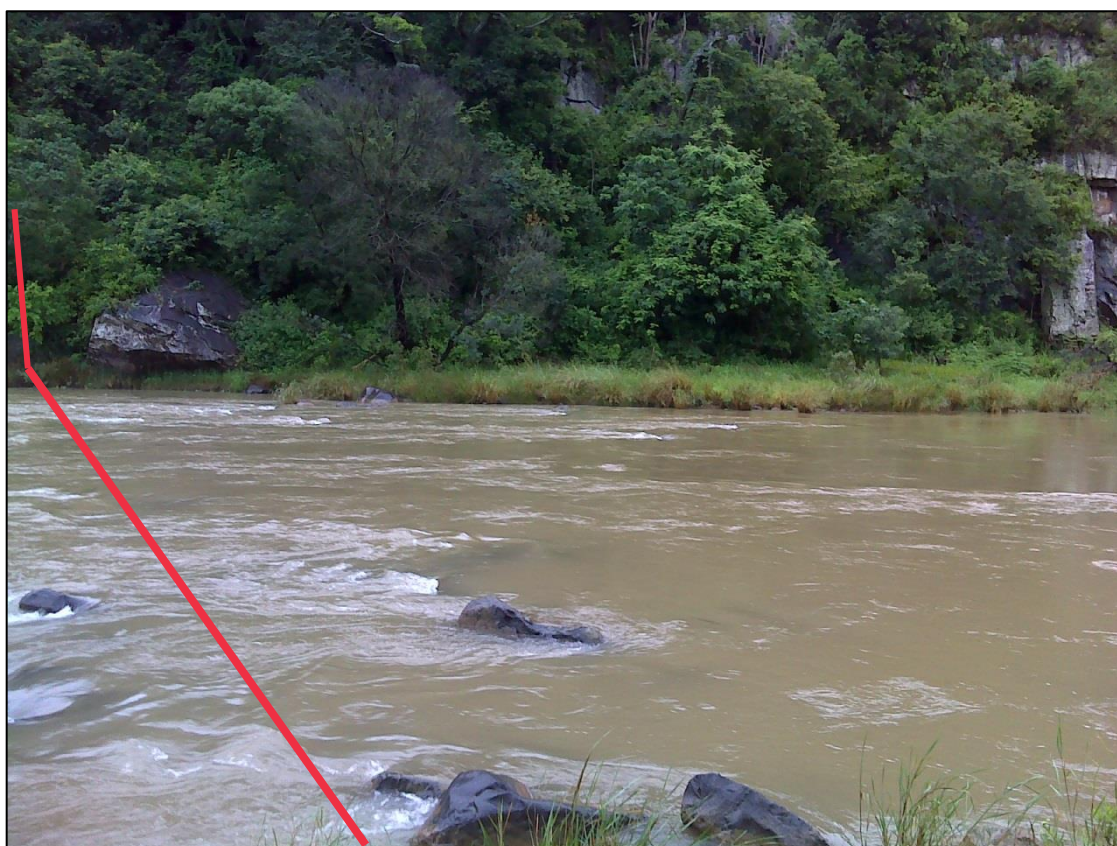
The centreline of the site selected for survey has been included below as **Figure 4.9**.

Figure 4.9 Hella Hella – Site 3 showing centreline to be surveyed

The big advantage to site 3 – and the reason it was ultimately selected as the preferred site – is the sites close proximity to the ecological water requirement (EWR) / instream flow requirement (IFR) monitoring point – EWR/IFR Site 2. This point has been indicated on **Figure 4.1** and one can also see in this image that there are two streams joining the river downstream of site 1 and upstream of sites 2 and 3, which have been indicated in **Figure 4.2**. Since Smithfield Dam is going to have to release enough water to ensure sufficient flow at EWR/IFR Site 2 it is proposed that the gauging weir would be close to this point.
